**IN THE MATTER OF THE BOARD OF INQUIRY
INTO THE MCCRAE LANDSLIDES**

**ANNEXURES TO
WITNESS STATEMENT OF GERRARD RAYMOND BORGHESI**

CivilTest Pty Ltd Technical Memorandum dated 21 December 2023

RE: 10-12 View Point Road MCCRAE - Technical Memorandum

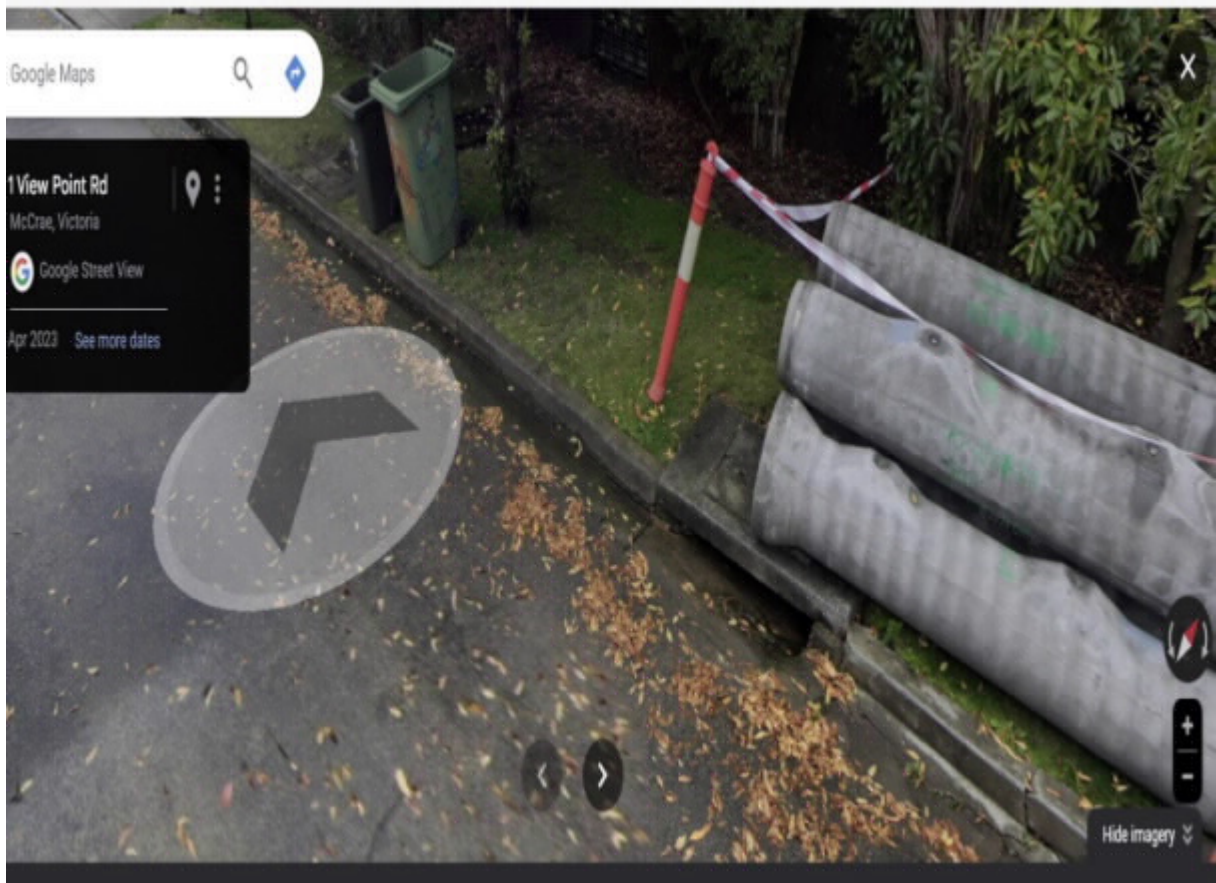
GB-2

“Photo of the Culvert”

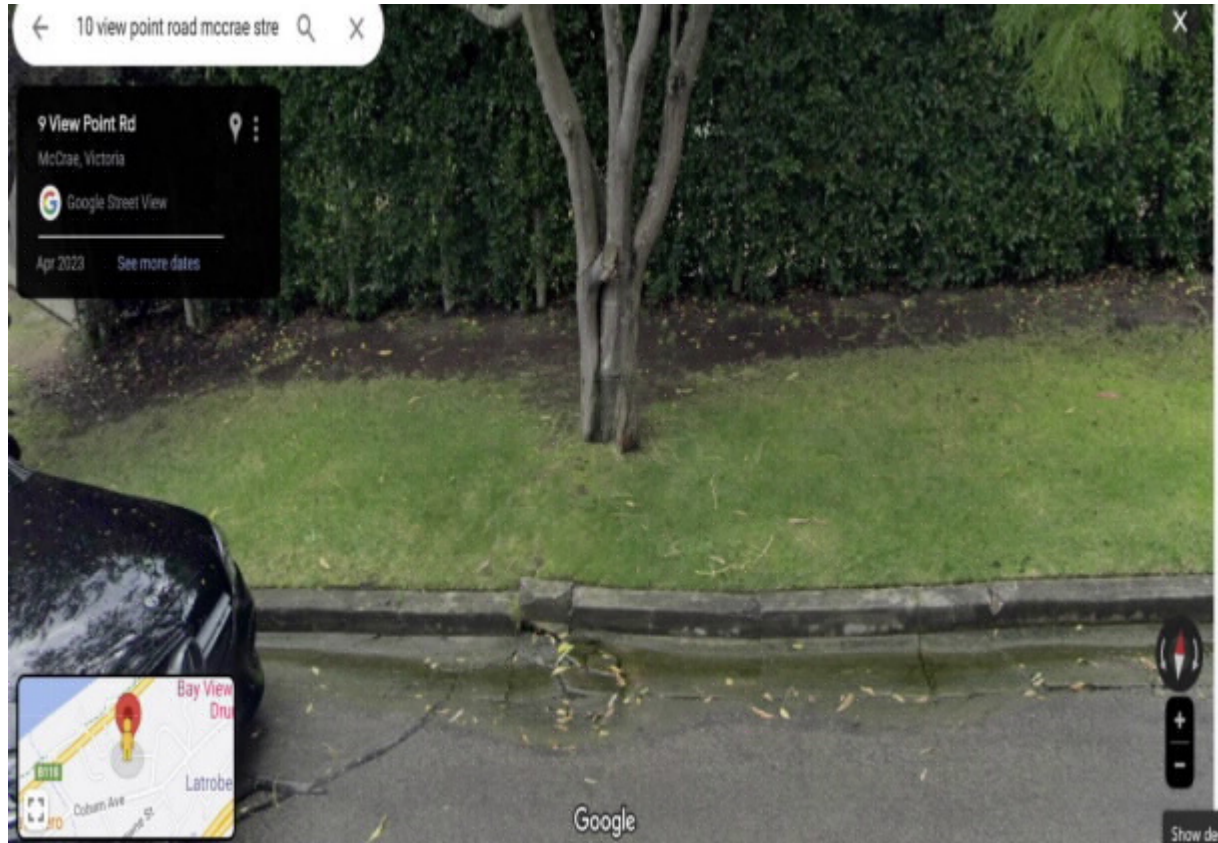
GB-3

“Image of the cracked northern kerb of View Point Road”

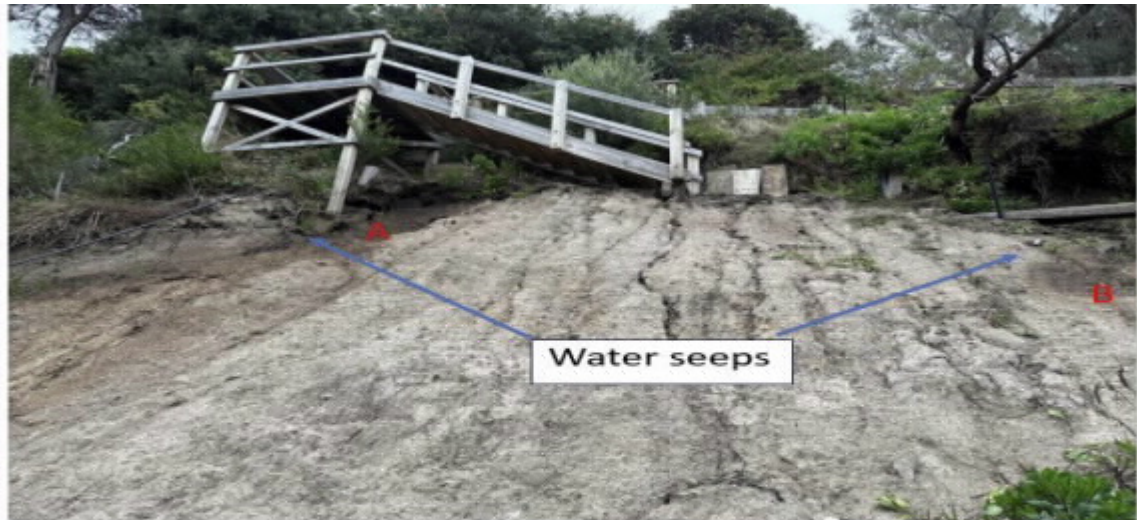
GB-4

“Seeps on Hillside”

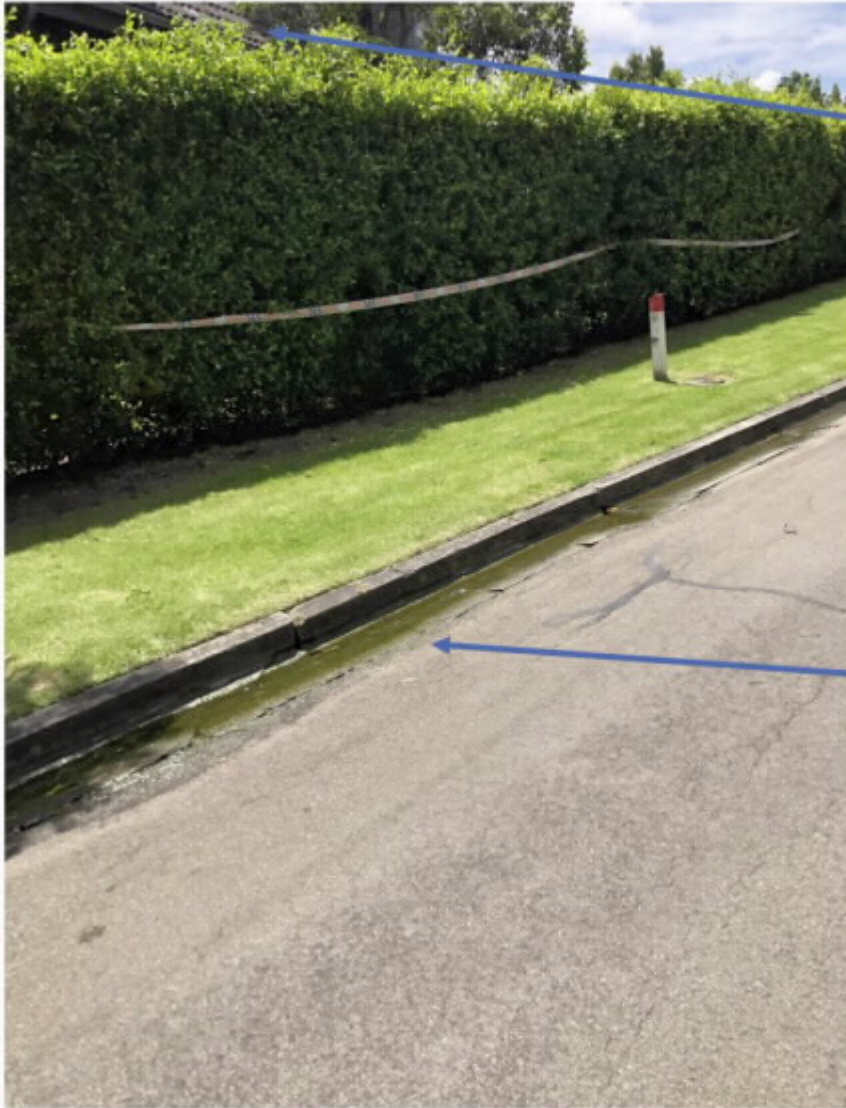
GB-5

"Moss and Algae"

Moss/Algae

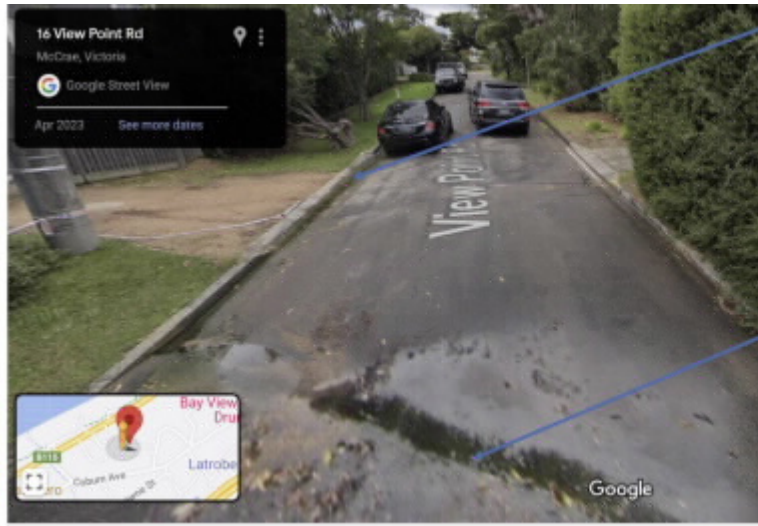
GB-6

void (picture 8) discovered
under cracked kerb

'Speed hump' installed by Council
to direct continuous water flow
to South side of View Point road

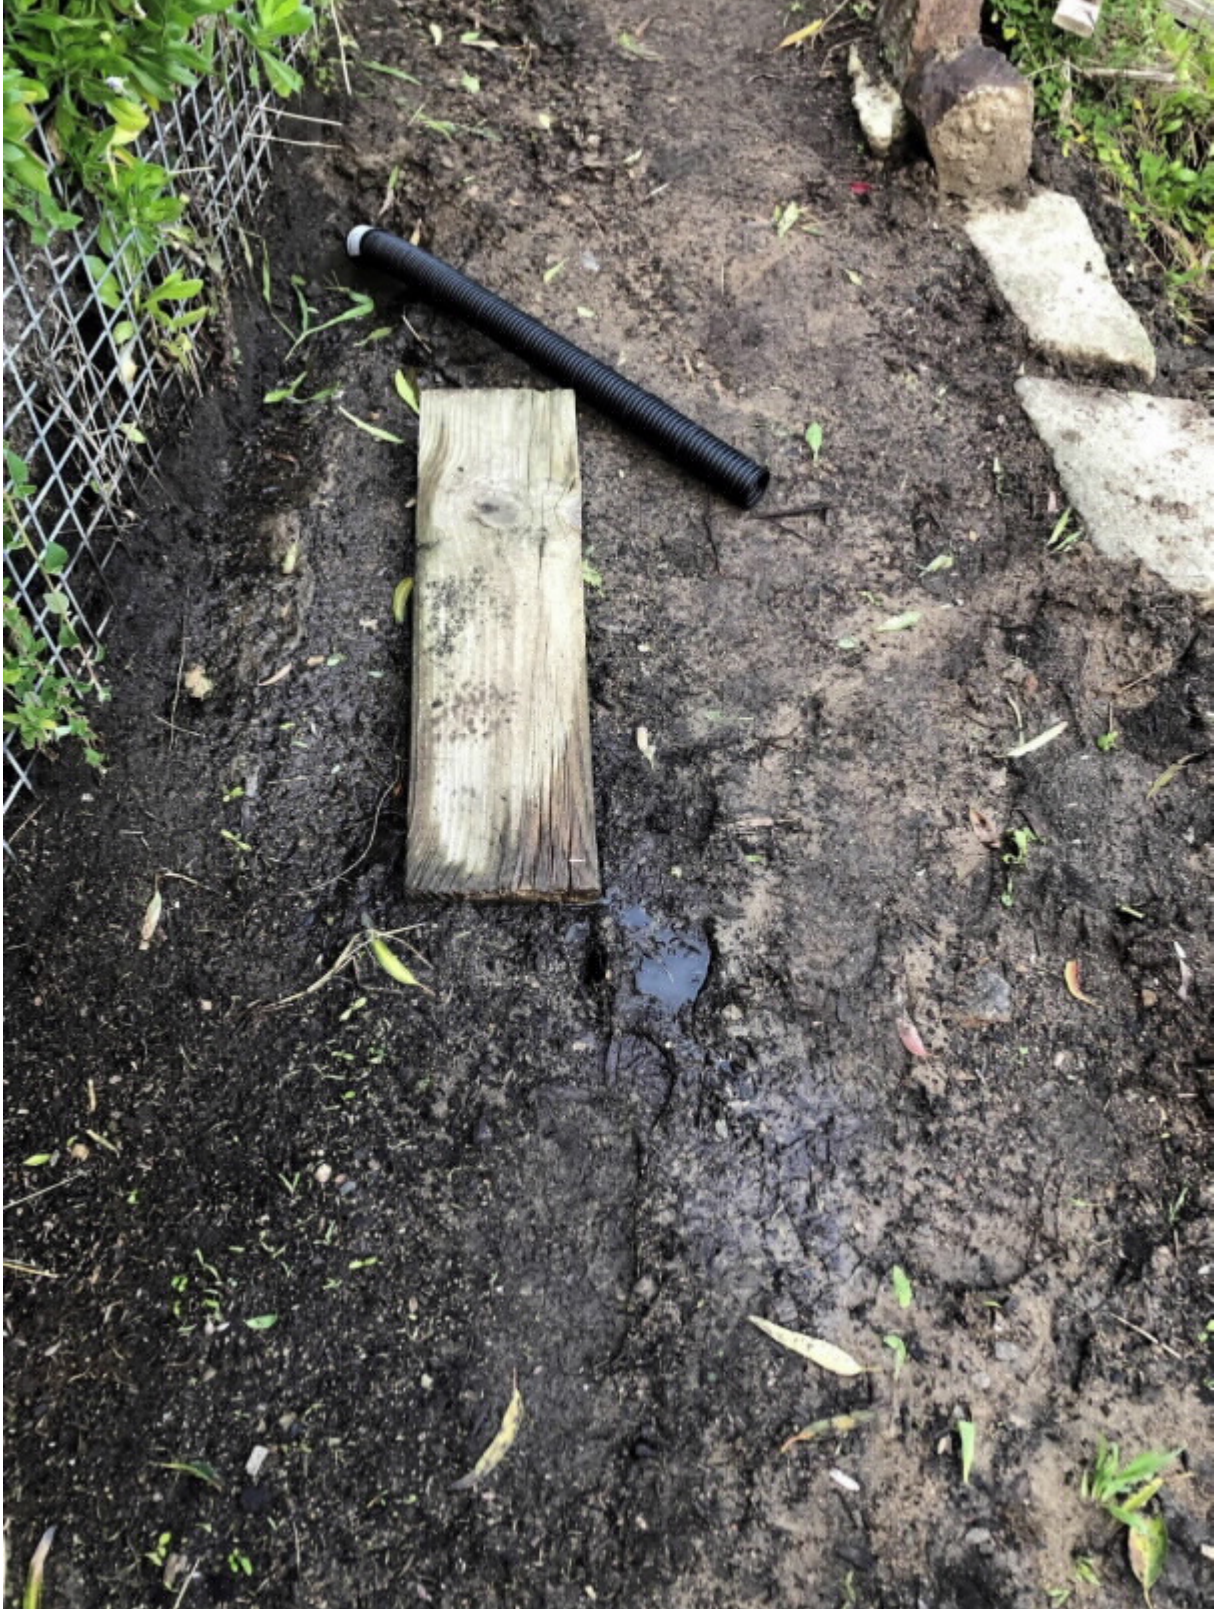
GB-7

“Saturated hillside where the aggie drains were installed”

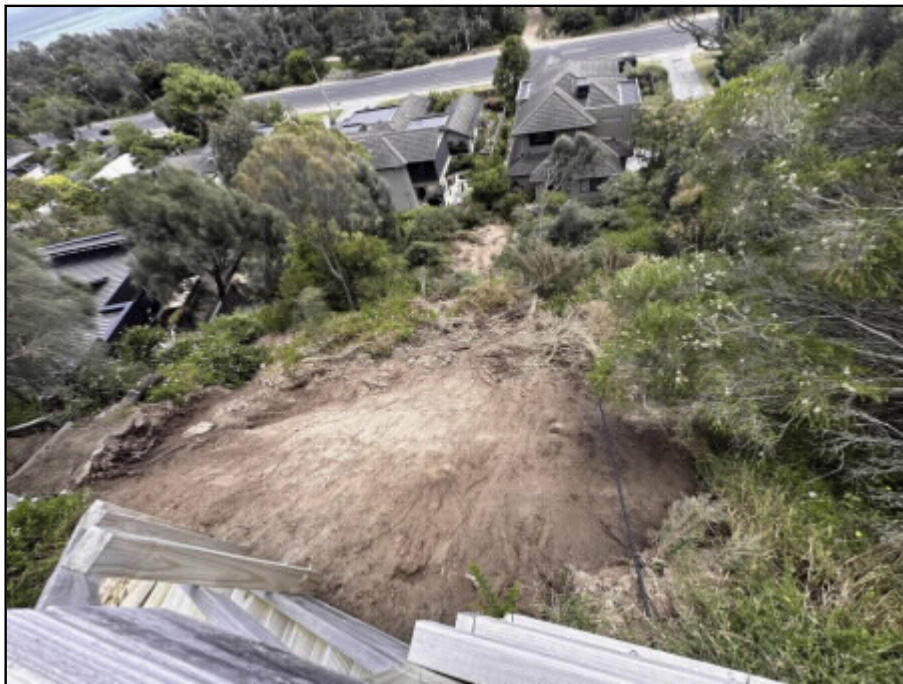
The inspected landslide can be classified as a Translational Earth FLOW, and this consisted of moist to wet sandy material and fine topsoil, which occurred along a distinctive planar surface of weakness. This planar surface of weakness is likely to be the interface of the upper Aeolian sandy material and the granitic residual soil, where the residual soil would be clayey and have lower permeability. Perched water could form at the abovementioned sandy material and granitic soil interface, which significantly reduces the shear strength of the material and forms a weak shear plane. The client has reported “three natural seeps” on the slope. The exposed batter near the top of the slide still showed moisture ingress at the surface at the time of the site inspection on 29 November 2022, which was conducted on a dry day. This is strong evidence of perched water forming at the materials interface due to the soil profile and topography of the area.

Figure 3: View looking down on the landslide

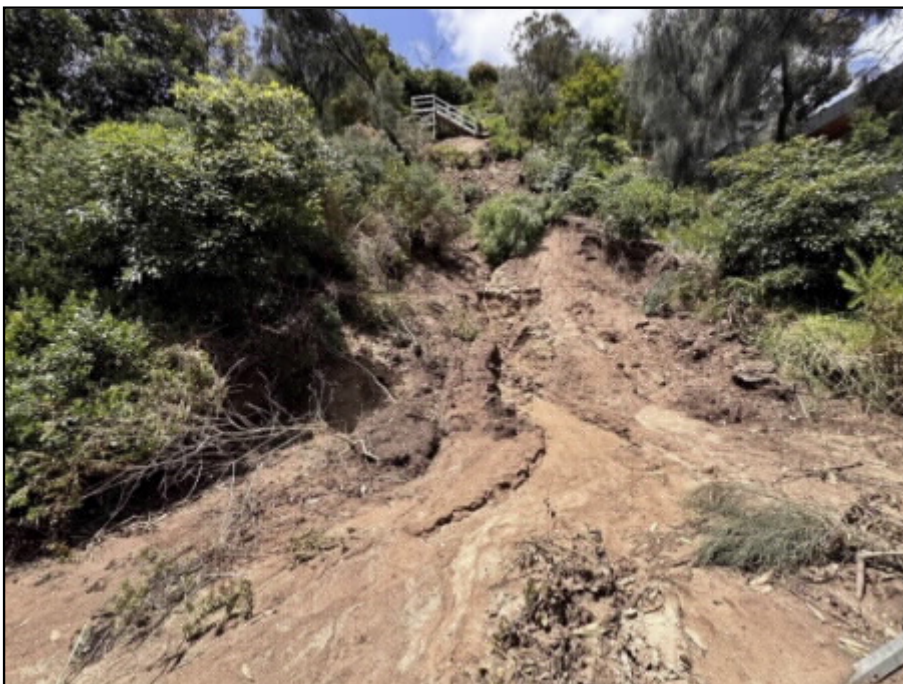
Figure 4: View looking up at the landslide

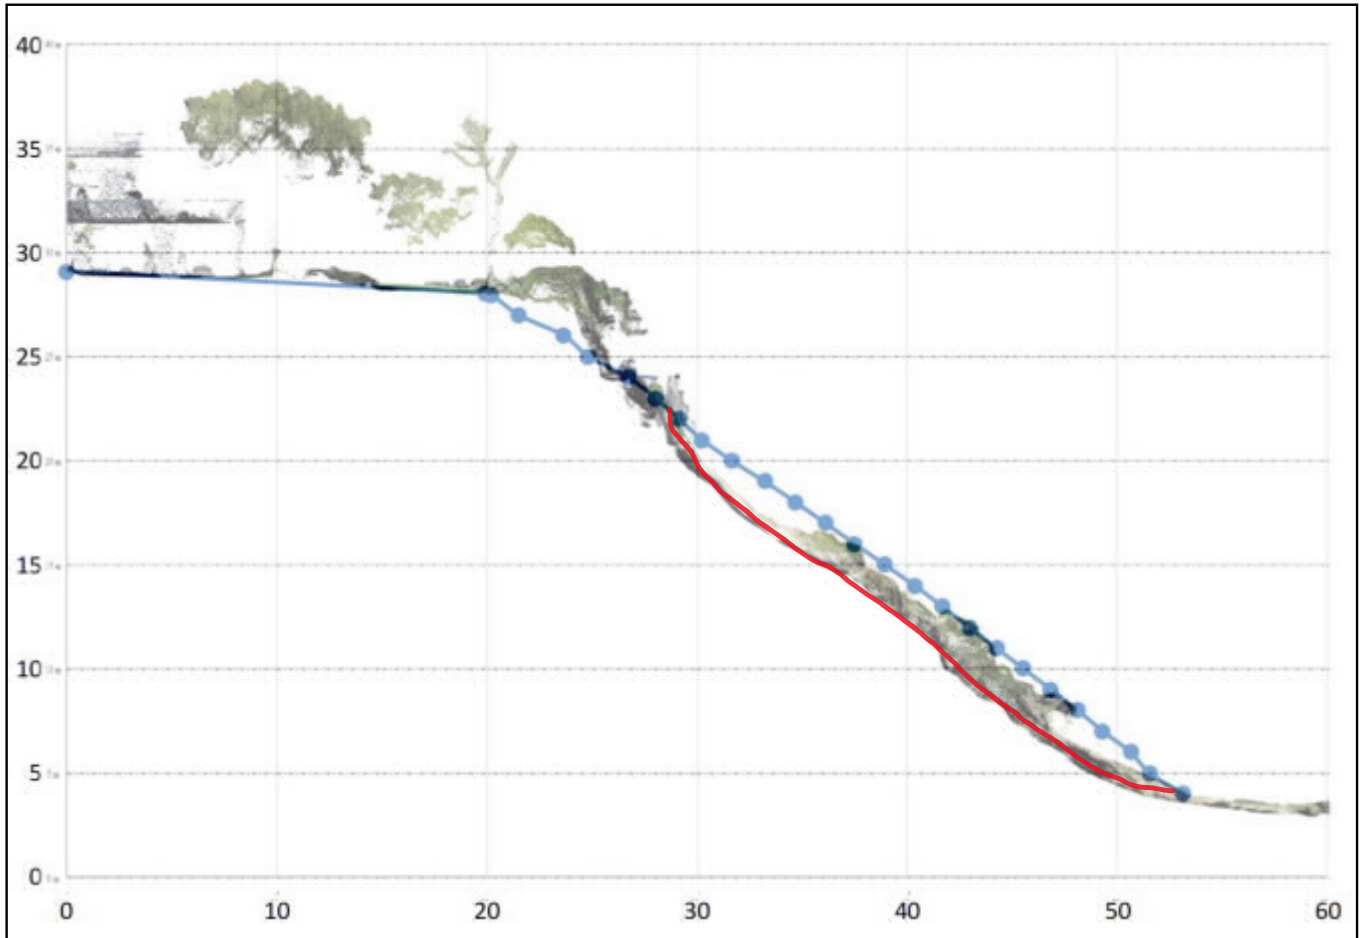
Figure 5: Before and After the Landslide, Section Comparison

The two surveys have been overlaid and a section (A-A) cutting through the location of the landslide has been obtained from both surveys to estimate the extent of the Earth FLOW. The section overlay is shown on **Figure 5** above. The blue dotted line represents the ground levels before the landslide. The background image showing trees represents the surface levels after the landslide event. The red line represents the estimated extent of the Translational Earth FLOW. The width of the section is approximately 8m from the top and the width varies with distance from the top. The material between the red line and blue dotted line is the residual disturbed earth that stopped moving at the middle to lower section of the slope, which did not flow down to the base of the slope. It should be noted that the contours provided in the abovementioned feature survey are at 1m intervals. The owner suggested the original slope was uniform, which is reflected in the feature survey. The original slope was approximately 35 degrees with the horizontal. It is possible that the feature survey has produced higher than actual ground levels due to the previous vegetation cover in the area and the steepness of the site, causing access issues for the Surveyor to survey the slope. Also, 1m contour intervals on the feature survey drawing would indicate the levels in between the contour lines are estimated. The estimated undisturbed part of the slope after the landslide has similar steepness, except the levels are 1m to 2m lower than the original levels, and the head scarp on the top is now much steeper, approximately 45 degrees.

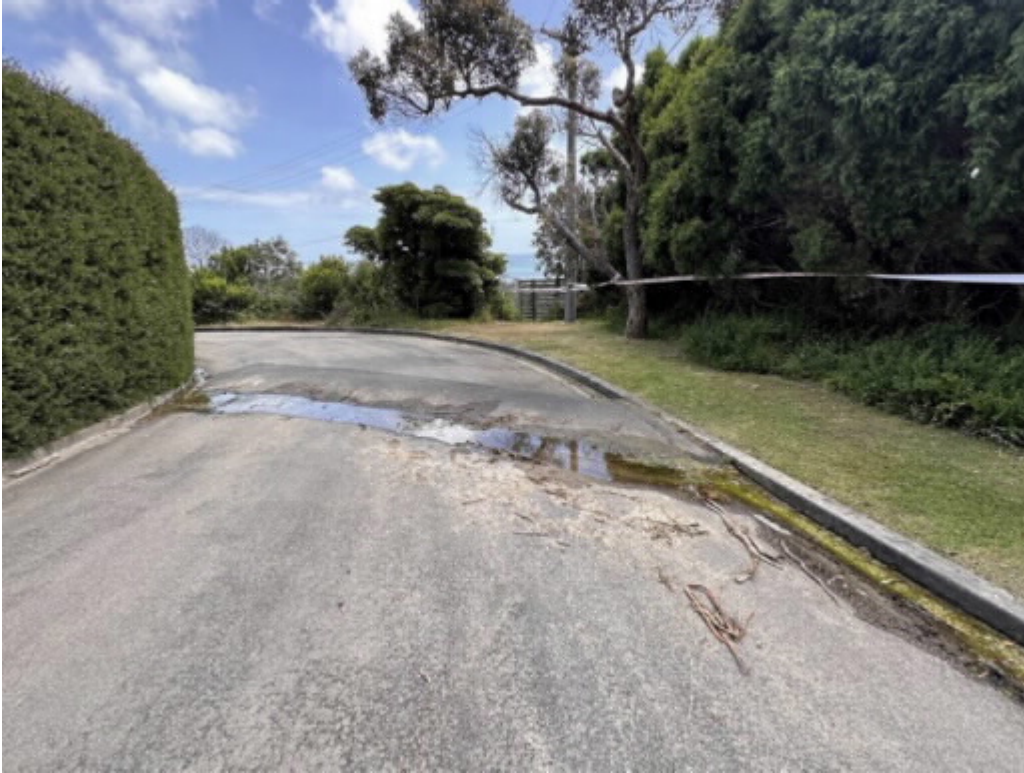
It is noted that on 29 October and 2 November 2022 (both of which were sunny days), there was continuous water flowing along the kerb drain on View Point Road. The point of discharge of the drain is at the end of View Point Road, which is not far from the subject landslide area. A hump was built onto the surface of the road to divert water from one side of the kerb on View Point Road to the other side. There were signs of cracks and bitumen patching along the kerb on View Point Road. The diverted runoff would then seep into the nature strip and flow at/along the interface of the sandy and clayey soils, following gravity, towards the landslide area. This would be the most likely trigger for the landslide, as the road drain collects surface runoff from a much larger catchment area, and the continuous flow through the cracks and possible voids would build up abnormal hydraulic pressure at the sandy and clayey soil interface, especially following the storm event that occurred the day before the landslide.

Figure 7: Water running along the kerb on View Point Road

Based on available Nearthmap aerial images, The hump shown in Figure 7 was built around 10 years ago for diverting any surface runoff from the kerb on the northern side of the road to the southern side of the road, so water can flow towards the drainage pit at the end of View Point Road. This intercepts the natural flowpath of water, which in turn led to building up of surface water on the kerb on the northern side of the road.

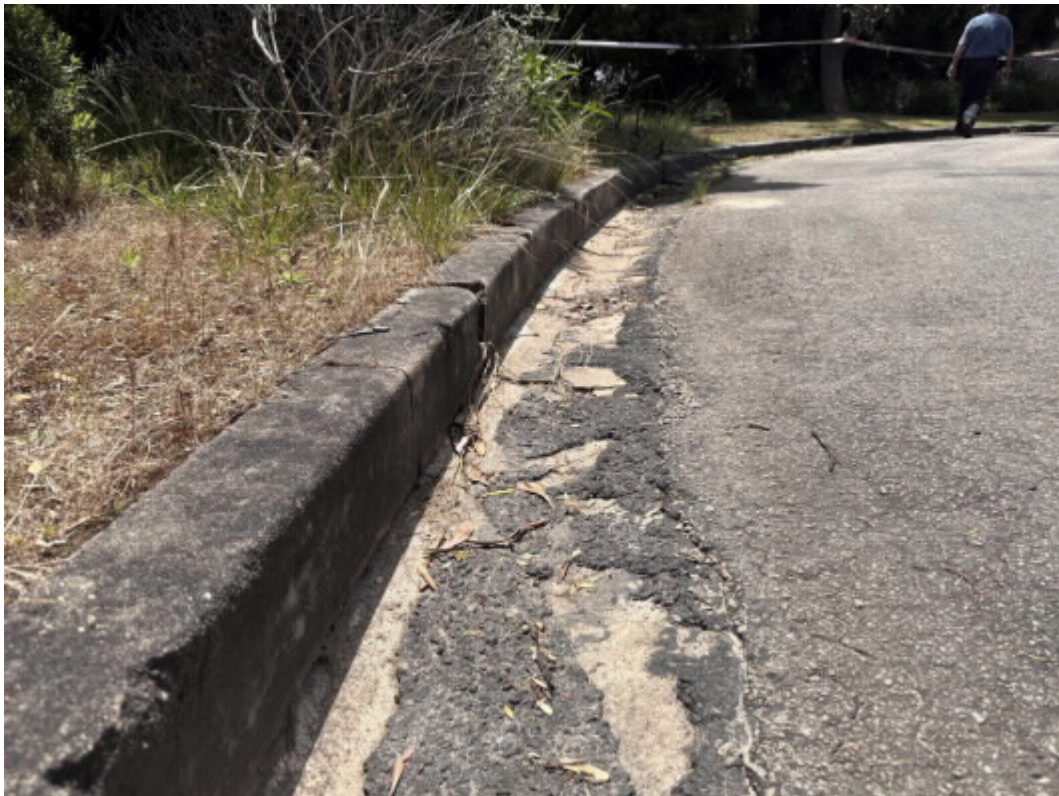
Figure 8: Cracks and patching along the kerb on View Point Road

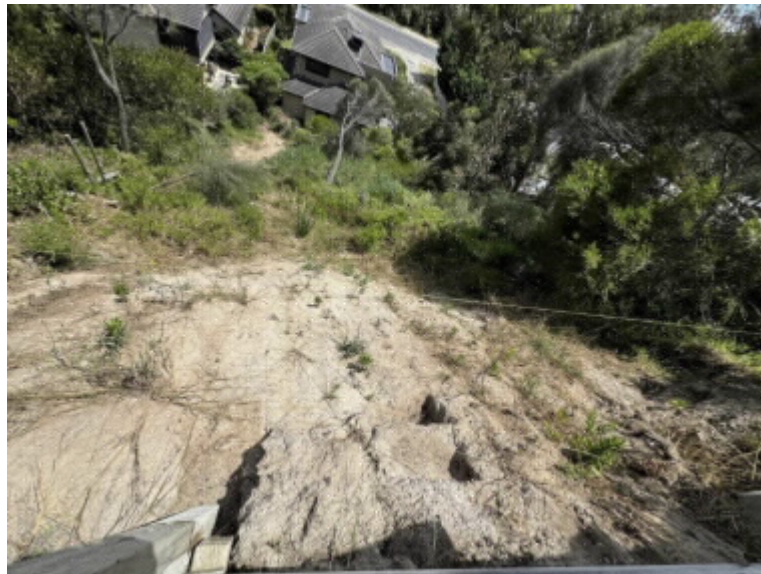
On 4 December 2023, a follow up site inspection was conducted by Civiltest and it was noted that further to the renewed road drainage installation conducted by the Council, the continuous seeps on the exposed hillside slope have dried out, as indicated in Figure 9 below.

Figure 9: Dried out head scarp (photograph taken 4 December 2023)

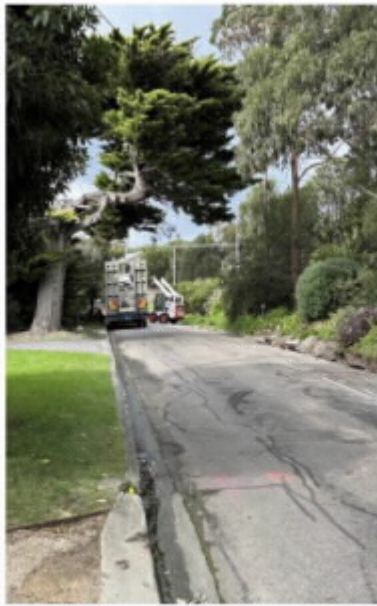
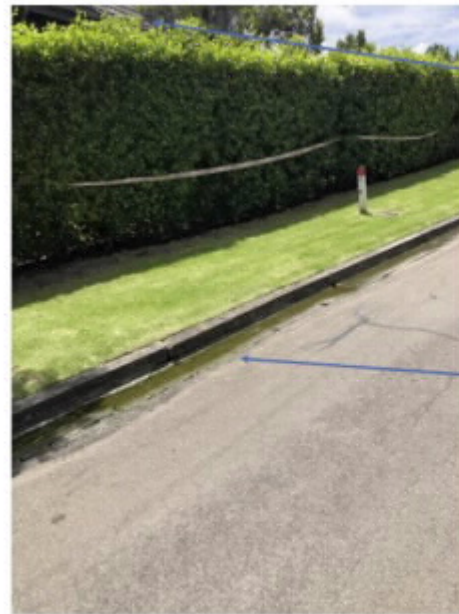
Pictures 3 and 4 – continuous water flow down View Point road, prior mid 2023 drainage works

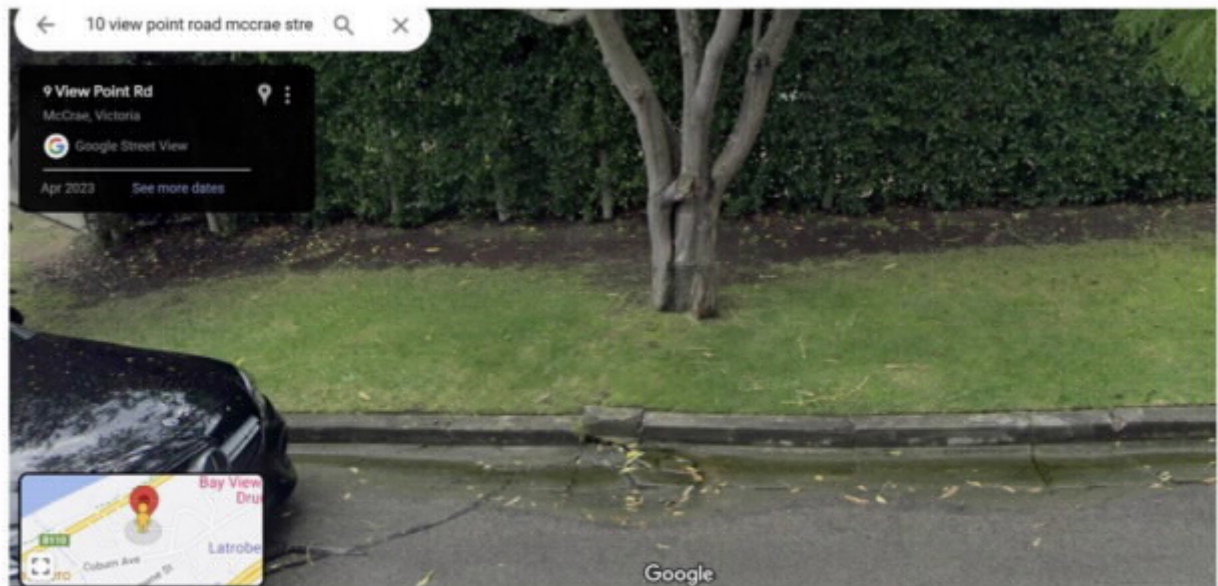
Picture 5 – example of major cracking in View Point road kerb prior mid 2023 drainage works

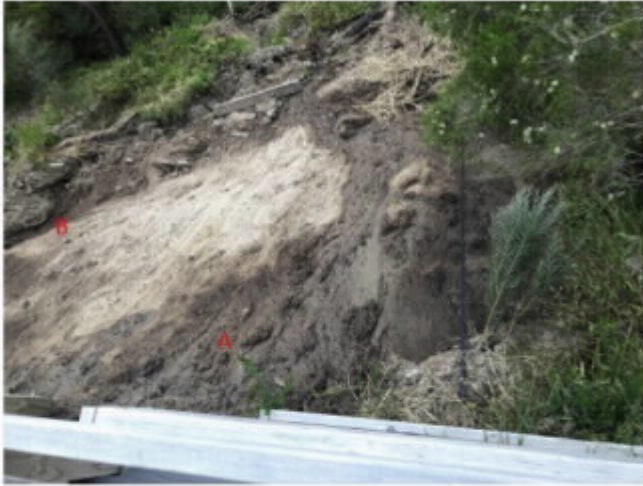
Picture 6 – looking North over timber stairs showing seeps A and B after landslip November 2022

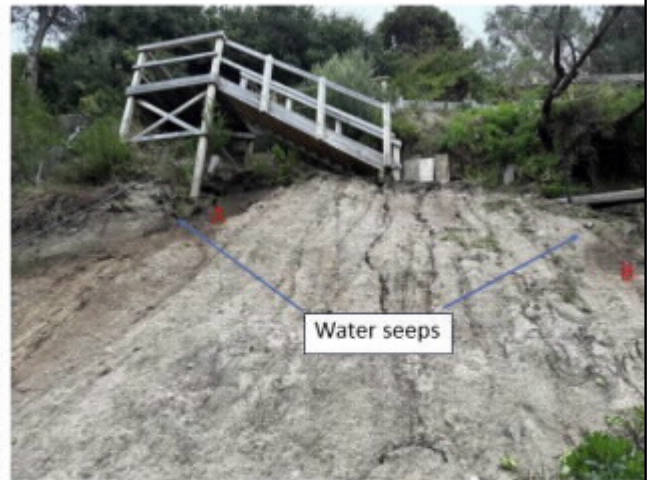
Picture 7 – looking South over landslide showing seeps A and B flanking the landslide

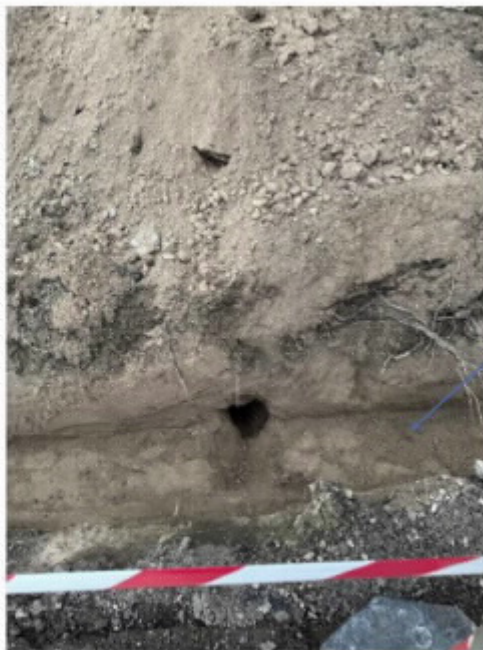
Bottom of excavation for new stormwater pipe, approximately 1.5m below ground

Picture 8 - Void discovered during earthworks to install drainage and new kerb on View Point road

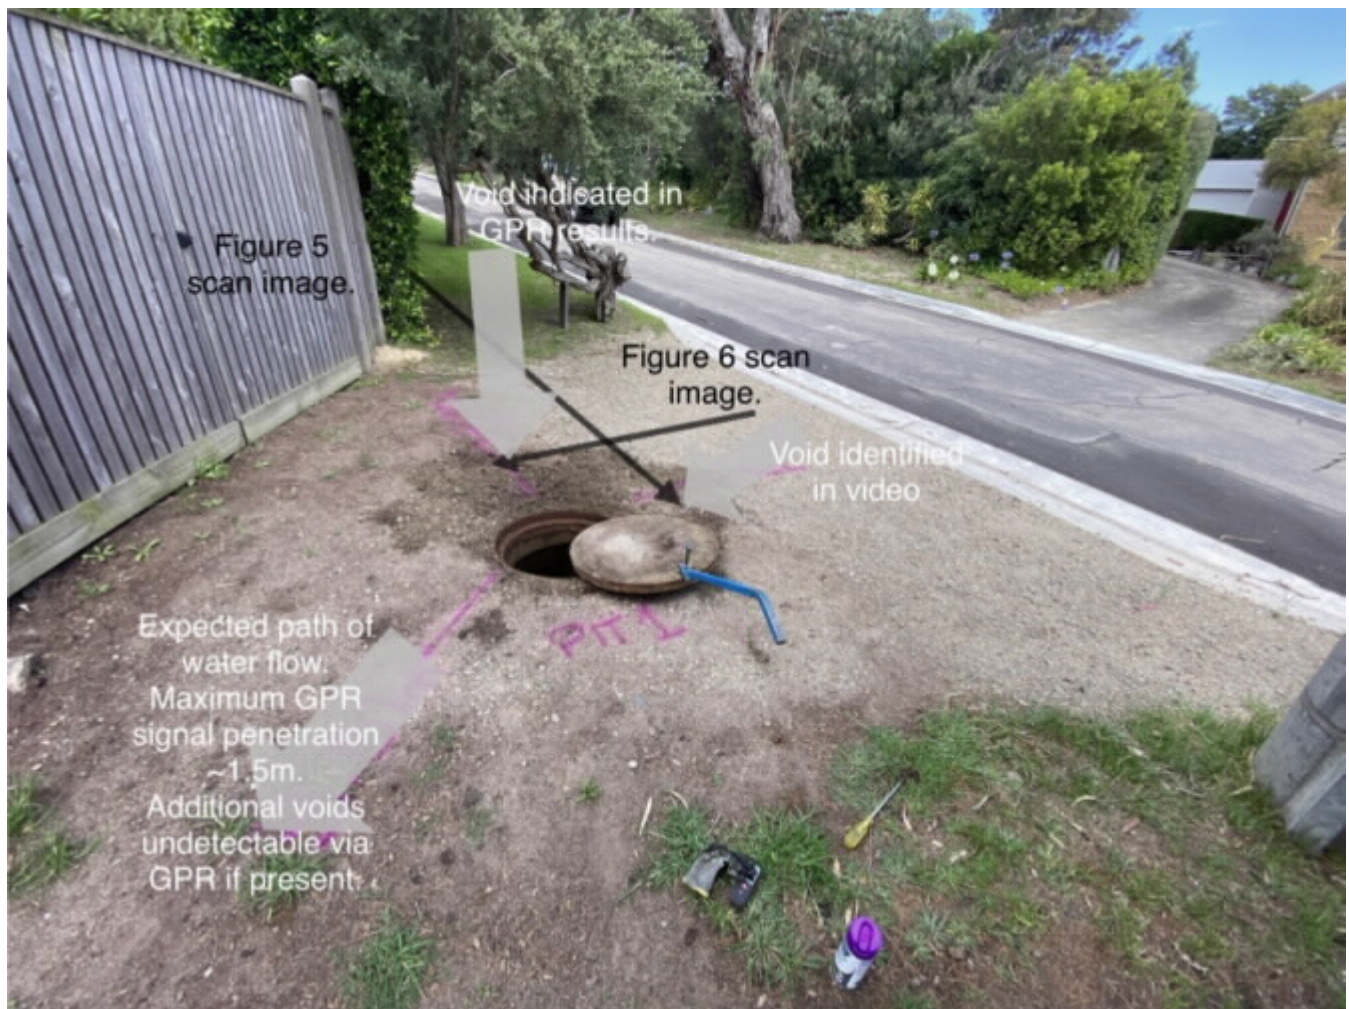
Fig 1 : Recorded scan locations included within the report indicated below
Identified void locations as marked.
Open sewer pit with invert levels and pipe directions noted in paint.

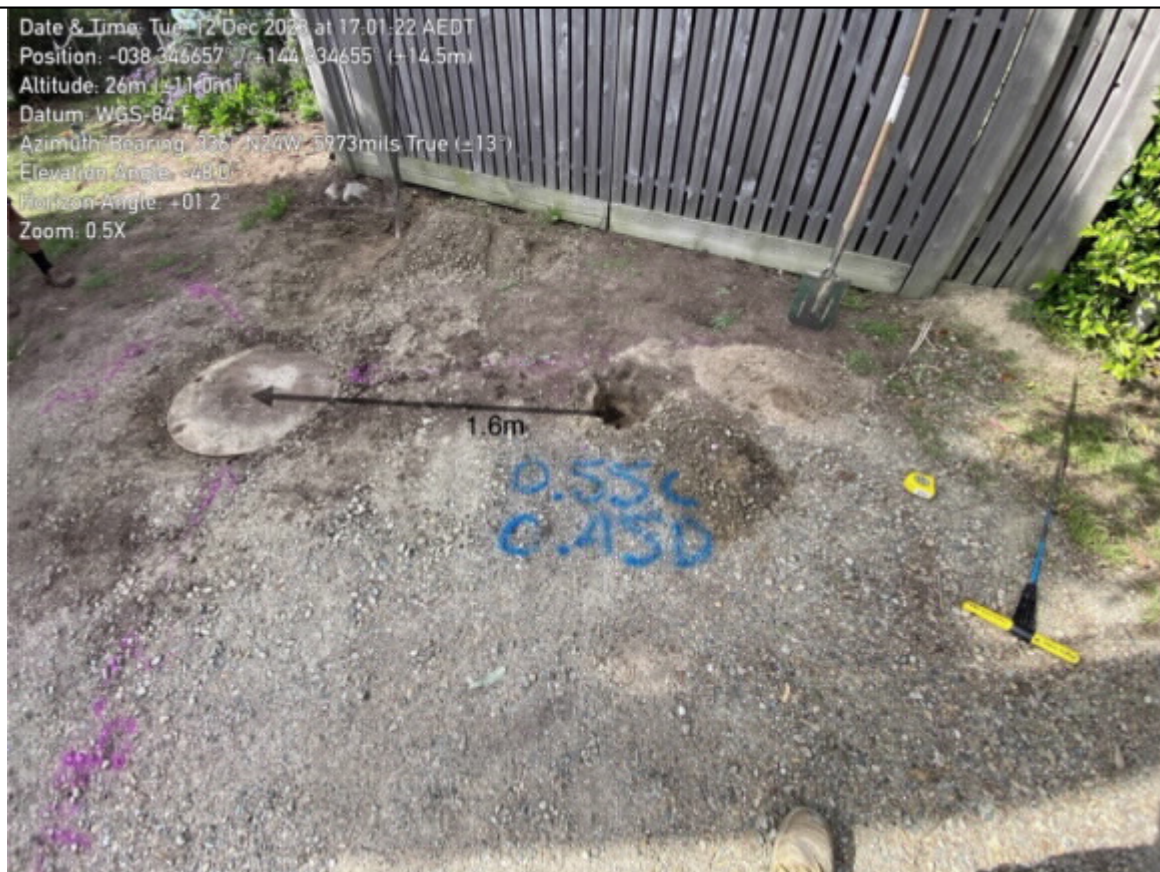
Fig 3: Scan validation location, positioned to avoid underground utilities. Void was proven with 0.55m cover.

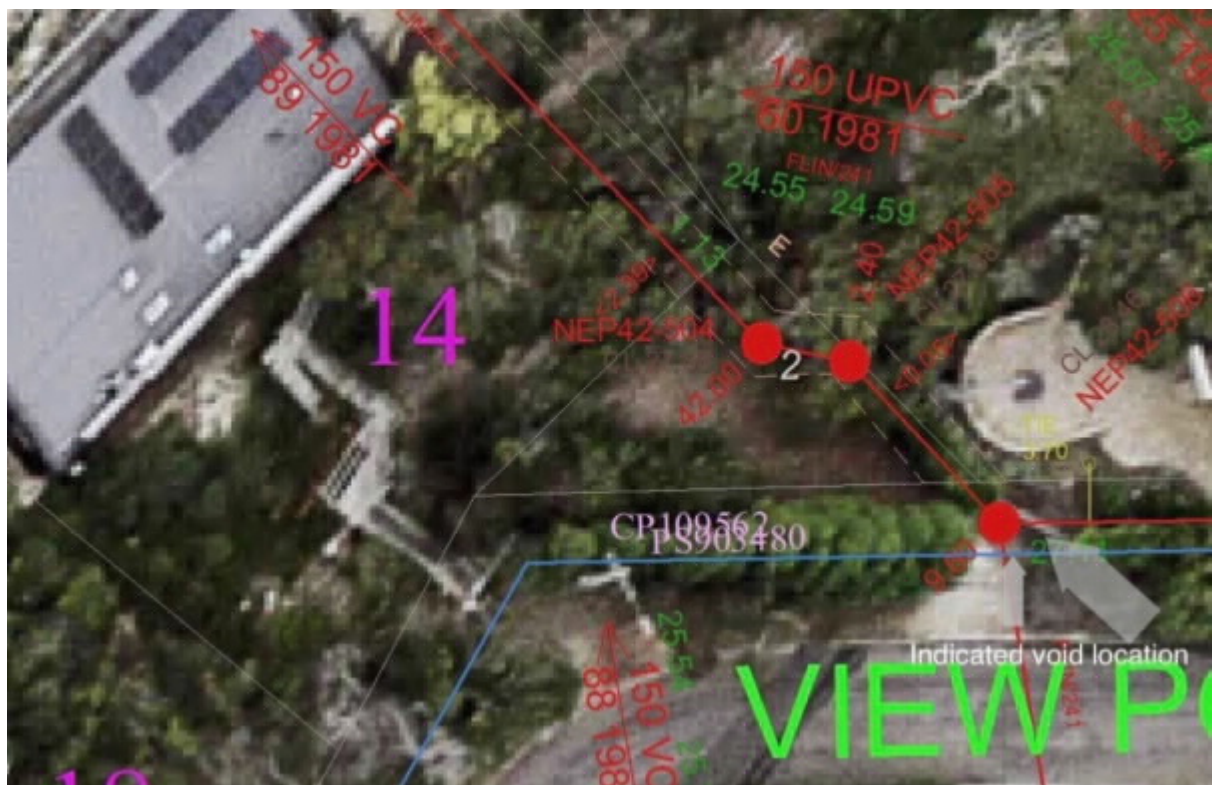
Fig 4:

Void locations indicated overlaid on South East Water GIS showing sewer and water infrastructure.

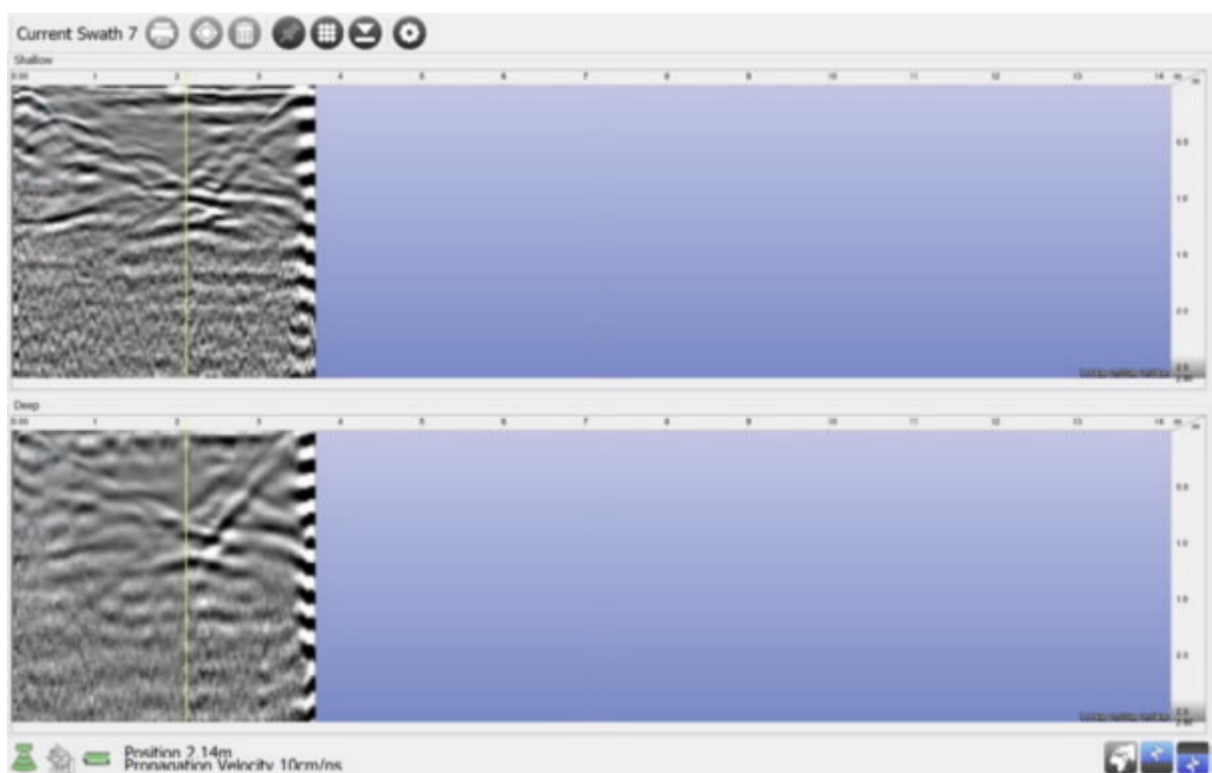
Fig 5:

Scan indicating void, physically verified in nature strip.

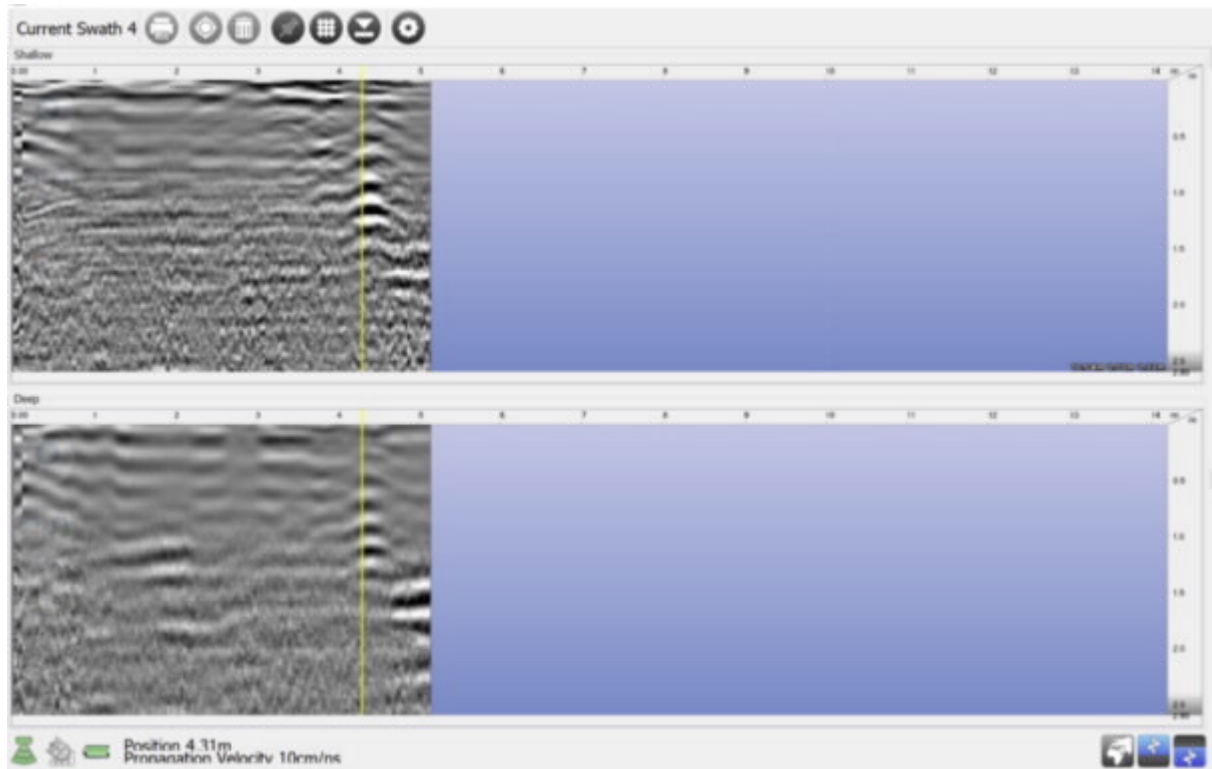
Fig 6:

Cross section of identified void in nature strip, physically verified.

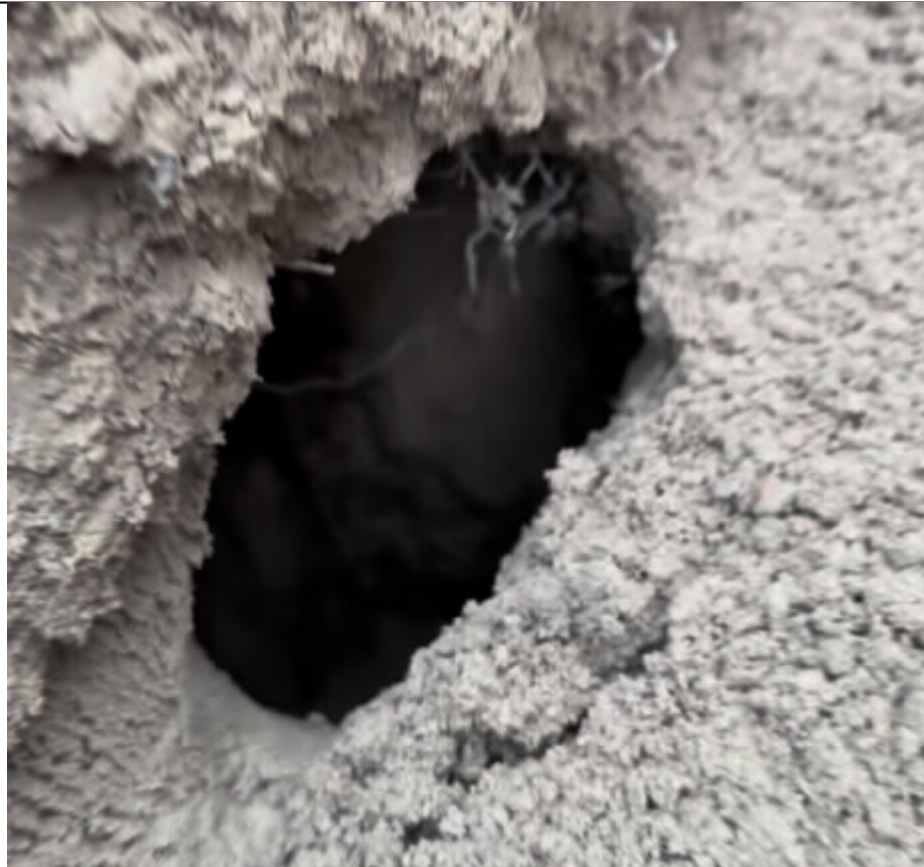
Fig 7:

Still image showing void, taken from a video provided by Gerry Borghesi during Storm Water upgrade.
