## BOARD OF INQUIRY INTO THE MCCRAE LANDSLIDE

### Statement of John Nicholas Bolch

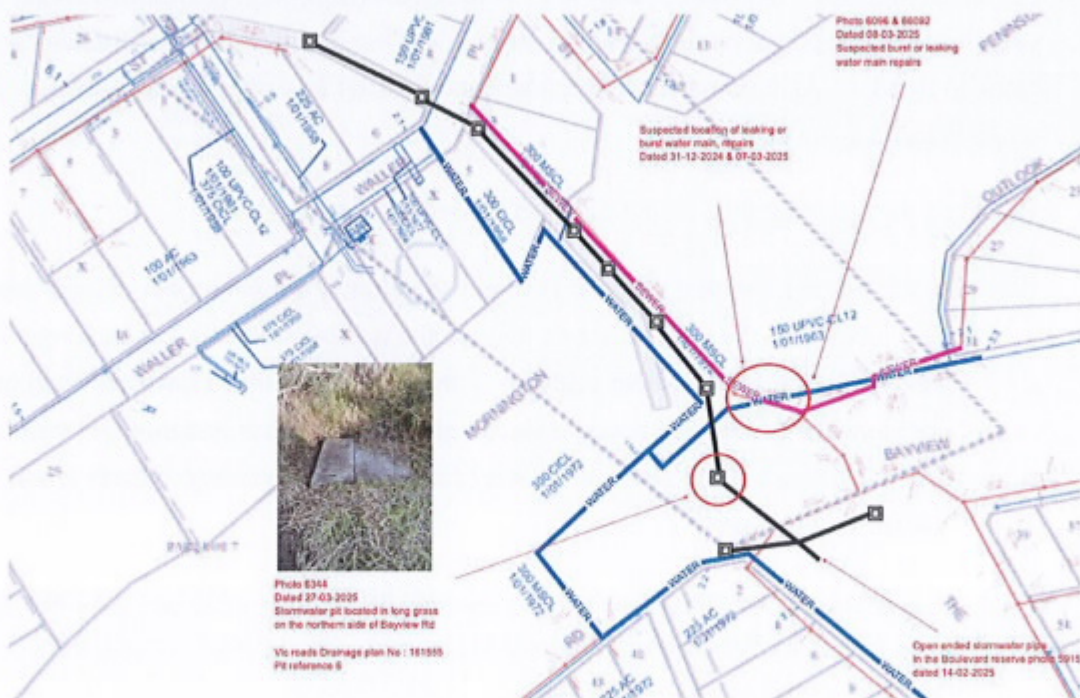
61. Having collected all this information, I have caused to be prepared an annotated map (extracted below), which is an overlay of two SEW maps I obtained from BYDA:

62. There are a few things to note about that annotated map:

- 62.1 the bolded lines, which I have caused to be added, shows the network of water mains, sewer and stormwater assets under the Mornington Peninsula Freeway and the surrounding area. The water mains pipework is shown by the blue lines. The sewer pipework is shown by the pink lines. The stormwater pipework is shown by the black lines, which is based on my understanding of stormwater drainage plans I obtained from VicRoads and accessed via the MPSC GIS;
- 62.2 according to SEW's map, the water mains pipe that runs through the larger red circle is a 150mm UPVC pipe (the **Affected Pipe**). The nominated date for the Affected Pipe is 1 January 1963, which I understand approximates when the Affected Pipe was installed; and
- 62.3 the larger red circle indicates my best estimate of the approximate location of the leak or burst on the Affected Pipe.

- 64.1 water leaking from the Affected Pipe would naturally seek the path of least resistance, which likely led the water to travel through the existing trenches surrounding the sewer, stormwater, and water main systems — those trenches could have provided pathways for the water to flow and accumulate. In other words, these underground channels may have facilitated the movement of water from the Affected Pipe through to the McCrae Landslide Area; and
- 64.2 it is likely that the water saturated the ground and surfaced through the road at various locations in the McCrae Landslide Area, including Charlesworth Street, Coburn Avenue and Waller Place (as described above).

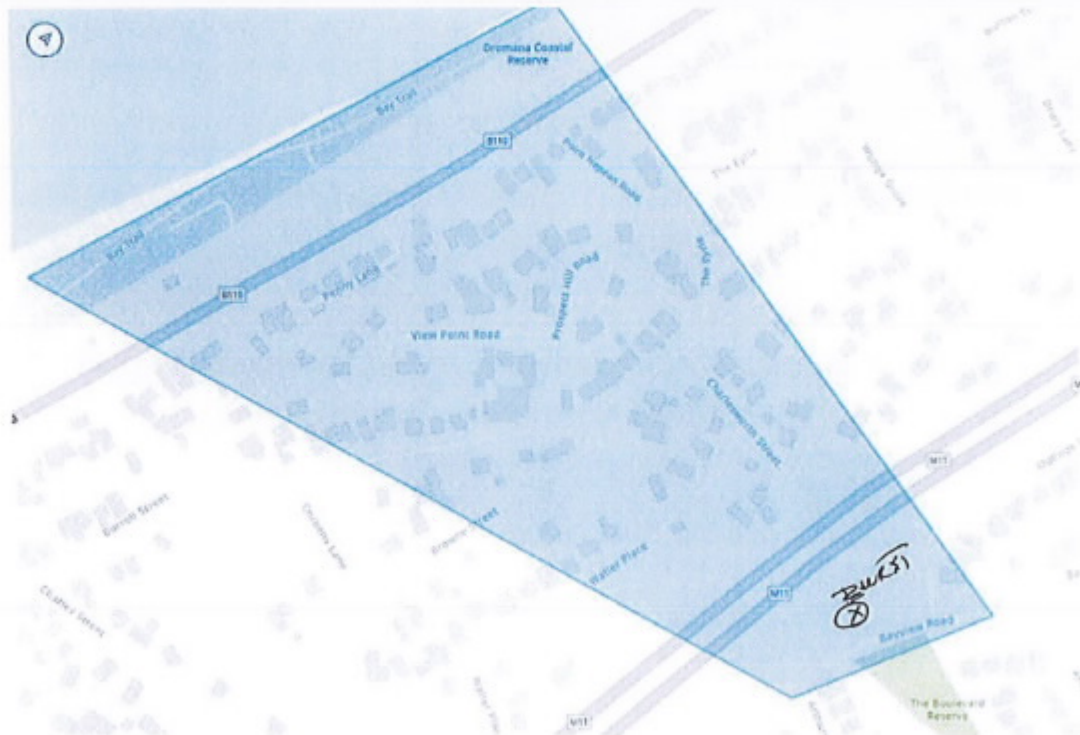
86. Based on the investigations conducted between mid-January and early March 2025, in my opinion, water saturation of the McCrae Landslide Area has been a significant contributing factor to the Landslides. The excessive water accumulation, potentially exacerbated by ongoing water leakage and inadequate stormwater drainage management, likely played a central role in destabilising the surrounding land and precipitating the Landslides.
87. Set out below is a map I prepared which shows the potential area of water saturation caused by the burst of the Affected Pipe shaded in blue (based on the topography of the McCrae Landslide Area):
