Landslip McCrae Jan 25

3 Penny Lane and 10-12 View Point

Owners – Actions Items

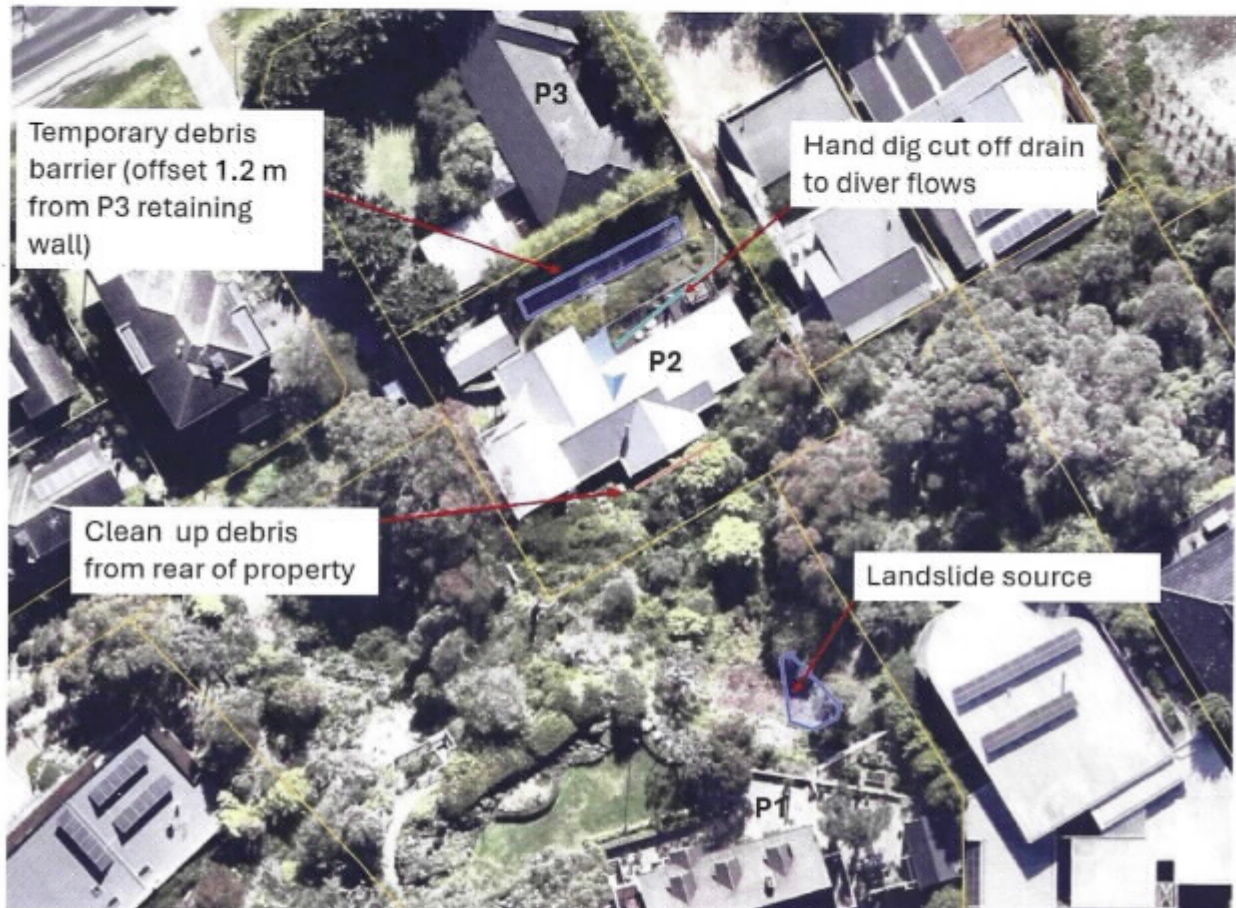
- Initiated from in front of a recently constructed retaining wall on P1 and has impacted the rear of P2, Photo 1.
- The Landslide was initiated on the night of Sunday, 5th January 2025, following two days of dry, hot weather. Rainfall **followed** the event.
- Translational slide which has evacuated materials down to the natural granitic soils at the base of the Landslide.
- A sub-vertical head scarp up to 1.5 m high, Photo 2.
- A significant portion of the headscarp was saturated and with measurable flow of water (0.15-0.2 L/s) flowing along the base and down the hill. The seepage was observed at the contact with surficial soils (fills/ancient landslide debris) and the underlying natural soils.
- Volume in the range of 15 to 20 m³.

Property	Actions
P1	<ul style="list-style-type: none"> • Monitor slopes immediately behind the failure for signs of change and or deterioration. • Cease all garden watering in the vicinity of the Landslide. • Surficial cut off bund with Coir logs or sandbags behind the retaining wall to direct surface water away from the head scarp. • Seek advice from their engaged Geotechnical engineer to make safe as best as is practical.

P2	<ul style="list-style-type: none"> • Monitor slopes immediately behind the house for signs of change and or deterioration. • Remove mud from between the house and the rear retaining wall. Do not disturb mud upslope of the retaining wall unless cutting temporary cut off drains. If the retaining wall has collapsed, seek further advice. Caution in areas of potentially unstable walls of the dwelling. This may require a spotter to monitor uphill slope behaviour. • Divert surface water around the dwelling (use hand cut off drains, Coir logs/sand bags). • Install a secondary cut off drain under the deck (hand dig, divert to east, Figure 1 • Install weep holes in northern most retaining wall as required (following installation and assessment of hand dug cut off drains/Coir logs) • Install one to two x ballasted shipping containers (2 x 20 ft or 1 x40 ft containers), 2.44 m wide) in the northern most section of lawn, Figure 1. These should be offset from the P3 retaining wall by at least the height of that retaining wall (~1.2m) and be aligned to protect P3. Ballast may be soil, F type barriers or plastic crash barriers filled with water. Temporary tie downs may be required (screw piles or equivalent). The containers should be back tilted into the slope without undercutting the existing retaining walls. This may require local cut/fill to achieve a 5 to 10% back tilt. Where bulk earthworks or retaining wall loading constraints apply, the containers may need to sit on screw piles or equivalent. Further advice should be sought to detail the design.
