## BOARD OF INQUIRY INTO THE MCCRAE LANDSLIDE

### Statement of Kevin Barry Hutchings

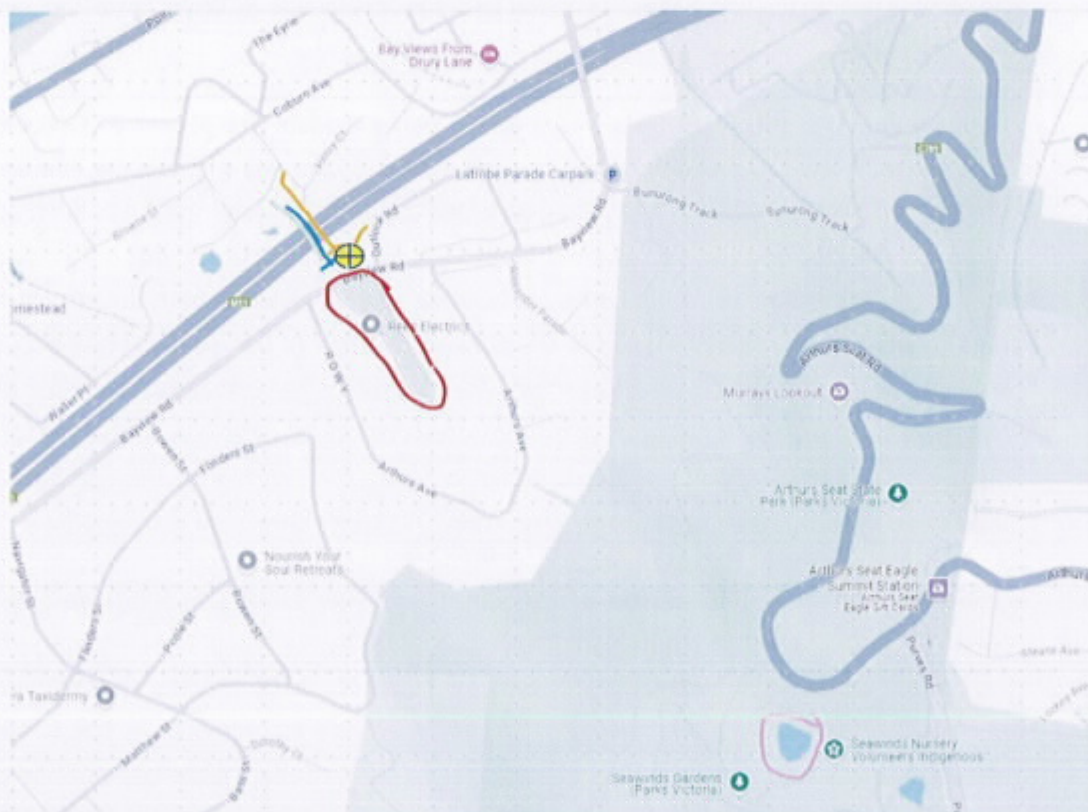
41. Set out below is a map I have prepared which shows: (i) the dam I inspected circled in pink; (ii) the Boulevard Stormwater Storage Basin circled in red; (iii) the Burst Site indicated by the yellow circle; and (iv) a rough indication of the stormwater, water and sewer lines flowing from the Burst Site as indicated by the green, blue and orange lines.

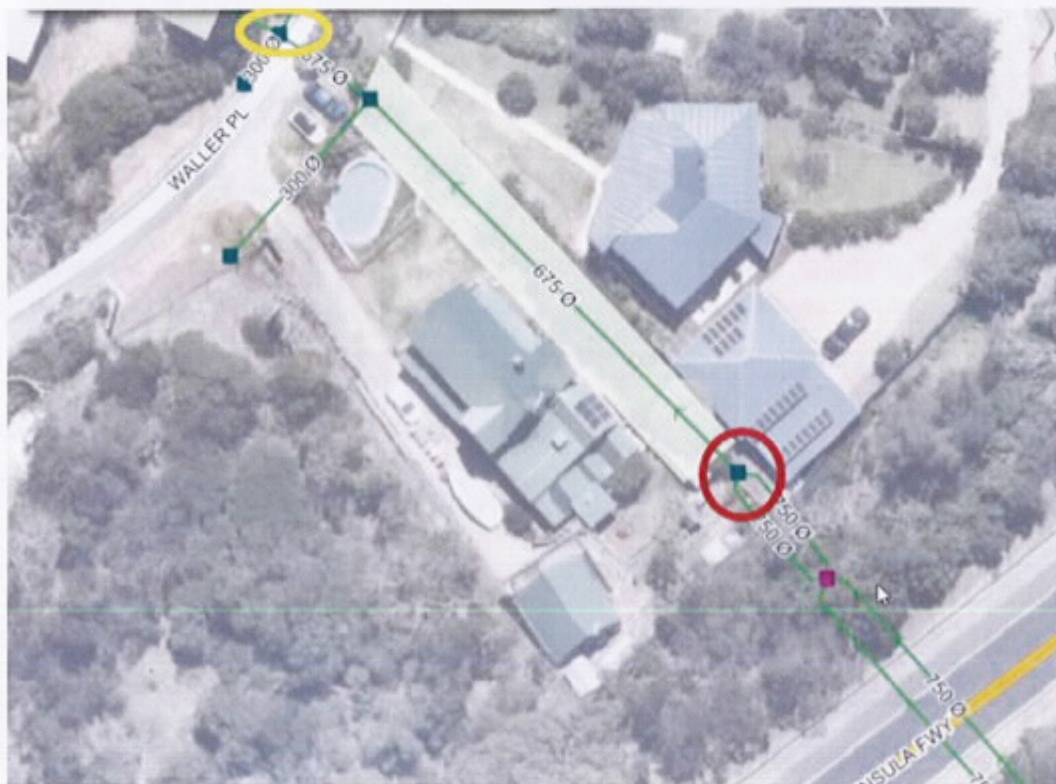
57. Set out below is a screenshot of an online map accessed on MPSC's Mapping GIS website. The map has been annotated to show: (i) the Waller Place Stormwater Drain circled in yellow; and (ii) what I understand to be the Rear Waller Place Stormwater Pit circled in red.

58. After I learned of this information from Brett, I started to connect the dots between the various pieces of information I had gathered. I realised that the leak near Outlook Road — that Greg first brought to my attention — may have caused trench flow or ground saturation, which is why there was a larger than usual volume of water flowing through the Waller Place Stormwater Drain. I thought that, if there was trench flow, a significant amount of water could have flowed from Outlook Road, under the Mornington Peninsula Freeway, through the old creek bed which travels perpendicular to Waller Place and into the drains, which caused the flow of water on Charlesworth Street.
