Legally Privileged Multidisciplinary Expert Report

# McCrae Landslip Project

Prepared for: Thomson Geer

5 May 2025

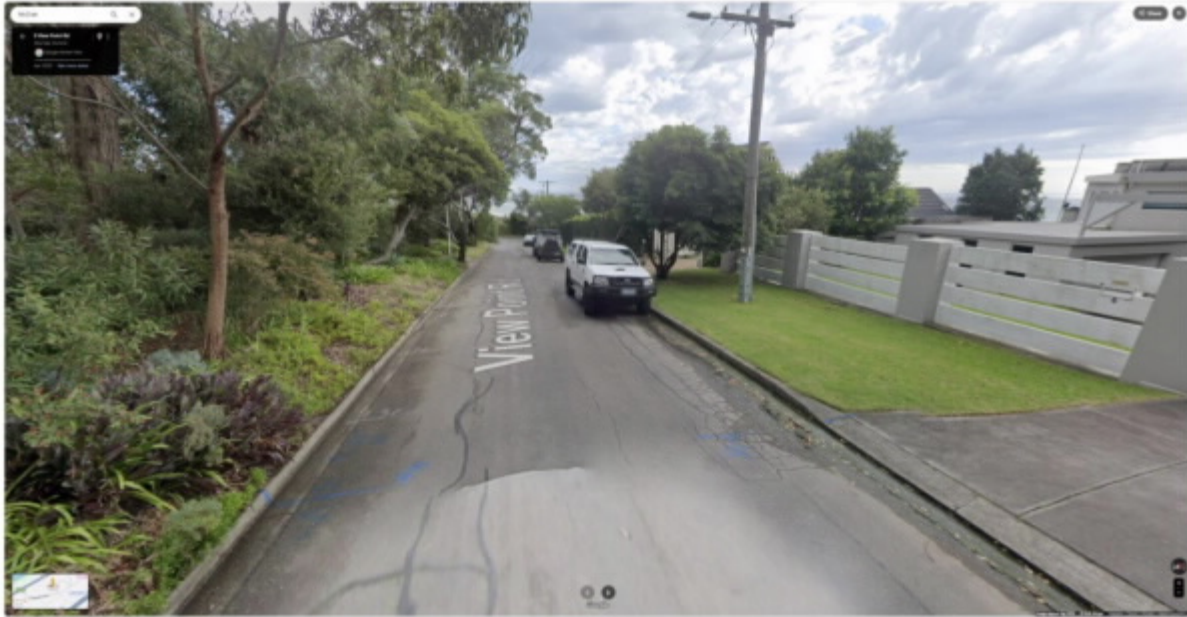
Figure 5, Figure 6 and Figure 7 provide an indication of the condition of View Point Road. The condition of the pavement is characterised by numerous longitudinal cracks (Figure 5) and areas of crocodile cracking and spalling. Such evidence can indicate pavement fatigue or aging, or weak subgrade. Water is noted to be flowing down the eastbound kerb within the photographs. The precise date of the photographs is not known. But we note the greenish tinge of the kerb and channel, compared to the south side, which could indicate vegetation build up due to high levels of moisture content.

Figure 6: Google Streetview image from April 2023 looking west from outside No. 6 View Point Road. Note the localised spalling and crocodile cracking of the pavement adjacent to the driveway of No. 6.

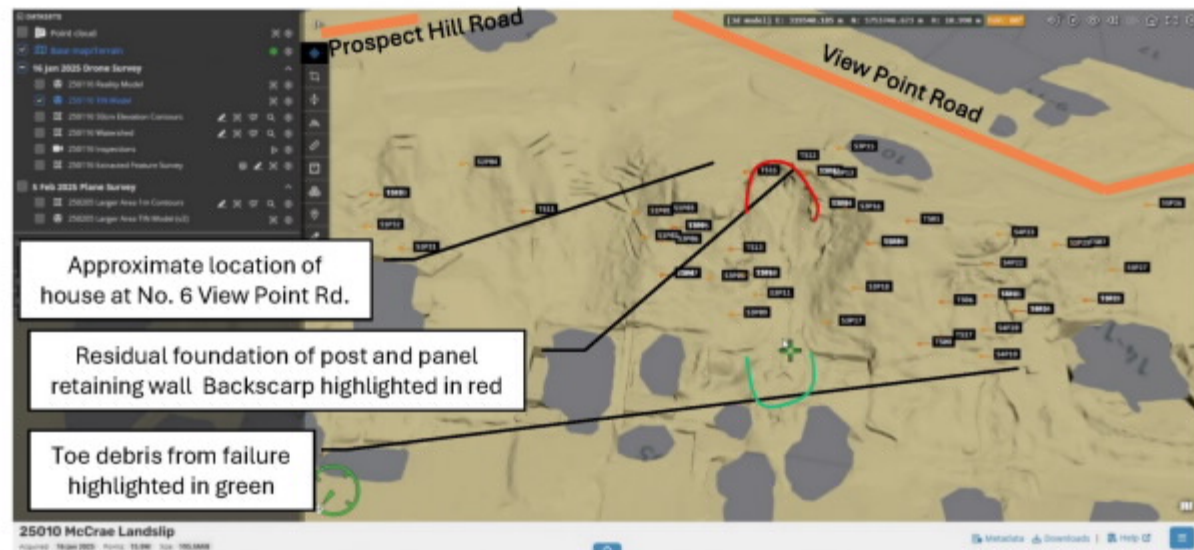
Figure 8: Imagery showing the subject site and adjacent slopes looking south west.

Figure 8 shows an overview of the site topography. The backscarp toe debris of the 14 January 2025 failure is highlighted. Note that the failure is within a clearly defined gully, which is a characteristic of the escarpment within the vicinity of the subject site.

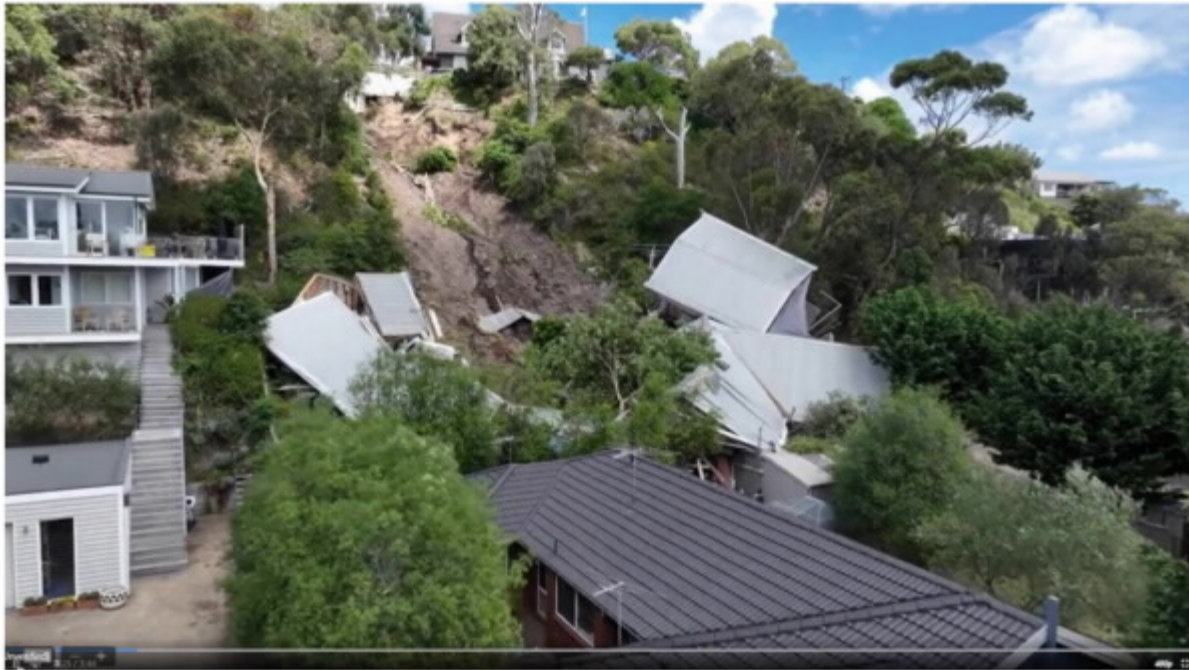
Figure 10: Drone footage taken from toe of slope failure showing the gully, denuded by slipping debris from upslope.

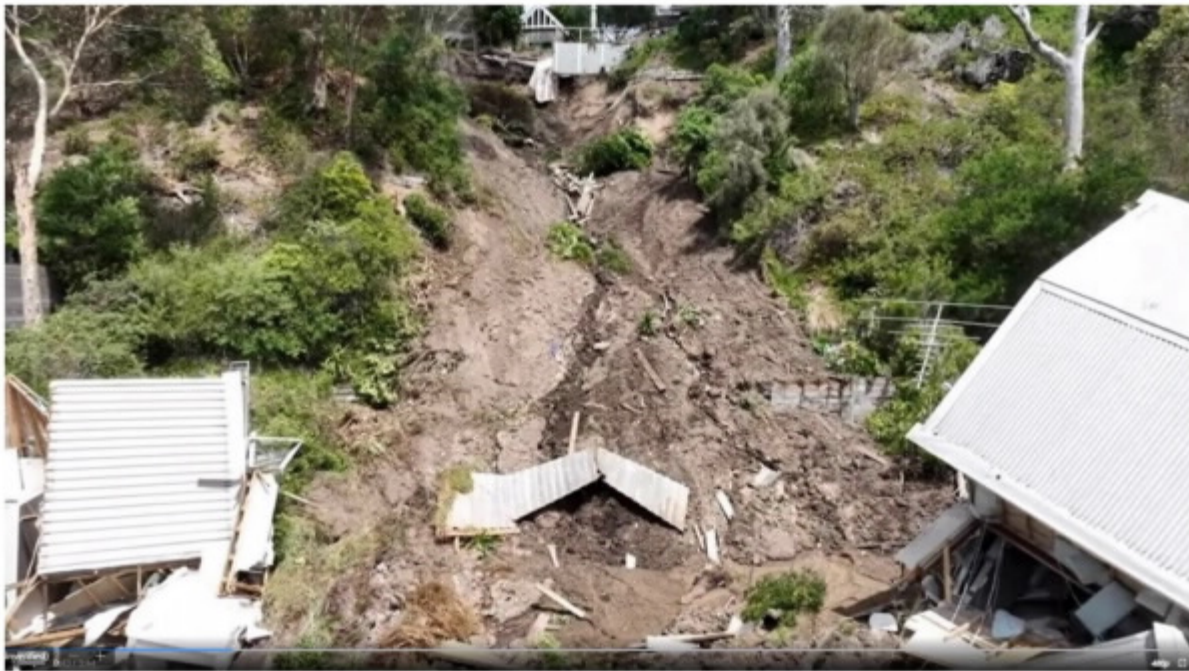
Figure 11: Drone footage taken from toe of failure, illustrating the 'bowl' shaped failure within the upper slope.

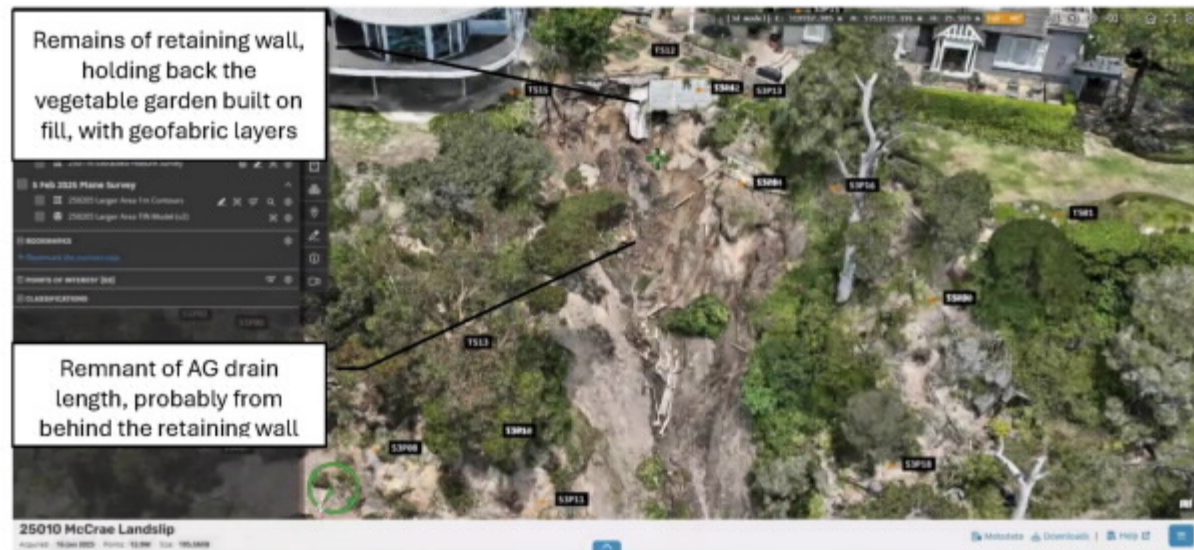
Figure 14: Drone footage showing detail of the failure.

Figure 14 shows the debris field of the failure. We note that a retaining wall at the crest of the site, and the retained platform behind, has been undermined by the slope movement, revealing geotextile layers. Fence panels are also seen in the debris. The varying colouration of the exposed soils suggest varying moisture content, and perhaps running water.

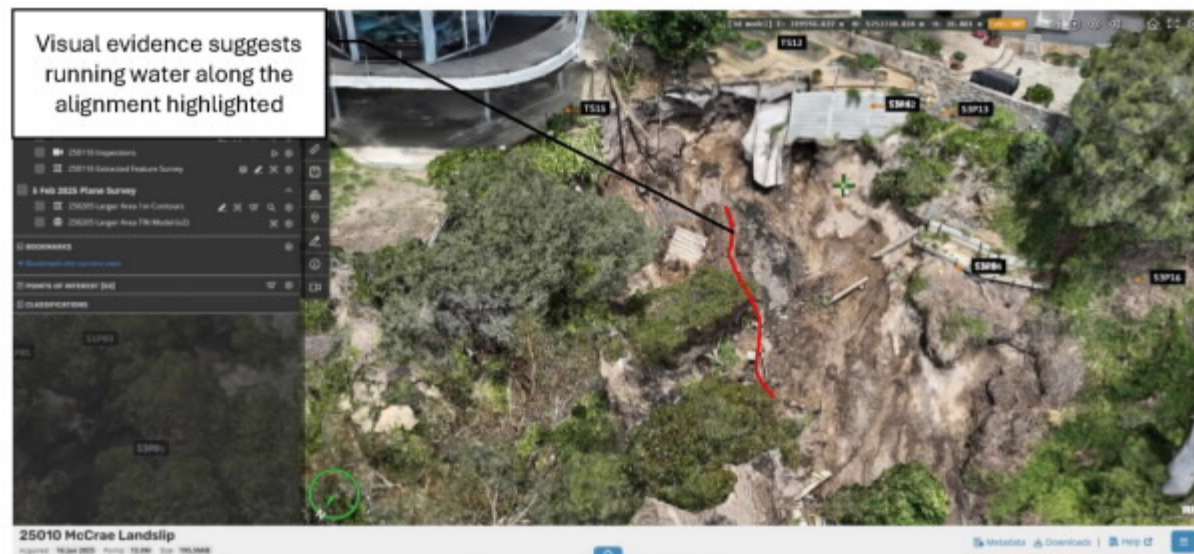
Figure 15: Detail of the presumed slip area with the red line an annotation of possible running water at the time of drone footage.

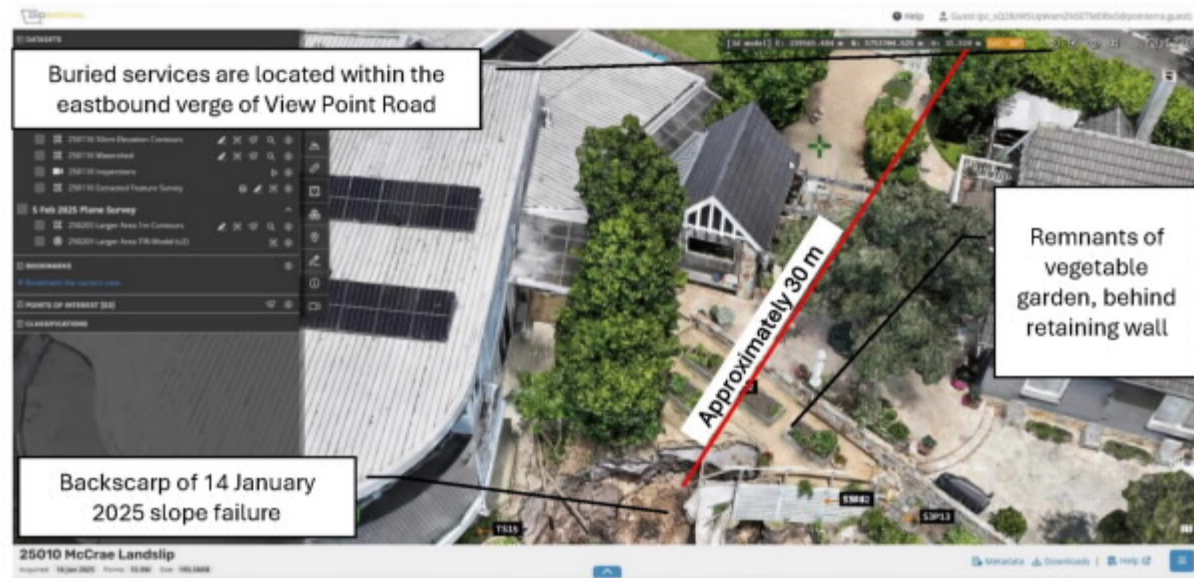
Figure 16: Drone footage showing the infrastructure, buildings vegetation and distance between View Point Road and the failure

The distance between the verge of View Point Road, the location of known SEW assets, and the failure, is approximately 30 m. Figure 16 includes View Point Road and the retaining wall, illustrating the approximate distance. Figure 16 also shows the vegetable garden behind the retaining wall, and mature tree.

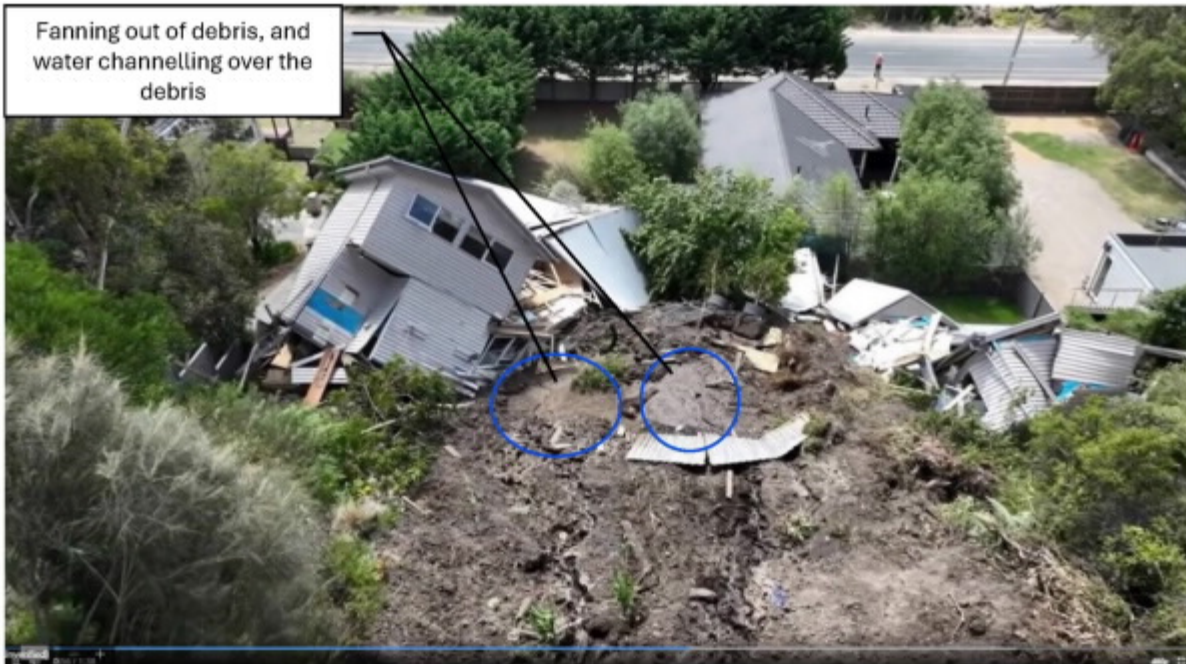
Figure 18: Drone footage, showing the toe debris.

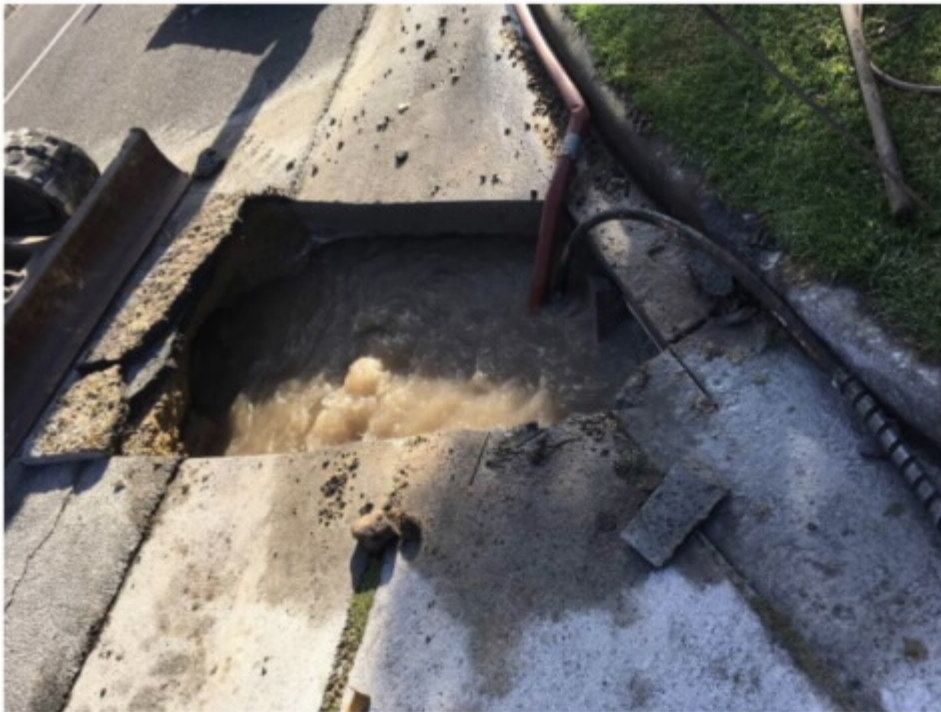
Figure 22: Photograph from SEW taken on 15 November 2022 (approximately), showing detail of water beneath concrete pavement construction prior to repair, being pumped out.

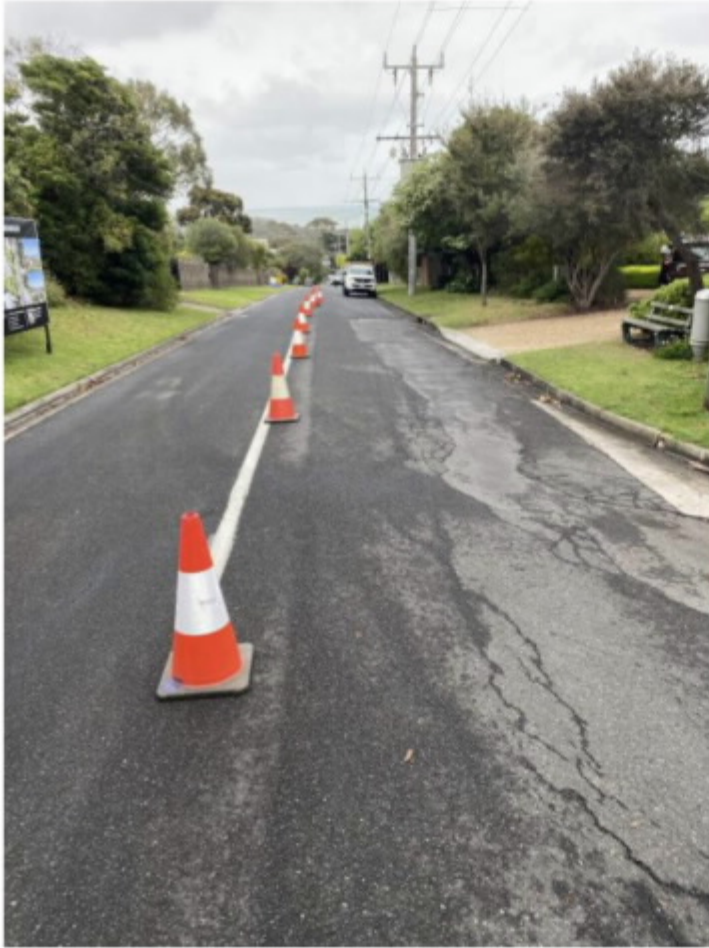
Figure 28: Photograph from SEW taken on 29 November 2023 (approximately), looking west along Coburn Avenue from junction with Prospect Hill Road showing condition of pavement prior to repair works.

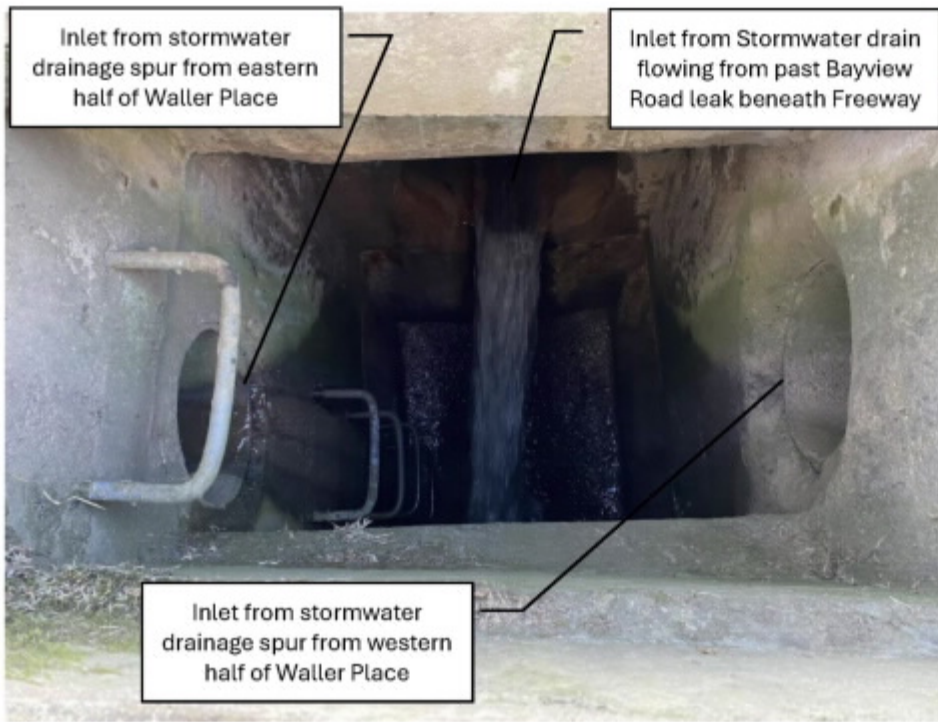
- the low volume flowing water (thought to be from the eastern half of Waller Place) may be from the seepage issues raised by nearby residents.
- The high-volume flowing water would corroborate the 'raging' description.

Figure 41: Photograph supplied by SEW, taken on 30 December 2024, showing water flowing into pit opposite 6 Waller Place

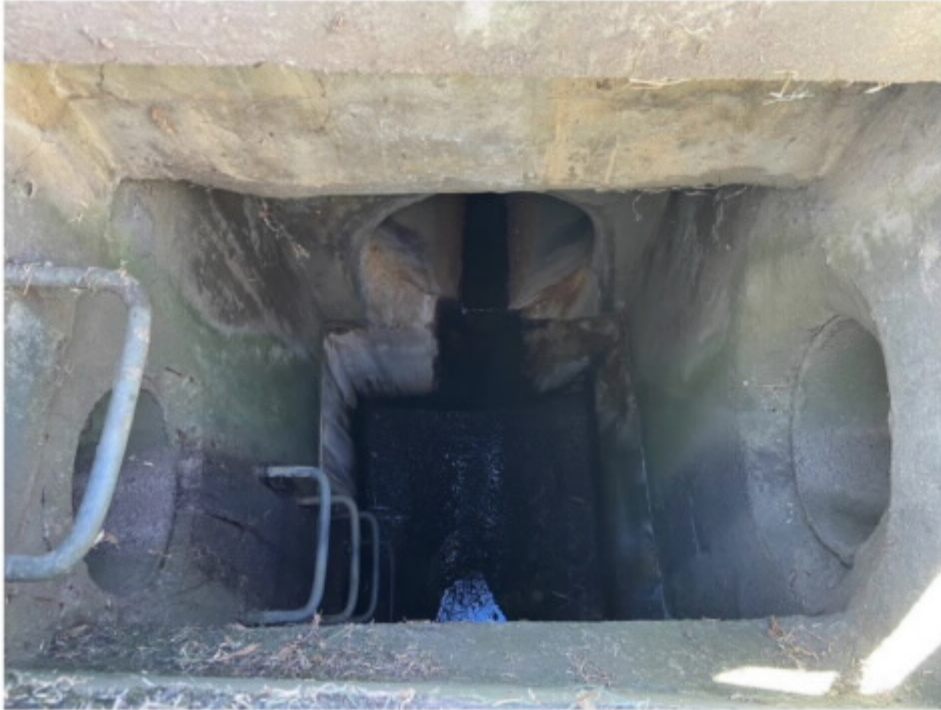
Figure 42: Photograph supplied by SEW, taken on 5 March 2025, showing water flowing into pit opposite 6 Waller Place.

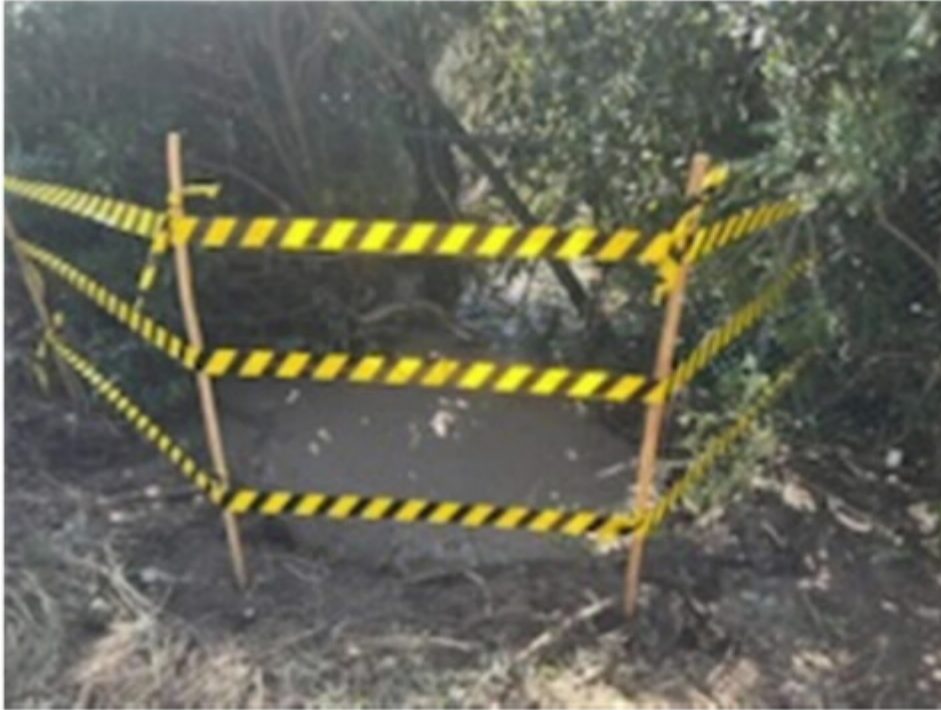
Figure 43: Provided by SEW, understood to have been taken on 31 December 2024, showing site condition upon arrival at the Bayview Road leak site. Note the ponded water, and flowing runoff into the background.

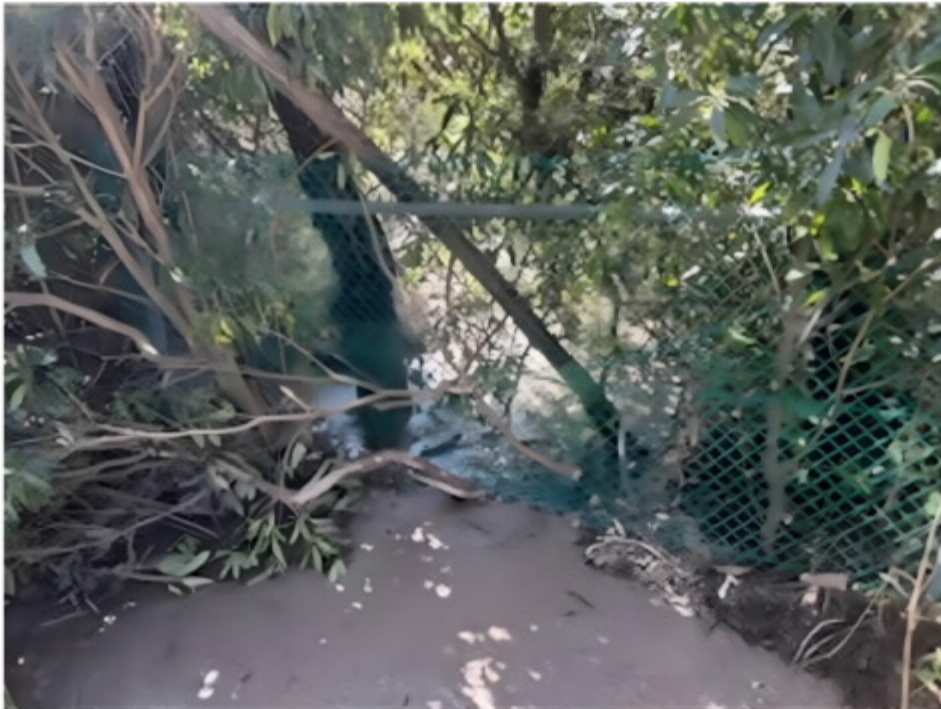
Figure 44: Provided by SEW, understood to have been taken on 31 December 2024, showing detail of ponded and flowing runoff at the Bayview Road leak site

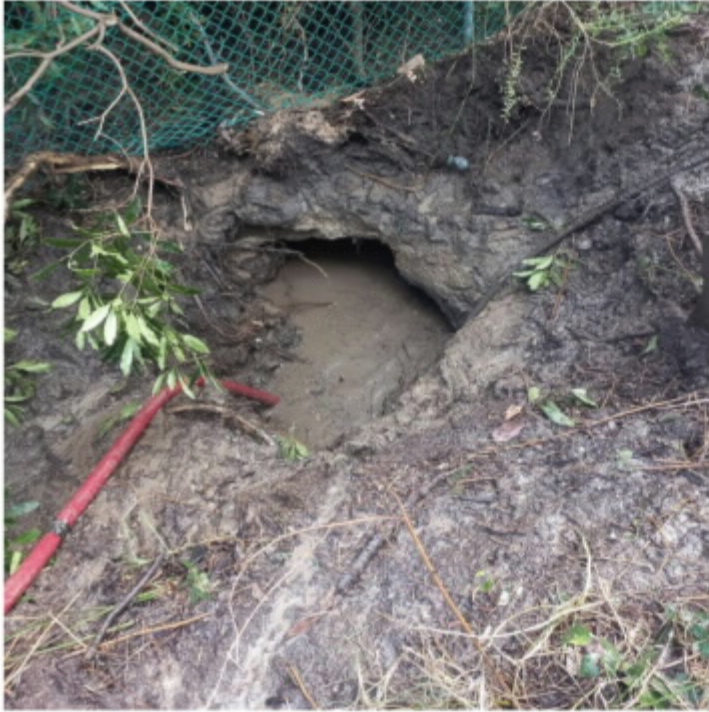
Figure 45: Provided by SEW, understood to have been taken on 31 December 2024, showing the ground collapsing during water pumping at Bayview Road leak site. Hole assumed to have been excavated by small excavator on site at the time.

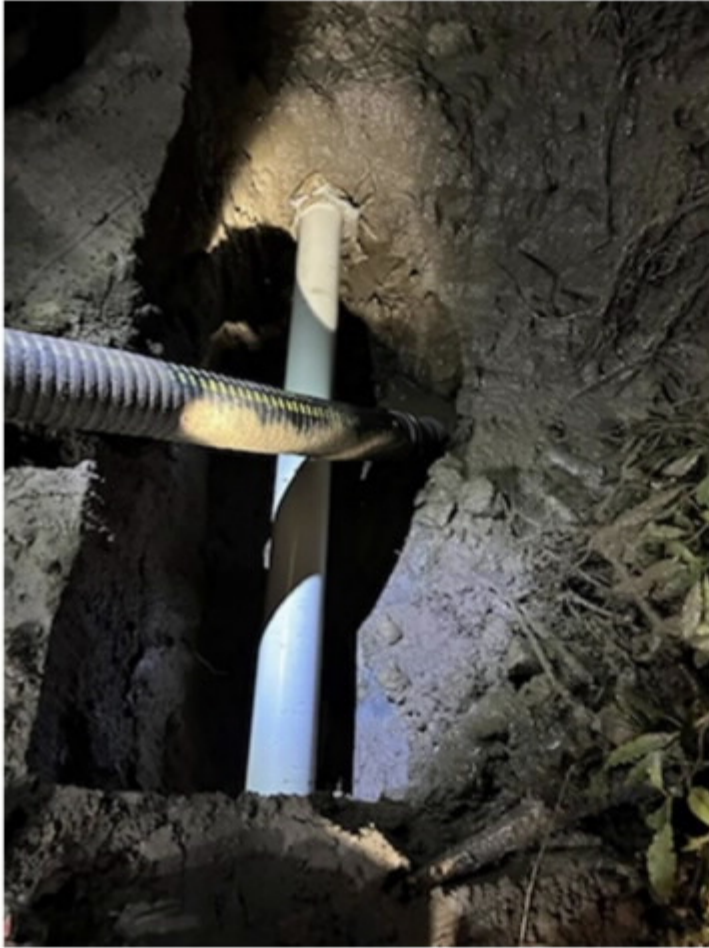
Figure 47: Provided by SEW, understood to have been taken on 1 January 2025, at the Bayview Road leak site showing exposure of pipe. Indicating the fracture is at the bottom of the pipe.

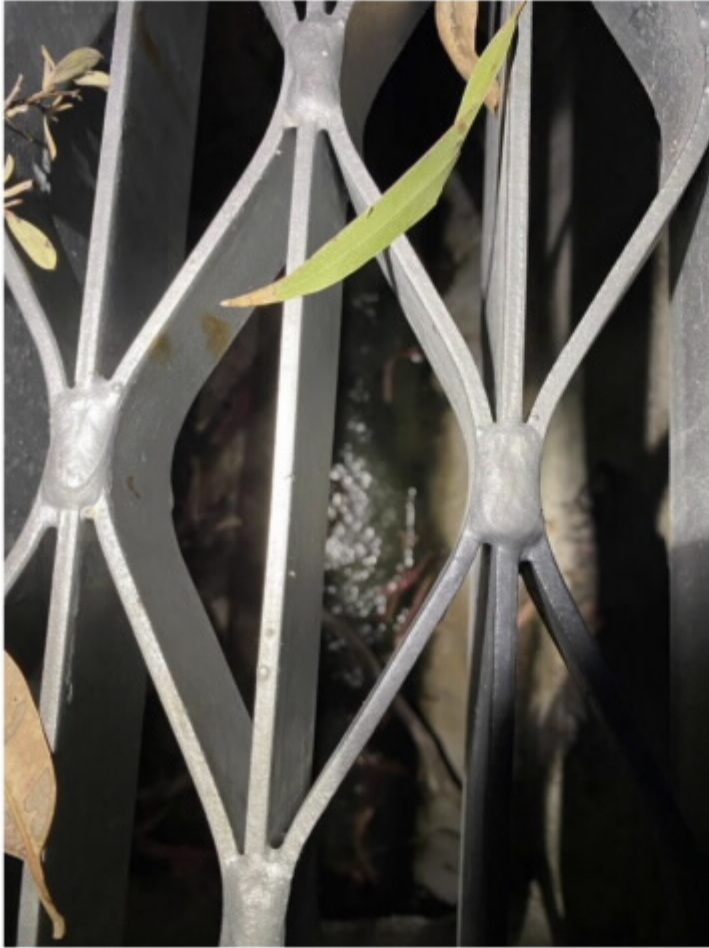
Figure 50: Photograph taken on the night of 5-6 January 2025, Showing flowing water within the stormwater drain shown in Figure 49.

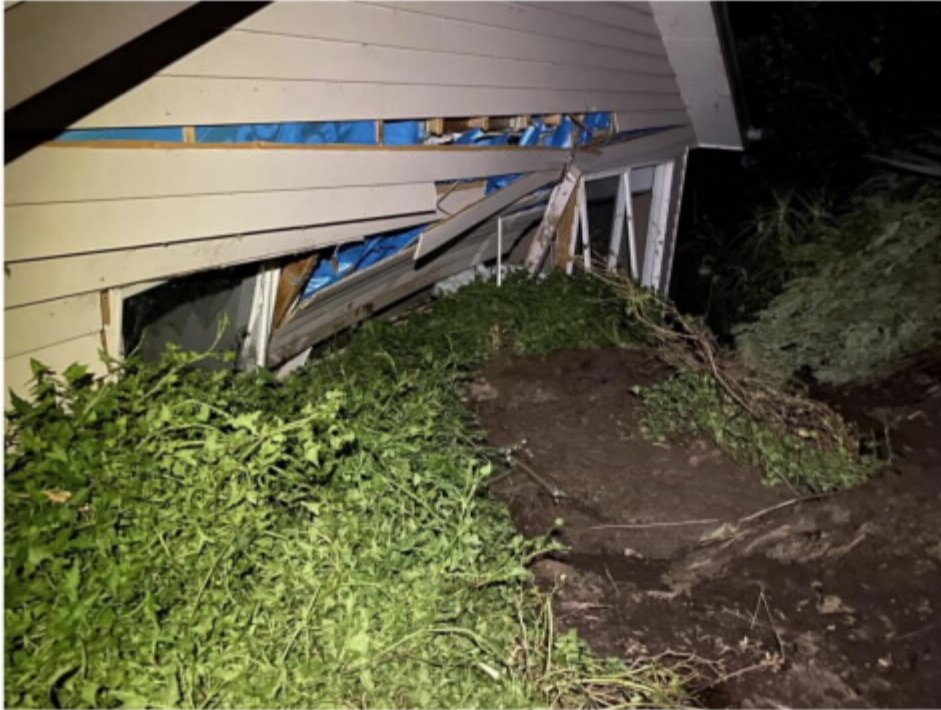
Figure 52: Photograph taken on the night of 5-6 January 2025 showing landslide debris against rear wall of 3 Penny Lane

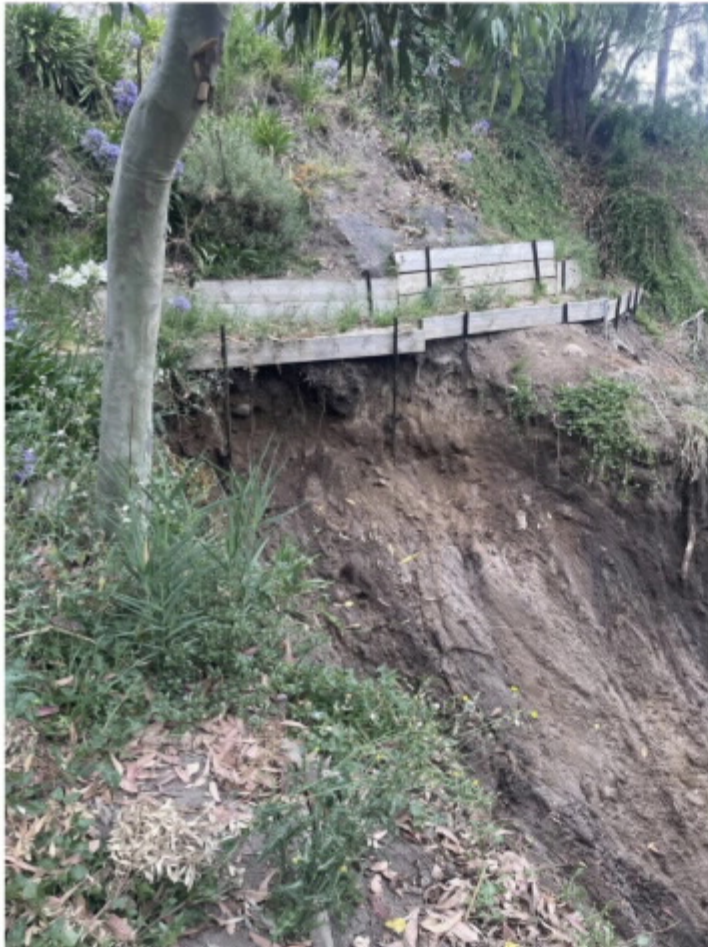
Figure 53: Photograph taken on 6 January 2025 looking west across the backscarp of the failure.

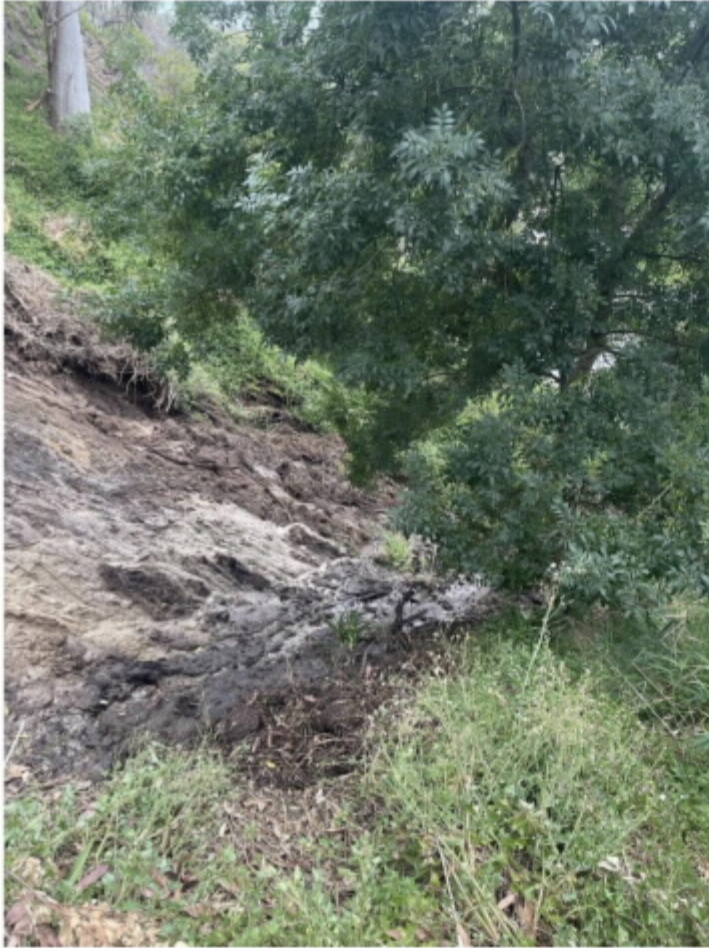
Figure 54: Photograph taken on 6 January 2025, looking downstope showing debris slide below the backscarp.

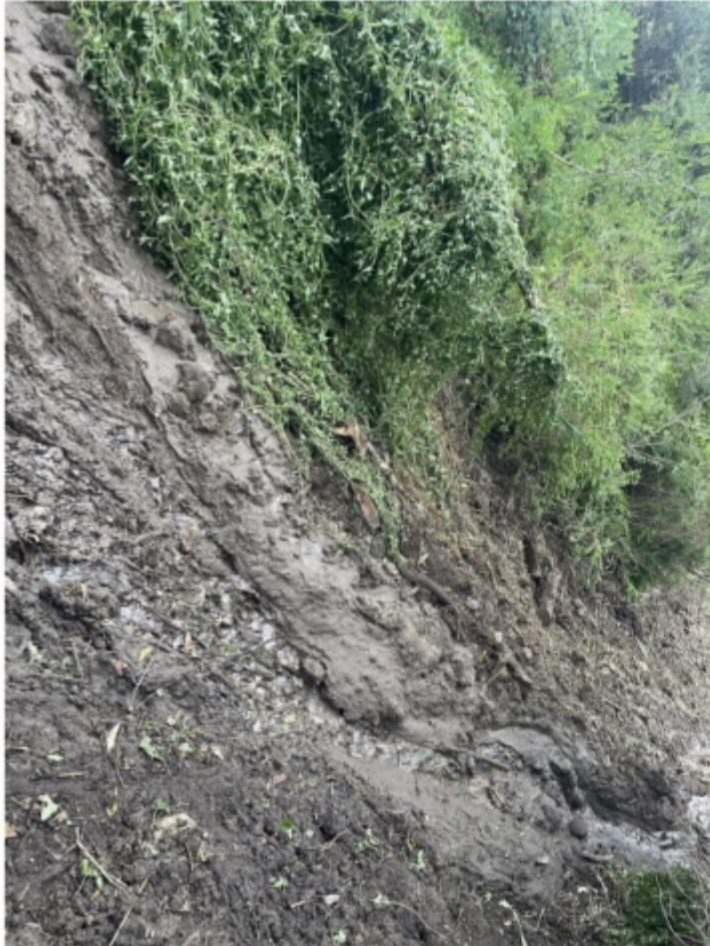
Figure 55: Photograph taken on 6 January 2025, showing slip debris of the 5 January 2025 landslide and water channel cutting through debris. The adjacent vegetation may indicate the original ground level and vegetation cover prior to the failure.

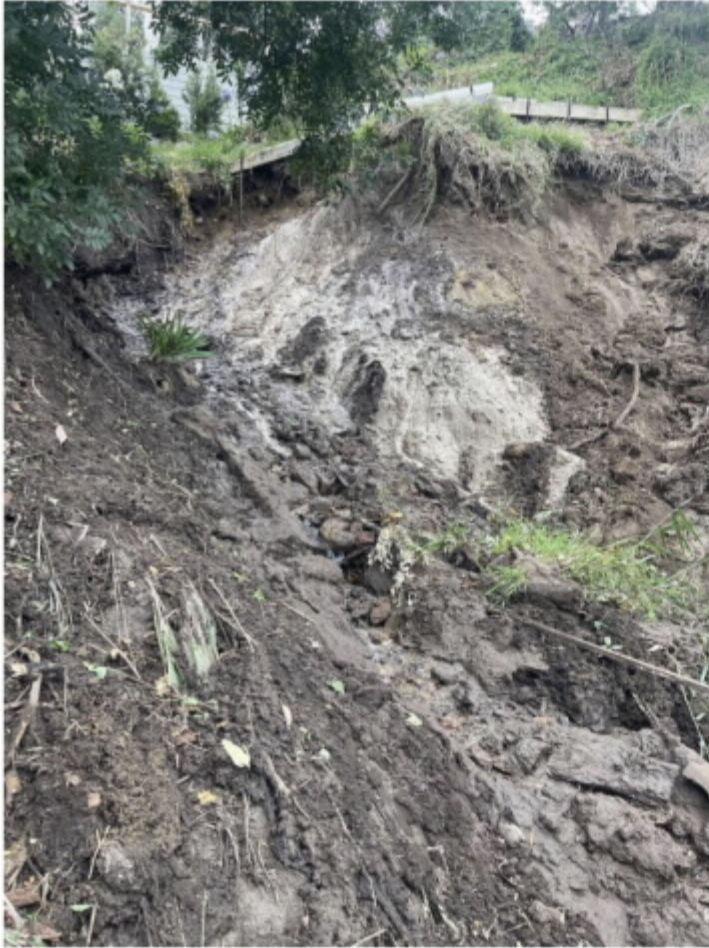
Figure 56: Photograph taken on 6 January 2025, looking up at the landslide, showing saturated debris flow surface with dry soil adjacent. Debris may include some boulders cobbles, but also anthropogenic and vegetation material
