# Expert Opinion Report - Landslide Assessment

10-12 View Point Road, McCrae

PSM5226-006R Rev0      11 June 2024

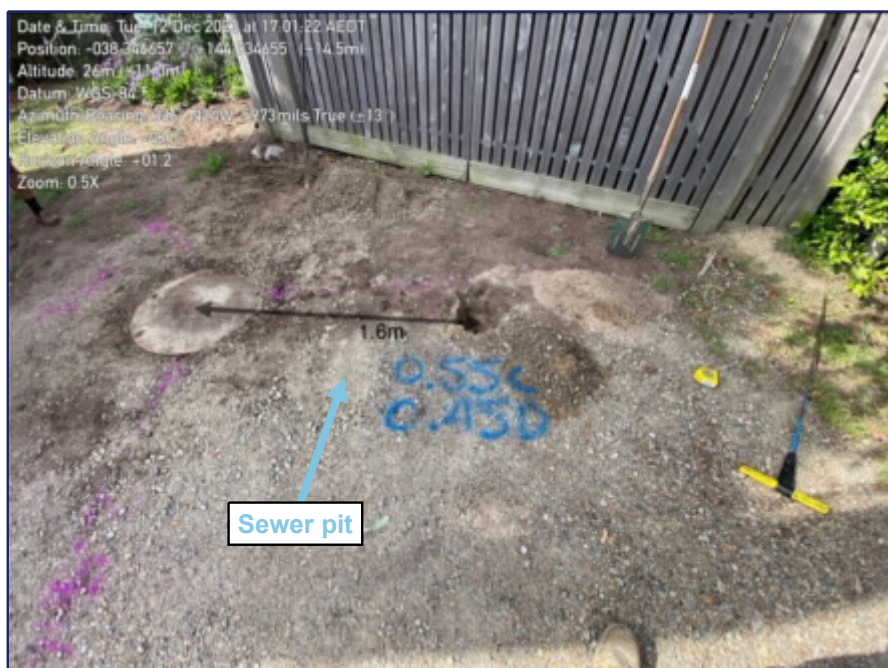
- The property owner of 10-12 View Point road observed a void during excavations for MPSC stormwater upgrade works in View Point Road. I have observed a low-resolution video of this inferred void. Based on the CivilTest report and the provided video I have marked on Figure 1 the approximate location of this void.

**Inset 4:** Figure 3 of Safety Scan scanning report showing location of identified void. I have added my commentary in blue

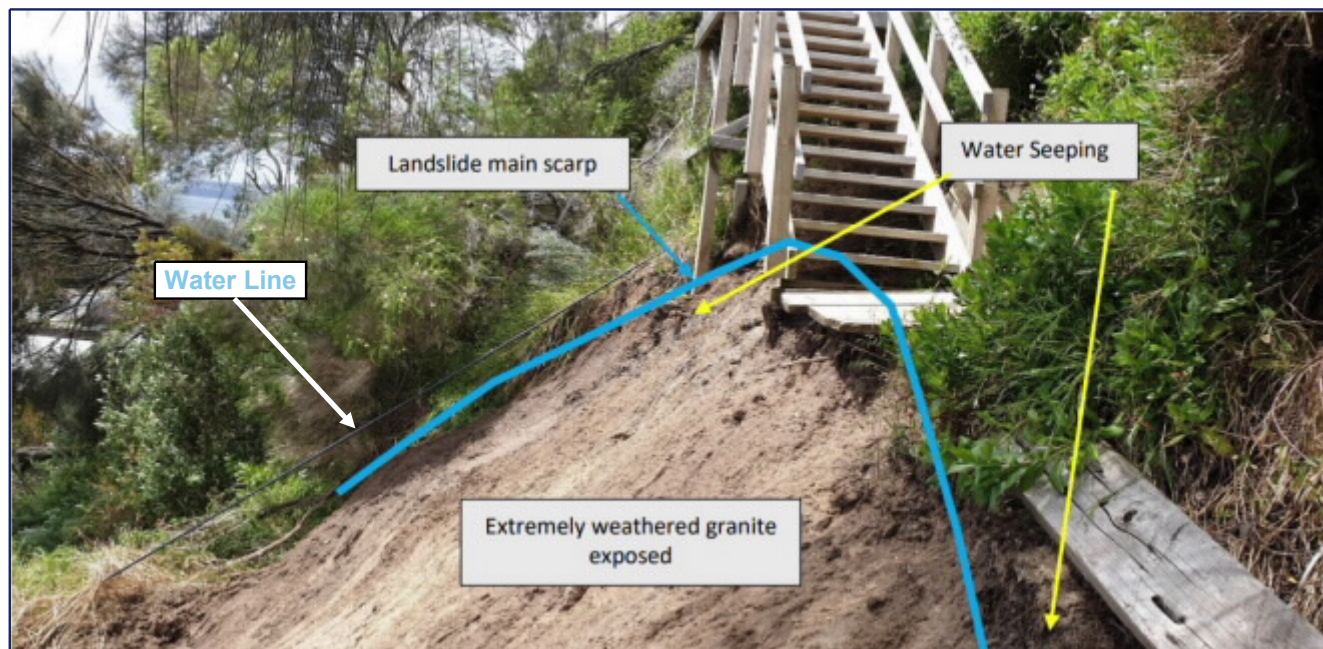
Figure 4-2 shows the main scarp of the landslide where it has undermined the existing stairs. It can be seen that the failure surface of the landslide runs parallel to the ground surface. The weathered granite is exposed in the failure surface. Looking at the side flank it can be seen that the thickness of soil that would have overlain the weathered granite is relatively shallow, possibly less than 0.5m.

Water was observed to be seeping from the head scarp at several locations more than 24 hours after the storm occurred. These seeps appear to be associated with natural springs further up slope.

**Inset 7: Figure 4-2 from the Stantec GA (pdf page 23 of the Brief), I have added my commentary in blue.**

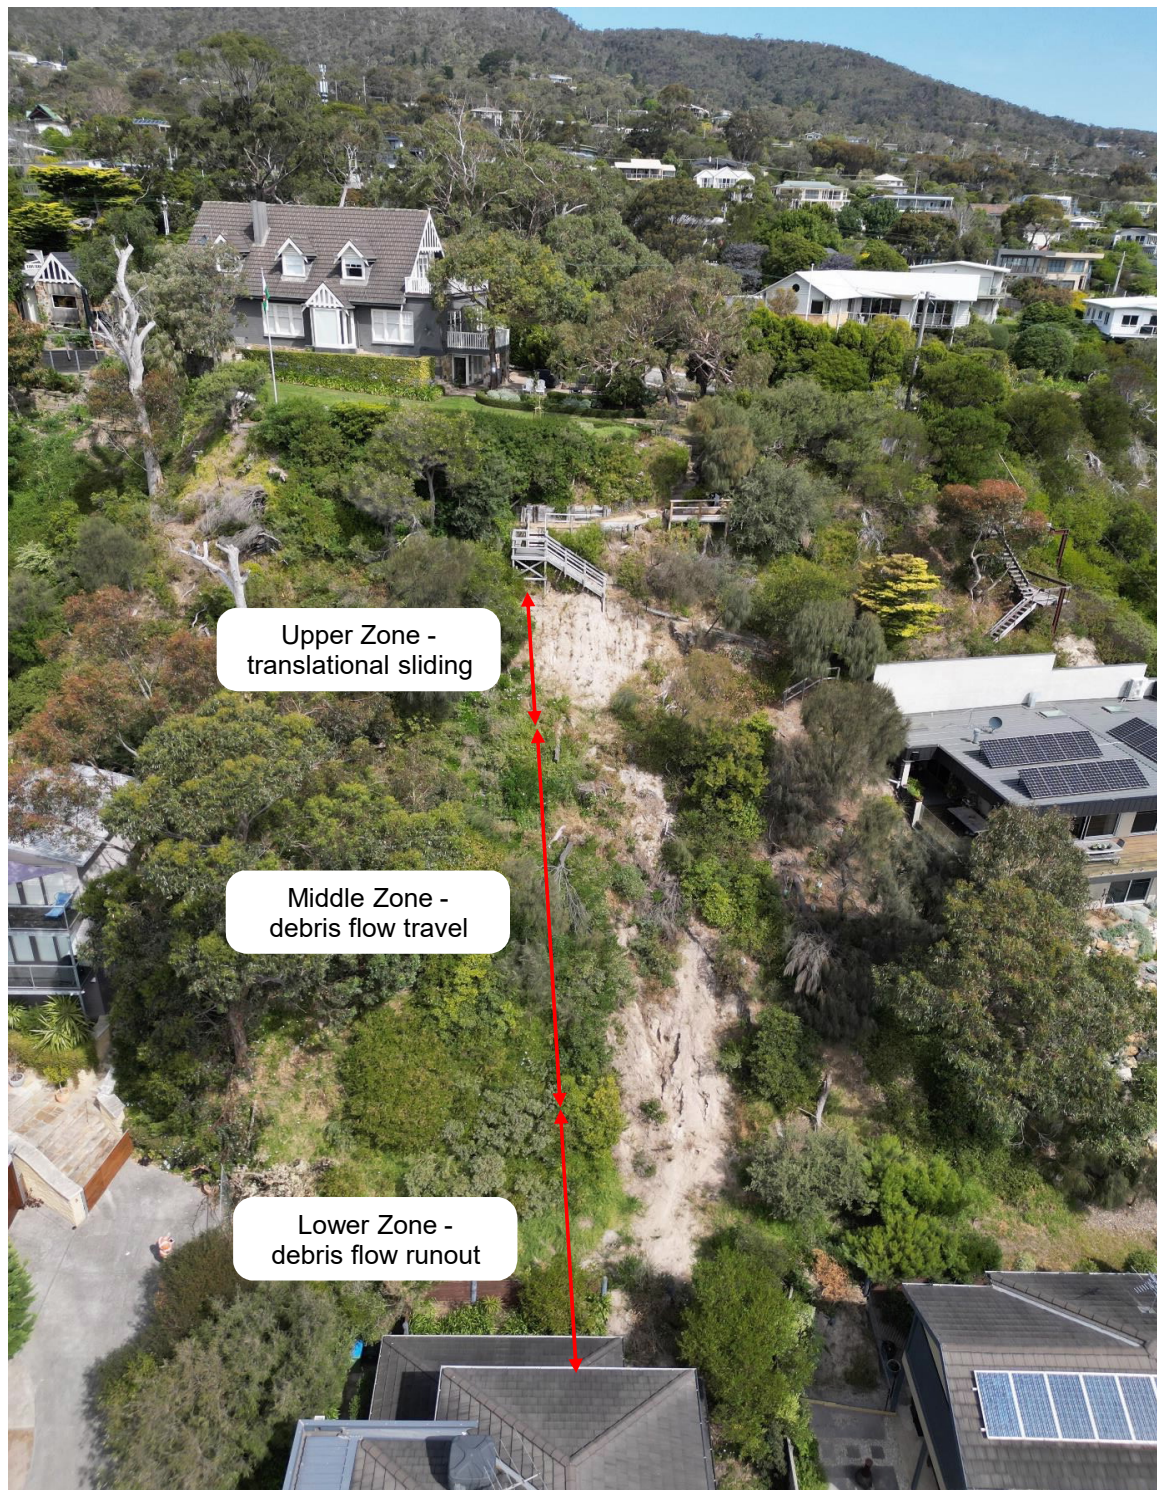
- (b) It was inferred to have initiated as a translational slide followed by mobilisation of failed material into a debris flow which was deposited at the toe of the slope, Photo 2 Appendix E.

Photo 1 - Landslide Overview, with zones indicated

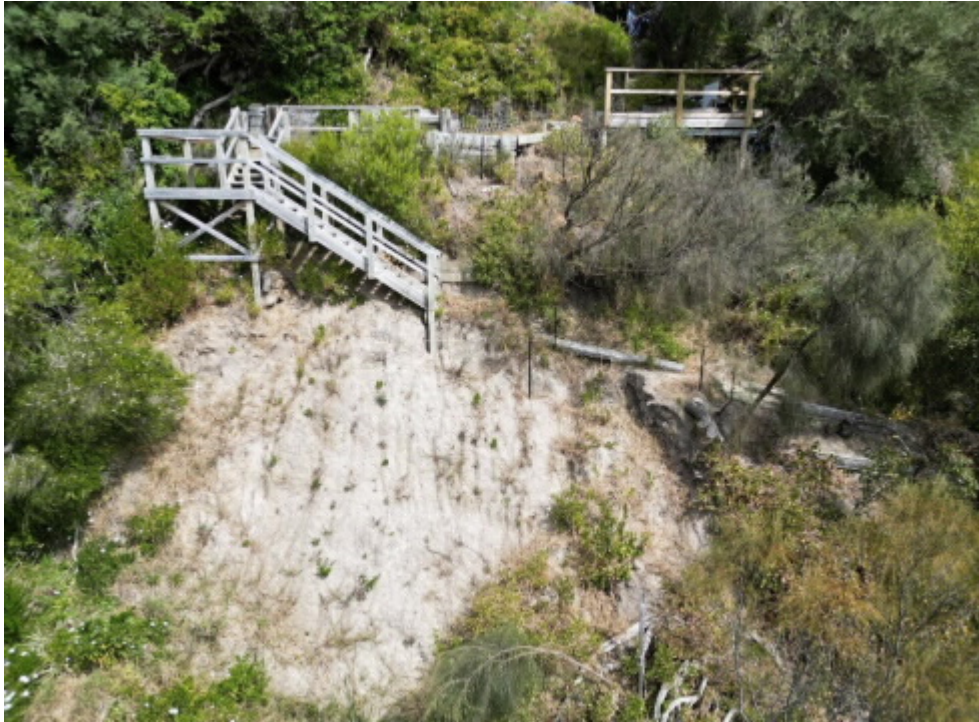
Photo 3 - Upper translational sliding area

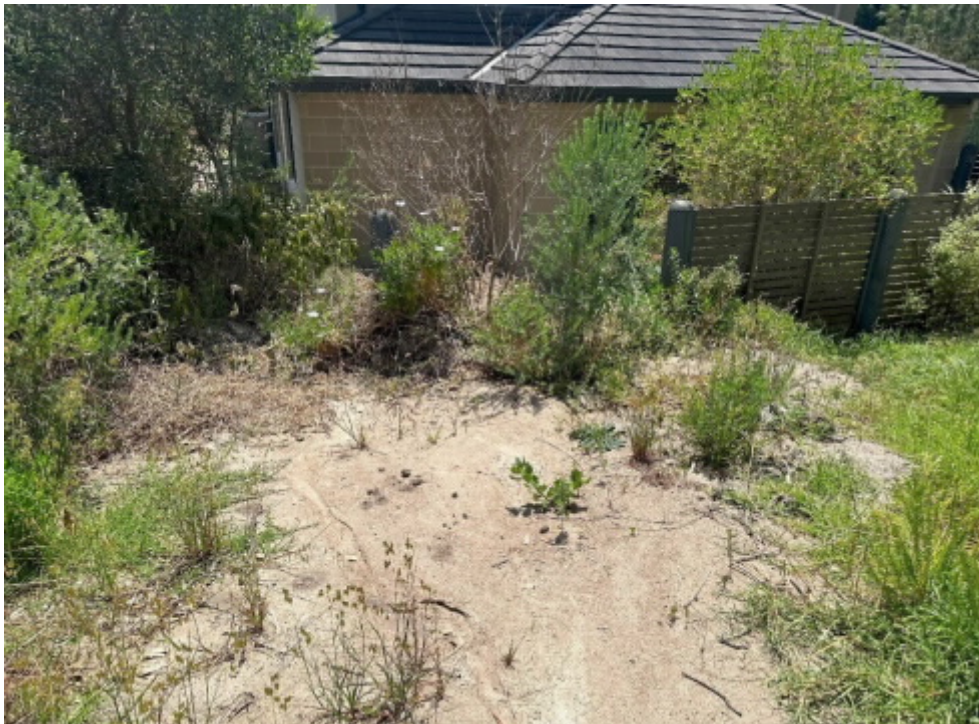
Photo 4 - Debris flow runout area, Property P2 visible in background

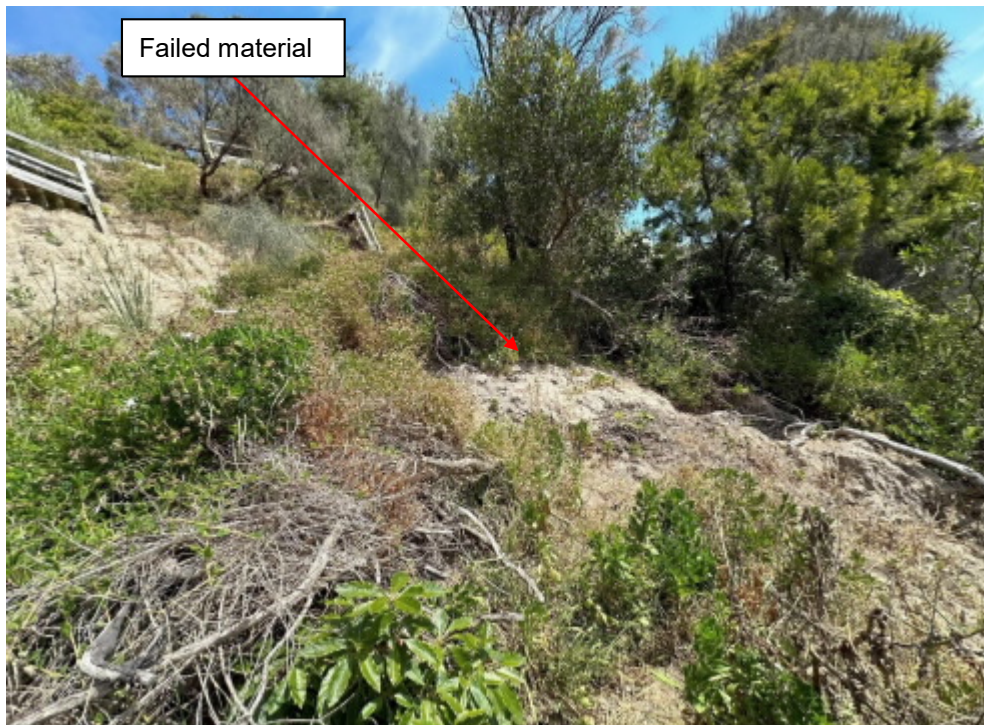
- (d) Disturbed ground that had undergone translational sliding but did not mobilise into a debris flow was observed on the right (western) flank of the Landslide, Photo 4 Appendix E.

Photo 4 - Failed material still on slope

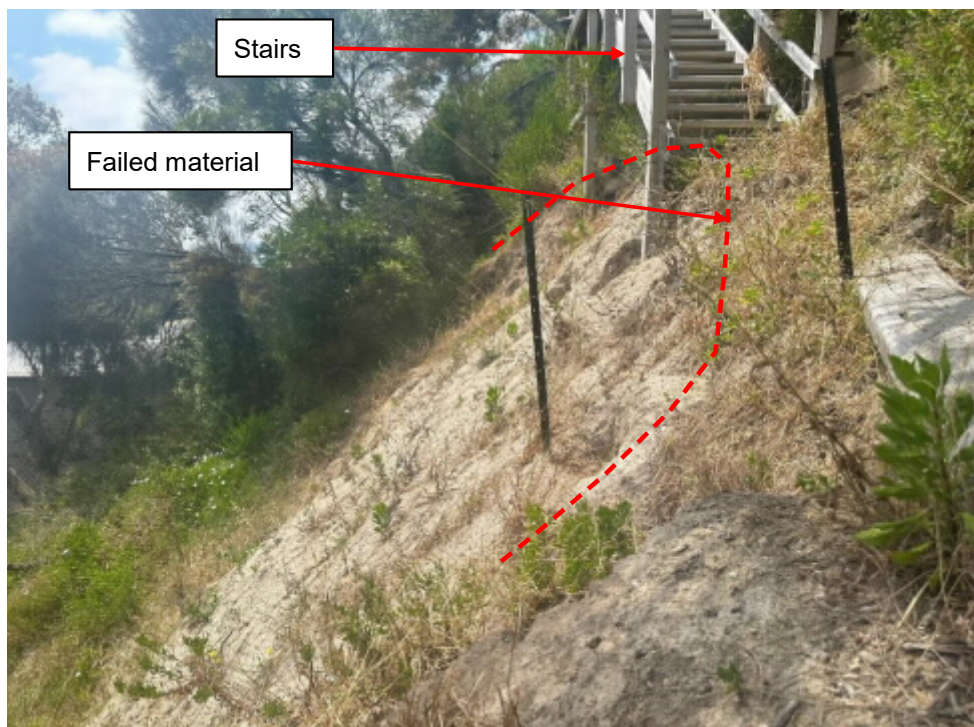
- (f) A lack of prominent backscarp, Photo 5 Appendix E, with minor steepening observed in the backscarp area and with a slope angle of approximately 45 degrees.

Photo 5 - Rear scarp of landslide, note lack of oversteepened backscarp

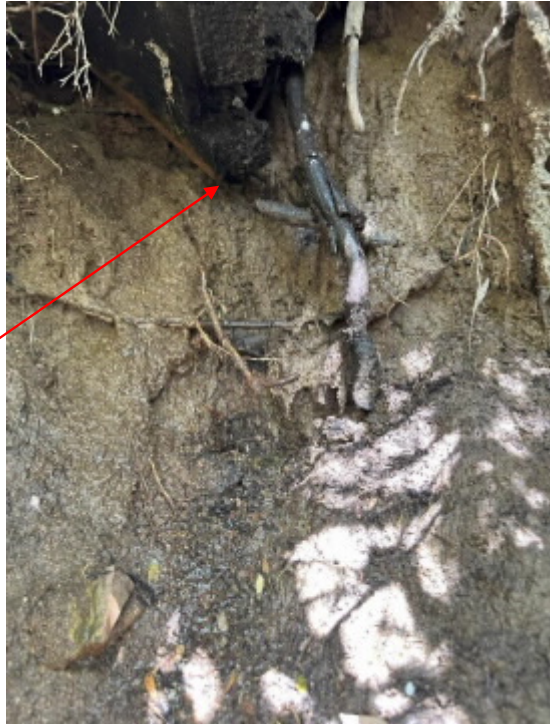
- (c) Groundwater was observed to be seeping from the slope to the east of the stairs, Photo 6 Appendix E. This location has been marked on Figure 1. I note this location is different from the headscarp seepage noted in the Stantec GA, refer paragraph [14(c)], however is consistent with Seepage on the eastern portion of the slope noted by Stantec GA, refer paragraph [14(d)].

Groundwater  
seeping from slope

Photo 6 - Groundwater seepage

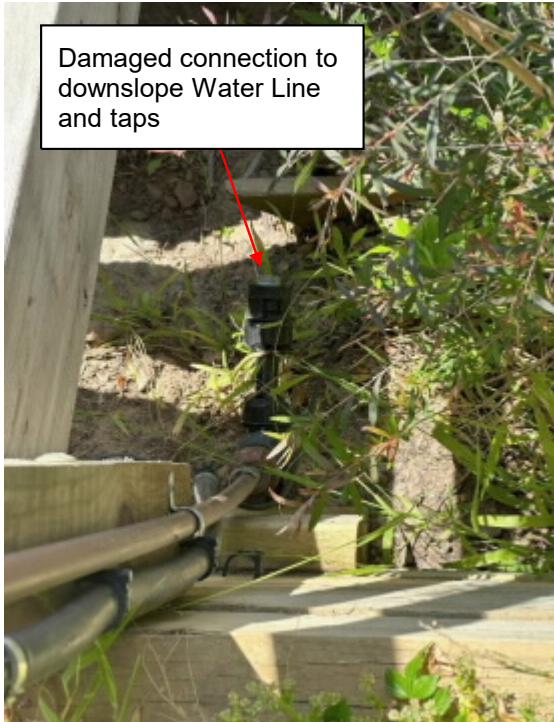
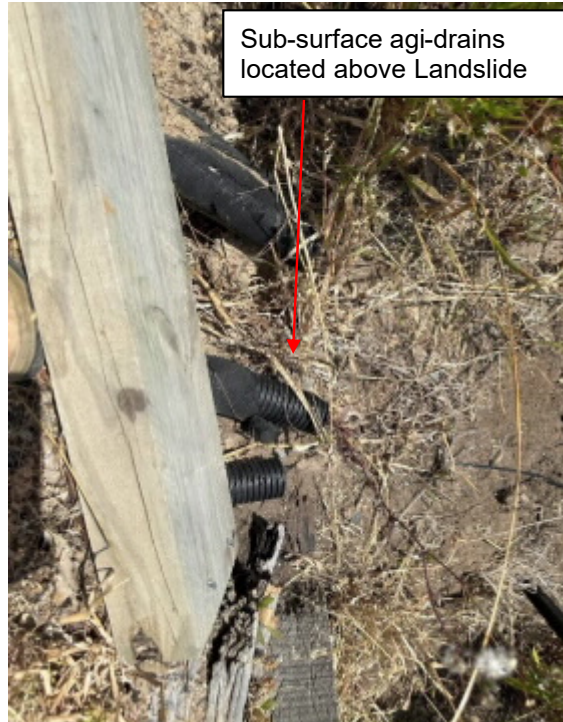
- (d) A variety of water infrastructure was observed across the Site, Photo 7 Appendix E including:
    - i. Subsurface 'agi-drains'
    - ii. Water pipes including taps. A 20 mm to 25 mm diameter blue line polyethylene pipe with a damaged connection was observed near the top of the stairs, immediately above the rear scarp of the landslide.

Damaged connection to  
downslope Water Line  
and taps

Sub-surface agi-drains  
located above Landslide

Photo 7 - Water infrastructure including water pipes (on left), and subsurface 'agi drains' (on right)

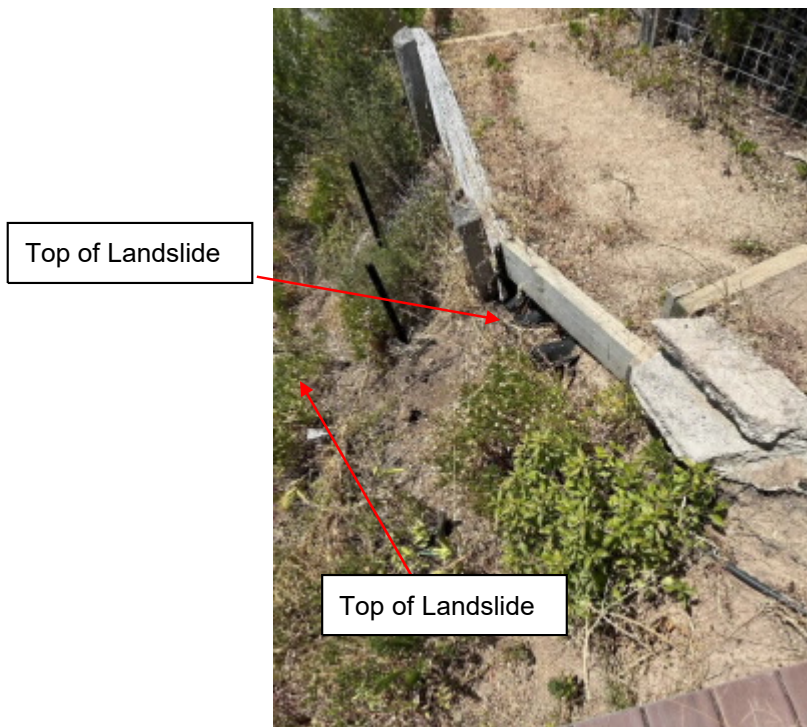
Photo 8 - Path above Landslide, note minor retaining walls and 'agi drains' from Photo 7

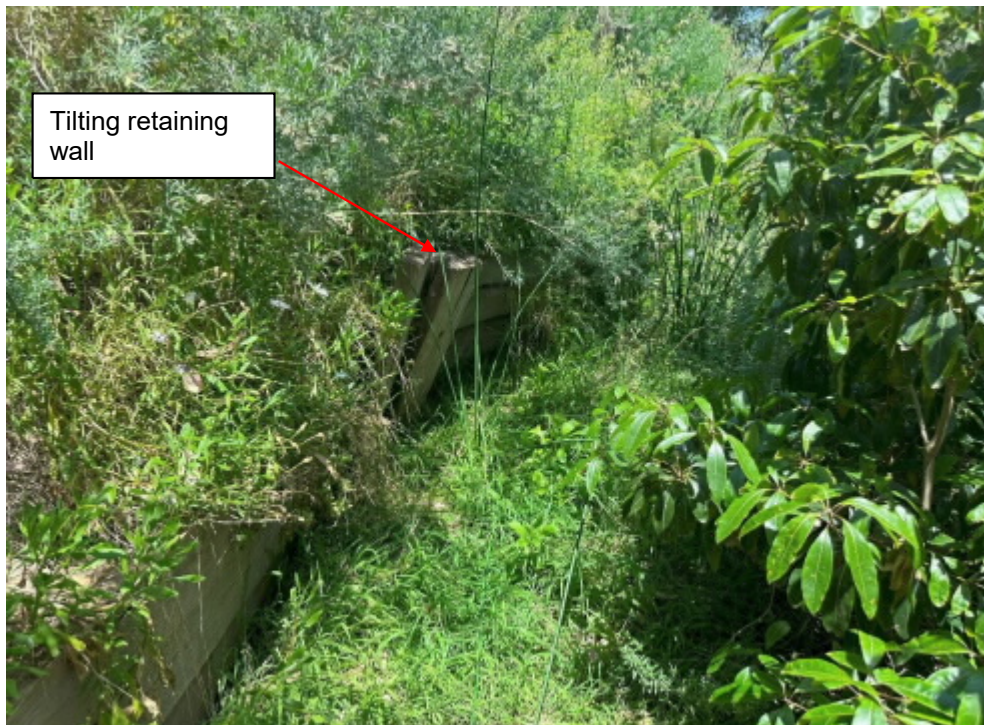
- (g) The condition of RWs across the Site was generally poor, with overturning and bulging RWs observed. A section of RW to the east of the Landslide had significant tilts. This indicates to me possible instability in the ground above the RW and possible structural or geotechnical failure of the RW, Photo 10 Appendix E. I note the RWs appear to be leaning more than as documented by Stantec (refer paragraph [20]).

Photo 10 - Tilting retaining walls on left side of Landslide

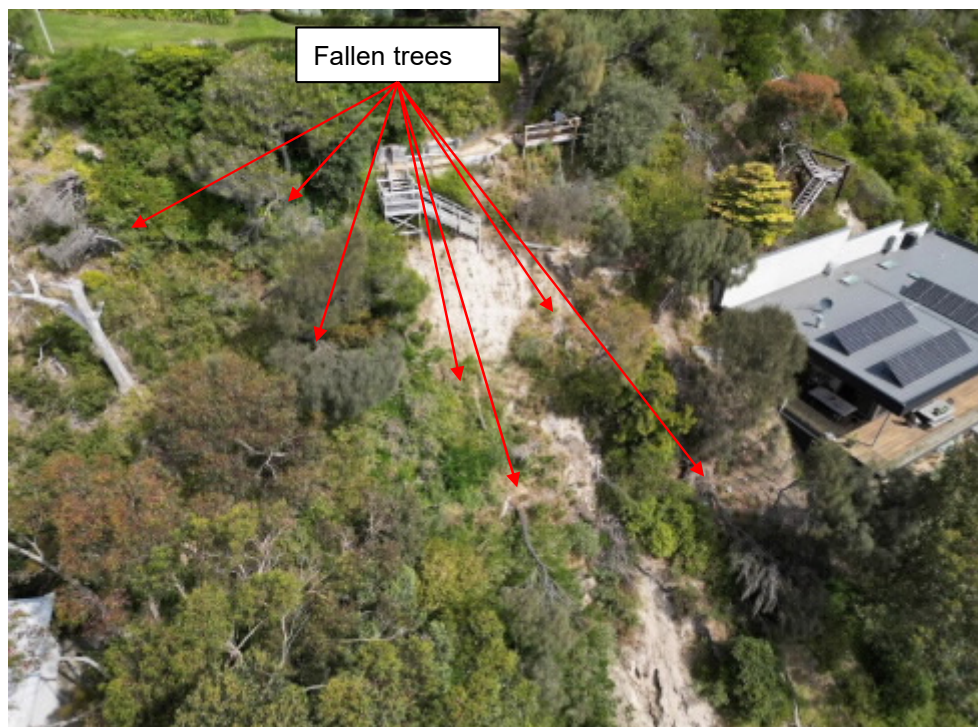
- (h) Numerous fallen trees were observed across the escarpment slope, Photo 11 Appendix E. I note that most of the failed trees appear to have failed from causes unrelated to the Landslide, i.e., wind or poor root embedment. I note at least one tree appears to have fallen because of the Landslide.

Photo 11 - Fallen trees

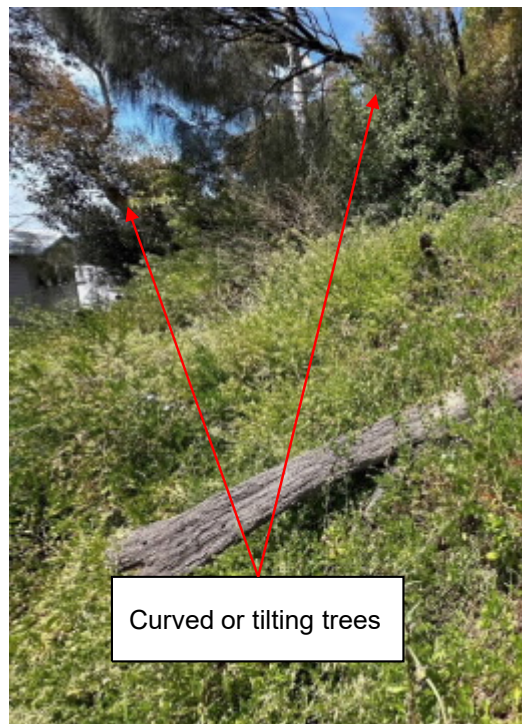
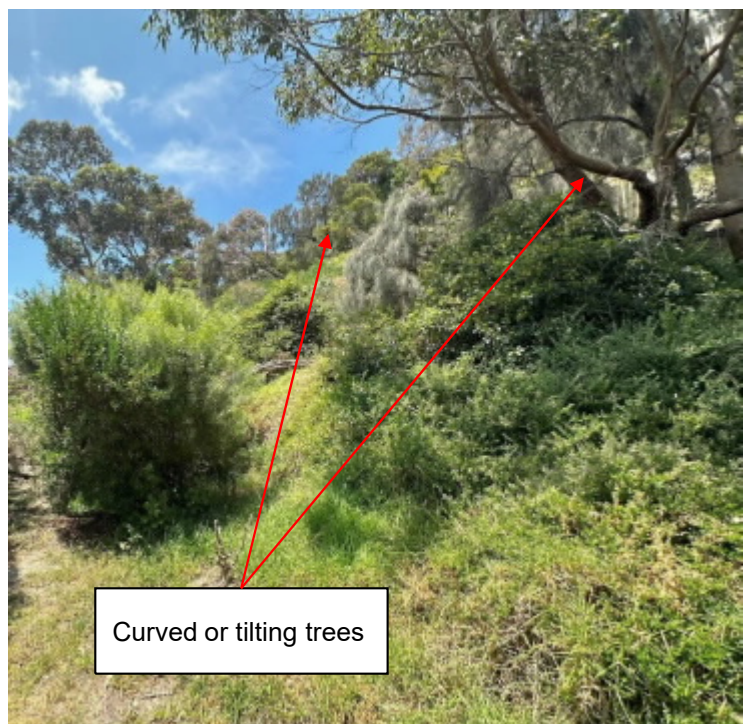
- (j) Leaning and curved trees were observed on the escarpment, suggesting possible creep movement of the slope, Photo 12 Appendix E.

Curved or tilting trees

Photo 12 - Curved or tilting trees
