9th Jan 2024

CHARLESWORTH ST & WALLER PL

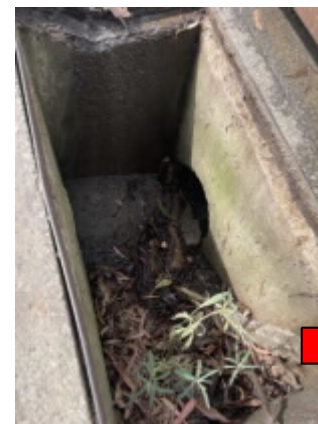
**Pit #1 - BEFORE**

Pit #1 was cleared by hand (even though not at intervention levels and the pipe outlet wasn't obstructed).

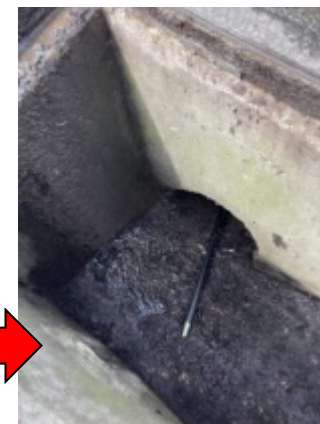
**AFTER PIT #1 CLEARED**

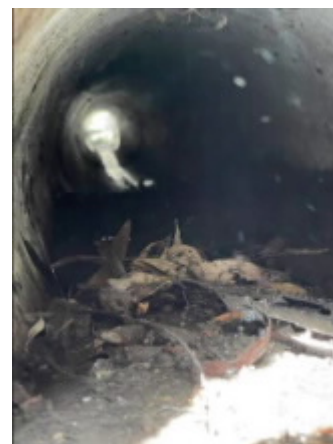
The line from Pit #1 to #3 was proved to be unobstructed and functional.

**Line from pit #1 to #3 is
clear and un-obstructed**

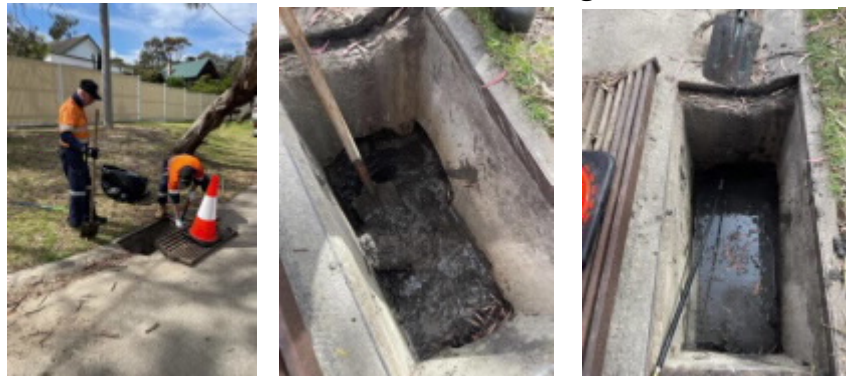
Pit #3 – Has approx 100mm slurry on bottom – but not within maintenance intervention & not obstructing inlet / outlets

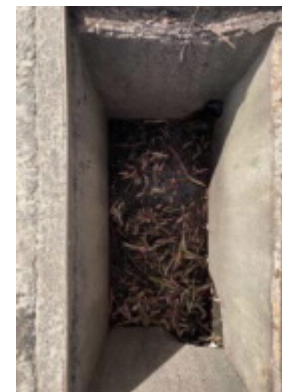
Pit #2 – Only light debris

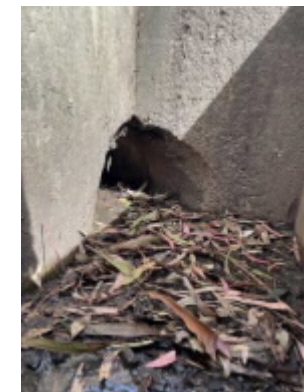
**Pit #2 – Outlet is clear.
Not within maintenance
intervention**

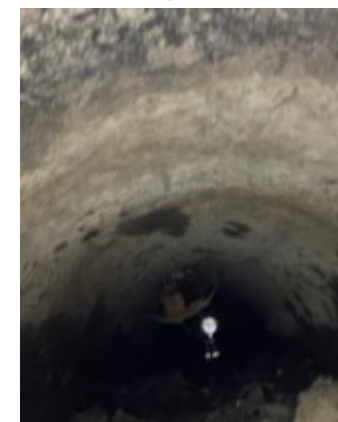
Line from pit #2 to #3

Line from pit #2 to 3 is proven to be unobstructed using flexi rods

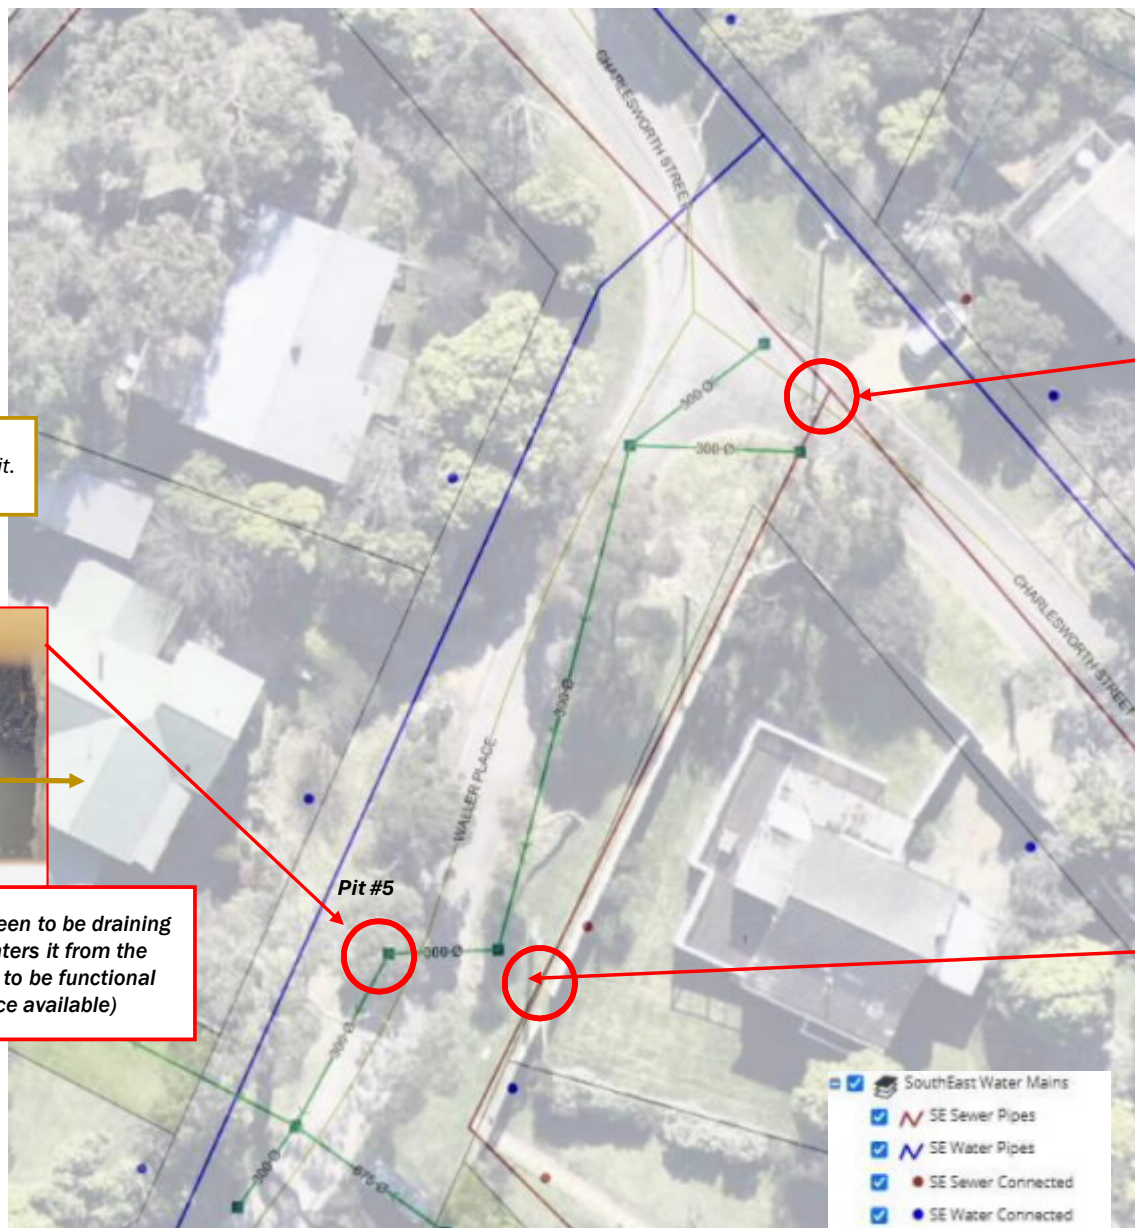
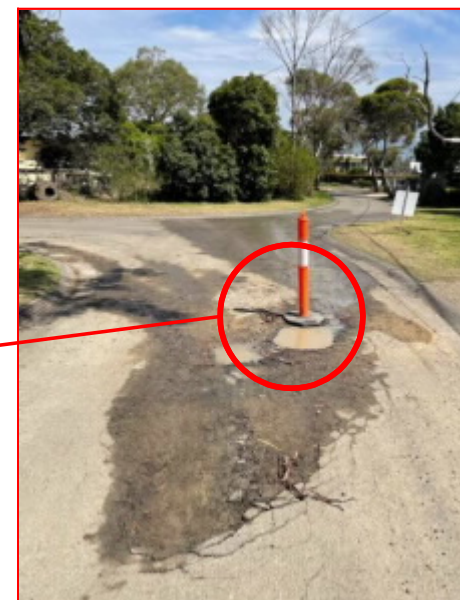
Pit #5 – Is visibly seen to be draining the water that enters it from the street. Confirmed to be functional (Video evidence available)

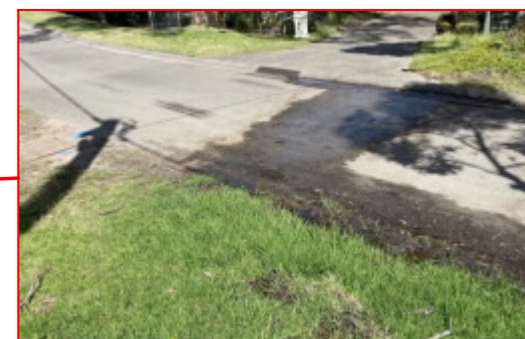
Water is visibly seen to be bubbling out from the pothole and running down the street into the kerb & storm water pits

Saturated nature strip flowing onto the road. Water is actively bubbling up on a day of no rain.

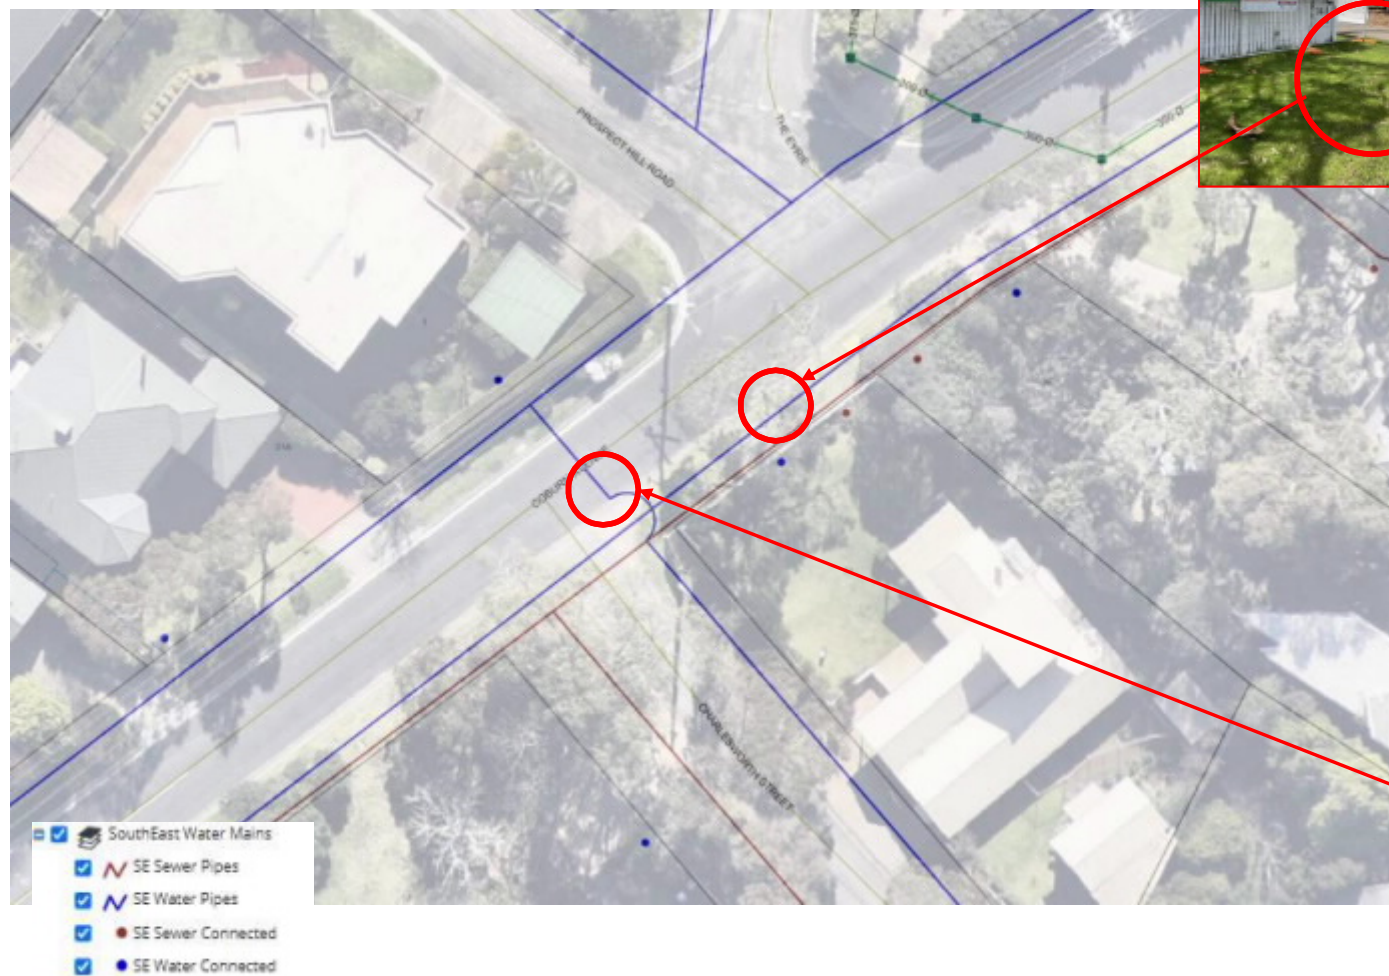
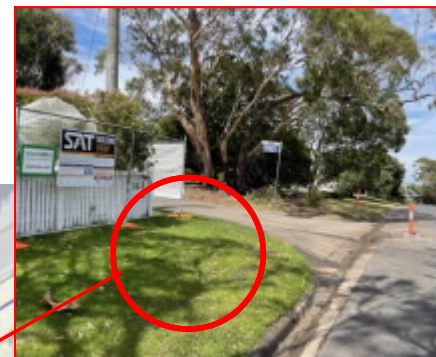
Nature strip is completely saturated

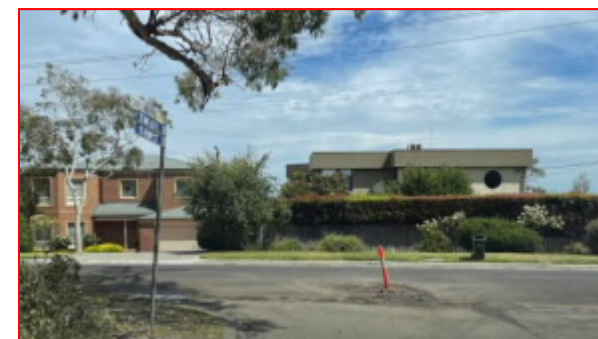
Water is seen to be actively coming up from the road / pothole on a day of no rain – 9/01/2025.

No stormwater assets under the road at this location
