Prepared for Mornington Peninsula Shire
 Asset ID NP12212055
 Location View Point Road, 1 McCrae
 Date 30/08/2023
 Operator Craig Hunt

Upstream Node 962658
 Downstream Node 964409
 Survey Direction Downstream
 Inspected Length 23.07 meters
 Camera Type Tractor
 Standard WSA 05-2008 2.2

Conduit Shape Circular
 Material PP
 Size 300

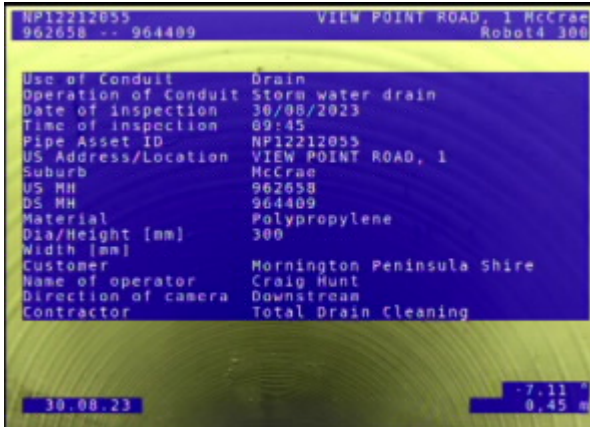
Location of Observation: 0.45m Video Position: 00:00:00

Observation Code: STMH

Start node, maintenance hole, Nodename:, 962658

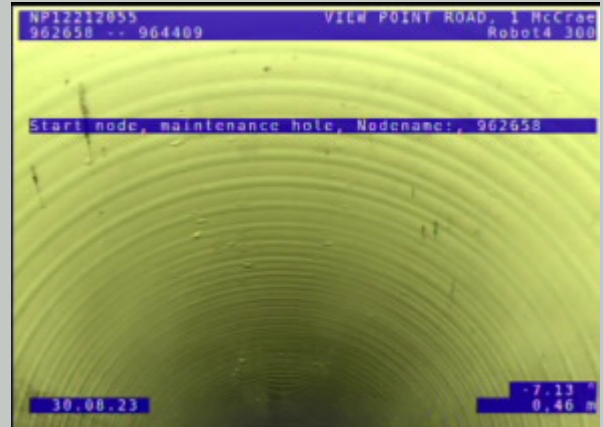
Location of Observation: 0.45m Video Position: 00:00:00

Observation Code: STMH [PHOTO 2]

Start node, maintenance hole, Nodename:, 962658

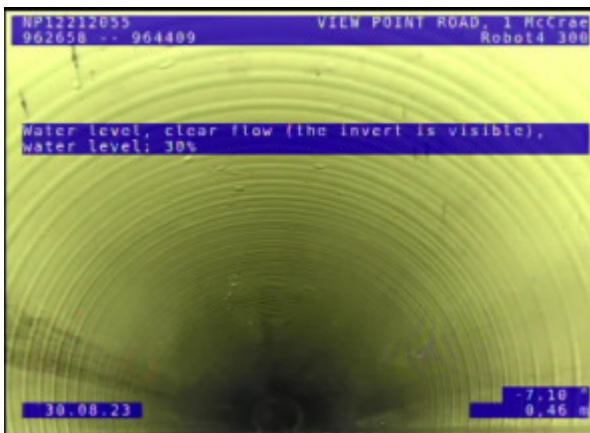
Location of Observation: 0.46m Video Position: 00:00:15

Observation Code: WLC

Water level, clear flow (the invert is visible), water level: 30%

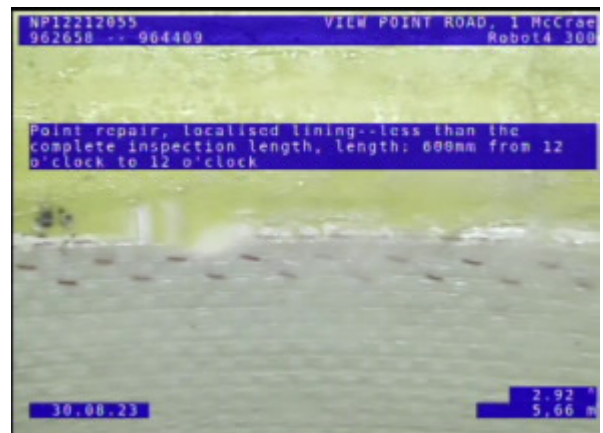
Location of Observation: 5.66m Video Position: 00:01:05

Observation Code: RPL

Point repair, localised lining--less than the complete inspection length, length: 600mm from 12 o'clock to 12 o'clock

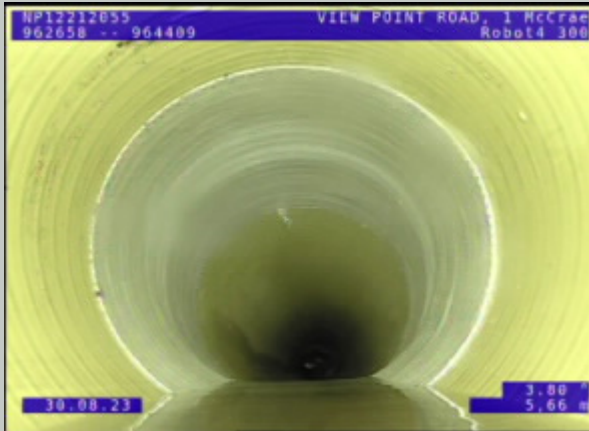
Location of Observation: 5.66m Video Position: 00:01:05
 Observation Code: RPL[PHOTO 2]
 Point repair, localised lining--less than the complete inspection length, length: 600mm from 12 o'clock to 12 o'clock

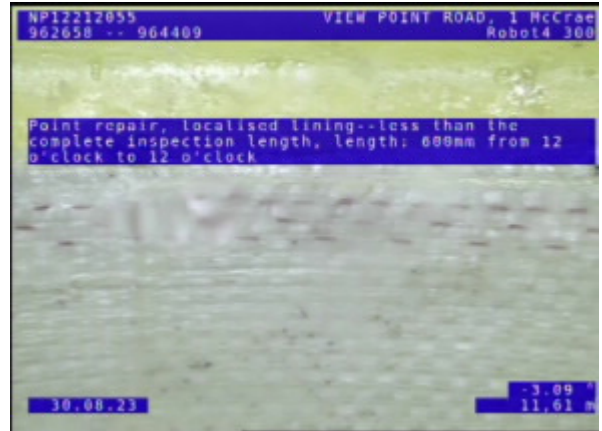
Location of Observation: 11.61m Video Position: 00:01:52
 Observation Code: RPL
 Point repair, localised lining--less than the complete inspection length, length: 600mm from 12 o'clock to 12 o'clock

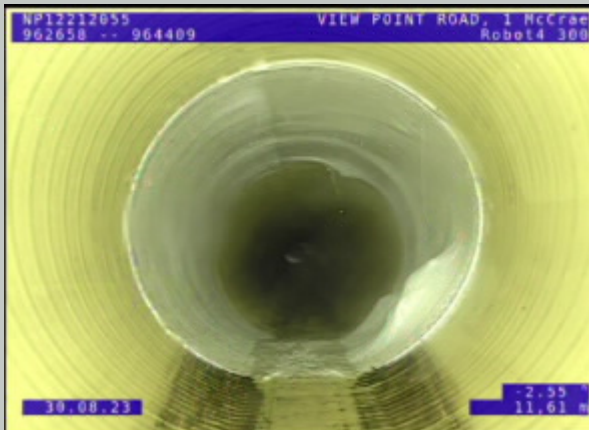
Location of Observation: 11.61m Video Position: 00:01:52
 Observation Code: RPL[PHOTO 2]
 Point repair, localised lining--less than the complete inspection length, length: 600mm from 12 o'clock to 12 o'clock

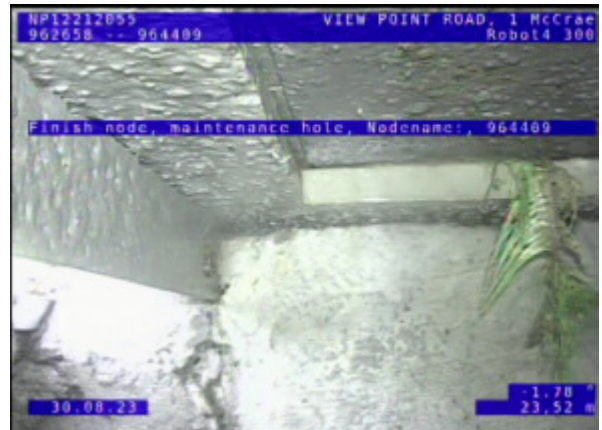
Location of Observation: 23.53m Video Position: 00:02:58
 Observation Code: FHHM
 Finish node, maintenance hole, Nodename:, 964409
