Prepared for Mornington Peninsula Shire
 Asset ID NP12212117
 Location Prospect Hill Road, 7 McCrae
 Date 30/08/2023
 Operator Craig Hunt

Upstream Node 929094
 Downstream Node 962658
 Survey Direction Upstream
 Inspected Length 34.88 meters
 Camera Type Tractor
 Standard WSA 05-2008 2.2

Conduit Shape Circular
 Material RC
 Size 300

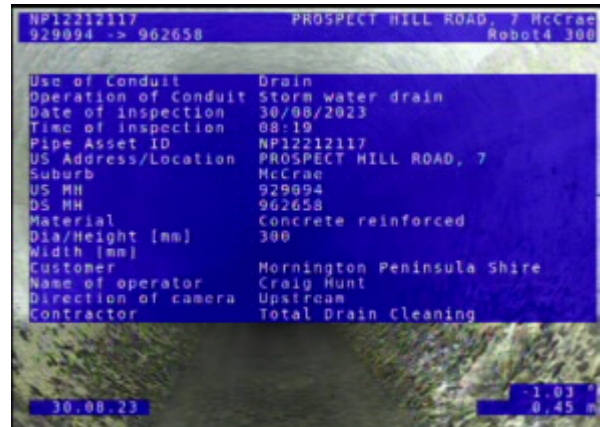
Location of Observation: 0.45m

Video Position: 00:00:00

Observation Code: STMH

Start node, maintenance hole, Nodename:, 962658

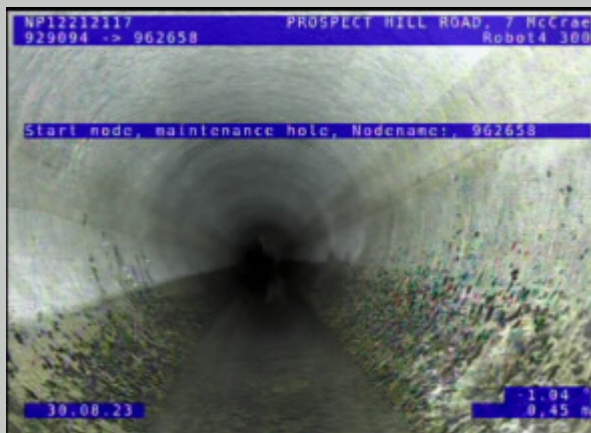
Location of Observation: 0.45m Video Position: 00:00:00

Observation Code: STMH[PHOTO 2]

Start node, maintenance hole, Nodename:, 962658

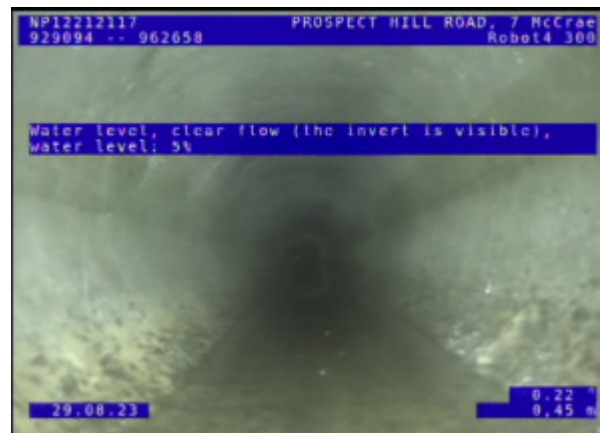
Location of Observation: 0.45m

Video Position: 00:00:17

Observation Code: WLC

Water level, clear flow (the invert is visible), water level: 5%

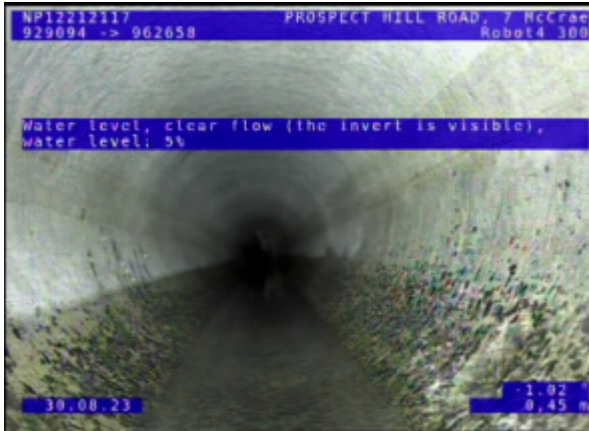
Location of Observation: 0.45m Video Position: 00:00:17
 Observation Code: WLC
 Water level, clear flow (the invert is visible), water level: 5%

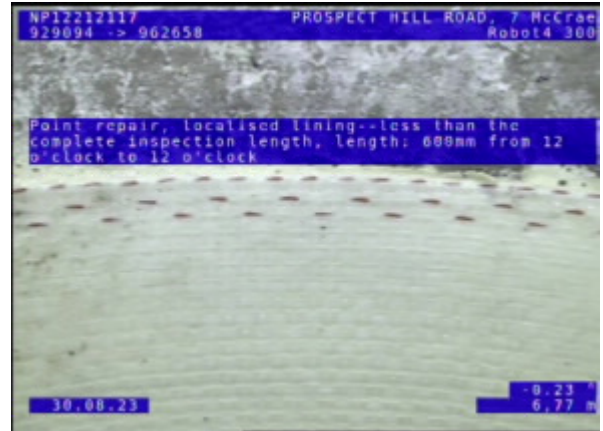
Location of Observation: 6.77m Video Position: 00:00:45
 Observation Code: RPL
 Point repair, localised lining--less than the complete inspection length, length: 600mm from 12 o'clock to 12 o'clock

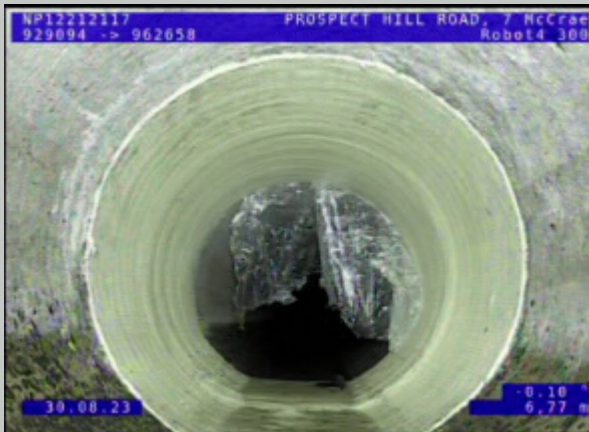
Location of Observation: 6.77m Video Position: 00:00:45
 Observation Code: RPL[PHOTO 2]
 Point repair, localised lining--less than the complete inspection length, length: 600mm from 12 o'clock to 12 o'clock

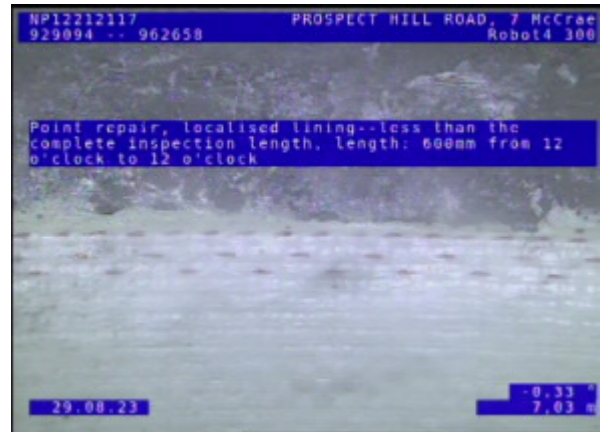
Location of Observation: 7.03m Video Position: 00:00:49
 Observation Code: RPL
 Point repair, localised lining--less than the complete inspection length, length: 600mm from 12 o'clock to 12 o'clock

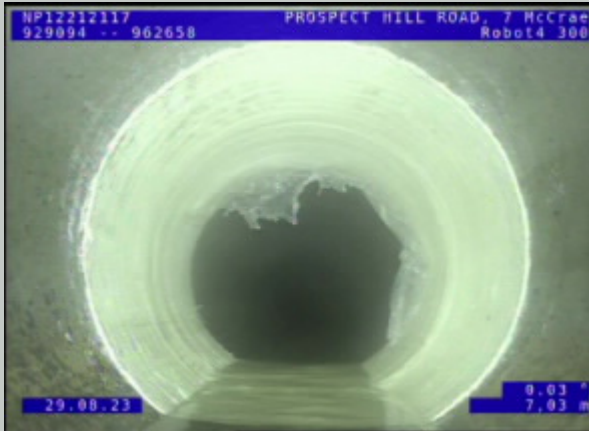
Location of Observation: 7.03m Video Position: 00:00:49
 Observation Code: RPL[PHOTO 2]
 Point repair, localised lining--less than the complete inspection length, length: 600mm from 12 o'clock to 12 o'clock

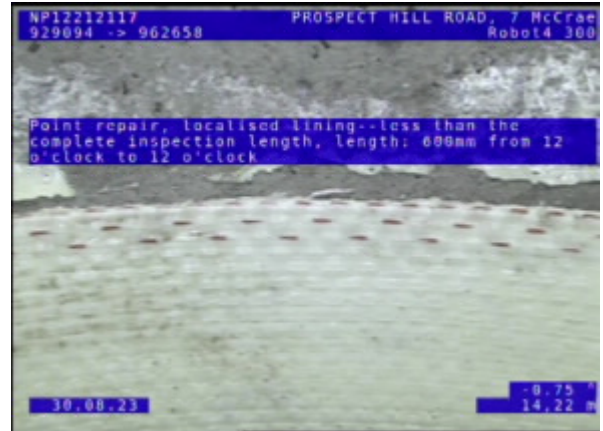
Location of Observation: 14.22m Video Position: 00:01:47
 Observation Code: RPL
 Point repair, localised lining--less than the complete inspection length, length: 600mm from 12 o'clock to 12 o'clock

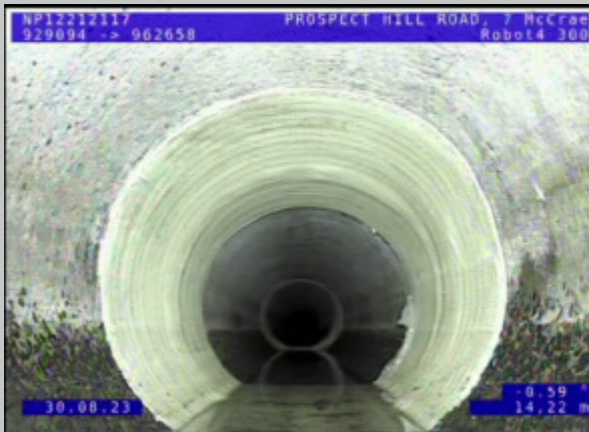
Location of Observation: 14.22m Video Position: 00:01:47
 Observation Code: RPL[PHOTO 2]
 Point repair, localised lining--less than the complete inspection length, length: 600mm from 12 o'clock to 12 o'clock

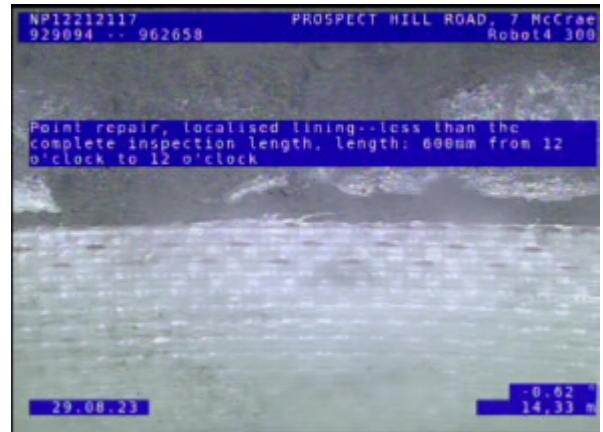
Location of Observation: 14.33m Video Position: 00:01:34
 Observation Code: RPL
 Point repair, localised lining--less than the complete inspection length, length: 600mm from 12 o'clock to 12 o'clock

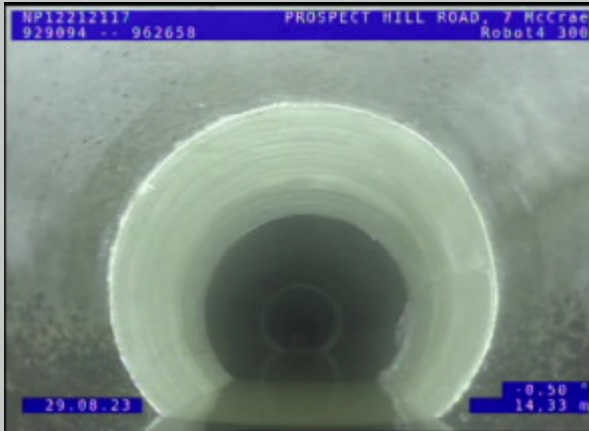
Location of Observation: 14.33m Video Position: 00:01:34
 Observation Code: RPL[PHOTO 2]
 Point repair, localised lining--less than the complete inspection length, length: 600mm from 12 o'clock to 12 o'clock

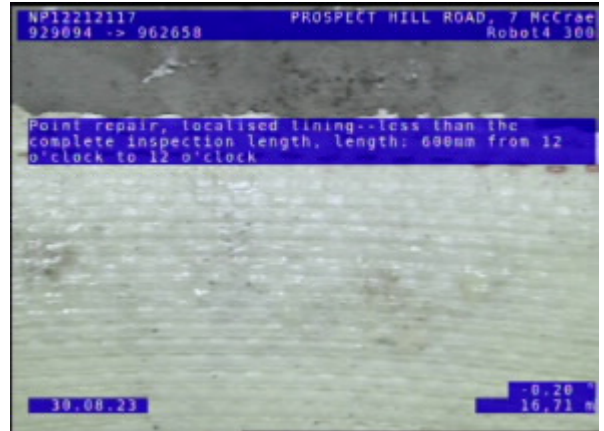
Location of Observation: 16.71m Video Position: 00:02:33
 Observation Code: RPL
 Point repair, localised lining--less than the complete inspection length, length: 600mm from 12 o'clock to 12 o'clock

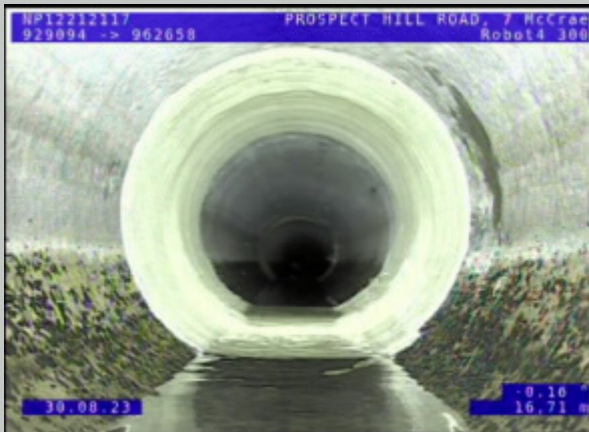
Location of Observation: 16.71m Video Position: 00:02:33
 Observation Code: RPL[PHOTO 2]
 Point repair, localised lining--less than the complete inspection length, length: 600mm from 12 o'clock to 12 o'clock

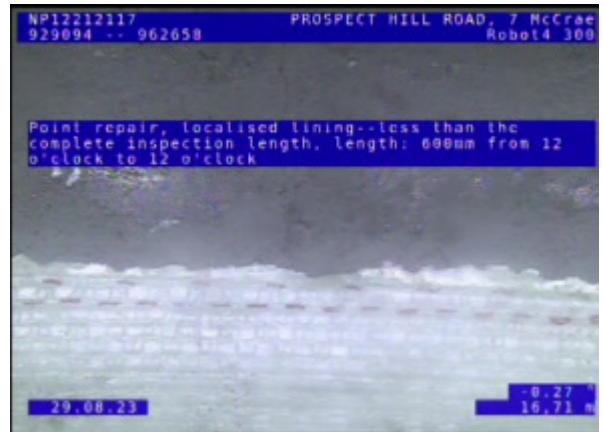
Location of Observation: 16.71m Video Position: 00:02:05
 Observation Code: RPL
 Point repair, localised lining--less than the complete inspection length, length: 600mm from 12 o'clock to 12 o'clock

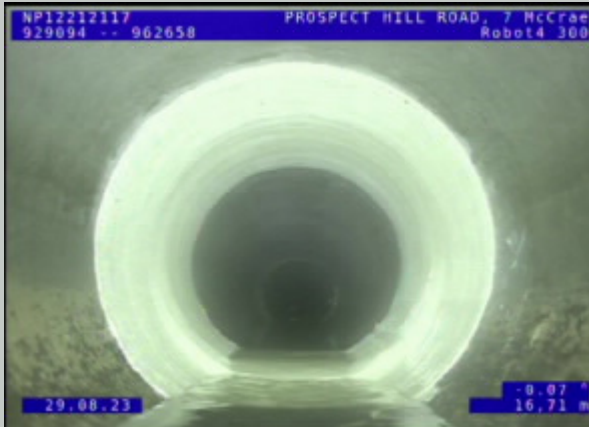
Location of Observation: 16.71m Video Position: 00:02:05
 Observation Code: RPL[PHOTO 2]
 Point repair, localised lining--less than the complete inspection length, length: 600mm from 12 o'clock to 12 o'clock

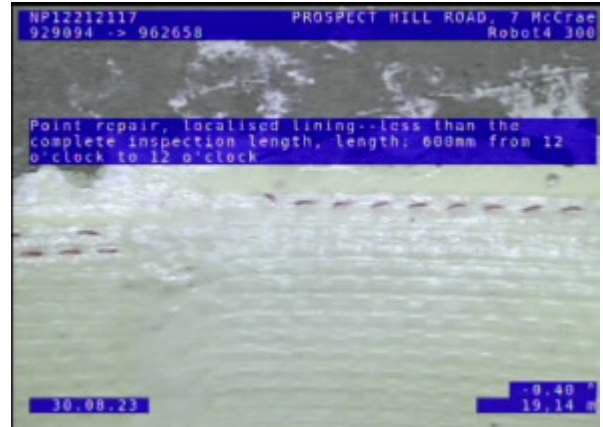
Location of Observation: 19.14m Video Position: 00:03:09
 Observation Code: RPL
 Point repair, localised lining--less than the complete inspection length, length: 600mm from 12 o'clock to 12 o'clock

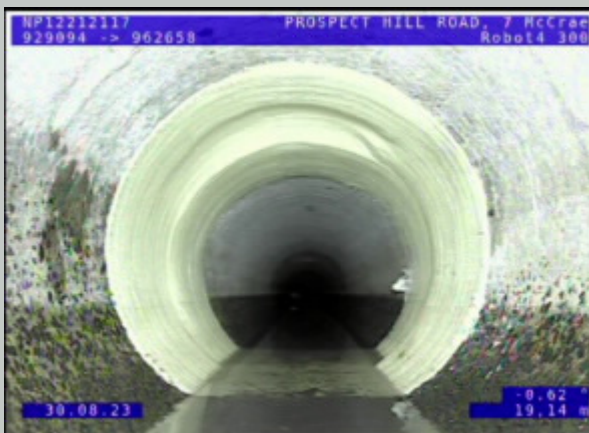
Location of Observation: 19.14m Video Position: 00:03:09
 Observation Code: RPL[PHOTO 2]
 Point repair, localised lining--less than the complete inspection length, length: 600mm from 12 o'clock to 12 o'clock

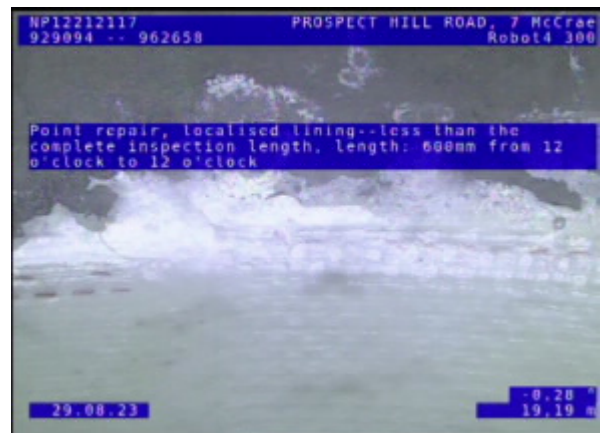
Location of Observation: 19.19m Video Position: 00:02:36
 Observation Code: RPL
 Point repair, localised lining--less than the complete inspection length, length: 600mm from 12 o'clock to 12 o'clock

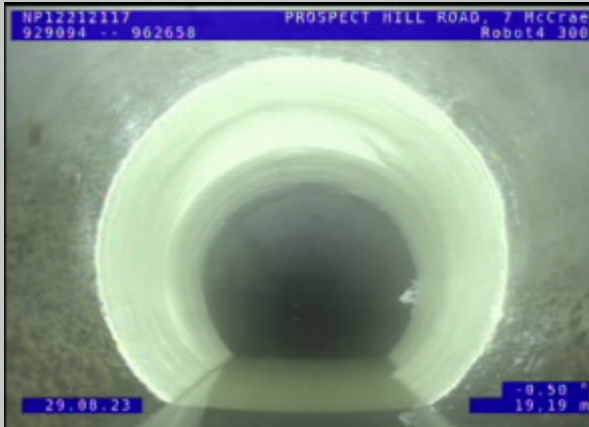
Location of Observation: 19.19m Video Position: 00:02:36
 Observation Code: RPL[PHOTO 2]
 Point repair, localised lining--less than the complete inspection length, length: 600mm from 12 o'clock to 12 o'clock

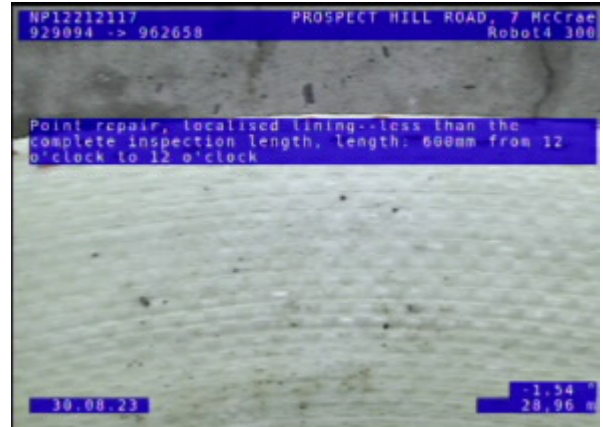
Location of Observation: 28.96m Video Position: 00:04:07
 Observation Code: RPL
 Point repair, localised lining--less than the complete inspection length, length: 600mm from 12 o'clock to 12 o'clock

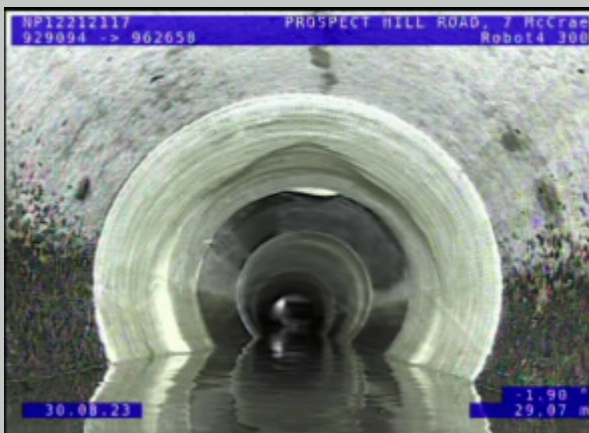
Location of Observation: 28.96m Video Position: 00:04:07
 Observation Code: RPL[PHOTO 2]
 Point repair, localised lining--less than the complete inspection length, length: 600mm from 12 o'clock to 12 o'clock

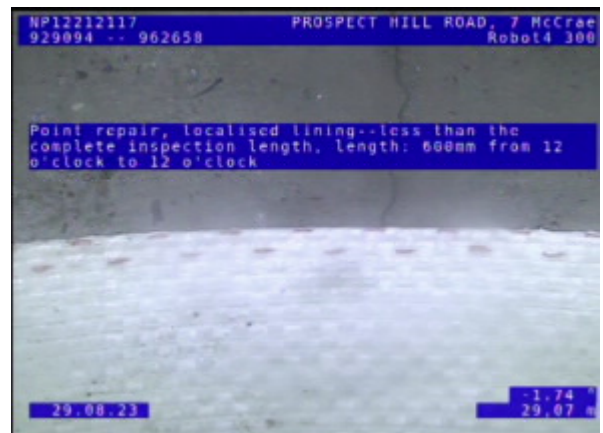
Location of Observation: 29.07m Video Position: 00:03:35
 Observation Code: RPL
 Point repair, localised lining--less than the complete inspection length, length: 600mm from 12 o'clock to 12 o'clock

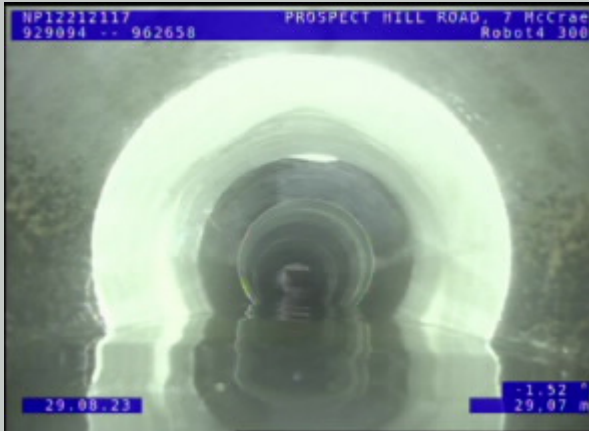
Location of Observation: 29.07m Video Position: 00:03:35
 Observation Code: RPL[PHOTO 2]
 Point repair, localised lining--less than the complete inspection length, length: 600mm from 12 o'clock to 12 o'clock

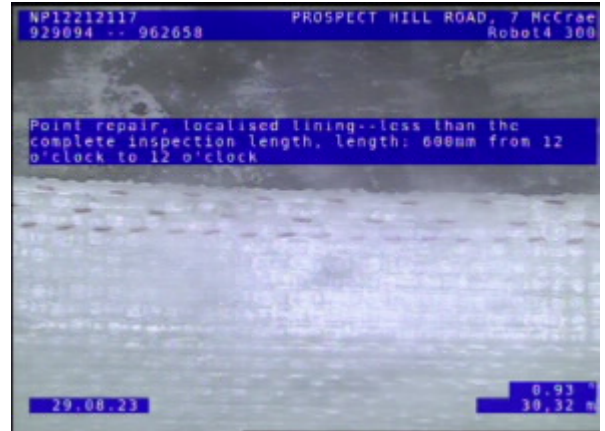
Location of Observation: 30.32m Video Position: 00:04:00
 Observation Code: RPL
 Point repair, localised lining--less than the complete inspection length, length: 600mm from 12 o'clock to 12 o'clock

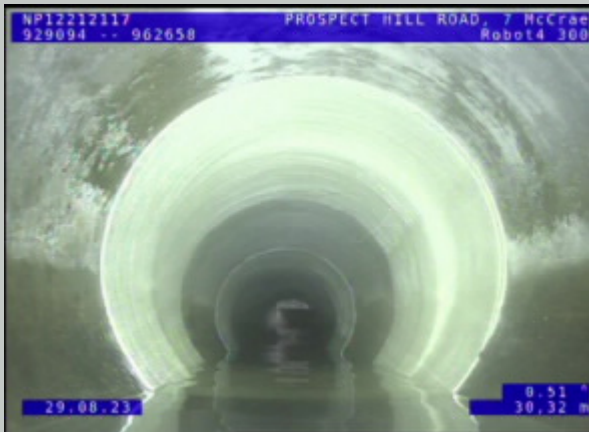
Location of Observation: 30.32m Video Position: 00:04:00
 Observation Code: RPL[PHOTO 2]
 Point repair, localised lining--less than the complete inspection length, length: 600mm from 12 o'clock to 12 o'clock

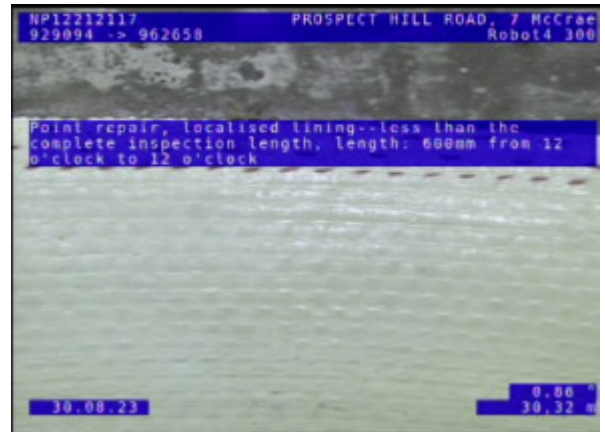
Location of Observation: 30.32m Video Position: 00:04:43
 Observation Code: RPL
 Point repair, localised lining--less than the complete inspection length, length: 600mm from 12 o'clock to 12 o'clock

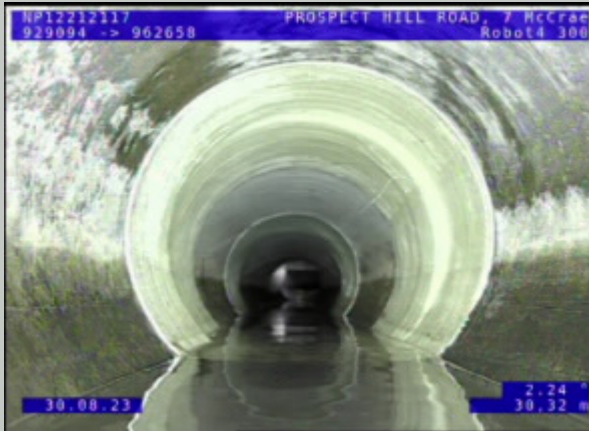
Location of Observation: 30.32m Video Position: 00:04:43
 Observation Code: RPL[PHOTO 2]
 Point repair, localised lining--less than the complete inspection length, length: 600mm from 12 o'clock to 12 o'clock

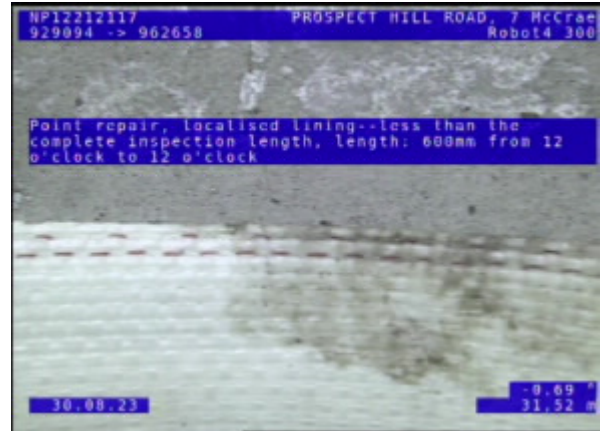
Location of Observation: 31.52m Video Position: 00:05:16
 Observation Code: RPL
 Point repair, localised lining--less than the complete inspection length, length: 600mm from 12 o'clock to 12 o'clock

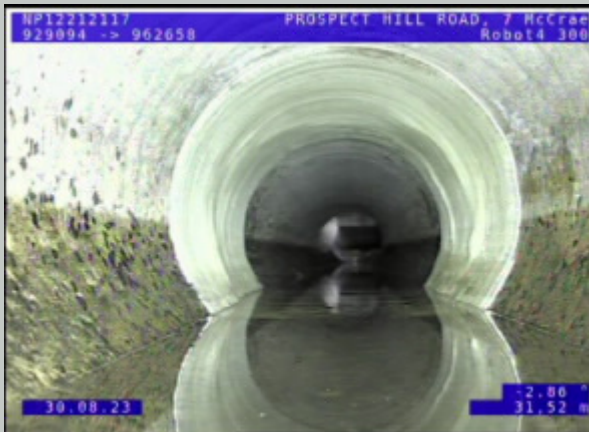
Location of Observation: 31.52m Video Position: 00:05:16
 Observation Code: RPL[PHOTO 2]
 Point repair, localised lining--less than the complete inspection length, length: 600mm from 12 o'clock to 12 o'clock

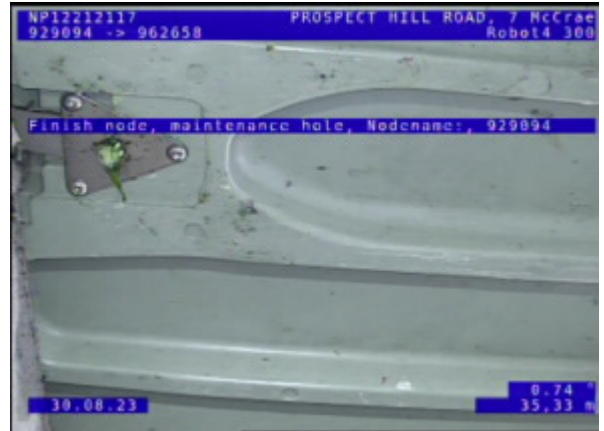
Location of Observation: 35.33m Video Position: 00:05:59

Observation Code: FHHH

Finish node, maintenance hole, Nodename:, 929094
