Date of inspection 15/01/2025	Time of inspection 9:00 AM	Land ownership Public land	Pipe Asset ID A TOO B	Nr. 1
Project name FULTONHOGAN - AE407 10-12 VIEW POINT ROAD MCCRAE	Contractor's Job Number	Coding Standard WSA 2020	Name of operator Alex Elliott	Job ID 10-12 VIEW POINT ROAD MCCRAE

Section Inspection - 15/01/2025 - A TOO B

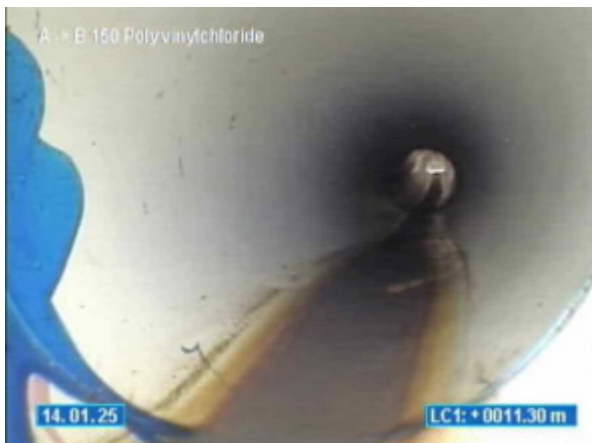
10-12 VIEW POINT ROAD MCCRAE_15.01.2025_090054_A
 TOO B _007.jpg, 00:03:24, 11.30
 Inspection (survey) abandoned, Line deviates

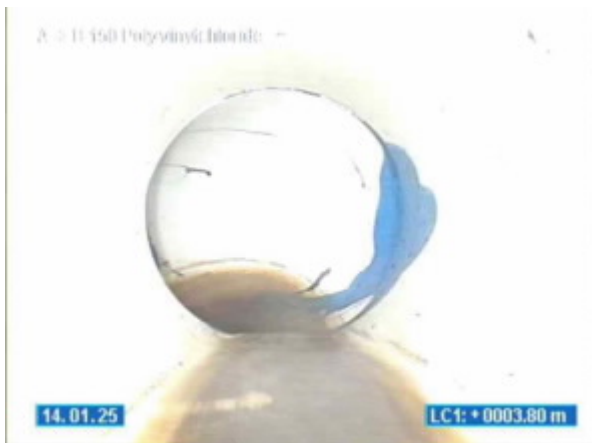
10-12 VIEW POINT ROAD MCCRAE_15.01.2025_083859_A
 TOO B _003.jpg, 00:04:25, 3.80
 The conduit curves to the left

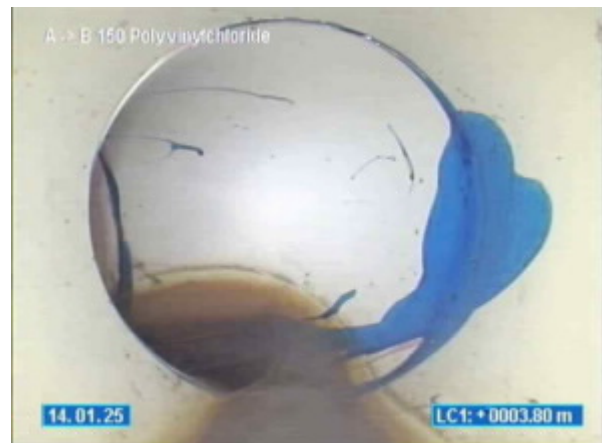
10-12 VIEW POINT ROAD MCCRAE_15.01.2025_083859_A
 TOO B _004.jpg, 00:05:13, 3.80
 Inspection (survey) abandoned, Line deviates

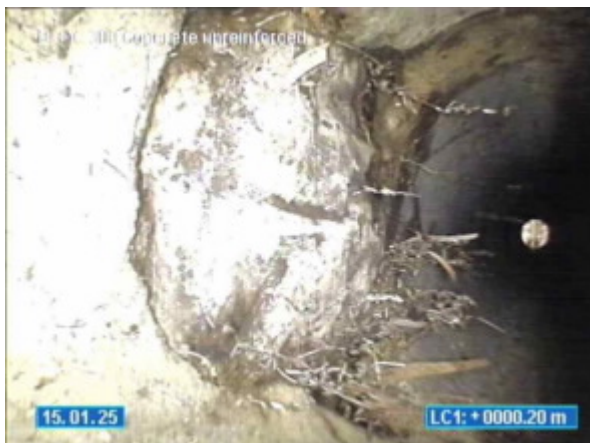
STR No. Def	STR Peak	STR Mean	STR Total	STR Grade	SER No. Def	SER Peak	SER Mean	SER Total	SER Grade
2	95.0	14.2	95.0	5	0	0.0	0.0	0.0	1

10-12 VIEW POINT ROAD MCCRAE_15.01.2025_102122_B
 TOO C _010.jpg, 00:02:28, 0.20
 Breaking, all pieces are present but some of them are visibly
 displaced from position, length of break: 300mm from 11
 o'clock to 1 o'clock

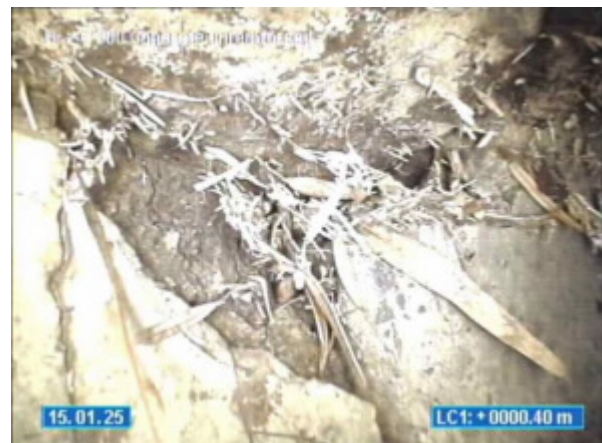
10-12 VIEW POINT ROAD MCCRAE_15.01.2025_102122_B
 TOO C _011.jpg, 00:02:54, 0.40
 Soil visible through defect

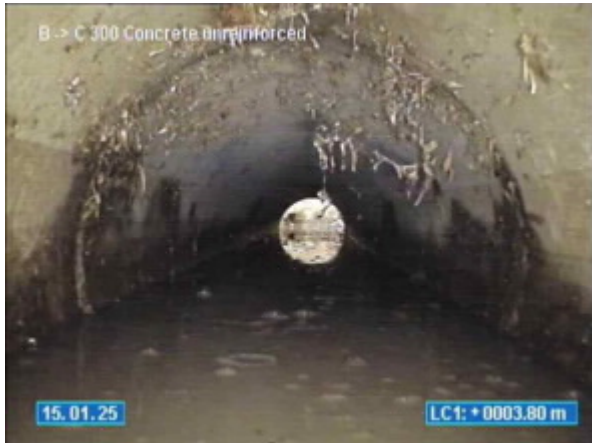
10-12 VIEW POINT ROAD MCCRAE_15.01.2025_102122_B
 TOO C _012.jpg, 00:03:34, 3.80
 Water flow at constant depth, turbid or discoloured water,
 20-25%

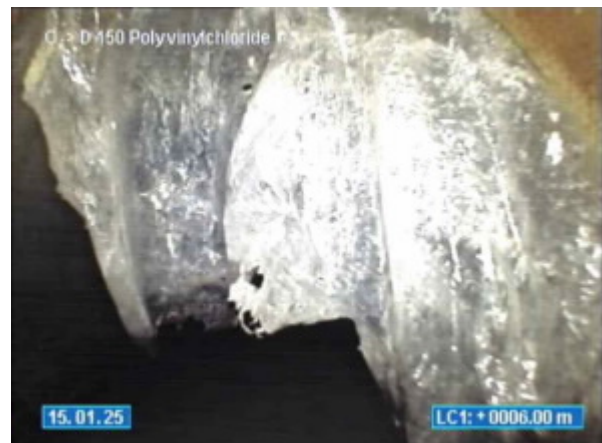
6.00	OBI	Obstruction, an object is intruding through the wall, Obstruction: 80% from 11 o'clock to 4 o'clock	00:04:25	10-12 VIEW POINT	5
	6.40	MC	Change of conduit material. New material, Concrete segments, at joint	00:04:25	10-12 VIEW POINT

STR No. Def	STR Peak	STR Mean	STR Total	STR Grade	SER No. Def	SER Peak	SER Mean	SER Total	SER Grade
0	0.0	0.0	0.0	1	1	80.0	3.2	80.0	5

10-12 VIEW POINT ROAD MCCRAE_15.01.2025_114611_C
 TOO D_024.jpg, 00:04:25, 6.00
 Obstruction, an object is intruding through the wall,
 Obstruction: 80% from 11 o'clock to 4 o'clock

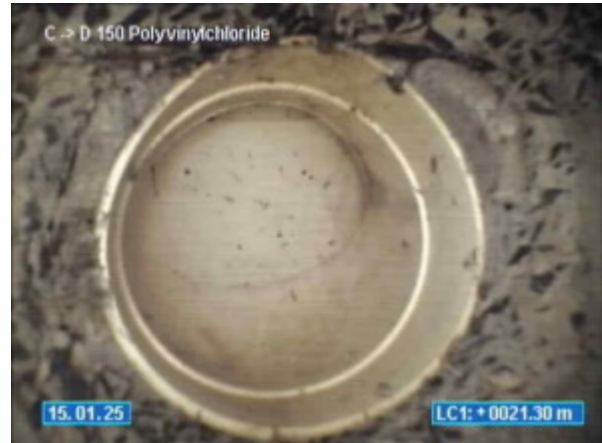
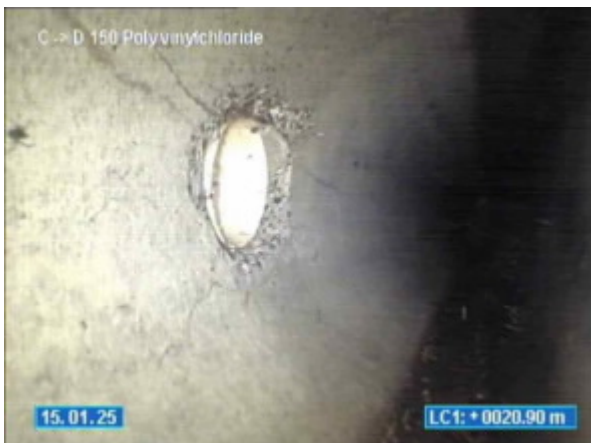
10-12 VIEW POINT ROAD MCCRAE_15.01.2025_114611_C
 TOO D_030.jpg, 00:04:25, 21.30
 Connection, unlined, connection appears to be open,
 Height/Diameter (mm): 100 at 12 o'clock

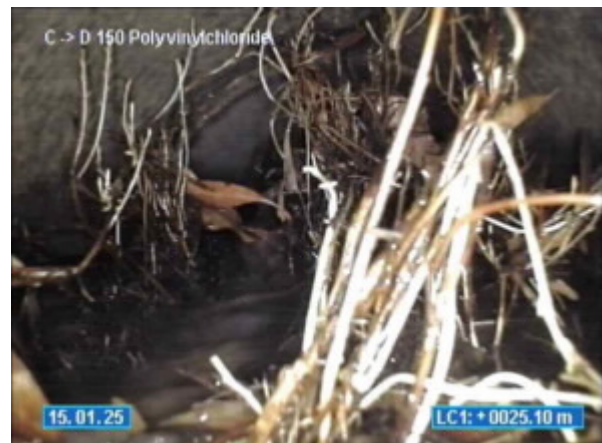
10-12 VIEW POINT ROAD MCCRAE_15.01.2025_114611_C
 TOO D_032.jpg, 00:00:00, 25.10
 Inspection (survey) abandoned, roots

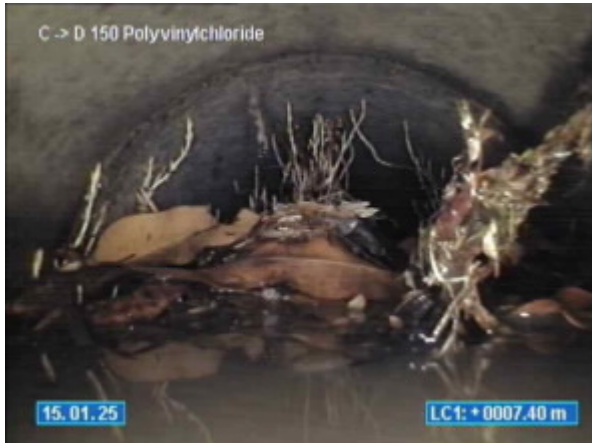
10-12 VIEW POINT ROAD MCCRAE_15.01.2025_104134_C
 TOO D_020.jpg, 00:05:13, 7.10
 Tap roots, reduction in cross sectional area, Obstruction: 50%
 from 9 o'clock to 3 o'clock

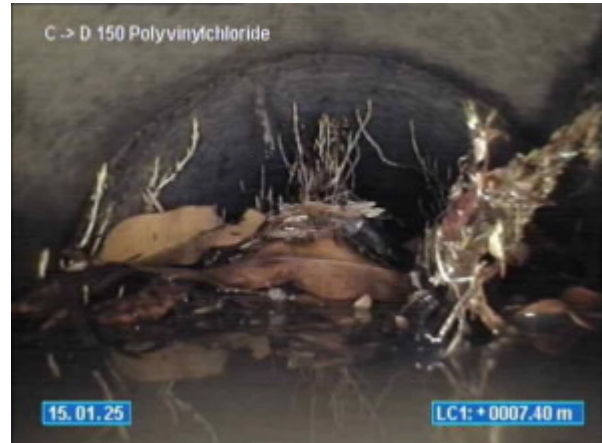
10-12 VIEW POINT ROAD MCCRAE_15.01.2025_104134_C
 TOO D_019.jpg, 00:07:08, 7.40
 Inspection (survey) abandoned, roots

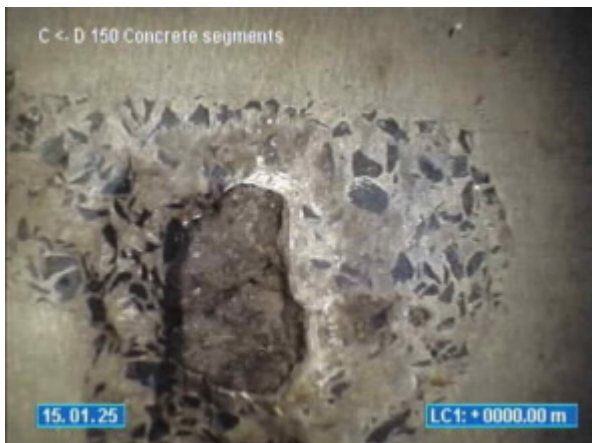
0.00	BM	Breaking, one or more pieces of conduit are missing, length of break: 100mm from 11 o'clock to 1 o'clock	00:33:07	10-12 VIEW POINT	3
	0.00	SV	Soil visible through defect	00:33:07	10-12 VIEW POINT	4

Construction Features					Miscellaneous Features				
Structural Defects					Service & Operational Defects				
STR No. Def	STR Peak	STR Mean	STR Total	STR Grade	SER No. Def	SER Peak	SER Mean	SER Total	SER Grade
2	75.0	2.2	75.0	5	0	0.0	0.0	0.0	1

10-12 VIEW POINT ROAD MCCRAE_15.01.2025_132020_D
 TOO C _035.jpg, 00:33:07, 0.00
 Breaking, one or more pieces of conduit are missing, length of
 break: 100mm from 11 o'clock to 1 o'clock

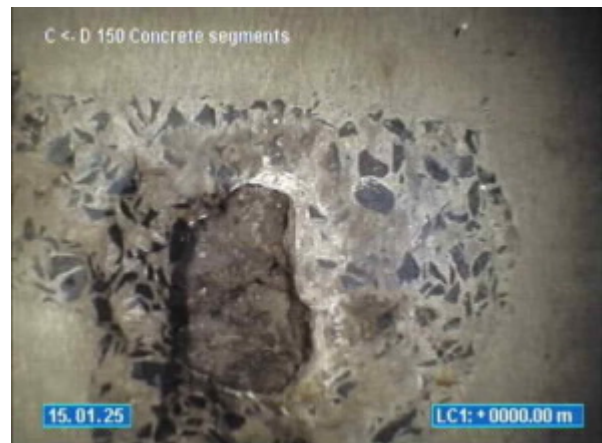
10-12 VIEW POINT ROAD MCCRAE_15.01.2025_132020_D
 TOO C _036.jpg, 00:33:07, 0.00
 Soil visible through defect

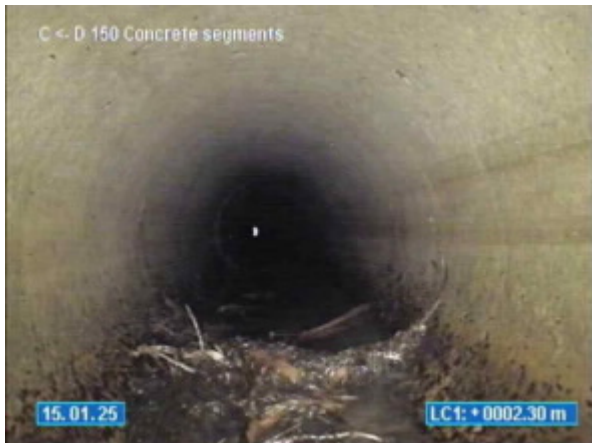
2.30	RRF	Recently cut fine roots-a relatively small number of cut minor roots remain, Obstruction: 20% from 4 o'clock to 8 o'clock	00:33:07	10-12 VIEW POINT	1

10-12 VIEW POINT ROAD MCCRAE_15.01.2025_132020_D TOO C _037.jpg, 00:33:07, 2.30
 Recently cut fine roots-a relatively small number of cut minor roots remain, Obstruction: 20% from 4 o'clock to 8 o'clock

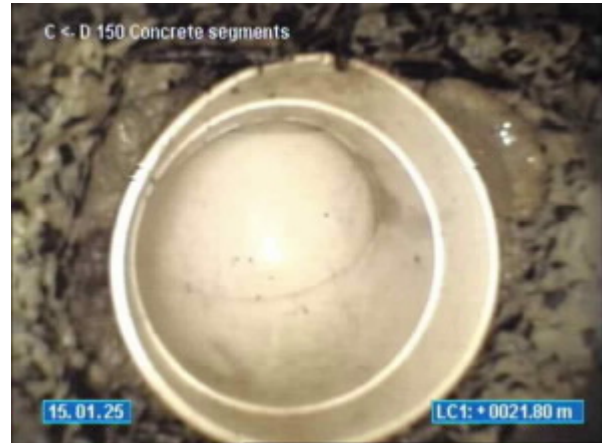
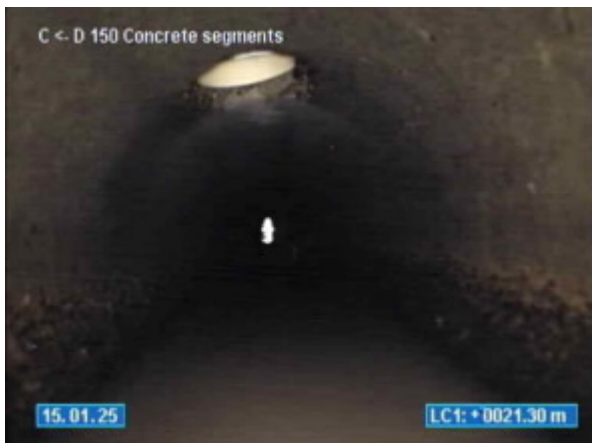
10-12 VIEW POINT ROAD MCCRAE_15.01.2025_132020_D TOO C _042.jpg, 00:33:07, 21.80
 Connection, unlined, connection appears to be open, Height/Diameter (mm): 150 at 12 o'clock

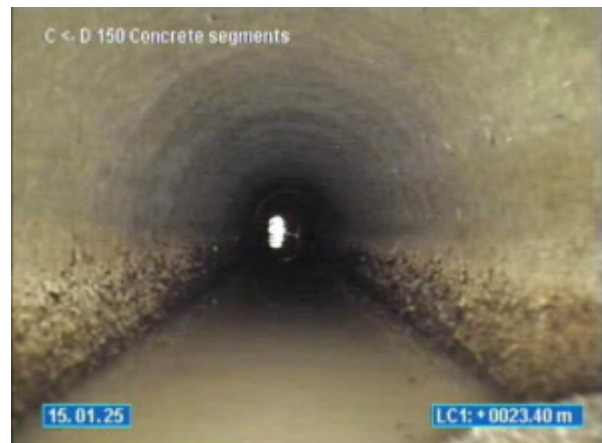
10-12 VIEW POINT ROAD MCCRAE_15.01.2025_132020_D TOO C _044.jpg, 00:33:07, 23.20
 Recently cut fine roots-a relatively small number of cut minor roots remain, Obstruction: 40%, at joint from 4 o'clock to 6 o'clock

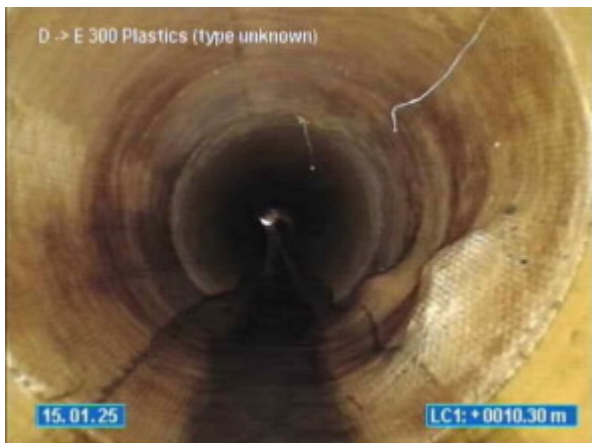
10-12 VIEW POINT ROAD MCCRAE_15.01.2025_135956_D
 TOO E _049.jpg, 00:01:48, 10.30
 The non-structural liner has bulged (no longer attached but
 liner is still intact) at 4 o'clock

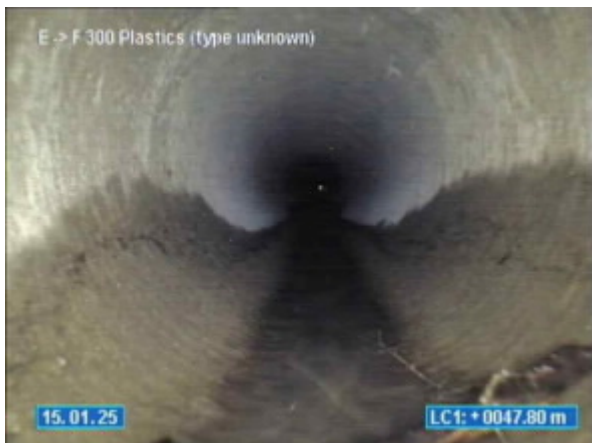
10-12 VIEW POINT ROAD MCCRAE_15.01.2025_141137_E
 TOO F _053.jpg, 00:05:39, 47.80
 Tap roots, reduction in cross sectional area, Obstruction: 10%
 from 6 o'clock to 7 o'clock

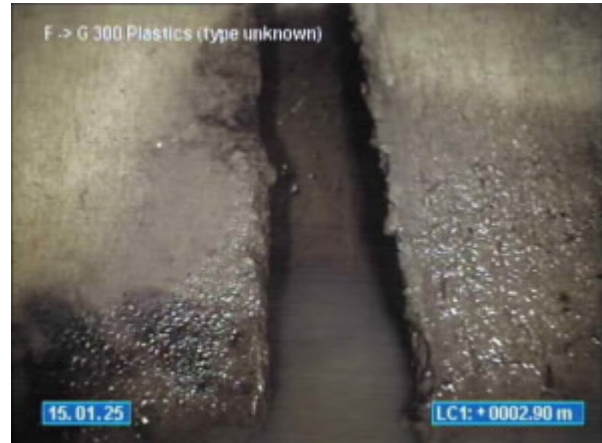
10-12 VIEW POINT ROAD MCCRAE_15.01.2025_142844_F
 TOO G _055.jpg, 00:01:41, 2.90
 Soil visible through defect, at joint
