Task Number:1295094/001
Task Address:4 WALLER PLACE, MCCRAE VIC 3938 MapRef : 159B10
Program Name:
Task Work Type:Planned Maintenance - Repair
Source Of Work:
Facility:
Permit Not Required:No
Permit Pre Approved:No
Permit Reason:Other
Permit Other Reason:
Task Story:[Exall,Kirsty] [16/12/2024 13:45] [AWARDED] Property Number:02E//00478/4 [Ludewig,Ralph] [16/12/2024 13:48] [AWARDED] Checked [FT] [SSf0213] [17/12/2024 06:35] [ON SITE] on site water seeping from nature main on other side of rdway sounded all long and short side services sounded nearby valves and fireplug no noise gained access to no1 water siiting in nfrount yard tested at 225 meter not turning raining on site no indication of sew asset leak storm water [Copeland,Bryce] [17/12/2024 18:25] [DATA COMPLETE] Margret Campbell 0458682510 from 4 Waller Pl, called with another report for this one. advised we have already attended and there doesn't seem to be any leaks from the main or nearby. She reports water bubbling up from the ground around #1 on the corner of Charlesworth St, will adv. dispatch and see if there is anything else we can do.

Task Number:1295094/006

Request Details:Burst on the 150UPVC main opp 2 the boule

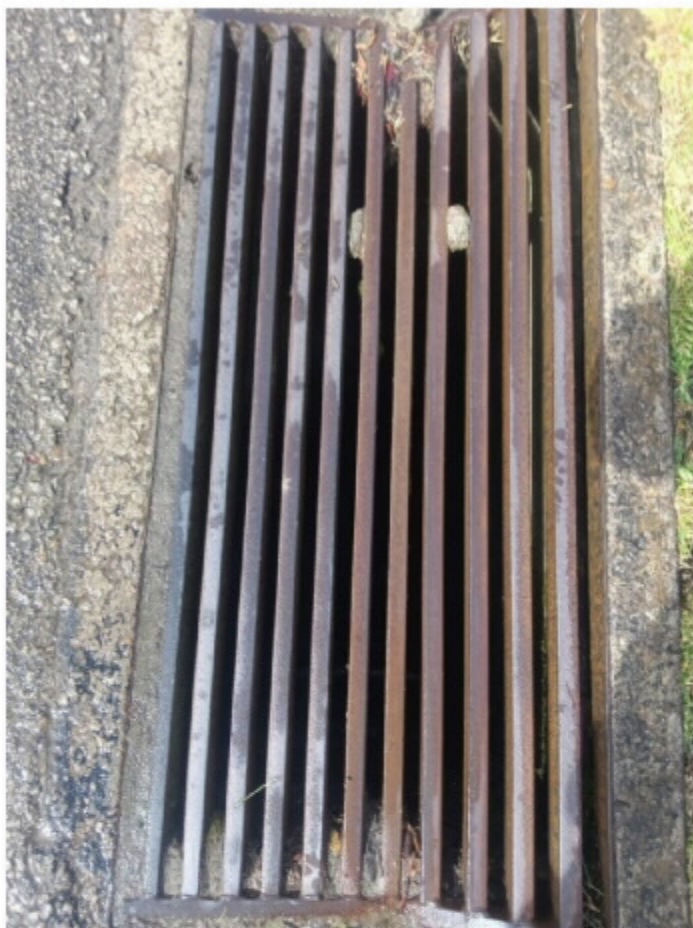
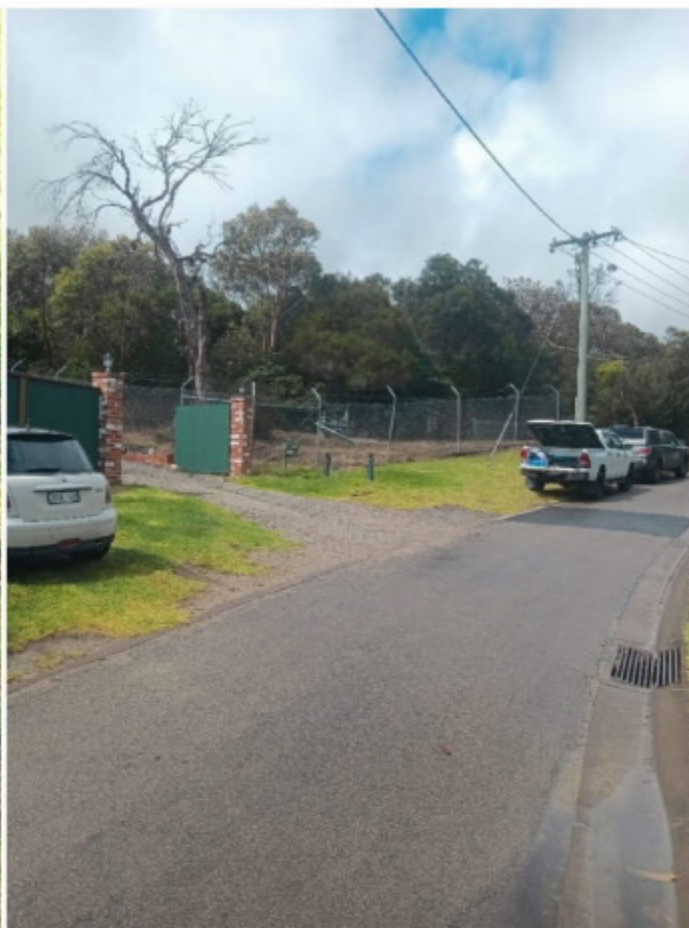
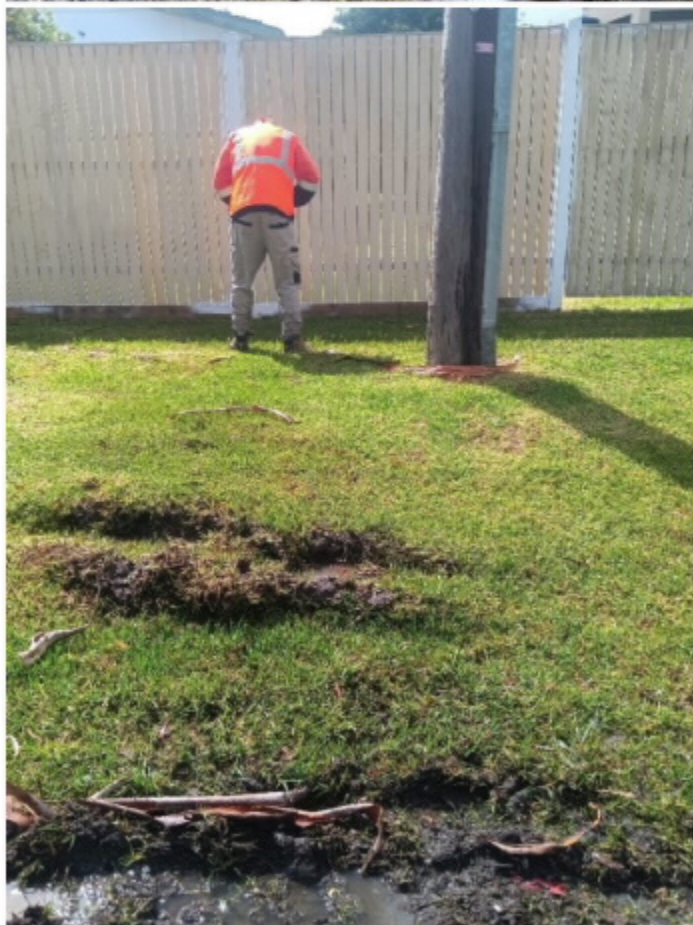
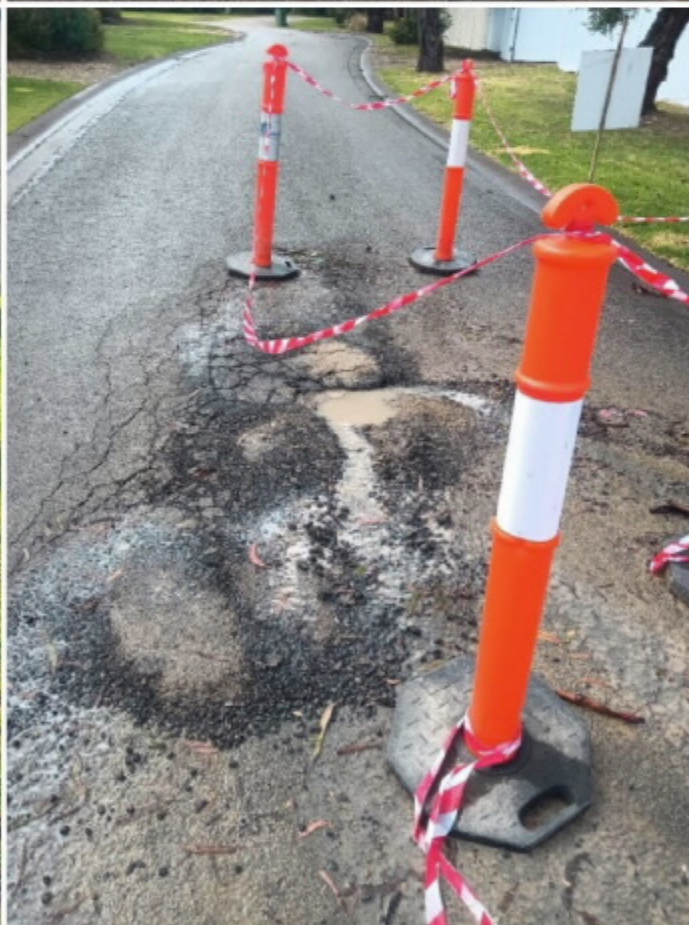
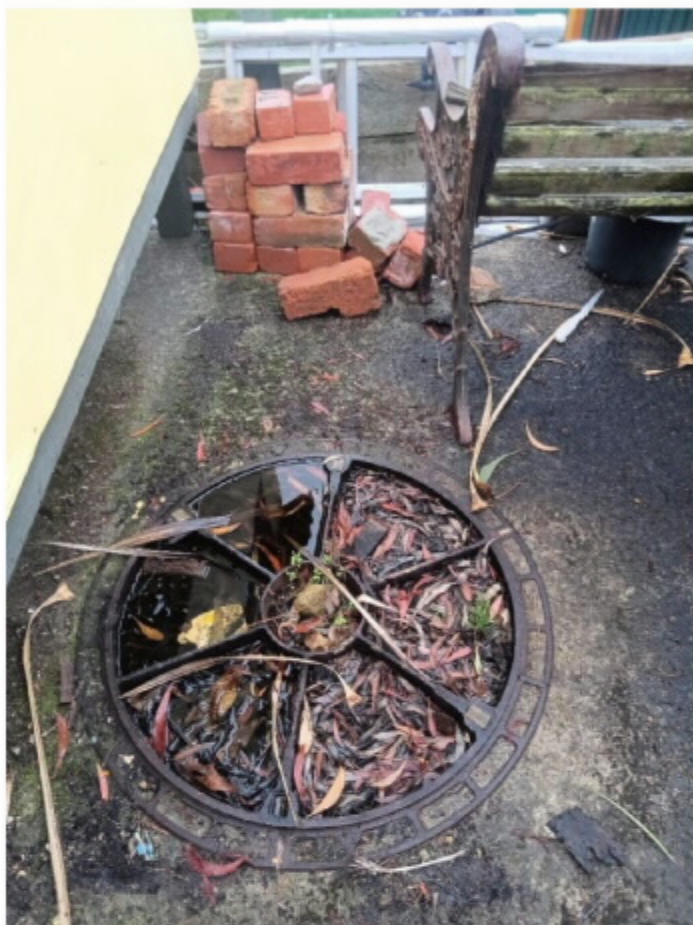
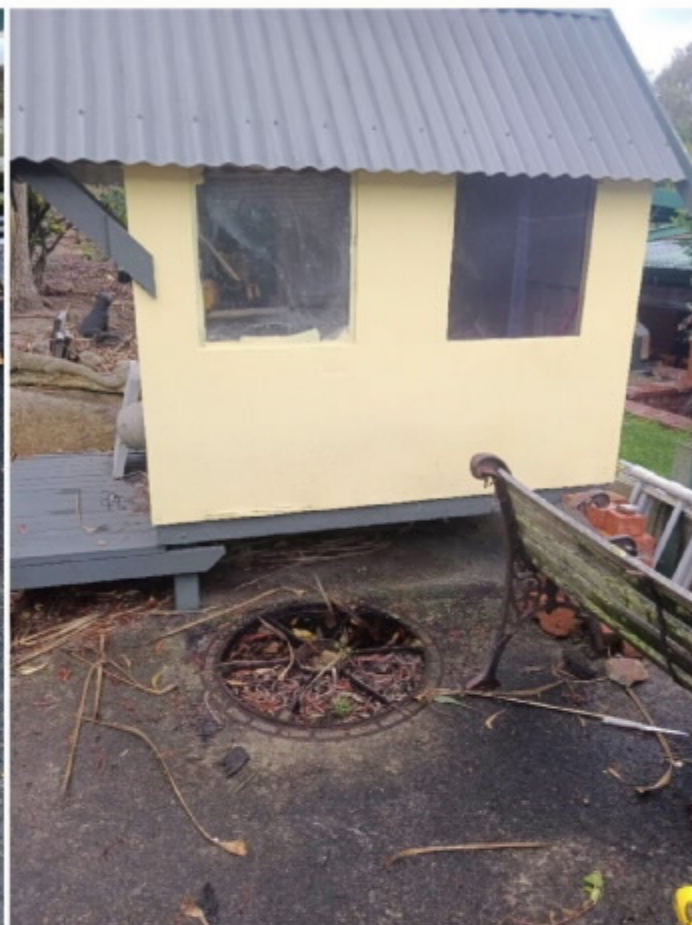
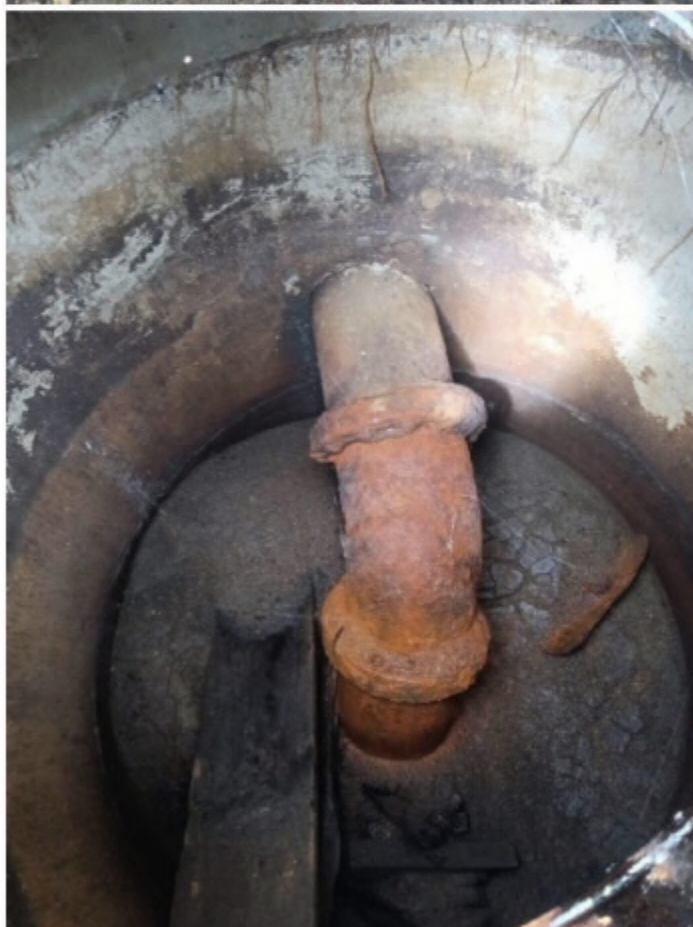
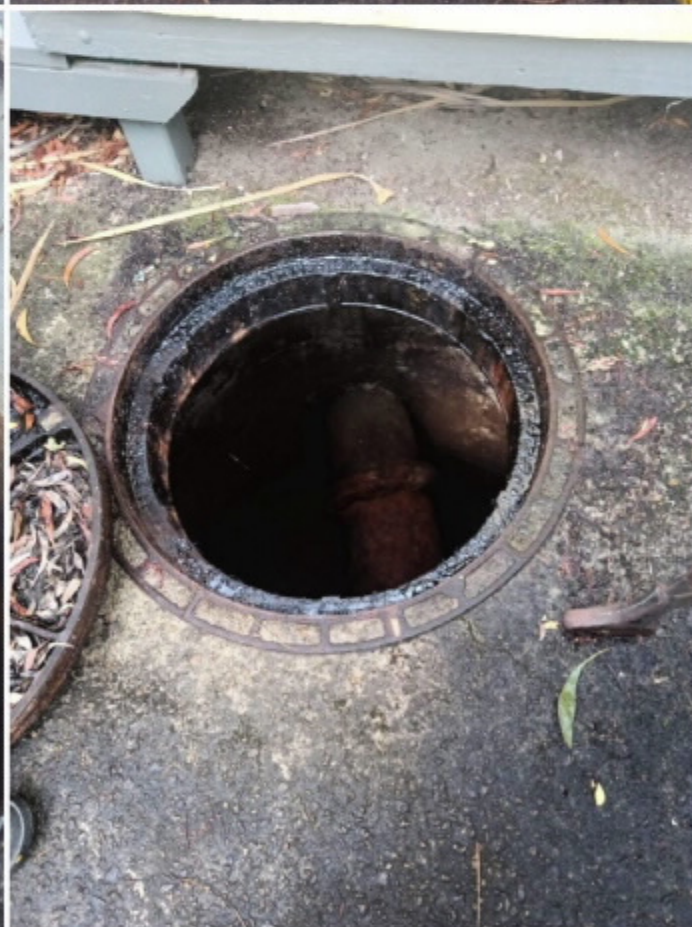
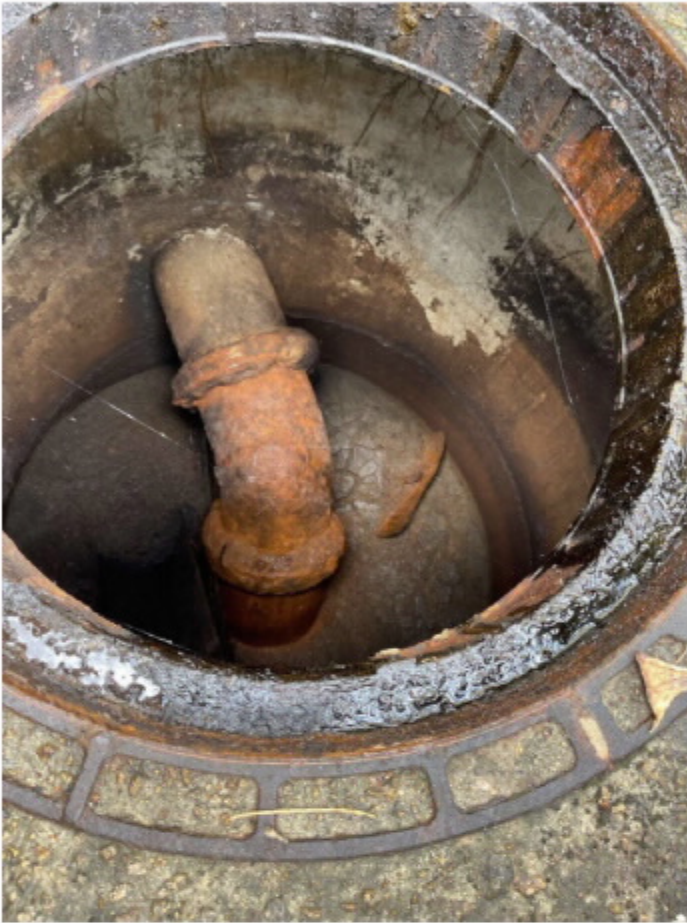
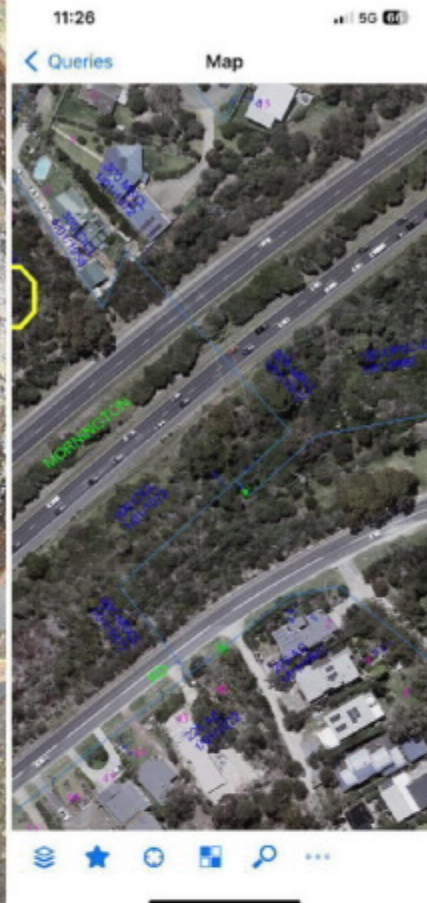
Leak Address	4 Waller Place McCrae Victoria 3938 Australia
Zone	South East Water ► Reactive Leaks
Leak Asset Type	No Leaks Found
Has the leak been called in by DS Technician?	Yes
Job Ref	1295094/003
Leak Visible	No

Sounded all assets in the area, followed suspect 300mm main and no leaks were detected. Chlorine sample needs to be taken when rain stops.

We also surveyed Bayview Rd above the Highway with no leak noises detected.

I don't believe there's any leaks on the mains but still some of the smaller pipes really haven't checked out. Jason Marsh will return take samples when it's not raining for a few days.

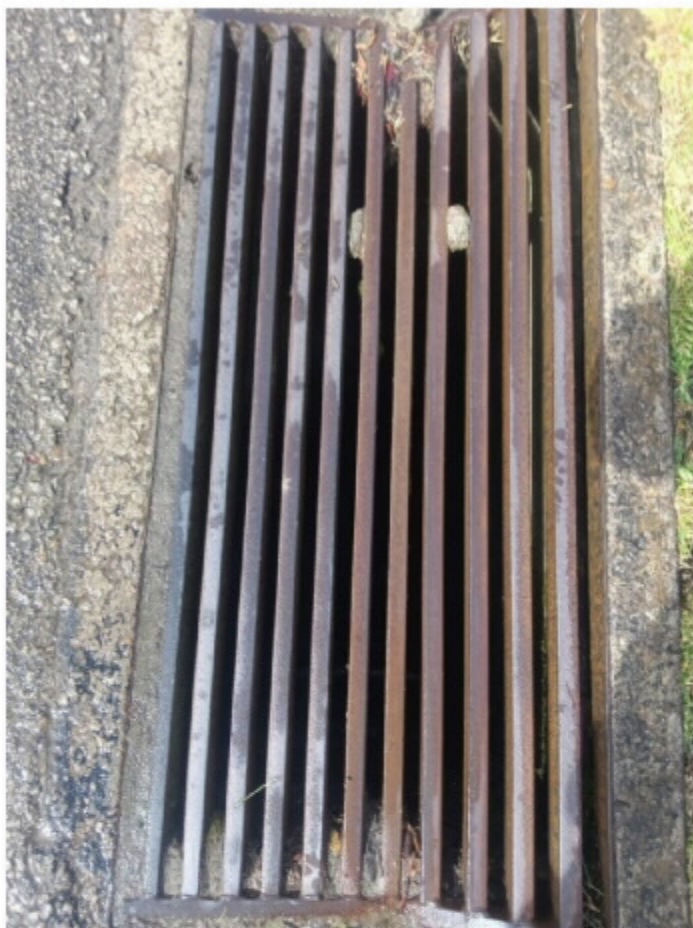
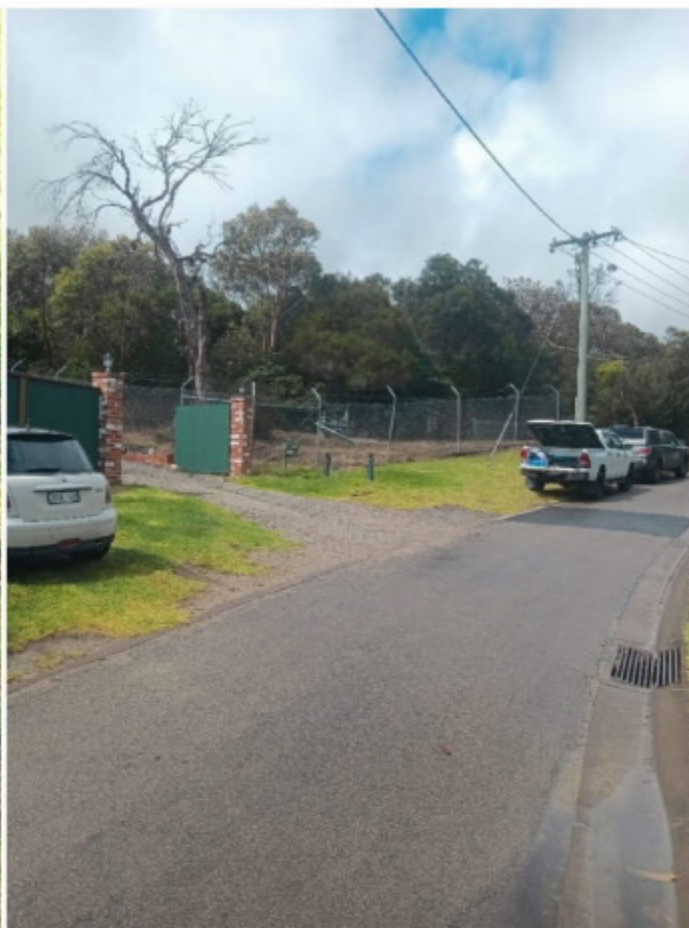
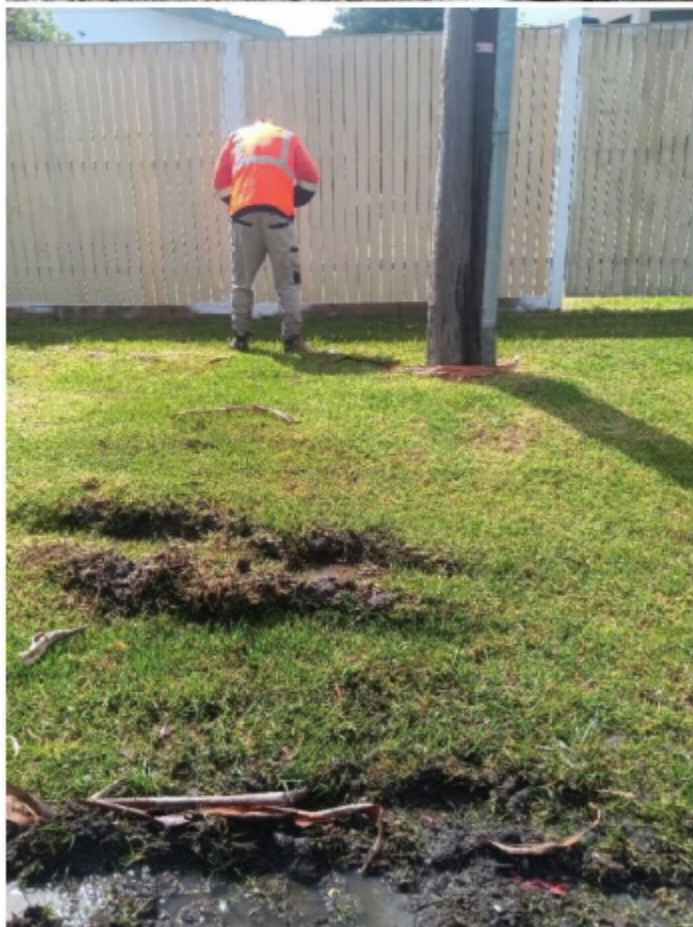
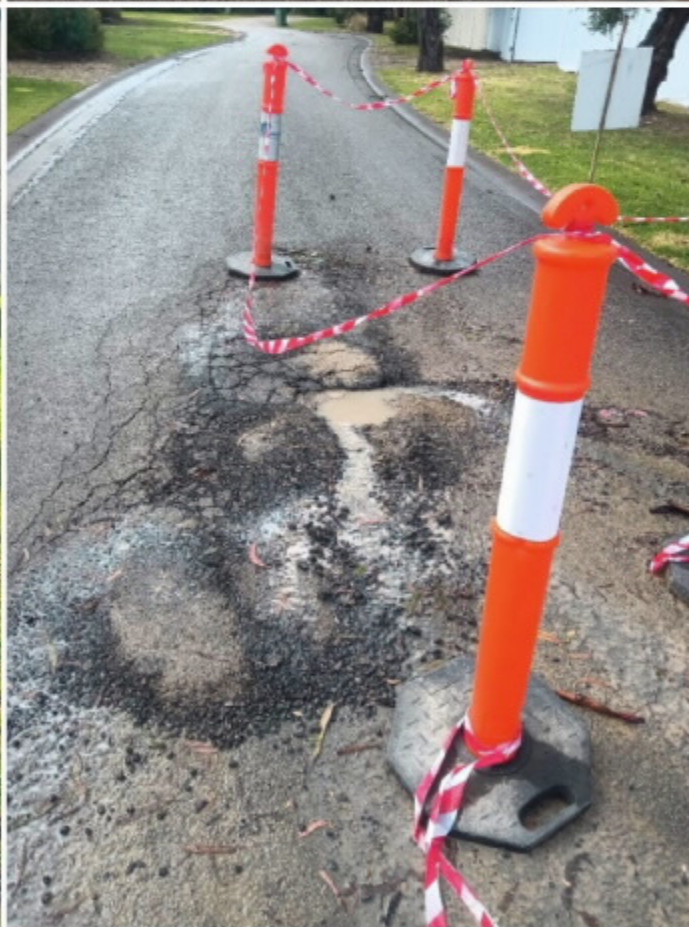
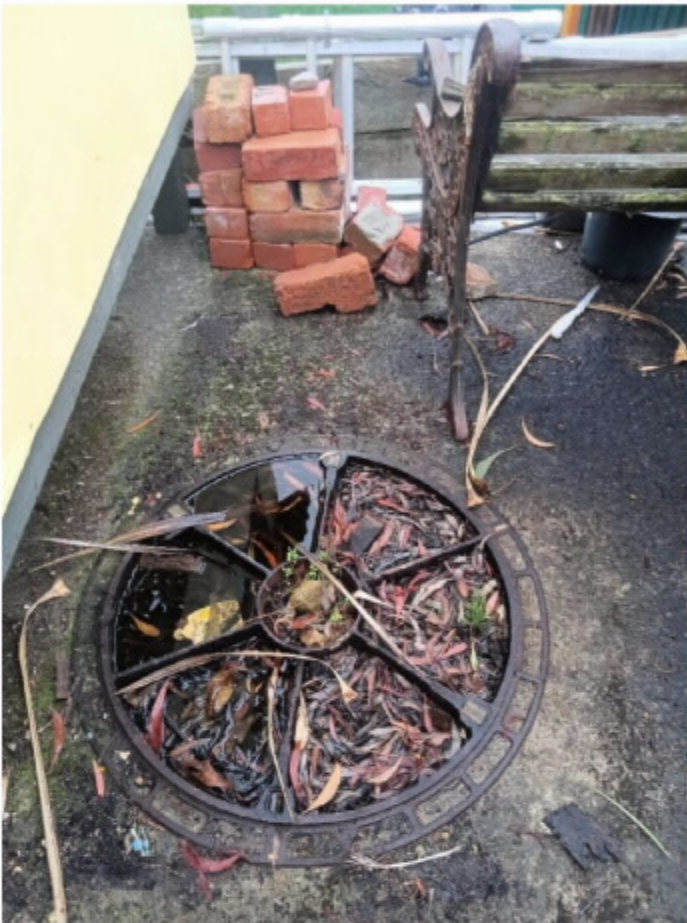
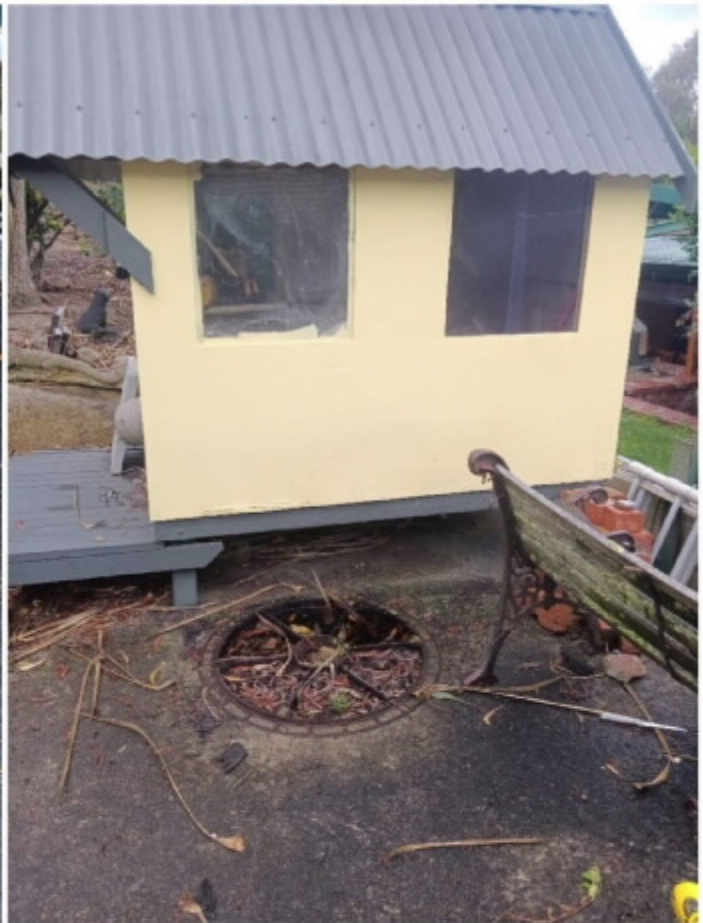
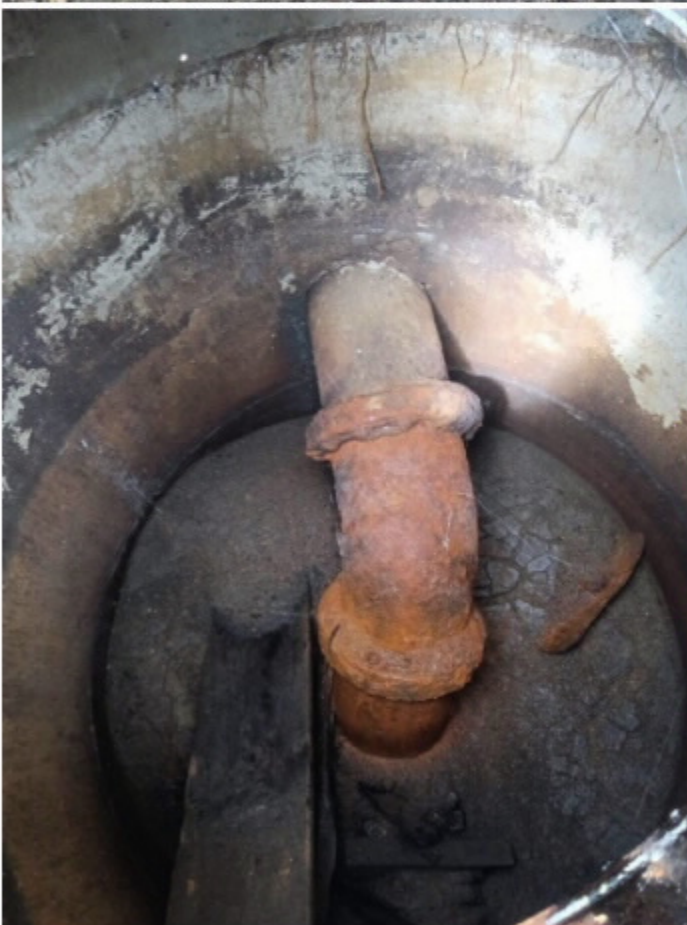
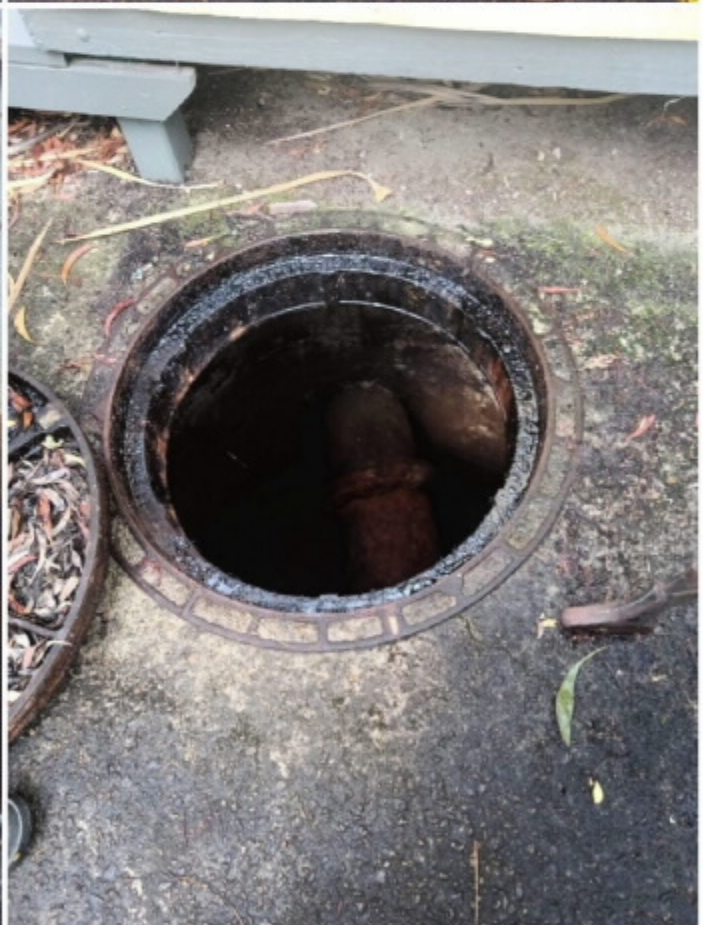
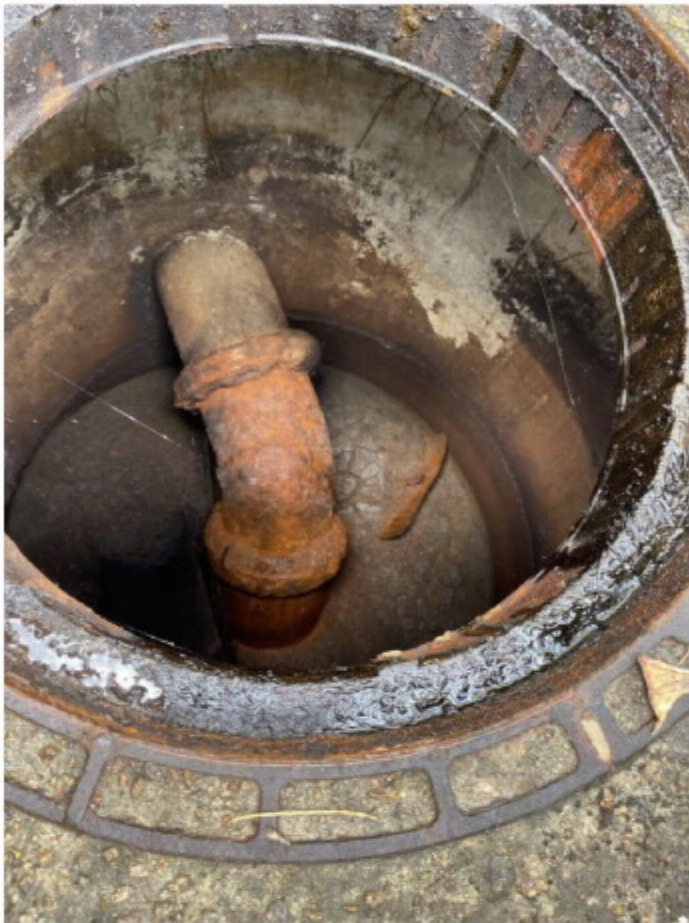
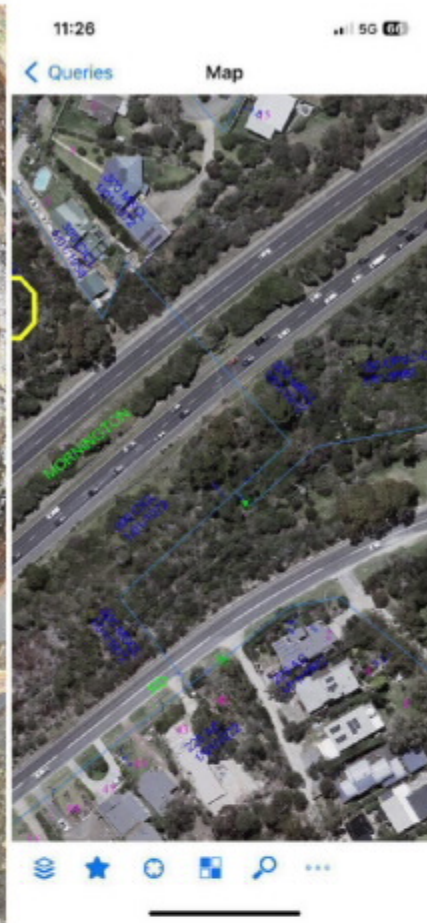
Leak Address	4 Waller Place McCrae Victoria 3938 Australia
Zone	South East Water ► Reactive Leaks
Leak Asset Type	No Leaks Found
Has the leak been called in by DS Technician?	Yes
Job Ref	1295094/003
Leak Visible	No

Sounded all assets in the area, followed suspect 300mm main and no leaks were detected. Chlorine sample needs to be taken when rain stops.

We also surveyed Bayview Rd above the Highway with no leak noises detected.

I don't believe there's any leaks on the mains but still some of the smaller pipes really haven't checked out. Jason Marsh will return take samples when it's not raining for a few days.

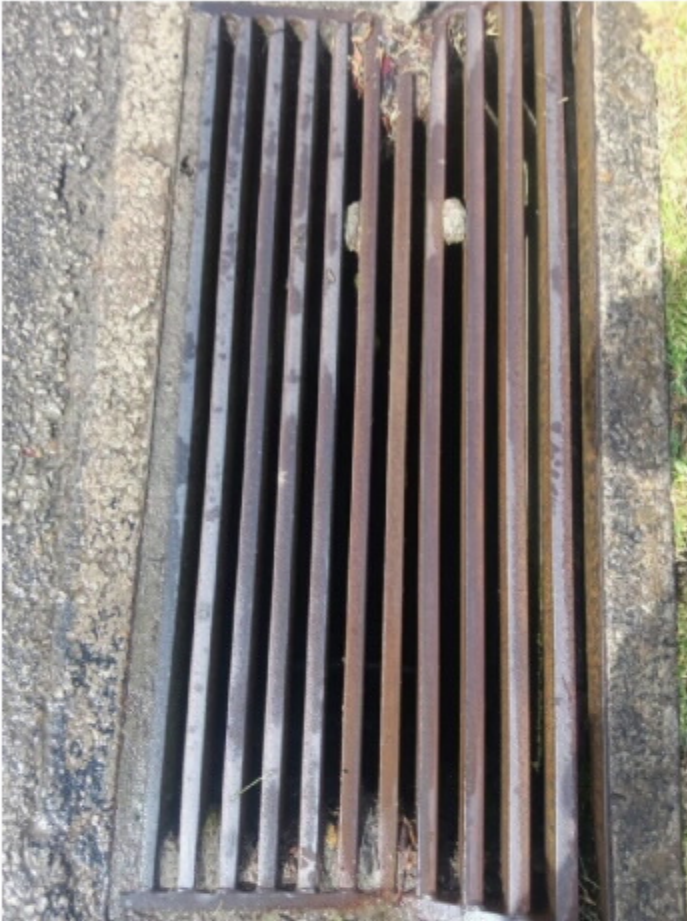
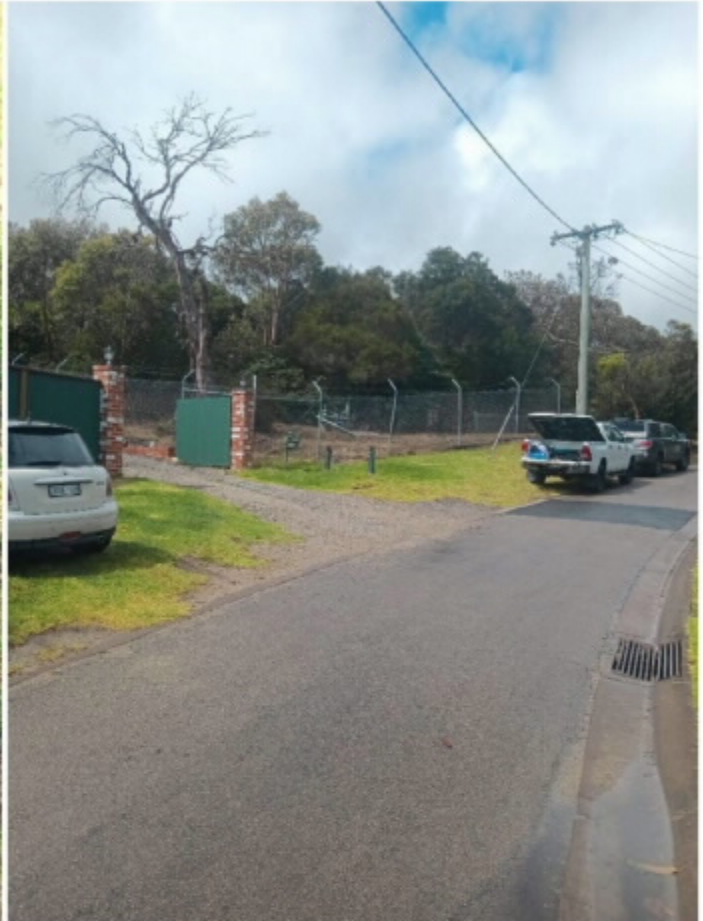
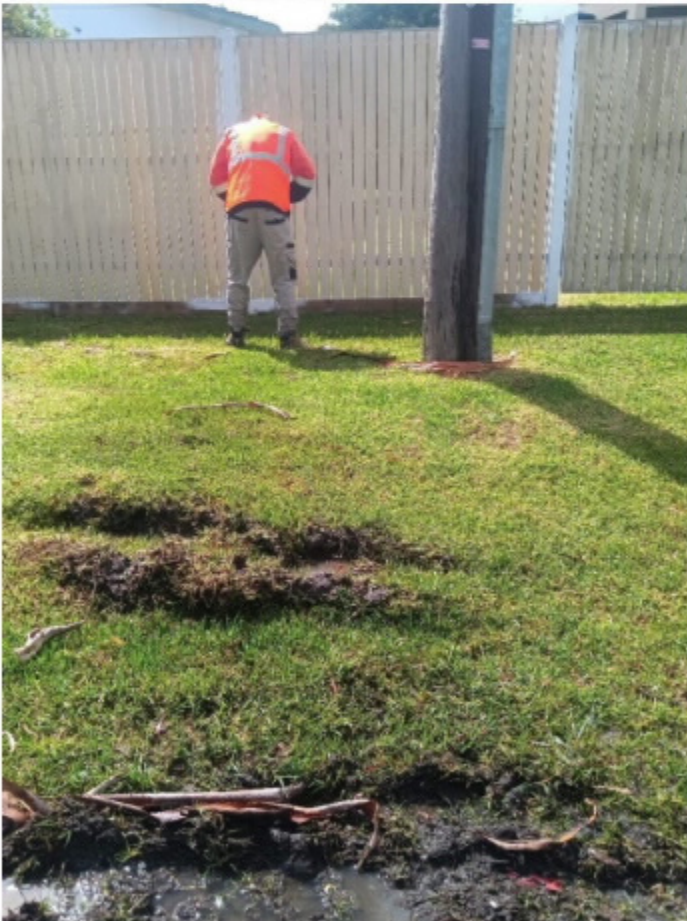
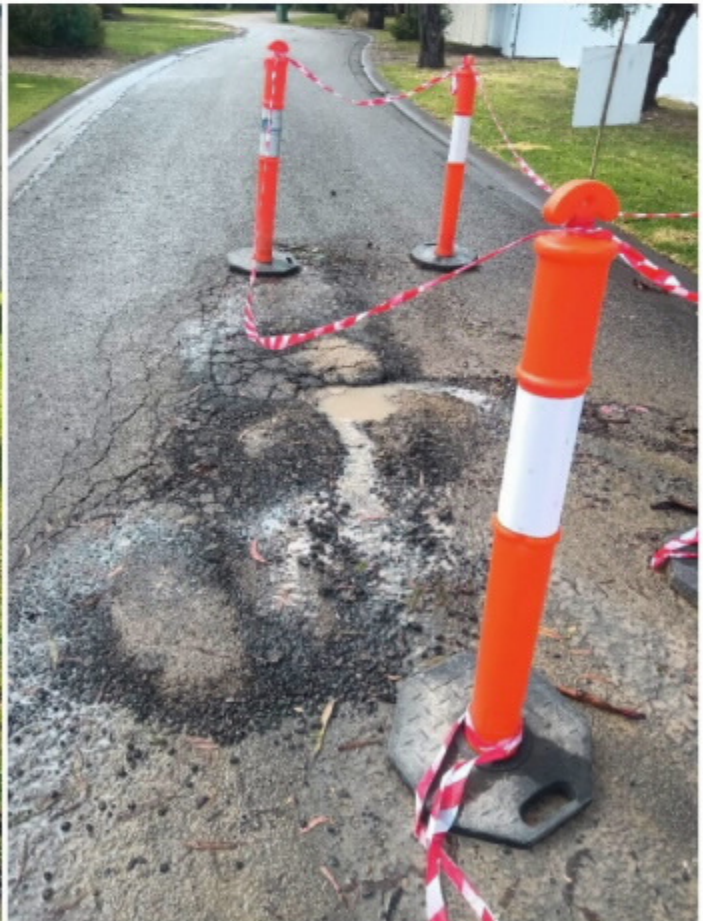
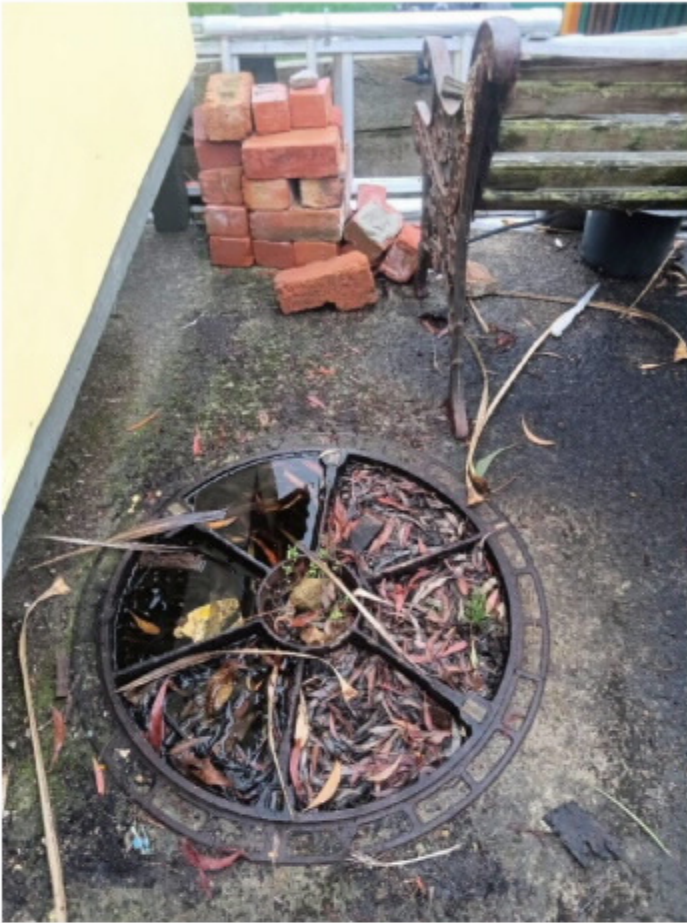
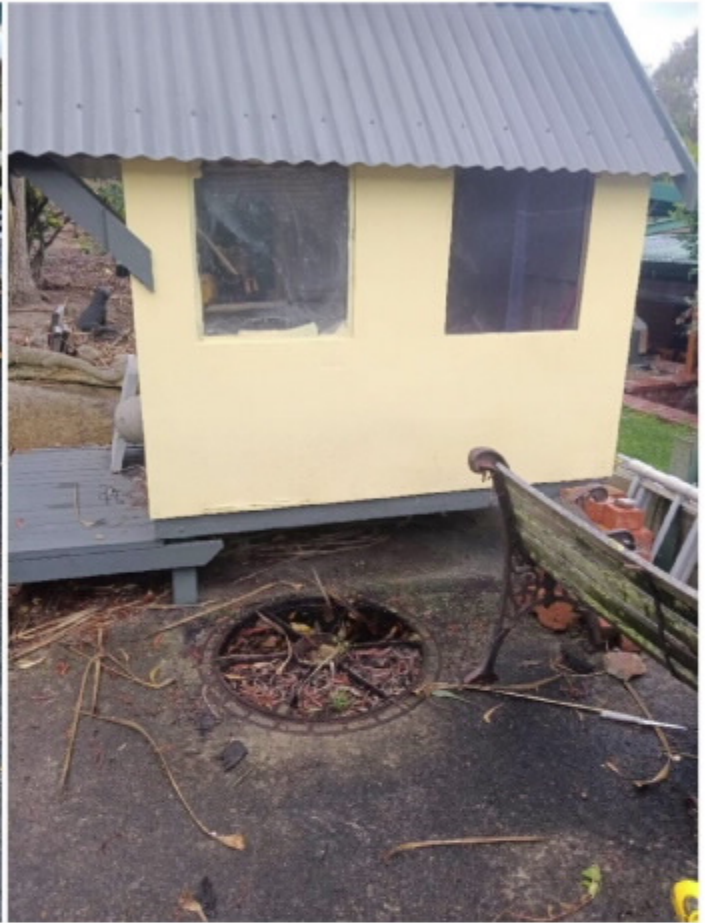
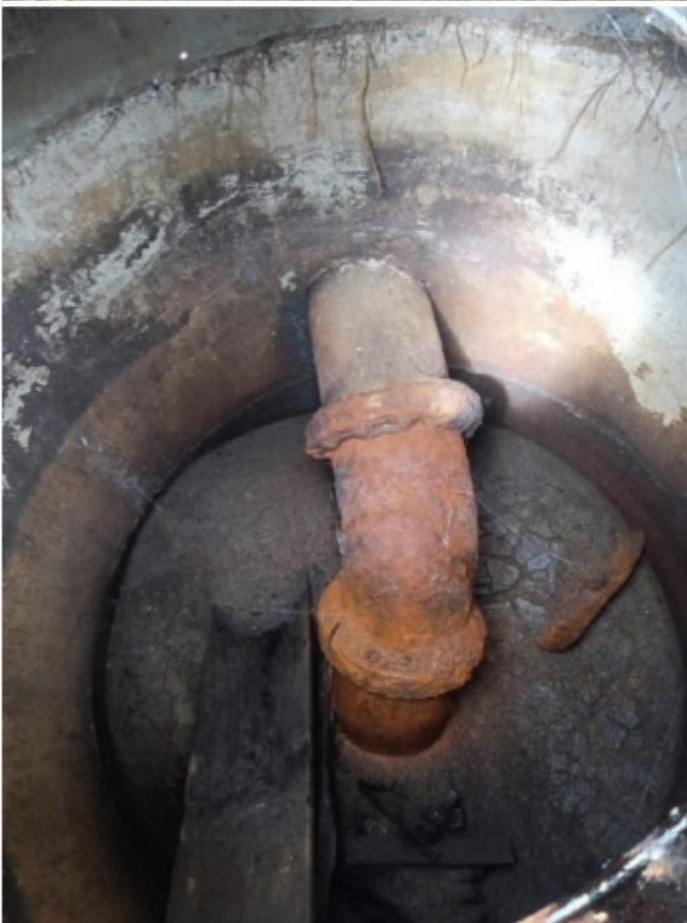
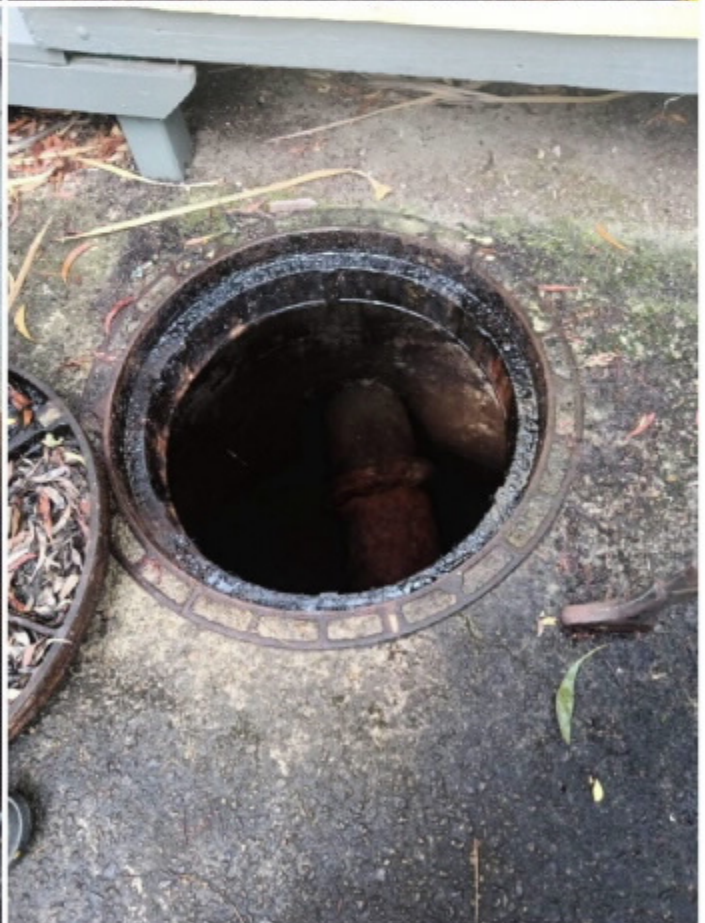
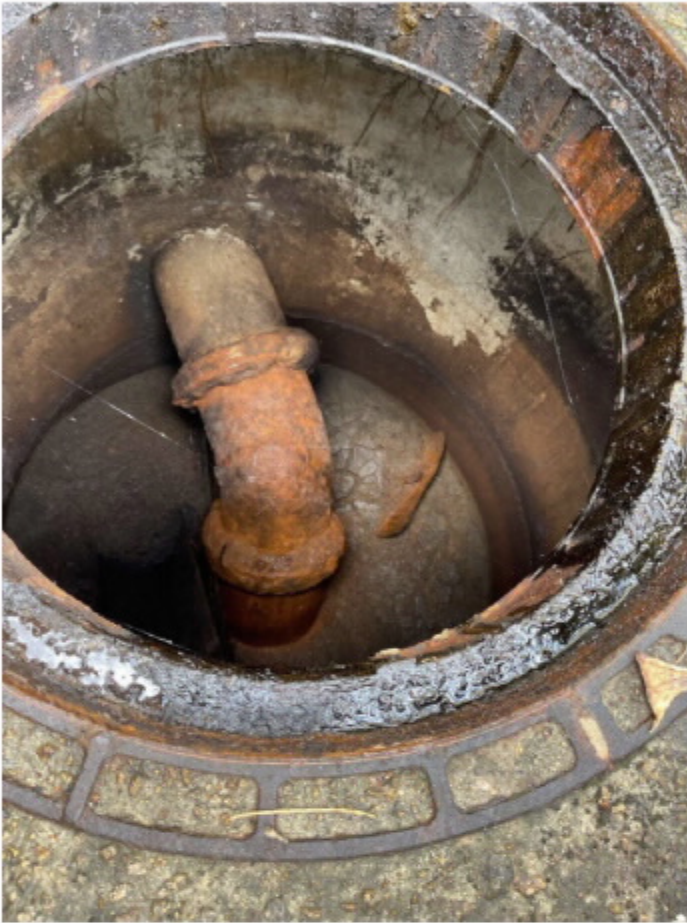
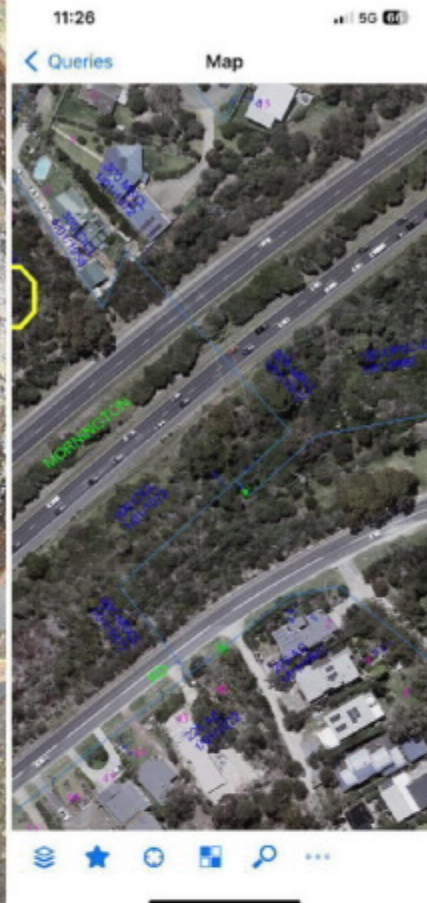
Leak Address	4 Waller Place McCrae Victoria 3938 Australia
Zone	South East Water ► Reactive Leaks
Leak Asset Type	No Leaks Found
Has the leak been called in by DS Technician?	Yes
Job Ref	1295094/003
Leak Visible	No

Sounded all assets in the area, followed suspect 300mm main and no leaks were detected. Chlorine sample needs to be taken when rain stops.

We also surveyed Bayview Rd above the Highway with no leak noises detected.

I don't believe there's any leaks on the mains but still some of the smaller pipes really haven't checked out. Jason Marsh will return take samples when it's not raining for a few days.
