Task Number:1295094/001
Task Address:4 WALLER PLACE, MCCRAE VIC 3938 MapRef : 159B10
Program Name:
Task Work Type:Planned Maintenance - Repair
Source Of Work:
Facility:
Permit Not Required:No
Permit Pre Approved:No
Permit Reason:Other
Permit Other Reason:
Task Story:[Exall,Kirsty] [16/12/2024 13:45] [AWARDED] Property Number:02E//00478/4 [Ludewig,Ralph] [16/12/2024 13:48] [AWARDED] Checked [FT] [SSf0213] [17/12/2024 06:35] [ON SITE] on site water seeping from nature main on other side of rdway sounded all long and short side services sounded nearby valves and fireplug no noise gained access to no1 water siiting in nfrount yard tested at 225 meter not turning raining on site no indication of sew asset leak storm water [Copeland,Bryce] [17/12/2024 18:25] [DATA COMPLETE] Margret Campbell 0458682510 from 4 Waller Pl, called with another report for this one. advised we have already attended and there doesn't seem to be any leaks from the main or nearby. She reports water bubbling up from the ground around #1 on the corner of Charlesworth St, will adv. dispatch and see if there is anything else we can do.

Task Number:1295094/006

Request Details:Burst on the 150UPVC main opp 2 the boule

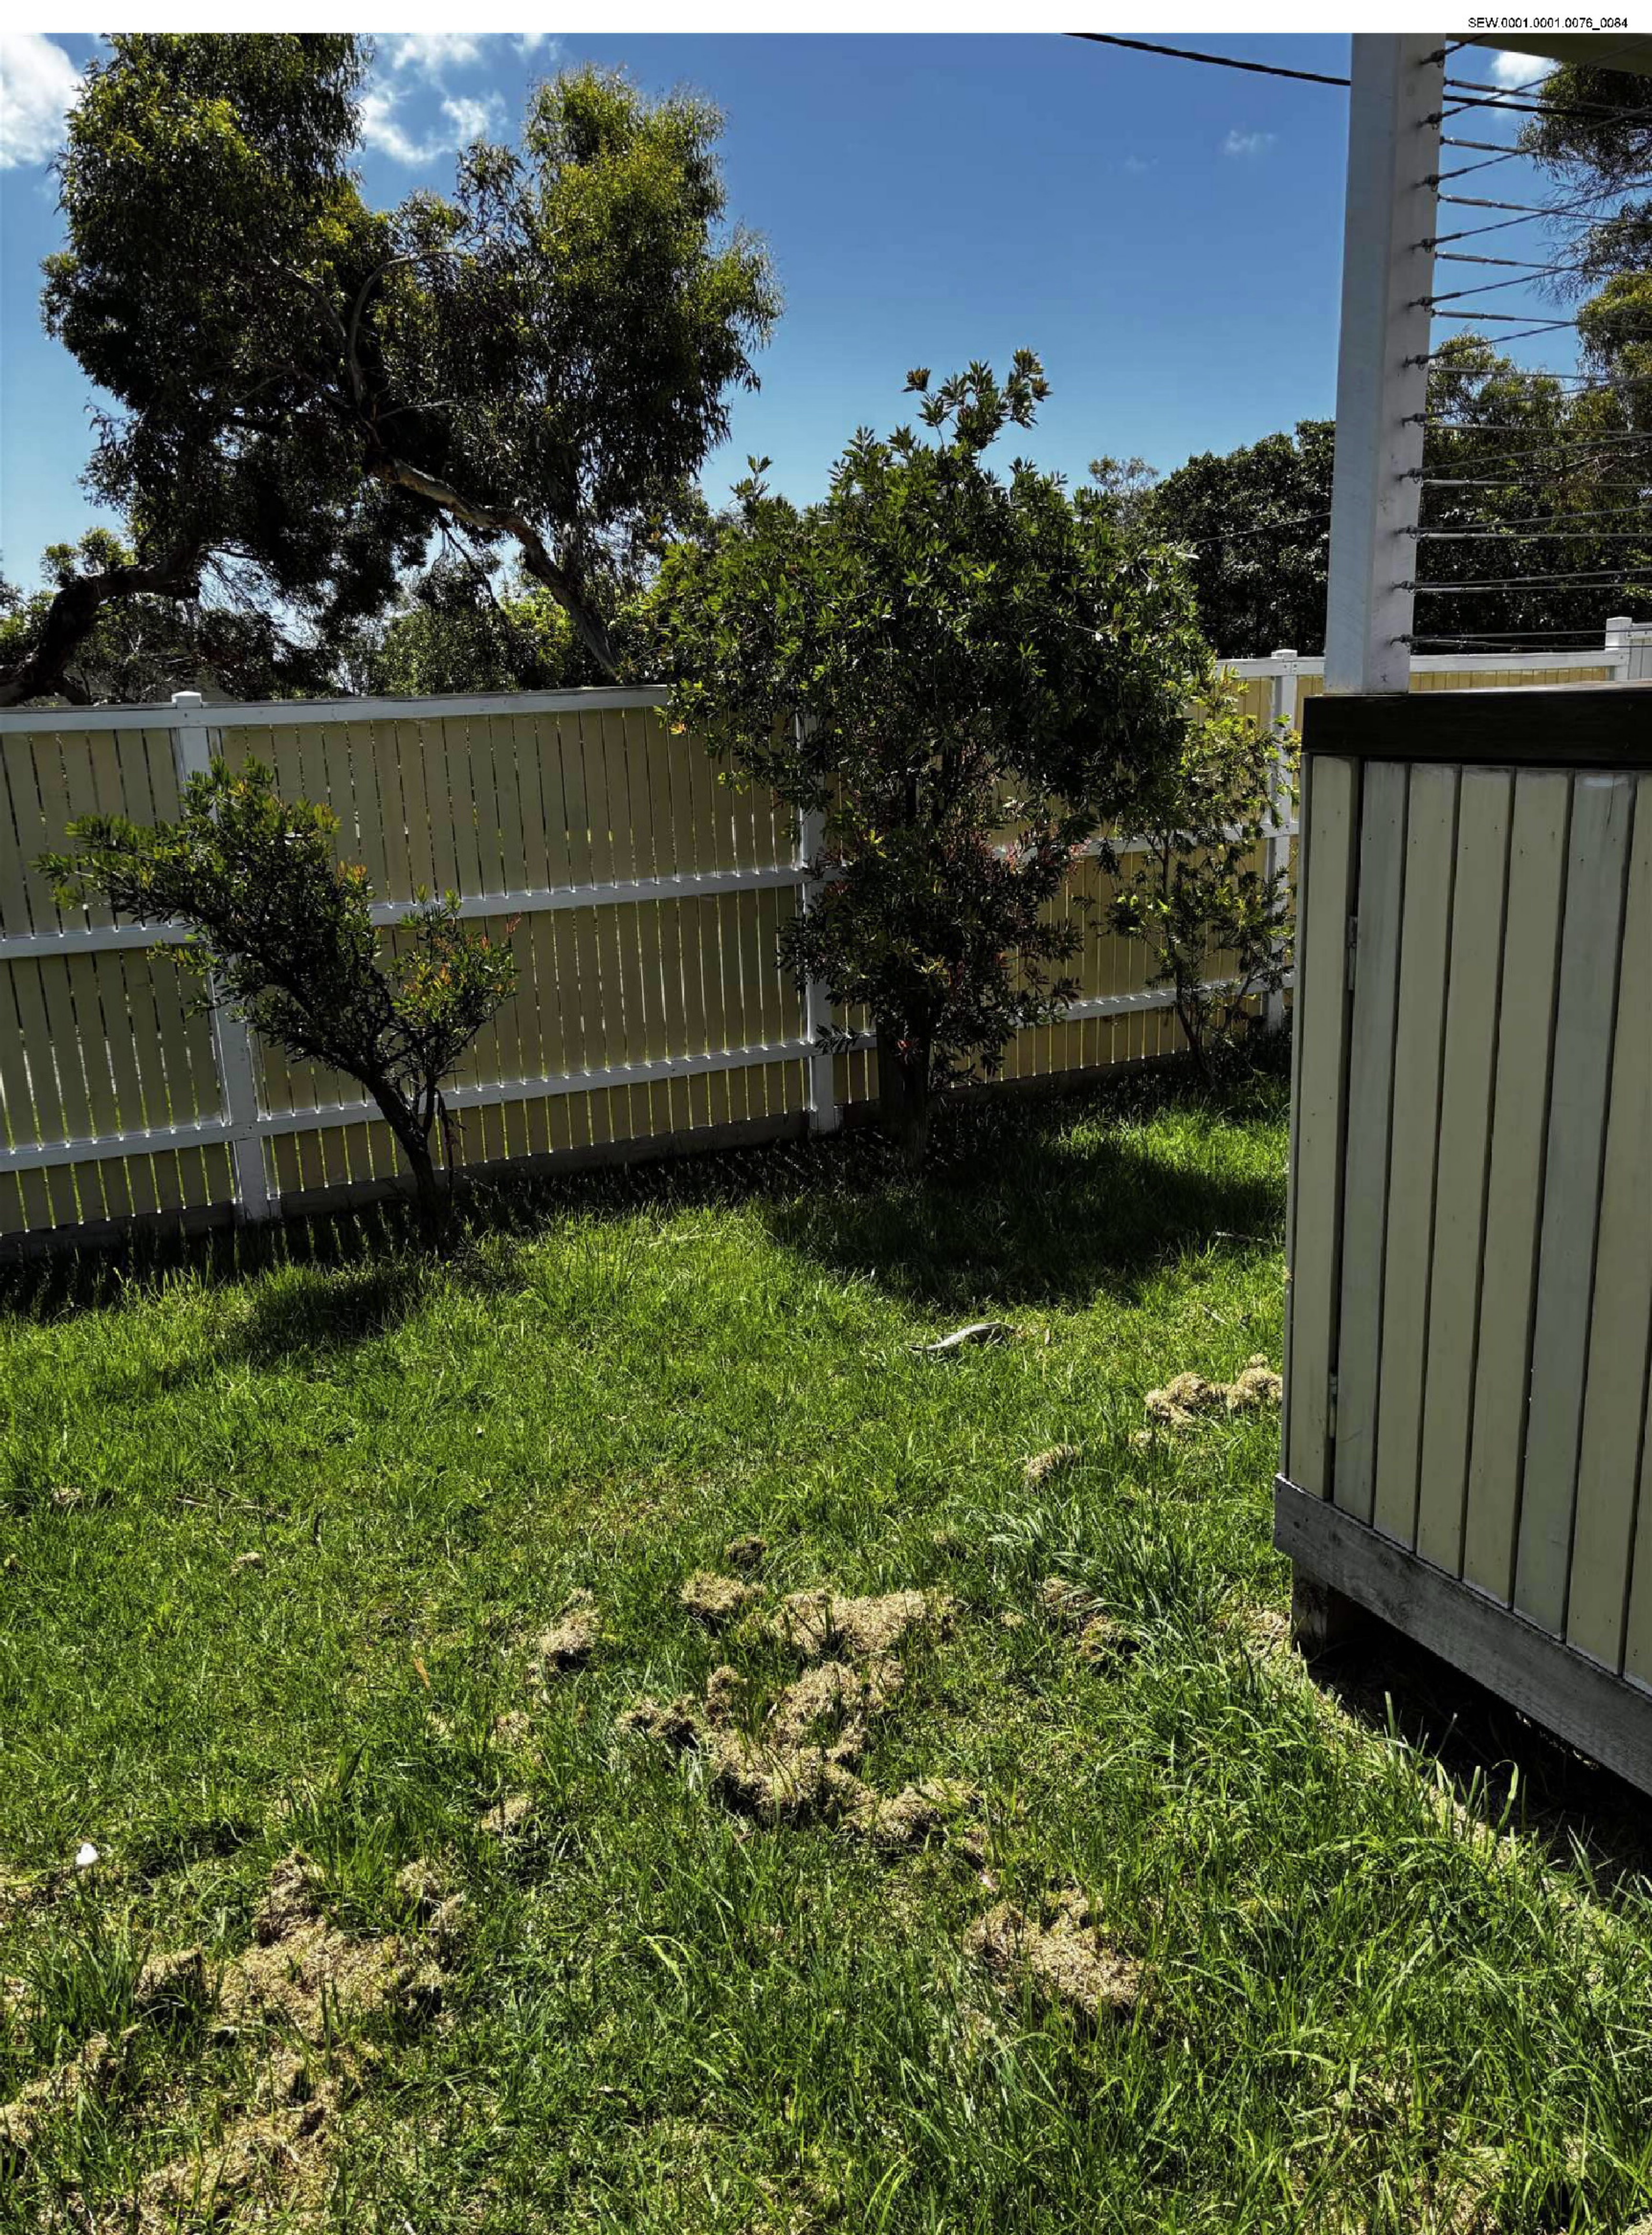
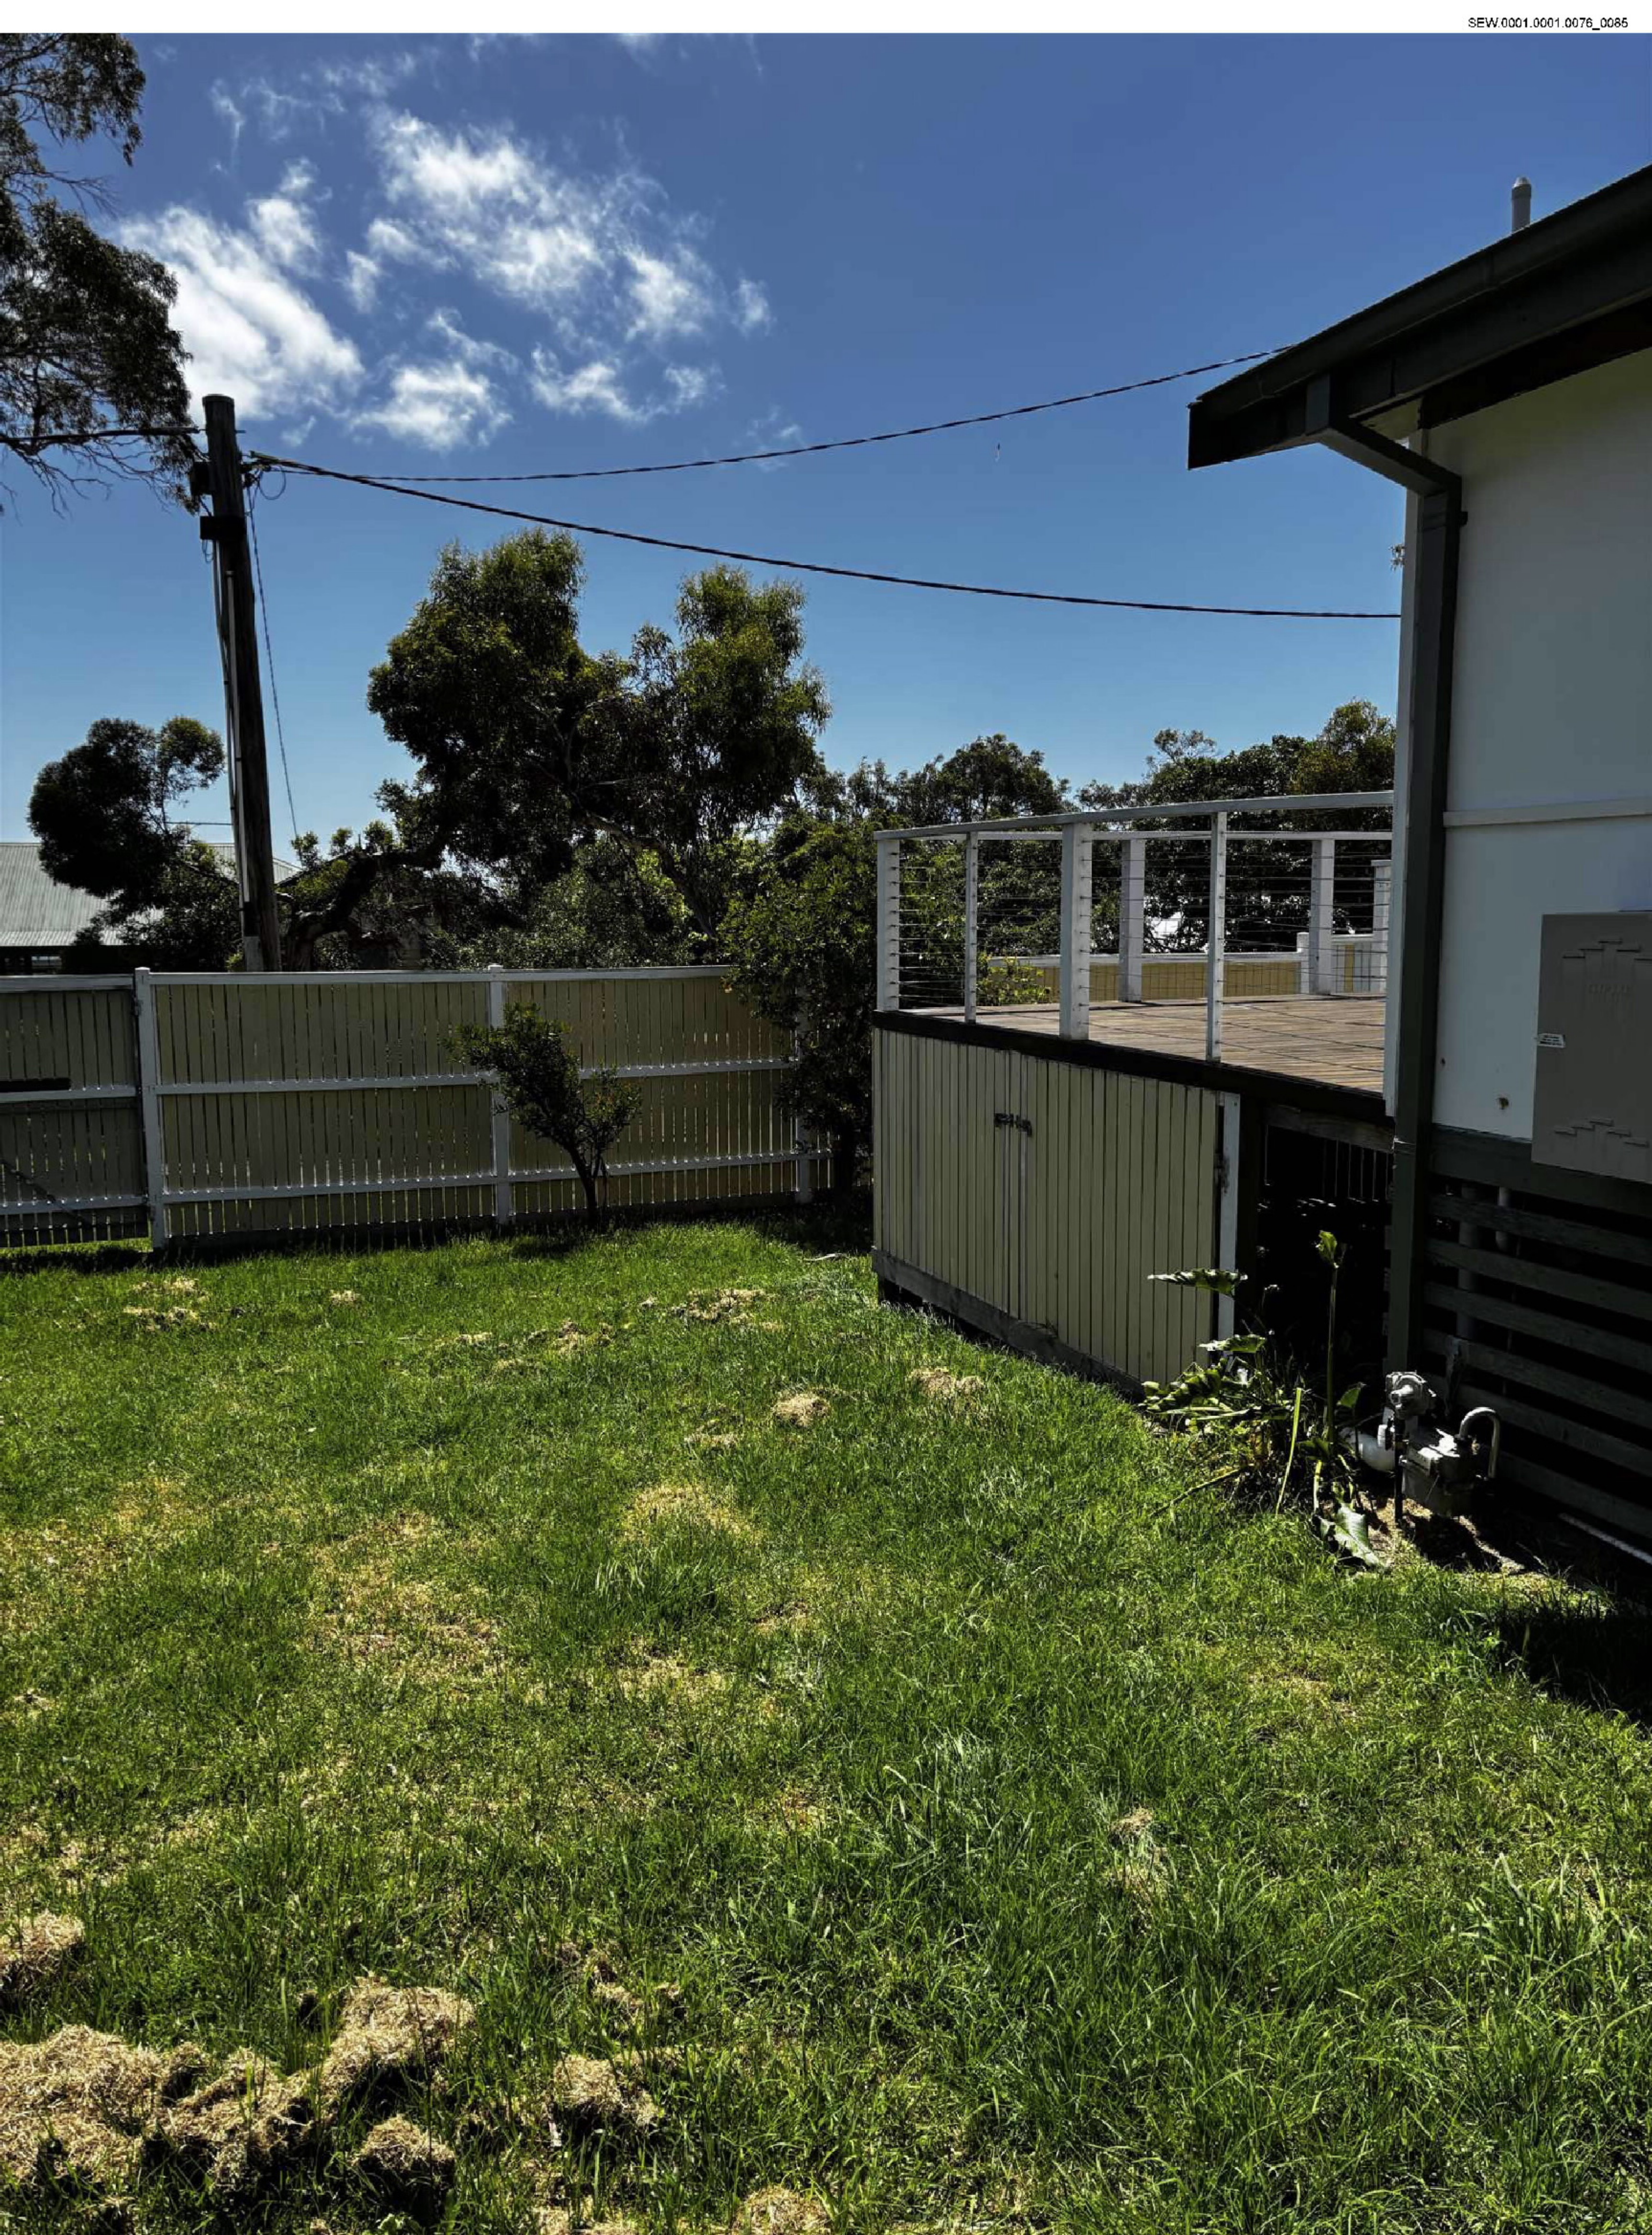
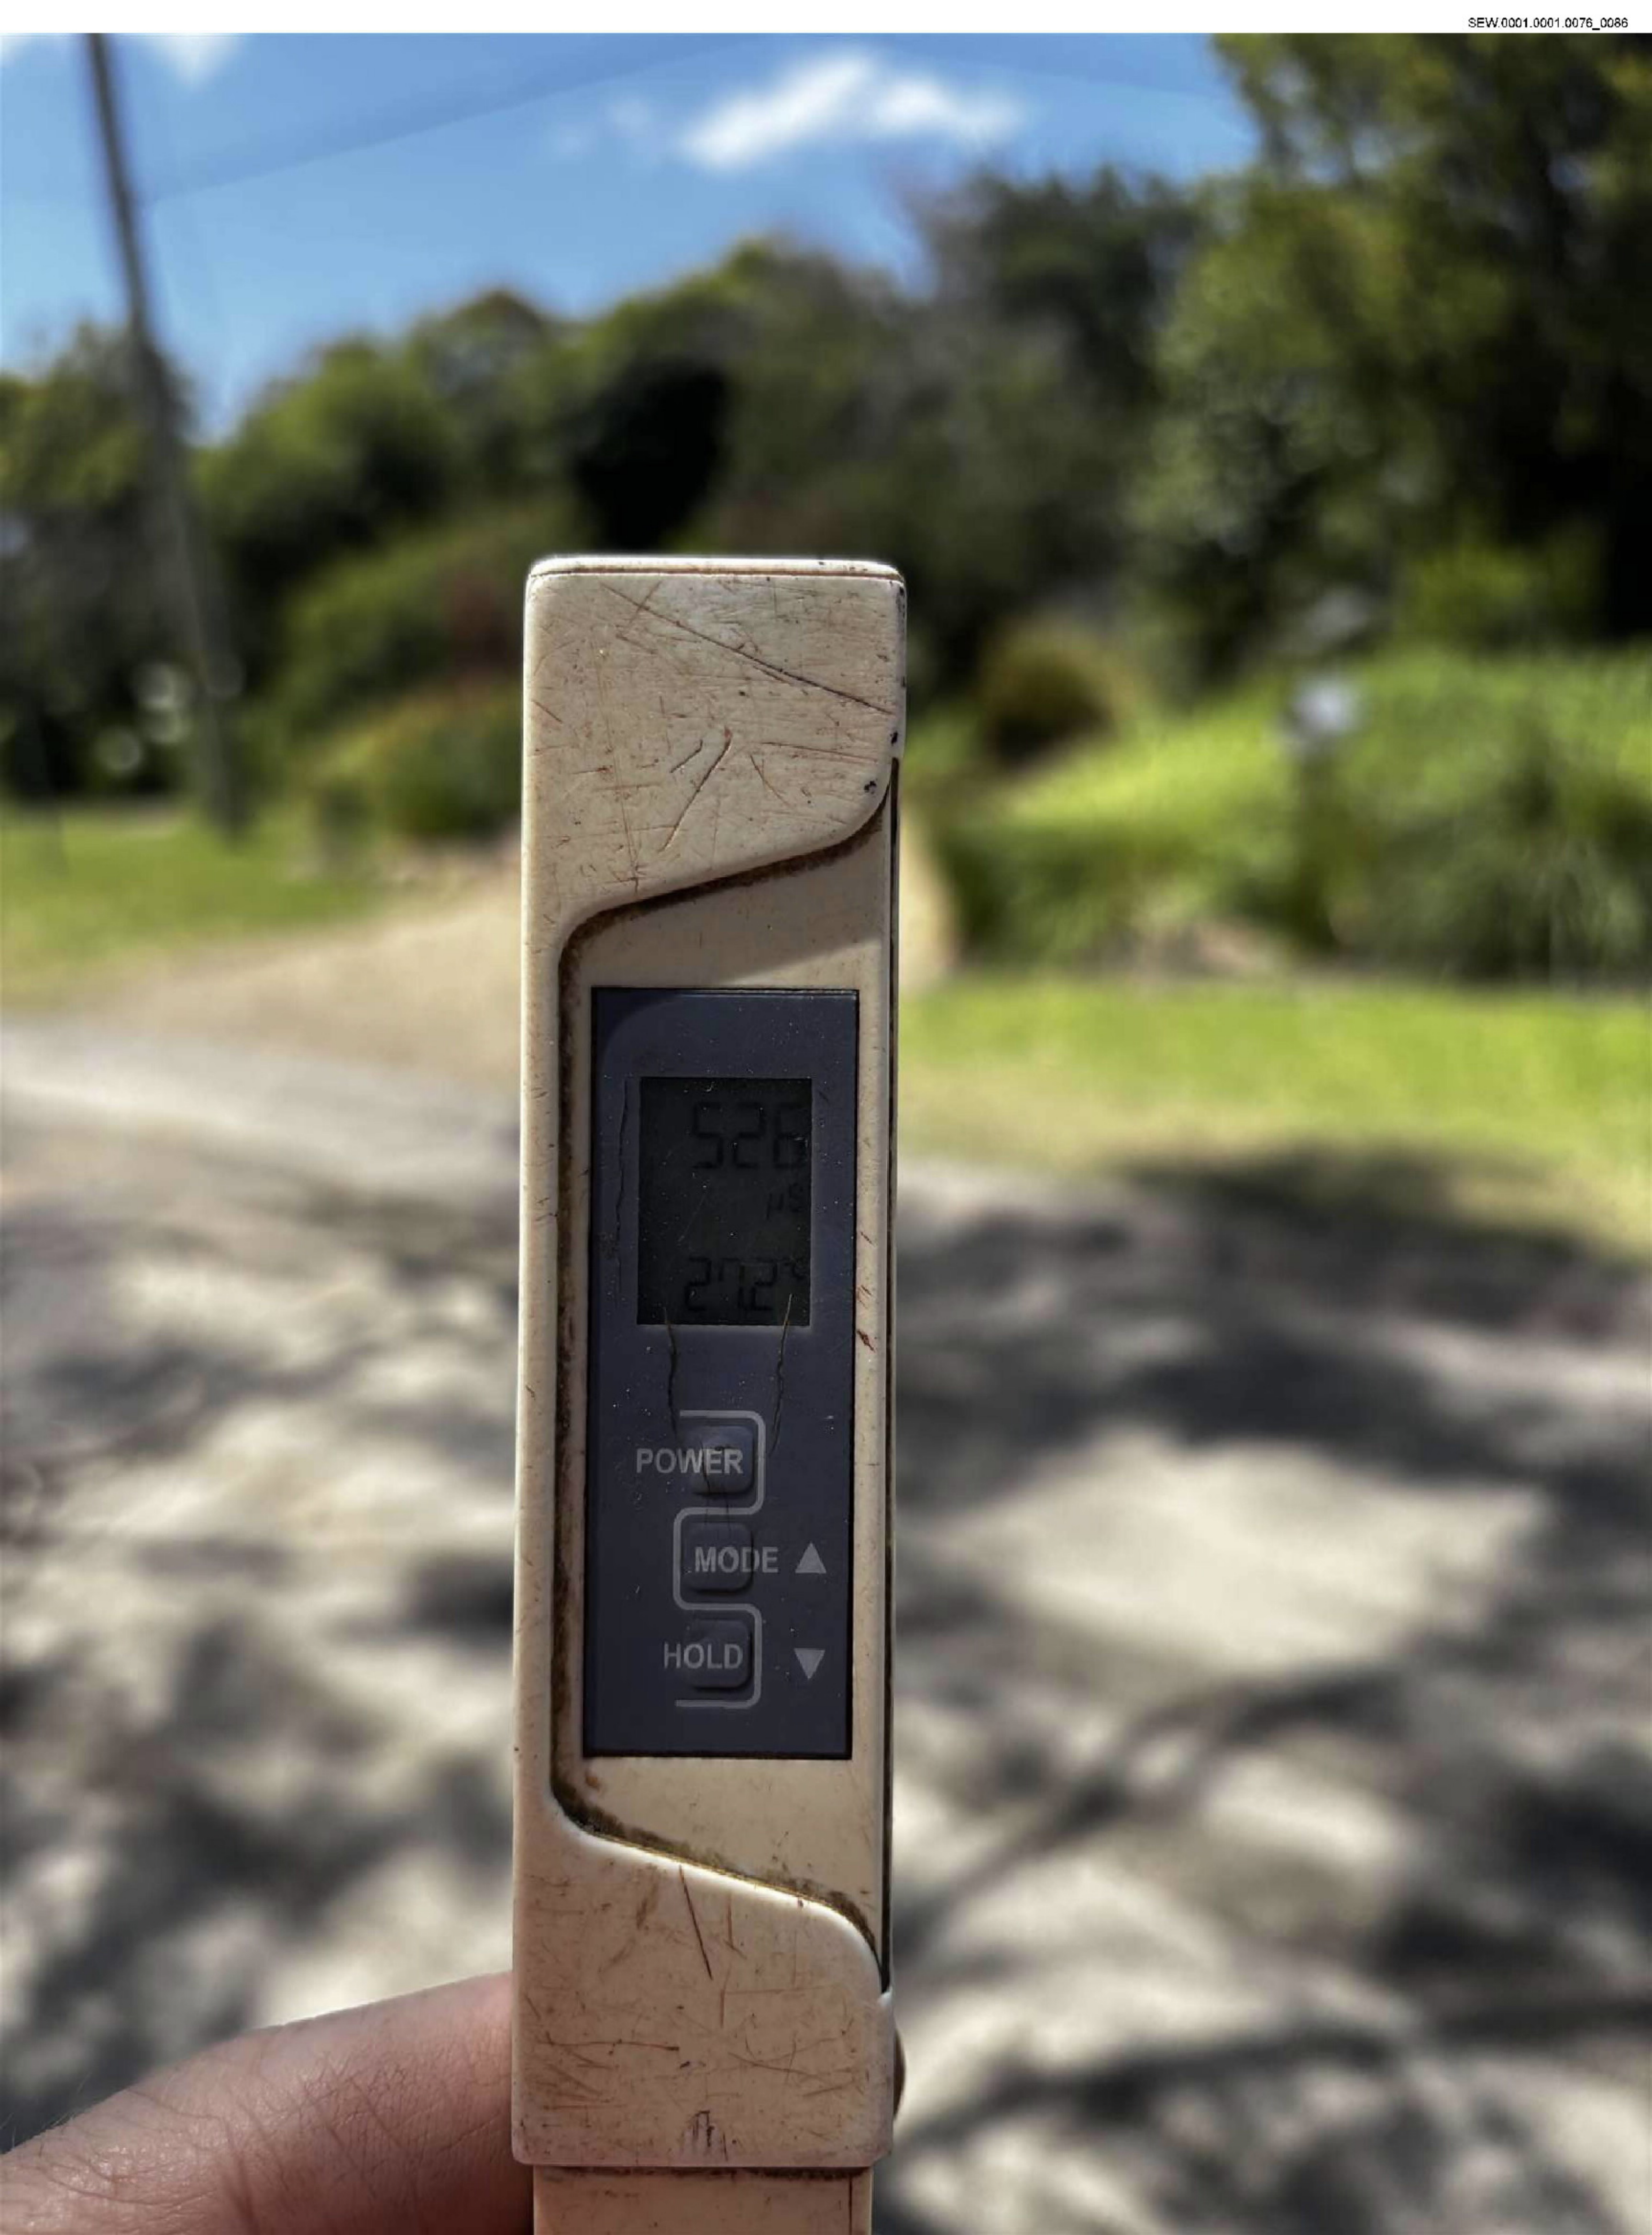
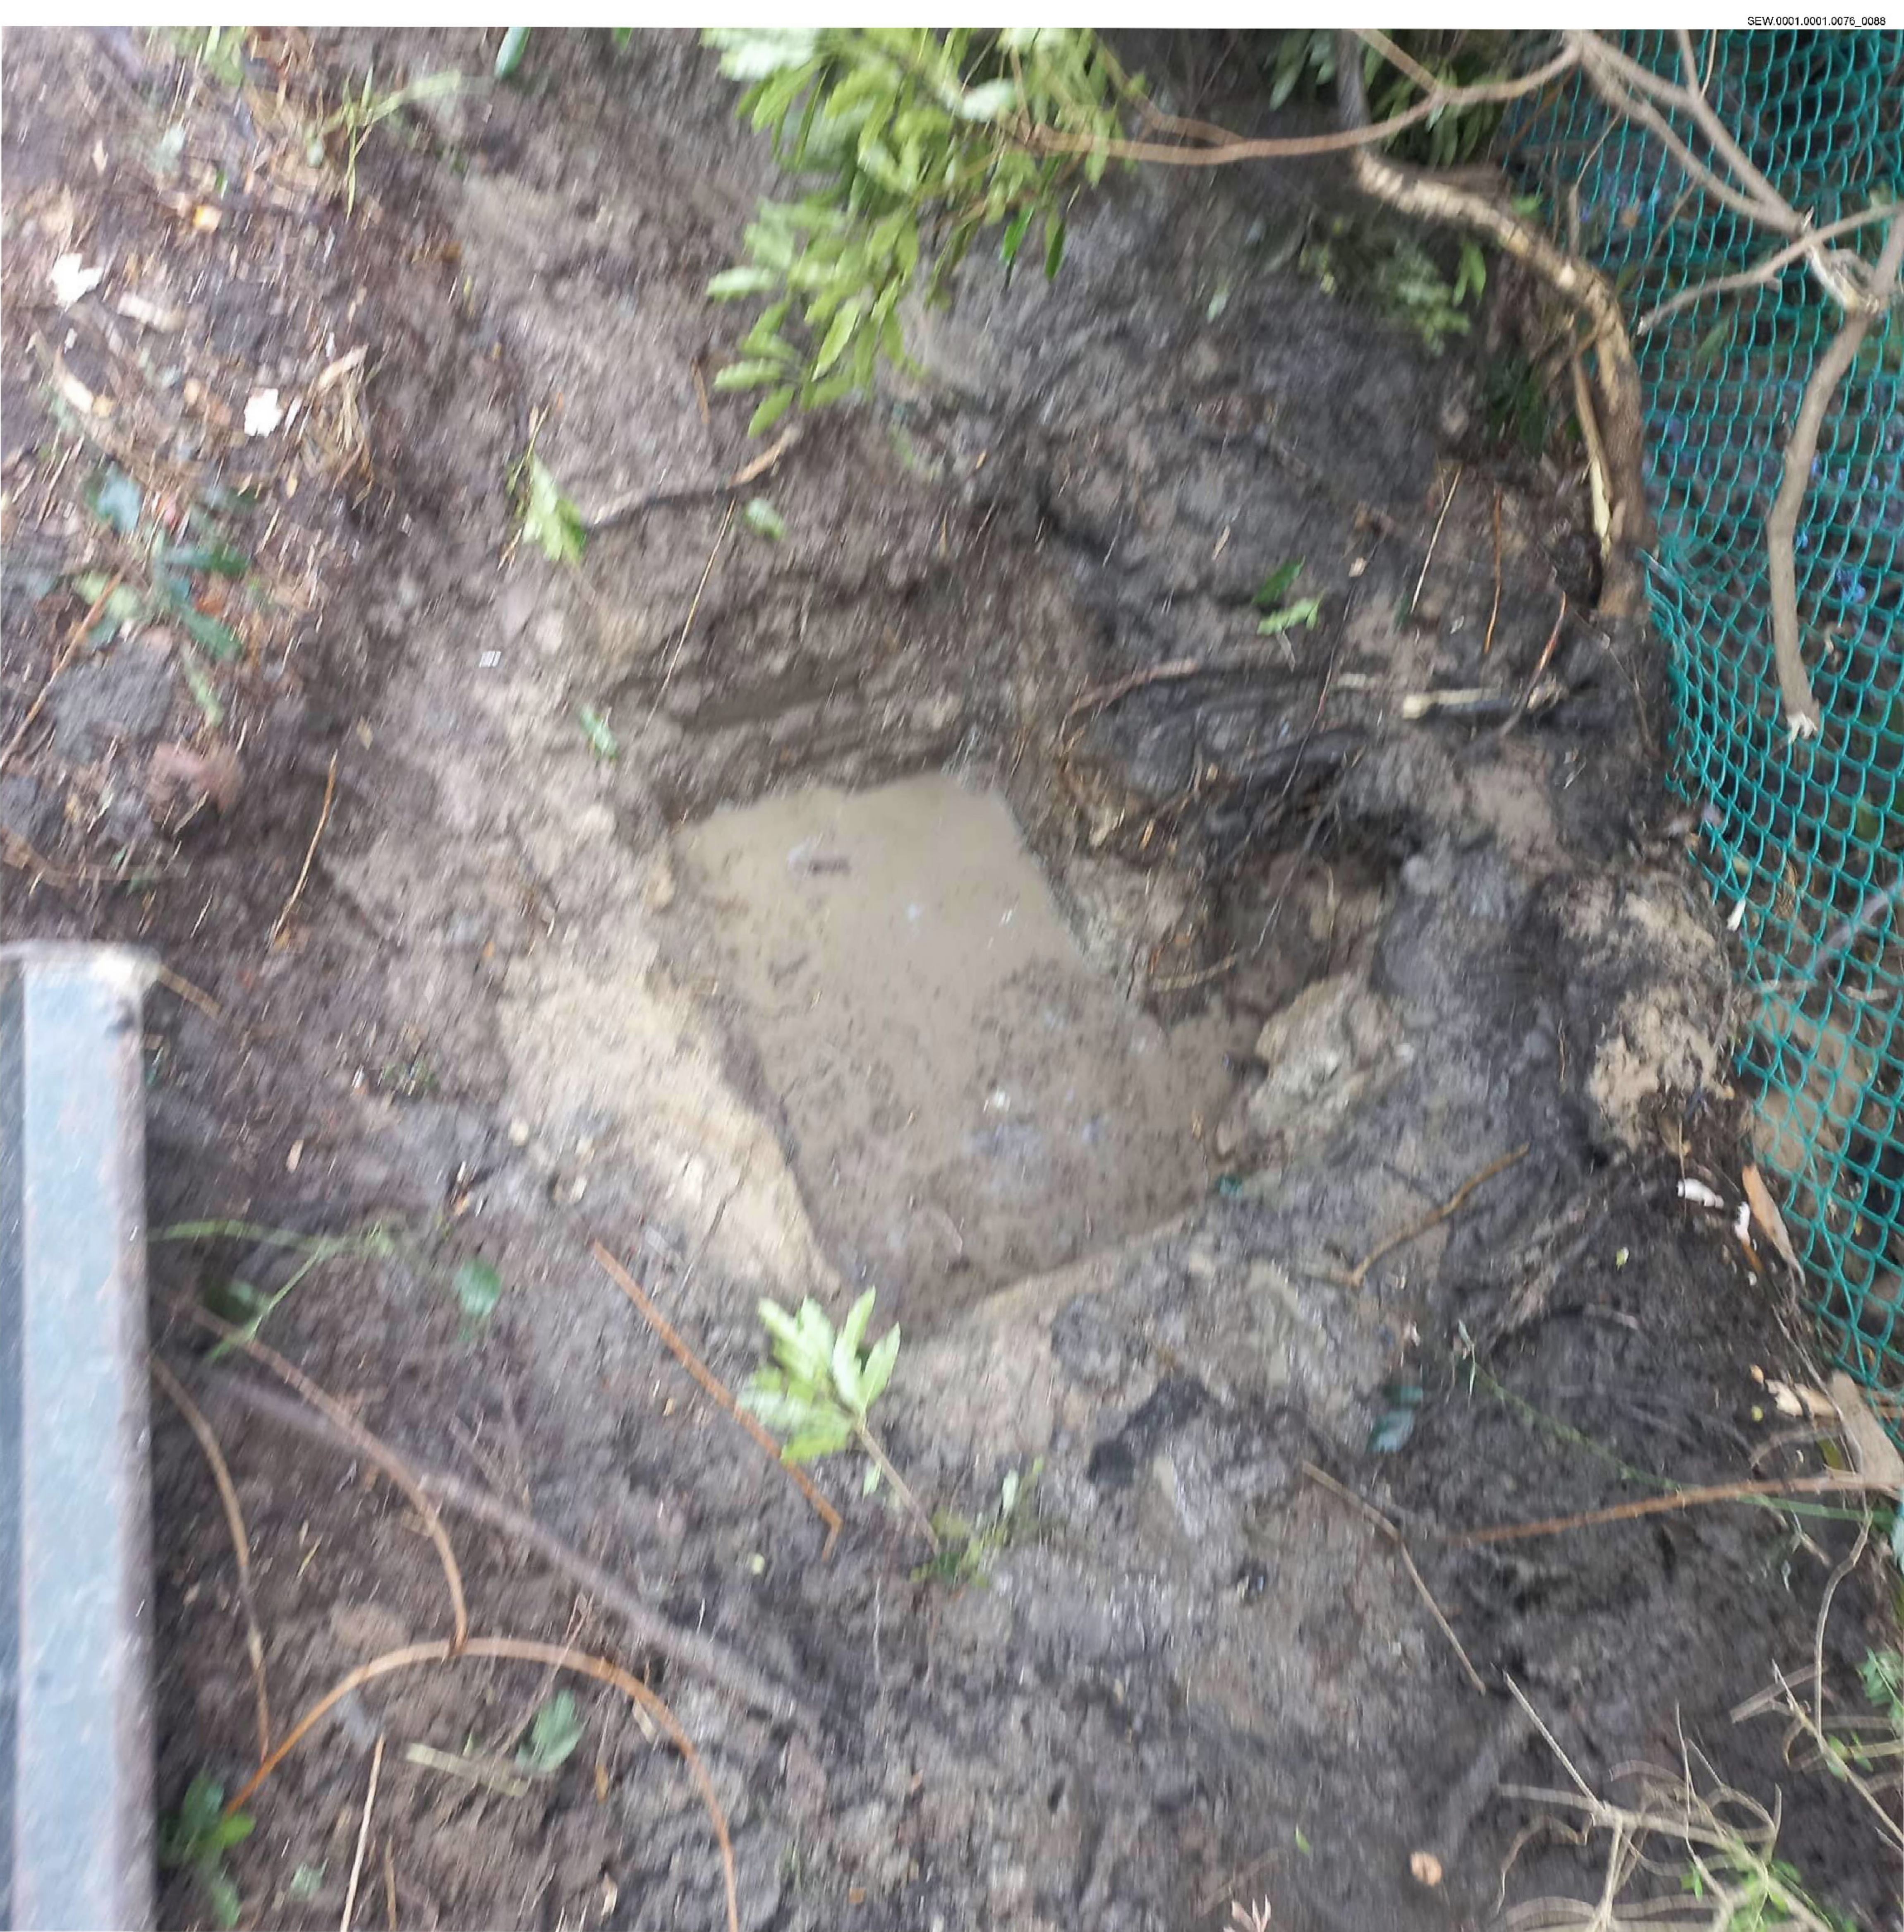
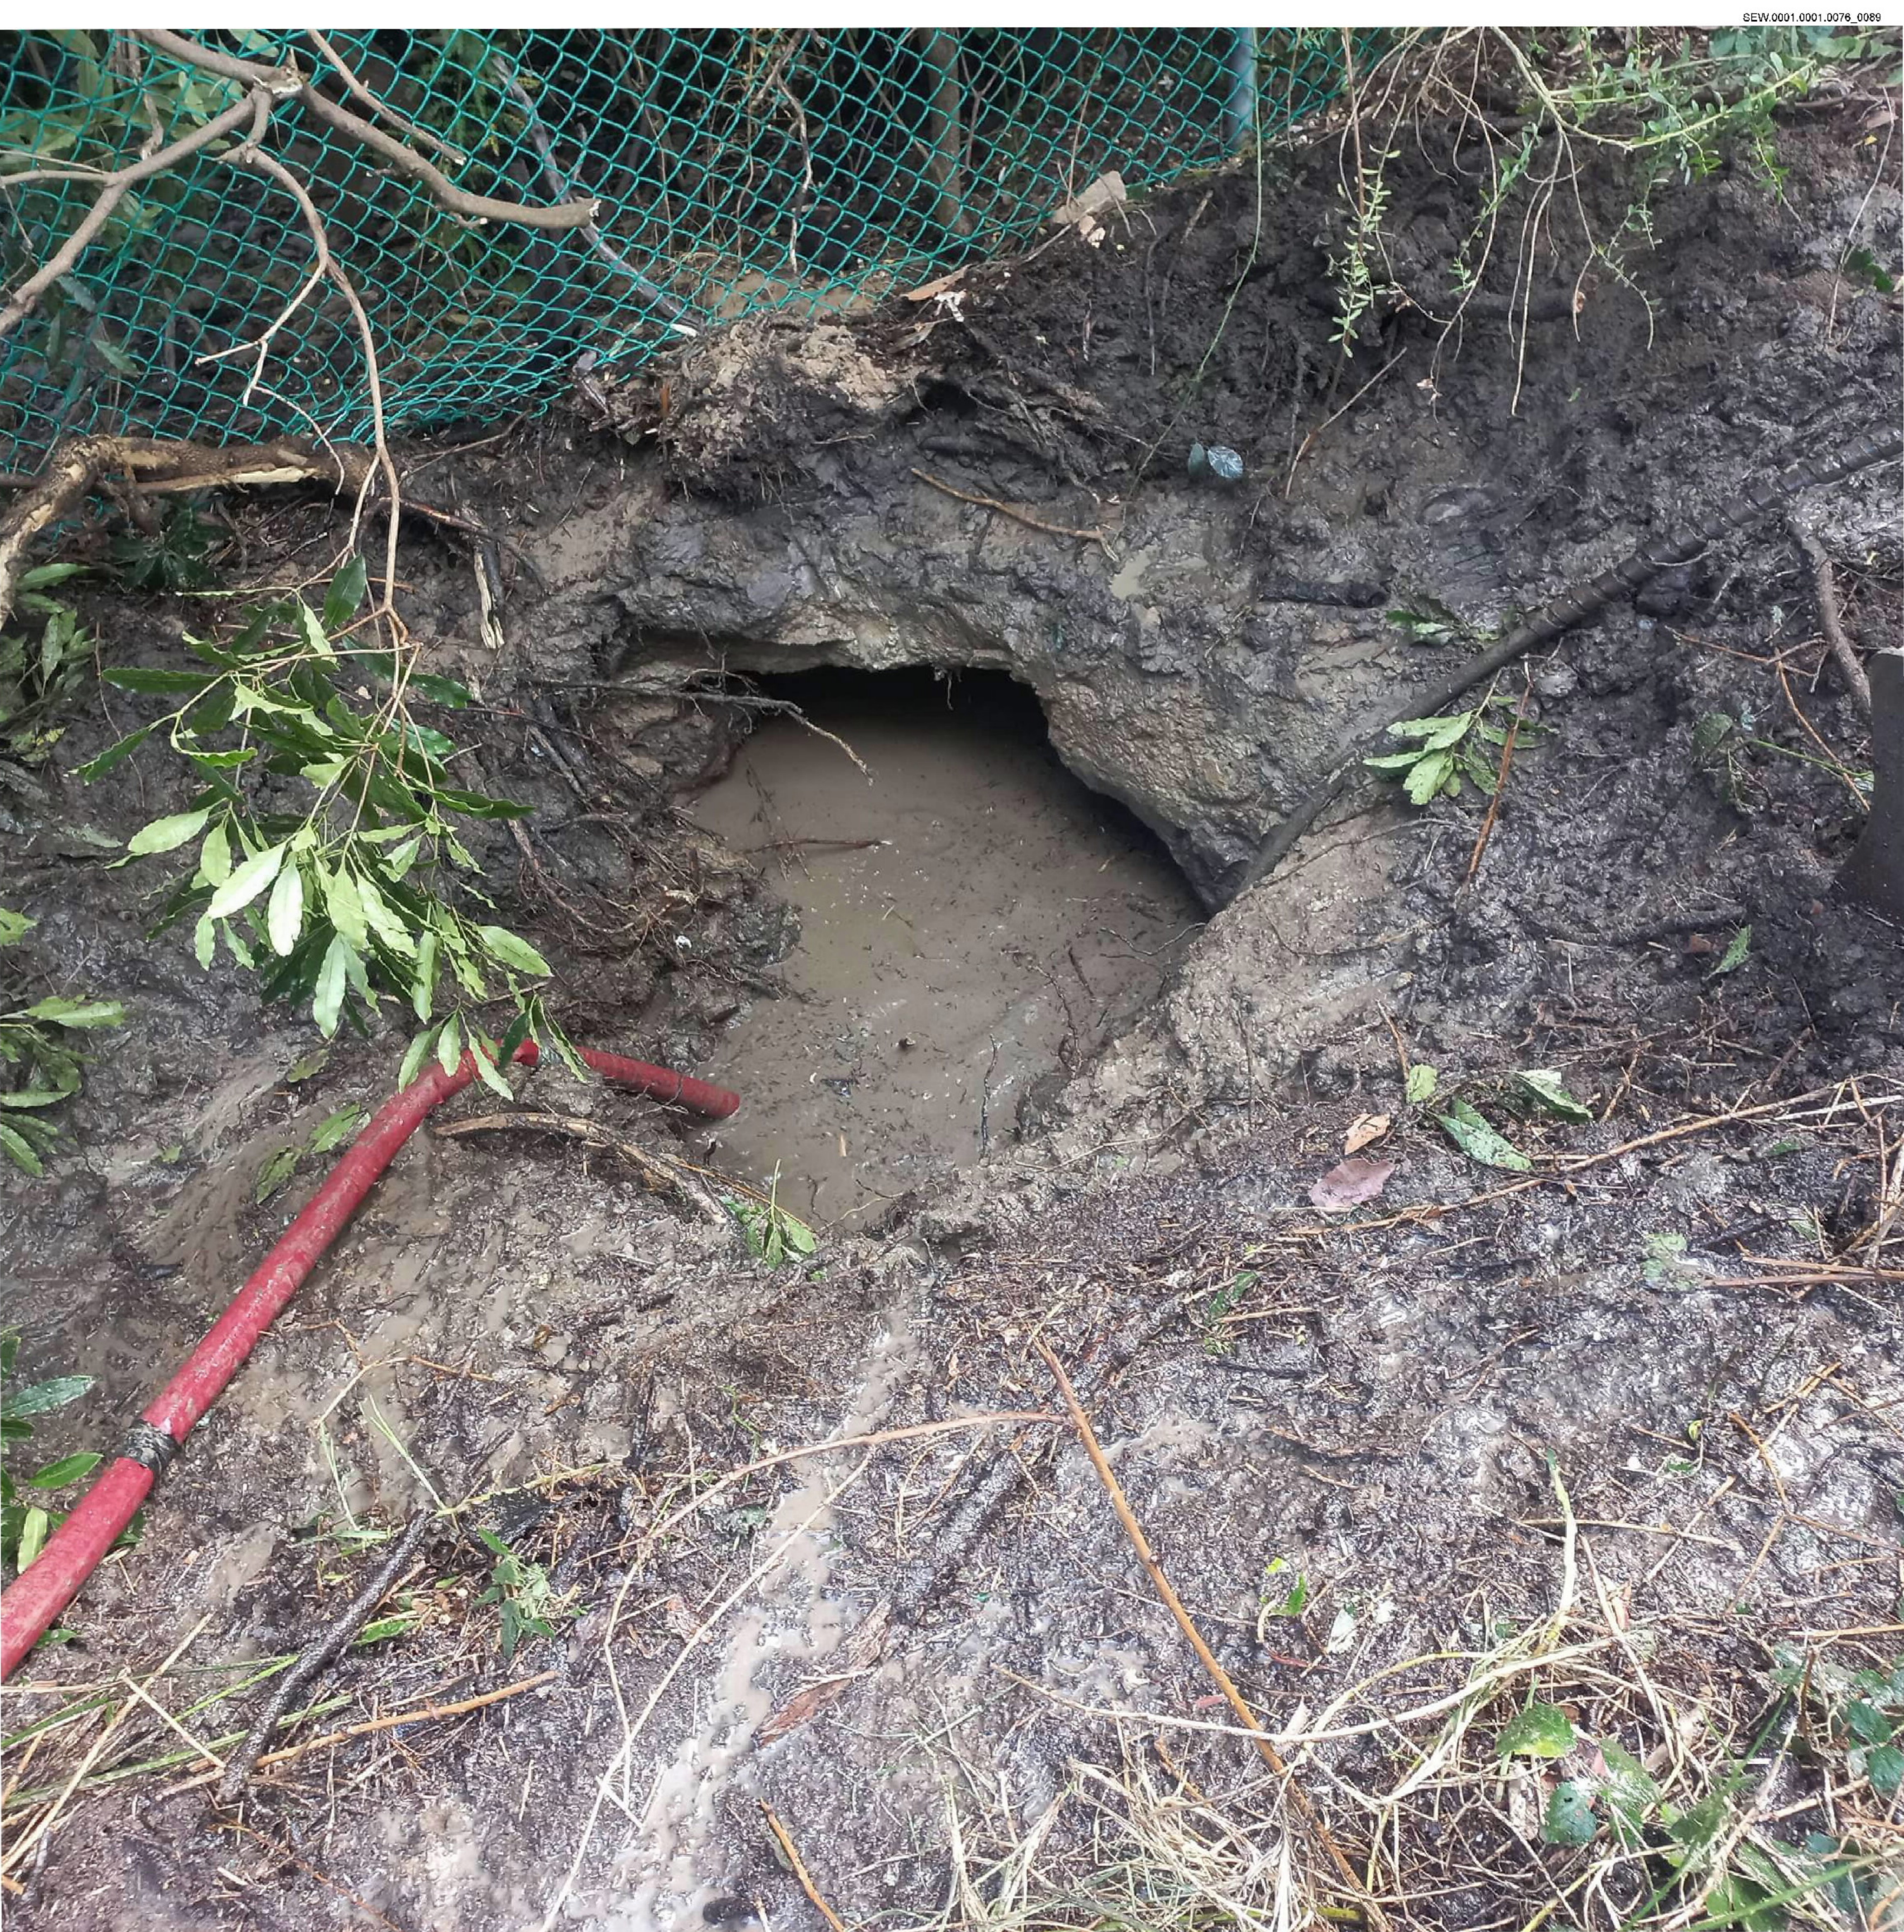
Task Story:[FT] [LLf0129] [30/12/2024 13:58] [ON SITE] Arrived on site to find burst on 150mm UPVC main in bushes need to follow barrier tape to burst & valves in bush checked all valves & found valve ID 363456 is very stiff I used heavy key wrench to turn very stiff did not want to snap top may need to extend shut off there is a gas transmission main in area its about 30 metres away from excavation [Ludewig,Ralph] [31/12/2024 08:14] [ON SITE] Pre water off notificaton received and sent [Ludewig,Ralph] [31/12/2024 08:42] [ON SITE] WSI Deleted by crew onsite [Aitken,Steve] [31/12/2024 09:08] [ON SITE] rob called - adv crew onsite [Ludewig,Ralph] [31/12/2024 09:14] [ON SITE] Pre water off notificaion received and sent [Pegg,Steve] [31/12/2024 12:47] [ON SITE] Zac advised when they had dug out tt the main and pumped the water out they found the area undermined close to a couple of large trees, one is hanging over the trench. the main is 1.7 to the top. the area is unsafe as is and to try and make safe will need a least one of the trees removing. explained this to gary louden and suggested we insert a valve near Outlook dve to isolate the main and program the repair. gary agreed [FT] [SSf0147] [31/12/2024 15:23] [ON SITE] off site need to check a p3 [Toe,Yasmine] [31/12/2024 15:24] [ON SITE] As discussed Jenna from Mornington council mb 0499562339 rang wanting to speak with supervisor. Says 1 Waller Place – Niki mb 0401100075 is flooded, house foundations and fence under water, unable to close their doors.Road is crumbling and 3 sink holes I the area and she will have to attend to close the road. Passed onto Dave MC, he will give Jenna a call back. Leak is being isolated and located on the other side of the mornignton freeway, will not know until leak is isolated [FT] [SSf0004] [31/12/2024 15:50] [ON SITE] Arrived on site and set up safety cones/signs.waited to get clearance from gas company to proceed job. Dug down and pumped out water n to find the surrounding ground collapsing due to high exposure to water,deemed usafe to complete job as the ground was undermining underneath 2 large trees that could fall at any point. main aprox 1.6-1.7m to the top of the main with a burst underneath the pipe.closeed area off with stakes and tape. turn one of two valves back on so residents had water but low pressure due to needing to limit amount of water coming out of burst main. Moved approx 100metres up to try and find the main to cut in valve which we could not find after digging about 2.5metres down which we then backfilled to make safe. jason from SEW tried to locate it under the road to give us a good indication where it was but was no successful in doing so.Packed up

Action Taken :Water Network - Water Main - Repair of burst in nature strip
