Our Ref: PSM5226-002L Rev1

RE: RISK ASSESSMENT. 10-12 VIEW POINT ROAD, MCRAE

PSM were commissioned by Harwood Andrews (**HA**) on behalf of Mornington Peninsula Shire (**MPS**) to carry out a Landslide Risk Assessment (**LRA**) at 10-12 View Point Road, McRae (the "**Site**") in accordance with the Australian Geomechanics Society (**AGS**) Guidelines on Landslide Risk Assessment (AGS, 2007). The scope of the LRA is restricted to the following:

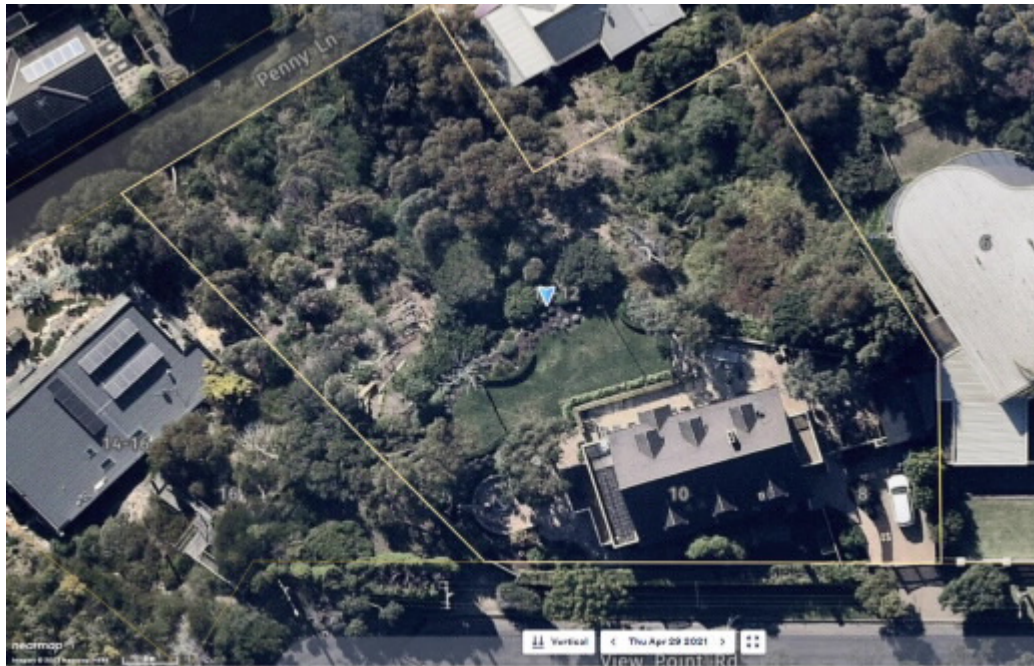
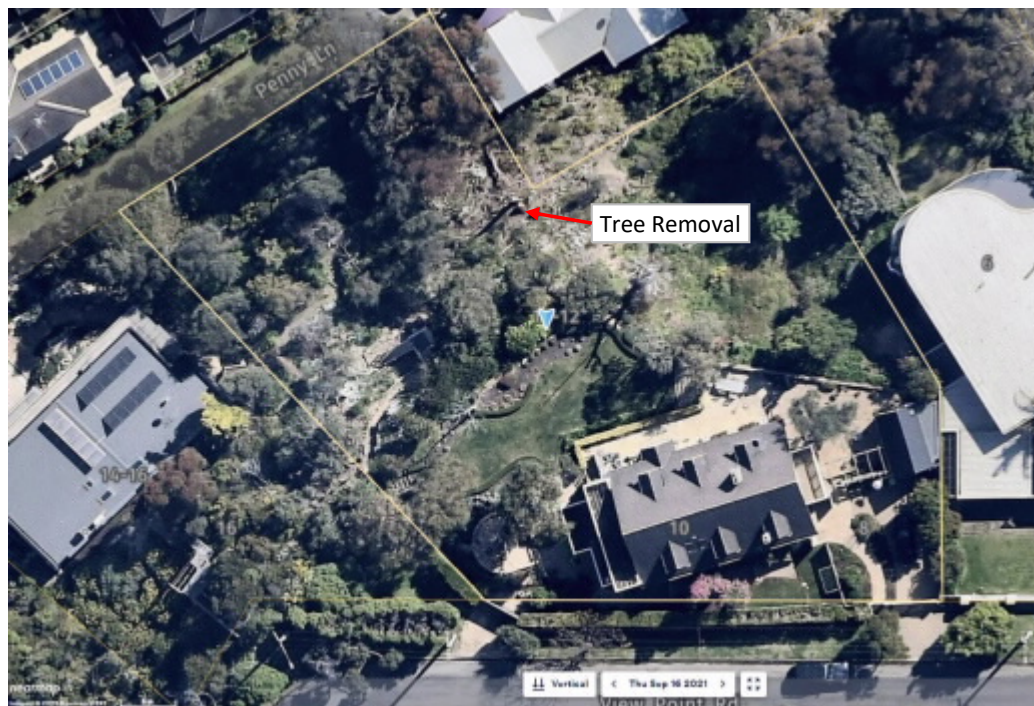
- A series of trees were removed on property P1 between April 2021 and September 2021, Appendix A1 & A2. This is supported by street view images between February 2018 and October 2022, Appendix A3 & A4.
- The translational slide scarp has approximate dimensions of 8 m x 5 m (in plan), Appendix A5.
- The debris flow:
 - Initiated from an area approximately 20m southeast of the property P1 northwestern boundary and was approximately 5 m wide.
 - Run out was approximately 5 m into properties P2 and P3, Appendix A6.

Figure A1: Nearmap 29/04/2021

Figure A2: Nearmap 16/09/2021

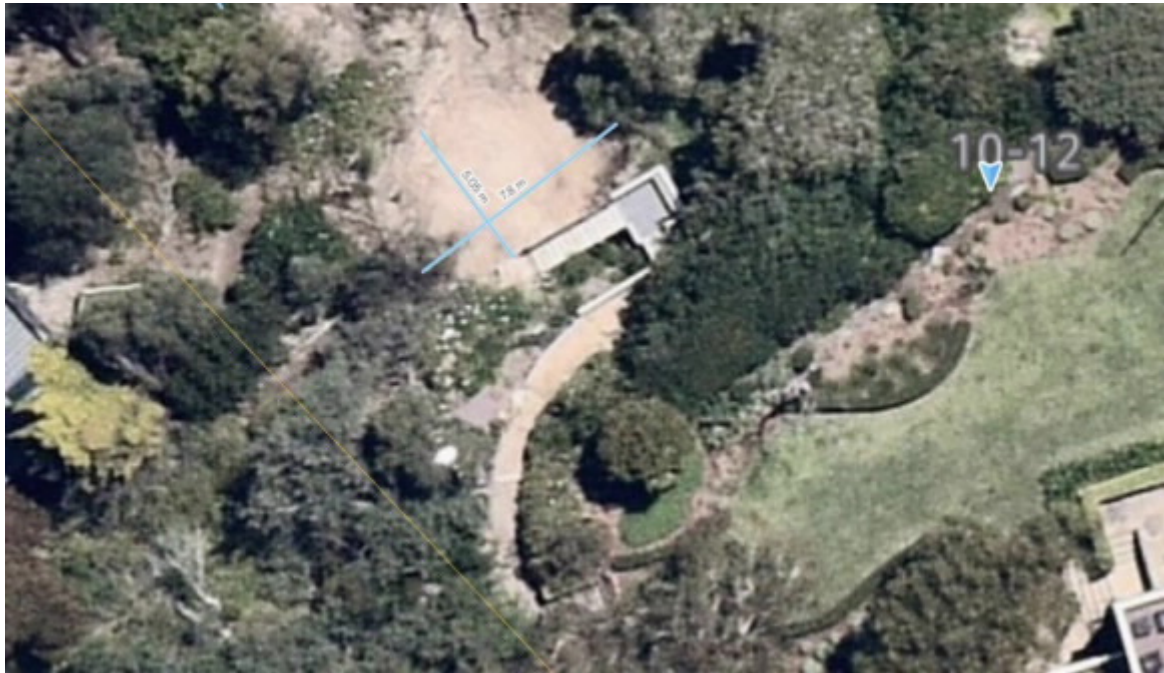
Figure A5: Nearmap 3/12/2022 approximate head scarp dimensions

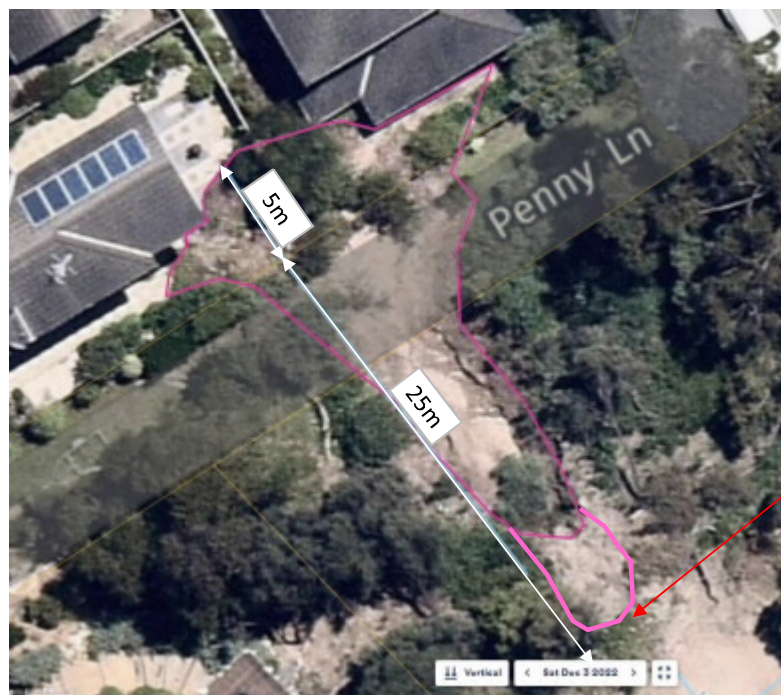
Figure A6: Nearmap 3/12/2022 approximate run out distances

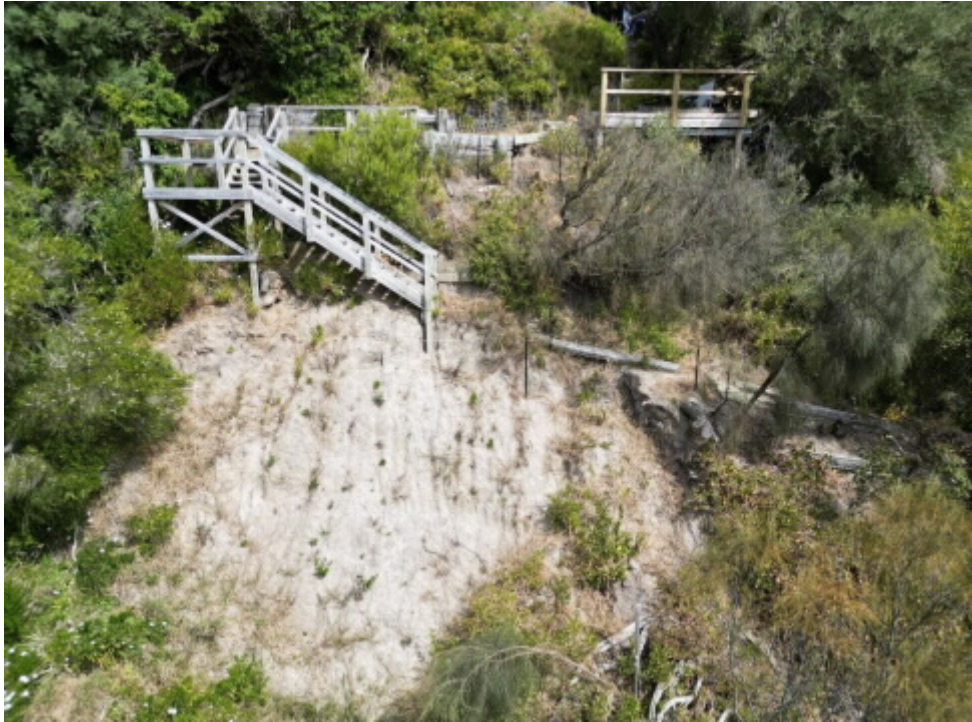
- It initiated in the upper to middle portion of the slope, with the rear scarp approximately at the base of the Stairs, Photo 1 Appendix B
- It was inferred to have initiated as a translational slide followed by mobilisation of failed material into a debris flow which was deposited at the toe of the slope, Photo 2 Appendix B
- The Landslide had three distinct zones being:

Photo 1 - Upper translational sliding area

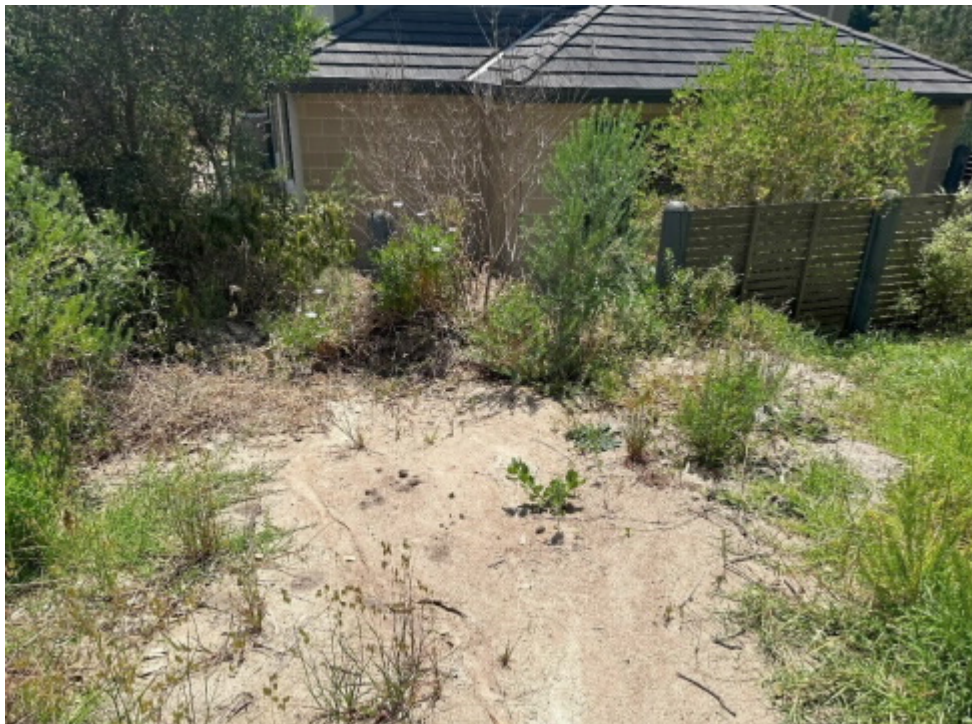
Photo 2 - Debris flow runout area, Property P2 visible in background

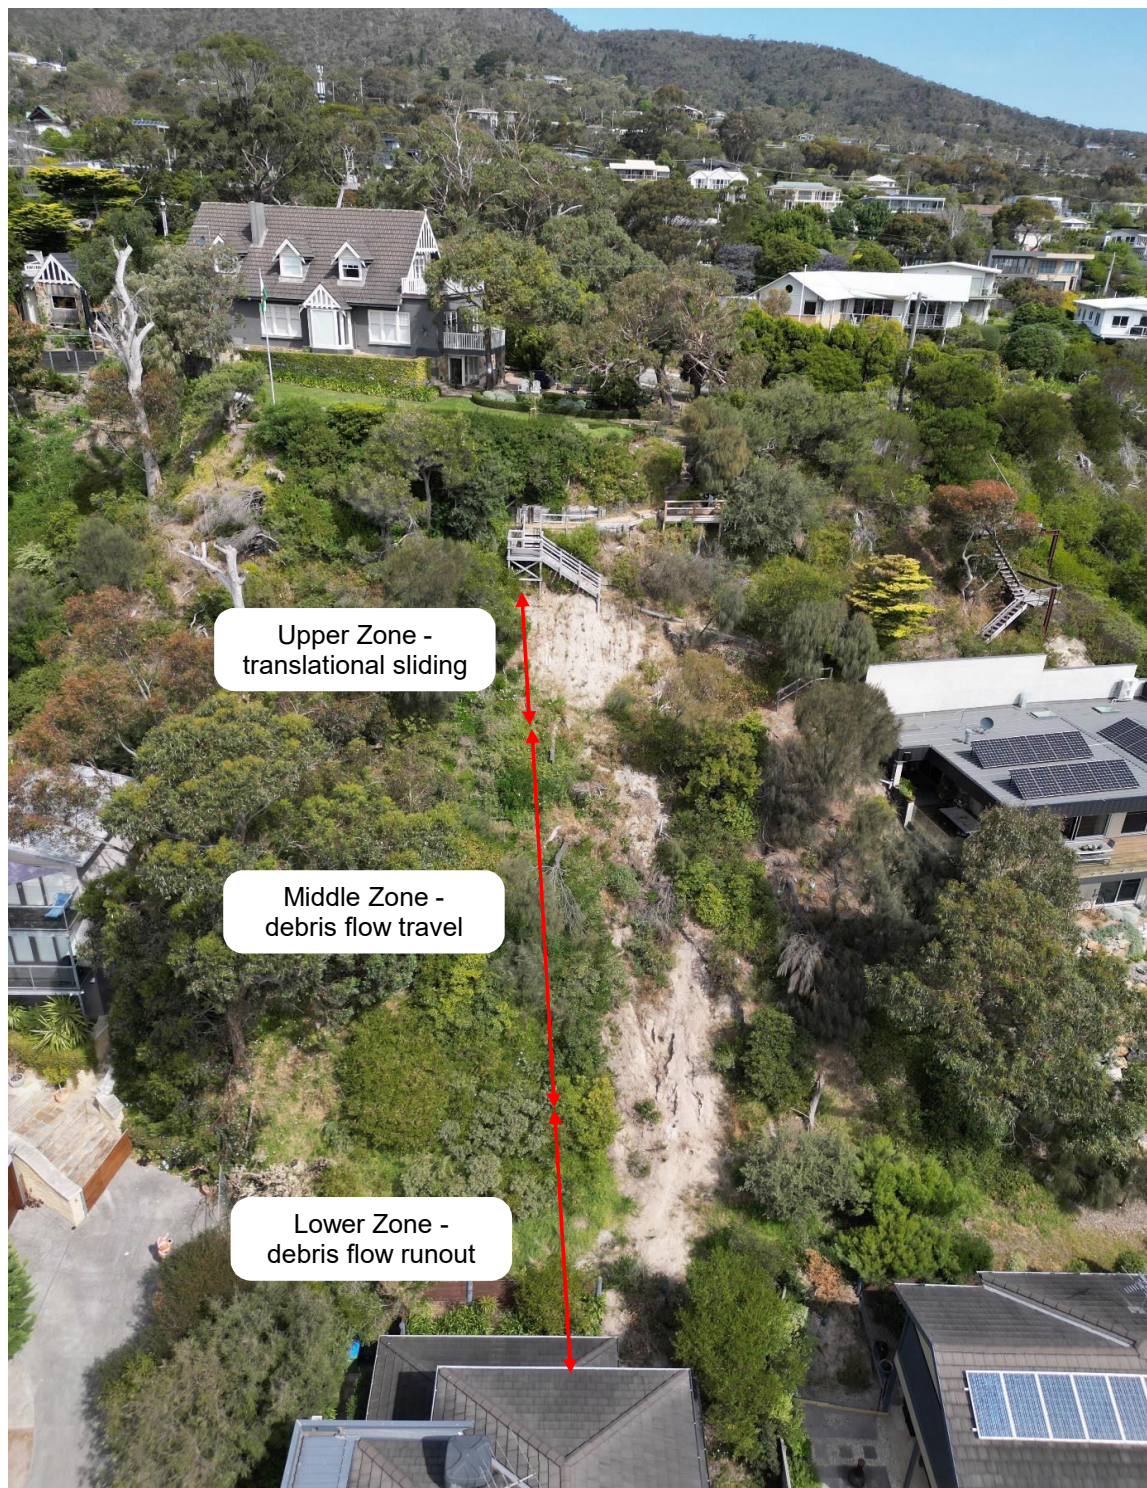
- A steep “**Upper Zone**” where the initial translational sliding occurred with approximate dimensions of 8 to 10 m wide x 8 to 10 m long x 0.3 m thick, Photo 3 Appendix B.

- A steep “**Middle Zone**” approximately 15 m long by 3 m wide through which the debris flow travelled, with some scour and erosion, Photo 3 Appendix B.

- A flatter “**Lower Zone**” of debris runout where the debris flow deposited at the toe of the slope, Photo 3 Appendix B. The approximate dimensions of deposited debris are 8 to 10 m wide, 9 to 10 m long, and 0.2 to 0.7 m thick.

Photo 3 - Landslide Overview, with zones indicated

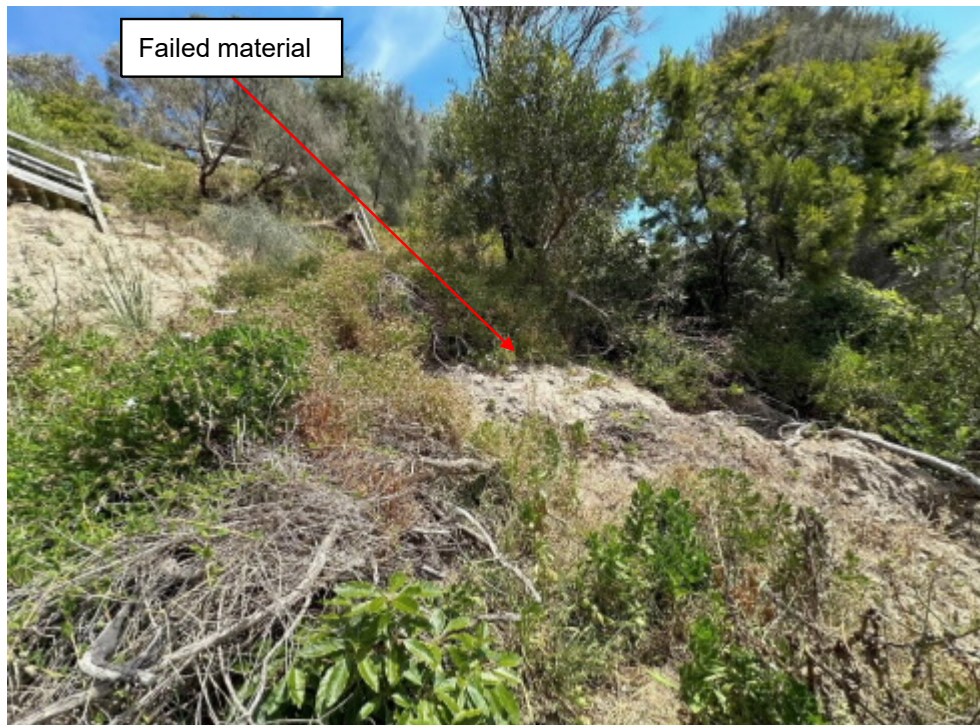
- Disturbed ground that had undergone translational sliding but did not mobilise into a debris flow was observed on the right (western) flank of the Landslide, Photo 4 Appendix B

Photo 4 - Failed material still on slope

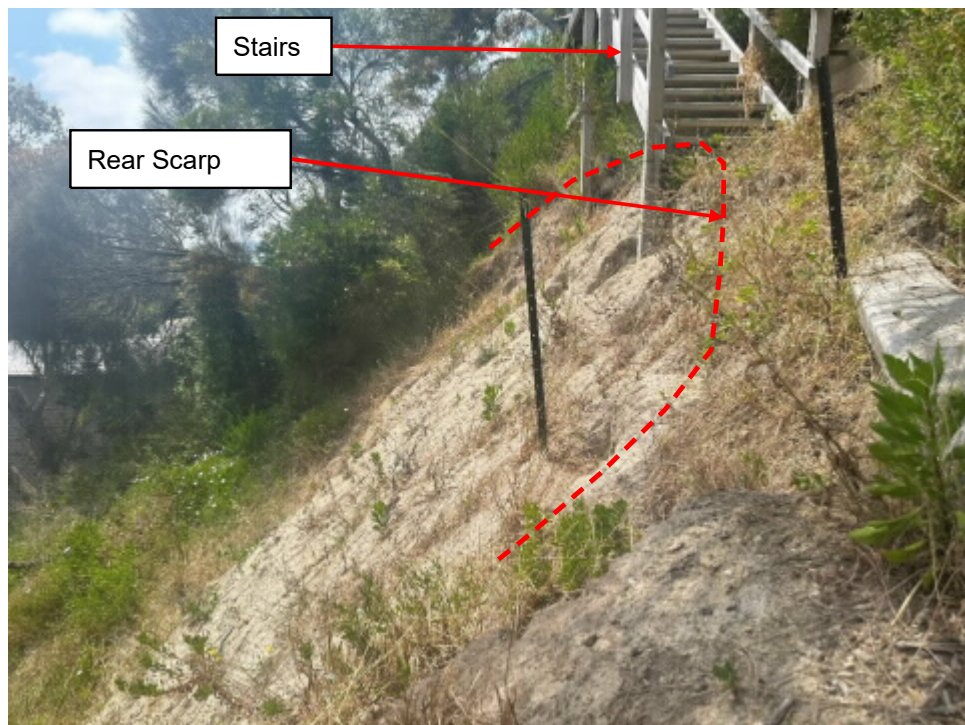
- A lack of prominent backscarp, Photo 5 Appendix B, with minor steepening observed in the backscarp area and with a slope angle of approximately 45 degrees.

Photo 5 - Rear scarp of landslide, note lack of oversteepened backscarp

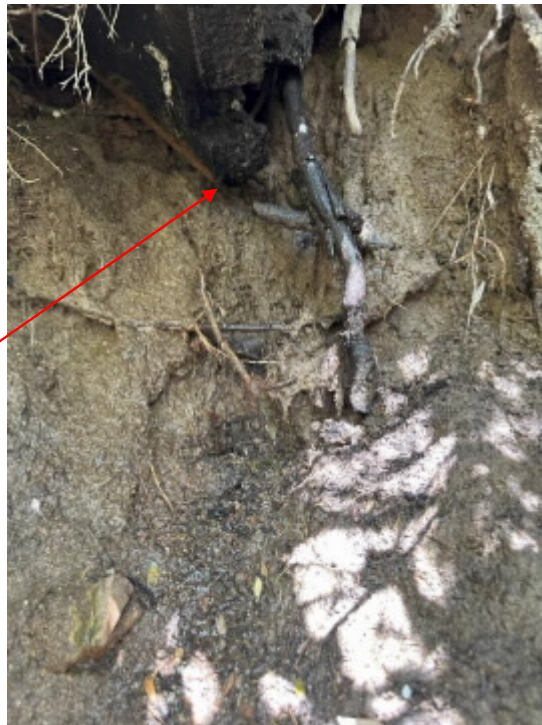
- Groundwater was observed to be seeping from the slope to the east of the stairs, Photo 6 Appendix B.
- A variety of water infrastructure was observed across the Site, Photo 7 Appendix B, including:

Groundwater seeping from slope

Photo 6 - Groundwater seepage

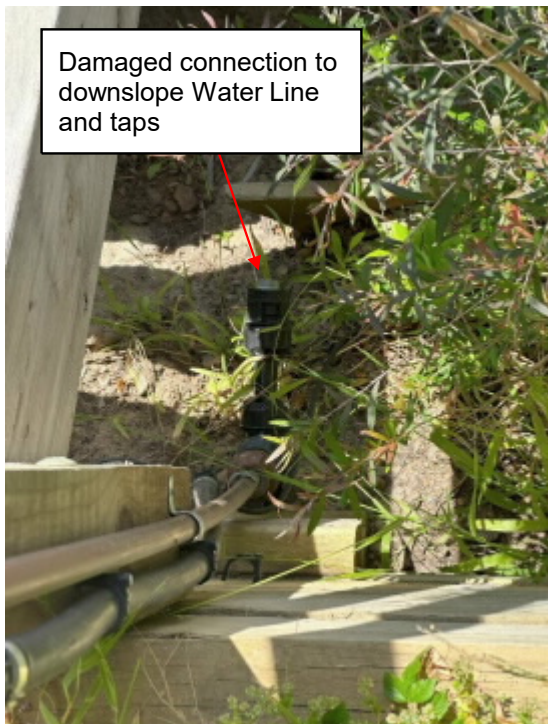
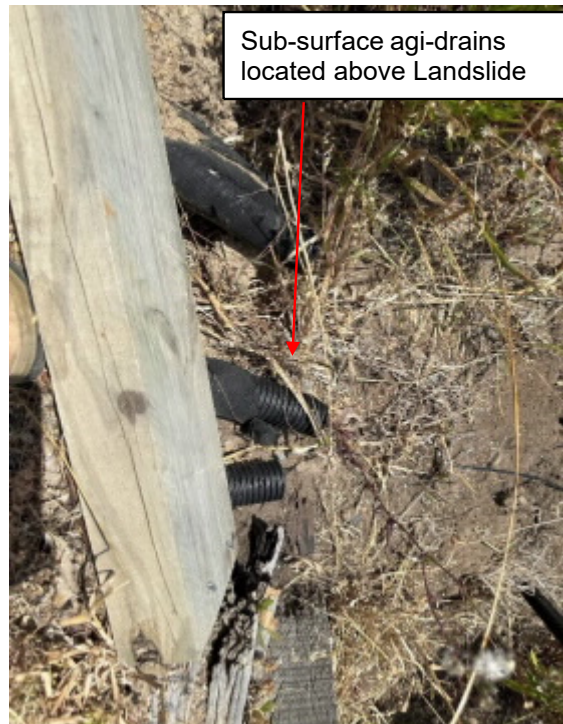
- Subsurface ‘agi-drains’
 - Water pipes including taps. A 20 to 25 mm diameter blue line polyethylene pipe with a damaged connection was observed near the top of the stairs, immediately above the rear scarp of the landslide.

Damaged connection to downslope Water Line and taps

Sub-surface agi-drains located above Landslide

Photo 7 - Water infrastructure including water pipes (on left), and subsurface 'agi drains' (on right)

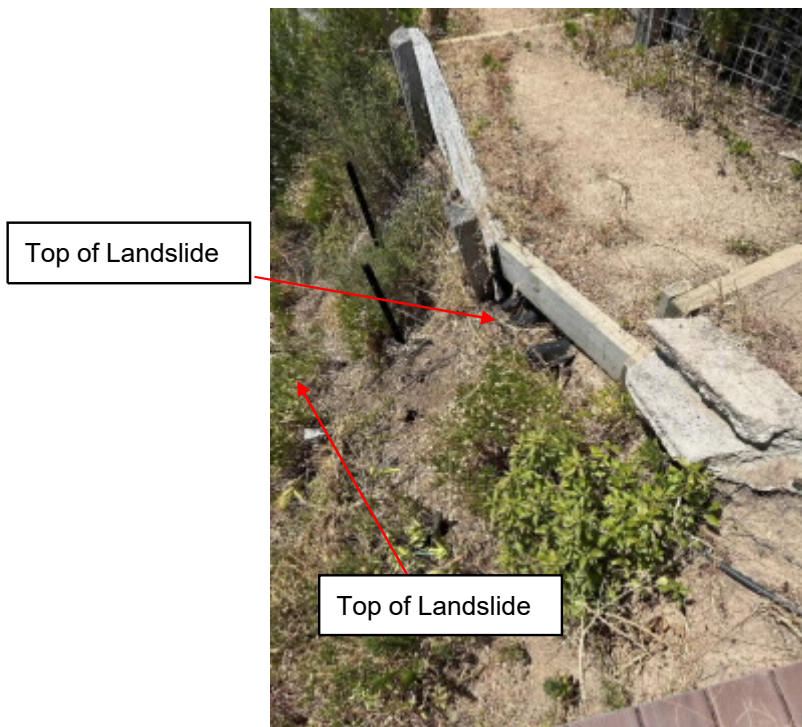
- A series of paths had been constructed across the slope to provide access from the top to the bottom of the escarpment, Photo 8 & 9 Appendix B. The paths are constructed from varying materials. Other infrastructure associated with the paths include minor RWs, board walks and stairs.

Photo 8 - Path above Landslide, note minor retaining walls and 'agi drains' from Photo 7

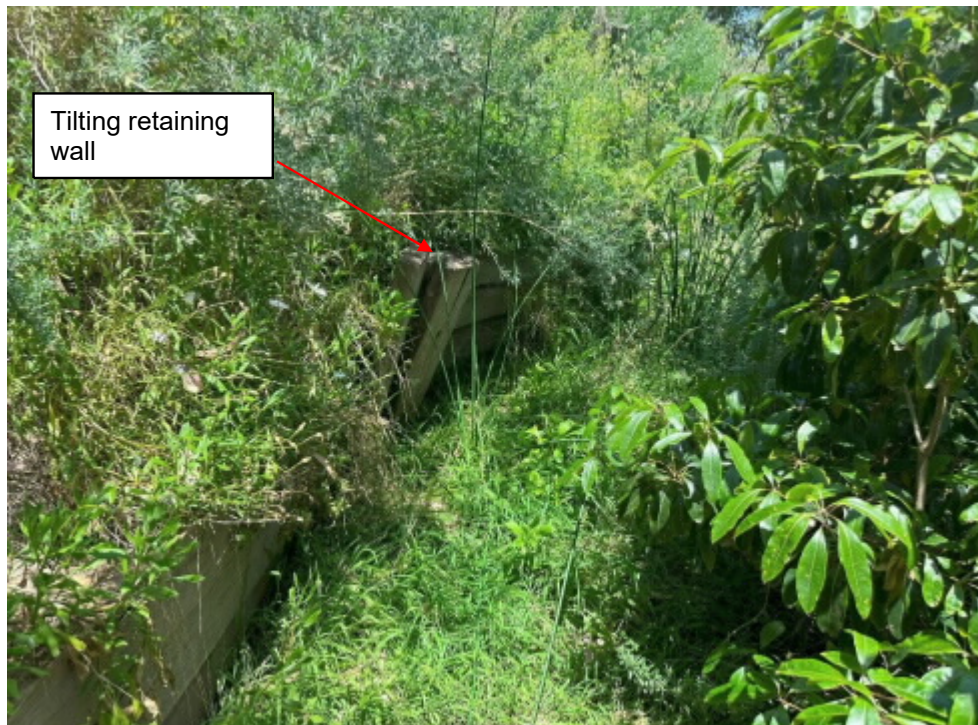
- The condition of RWs across the Site was generally poor, with overturning and bulging RWs observed. A section of RW to the east of the Landslide had significant tilts. This indicates possible instability in the ground above the RW and possible structural or geotechnical failure of the RW, Photo 10 Appendix B. RWs appear to be leaning more than as documented by Stantec (refer Section 2.2).

Photo 10 - Tilting retaining walls on left side of Landslide

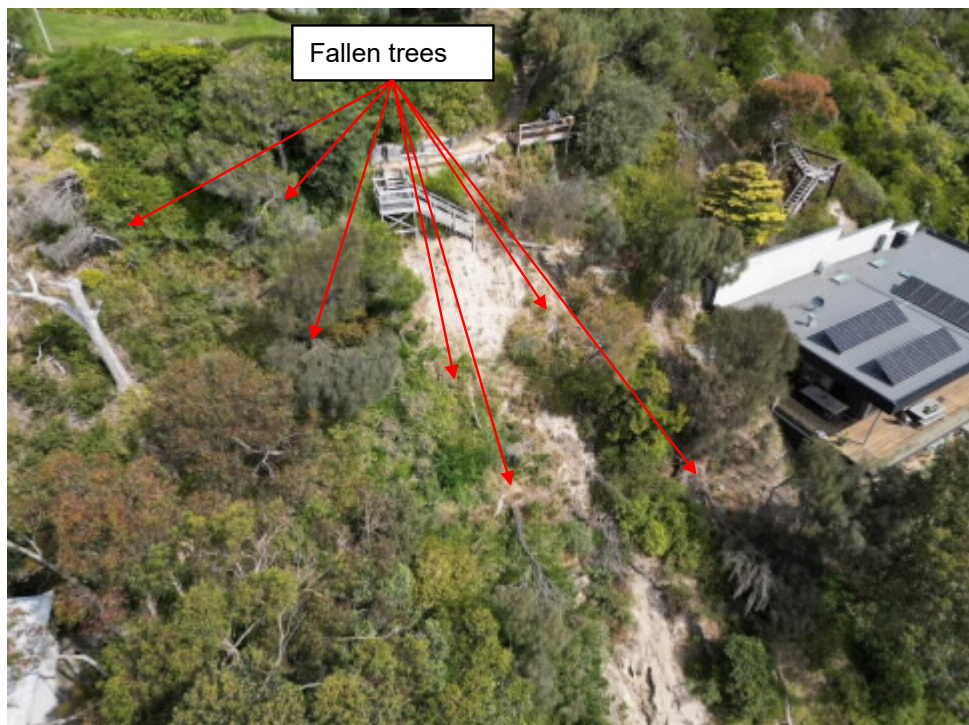
- Numerous fallen trees were observed across the escarpment slope, Photo 11 Appendix B. Most of the failed trees appear to have failed from causes unrelated to the Landslide, i.e., wind or poor root embedment. At least one tree appears to have fallen because of the Landslide.

Photo 11 - Fallen trees

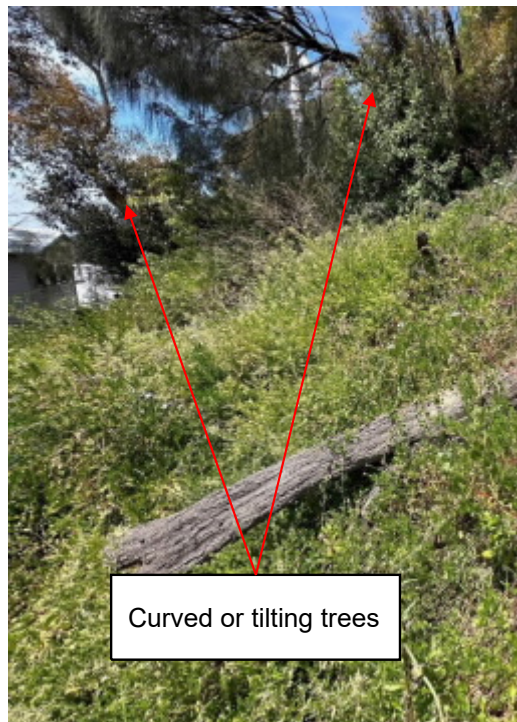
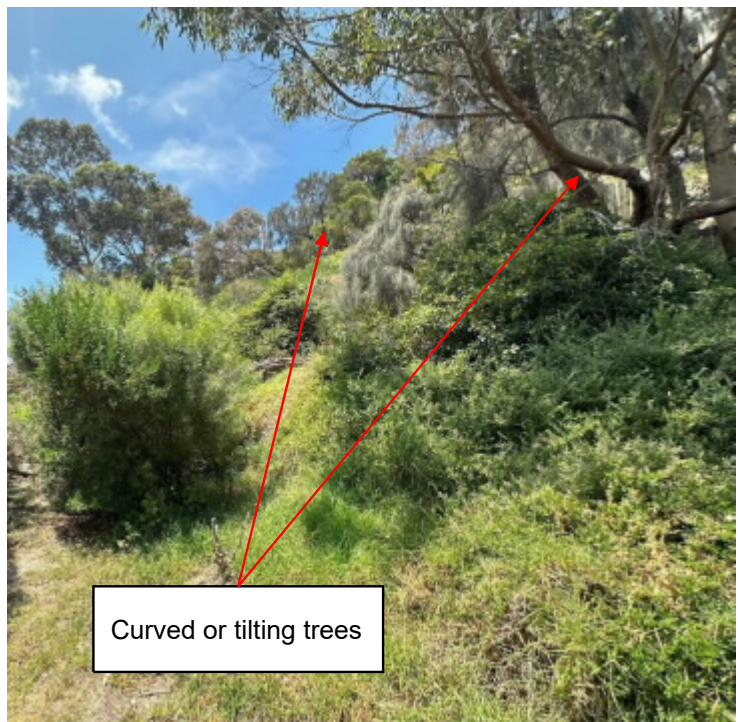
- Minor erosion was observed on unvegetated areas of the escarpment.
- Leaning and curved trees were observed on the escarpment, suggesting possible creep movement of the slope, Photo 12 Appendix B.

Photo 12 - Curved or tilting trees

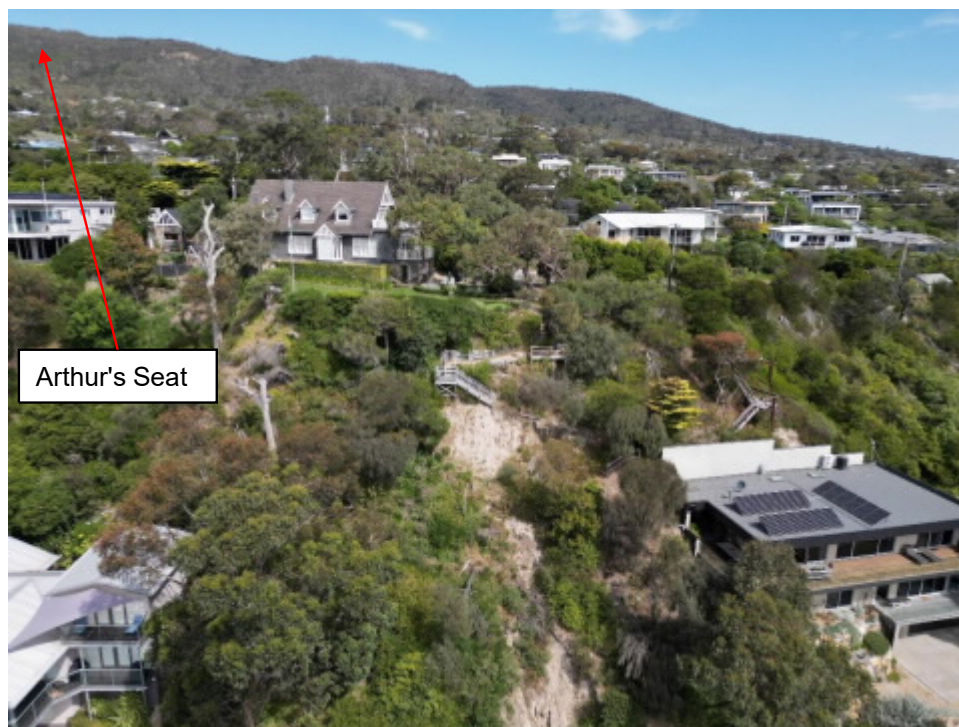
- Granite rock is exposed in shore platform below the road.
 - Steep to sub-vertical upper slopes is inferred to fail by undercutting and erosion of the lower slope leading to toppling/wedge style failures, Photo 15 Appendix B.

Photo 15 - Arthur's Seat in background
