TECHNICAL MEMORANDUM

To	Derek Rotter & Chris Lyne Mornington Peninsula Shire	From	Davin Slade Cardno now Stantec
Project	Penny Lane, McCrae	Date	7/12/2022
Subject	Geotechnical Assessment	Ref No.	V220600Report01.1

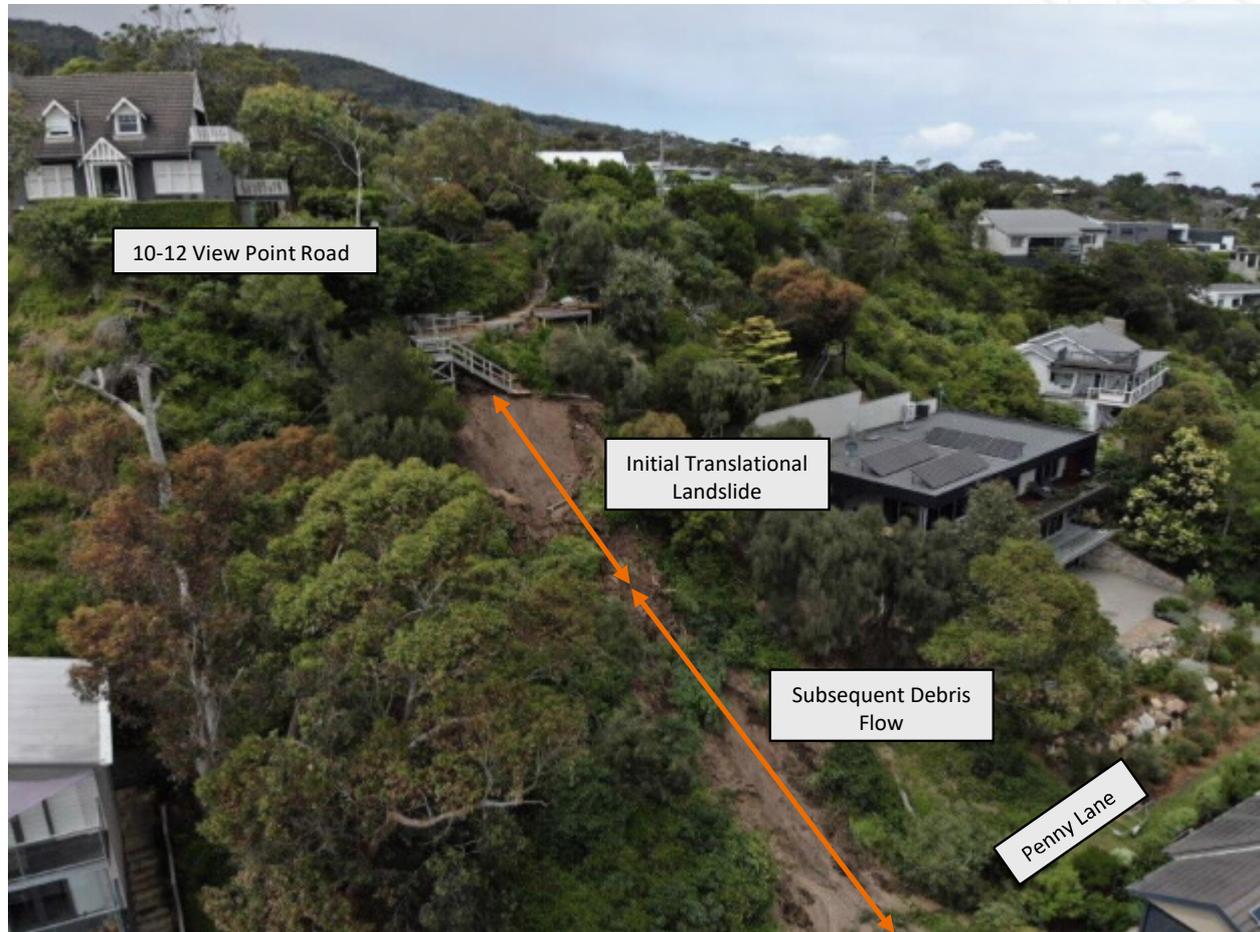
Figure 3-1: Oblique view of landslides

From the anecdotal discussions it is understood that an initial landslide is likely to have occurred in the late afternoon on Monday 14 November 2022. This day was a day of very heavy rain with approximately 80mm of rain recorded at the Bureau of Meteorology rain gauge located at Rosebud Country Club approximately 3-4km away. According to the data this was the highest single day of rainfall at that rain gauge since February 2005. This was coupled on top of what had already been a wet year. This landslide appears to have occurred as a translational landslide of the upper slope to the rear (north) of the house at 10-12 View Point Road.

Subsequently in the early morning of Tuesday 15 November 2022 a second landslide occurred. This landslide appears to have occurred as a debris flow from the middle part of the slope down to the toe resulting in impact on the dwelling at 3 Penny Lane as well as debris flowing into the yard of 3/613 Pt Nepean Road. From evidence on site, it appears that the debris flow may have been triggered by an irrigation pipe that could have been ruptured by the initial landslide.

An oblique view of the site showing the locations of the two parts of the landslide is shown in Figure 3-1.

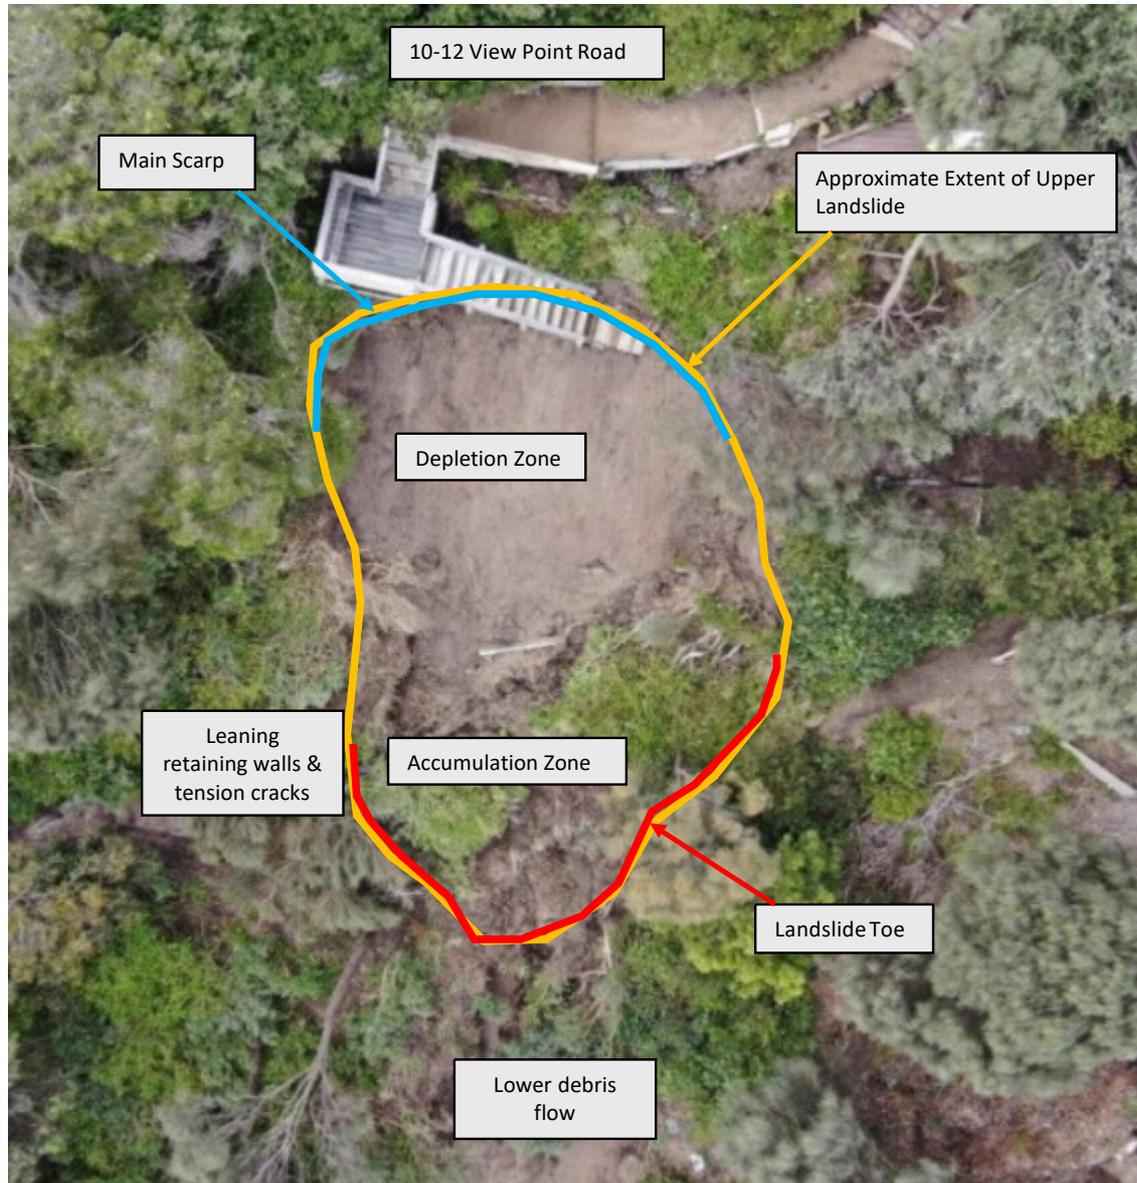
Figure 4-1: Aerial view of upper slope

The upper slope is dominated by a translational landslide that appears to have occurred in the upper soils overlying the underlying completely weathered granite. Across the area of the landslide a majority of the upper soils have translated downslope while the completely weathered granite has generally remained in place and is exposed in areas.

Figure 4-1 shows an aerial view of the site taken by Victoria Police drones. It shows the extent of the upper landslide and pertinent features associated with the landslide.

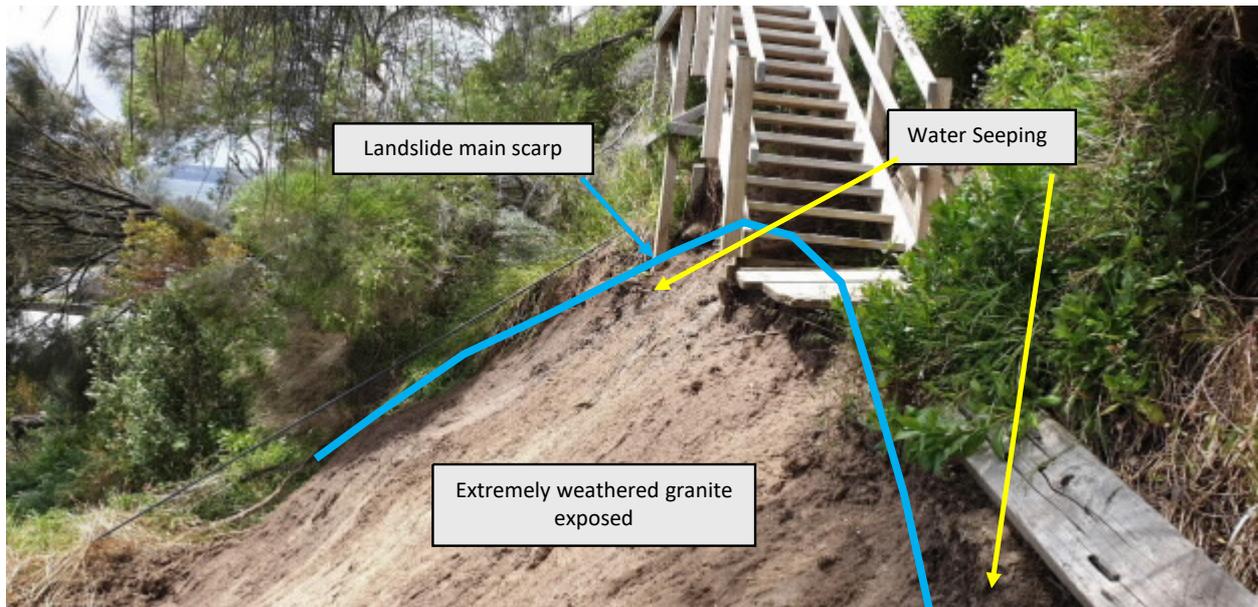
Figure 4-2: Main scarp of landslide

Figure 4-2 shows the main scarp of the landslide where it has undermined the existing stairs. It can be seen that the failure surface of the landslide runs parallel to the ground surface. The weathered granite is exposed in the failure surface. Looking at the side flank it can be seen that the thickness of soil that would have overlain the weathered granite is relatively shallow, possibly less than 0.5m.

Water was observed to be seeping from the head scarp at several locations more than 24 hours after the storm occurred. These seeps appear to be associated with natural springs further up slope.

The irrigation pipe that is likely to have failed during the initial landslide can be seen to be stretched tight in both figures.

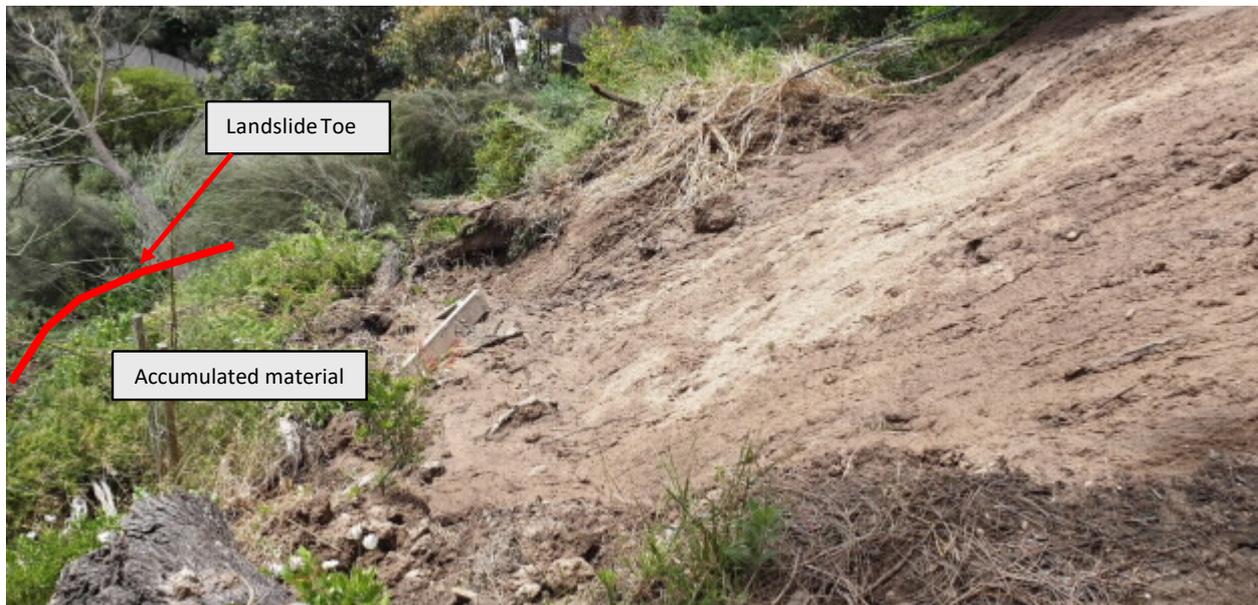
Figure 4-3: Accumulation zone of landslide

Figure 4-3 shows the accumulation zone of the upper landslide. It can be seen in the photograph that there is a significant volume of accumulated material and debris sitting at the toe of the landslide.

It is considered possible that with another significant rainfall event the material in the accumulation zone could remobilize and flow down slope. In addition, it is possible that some regression of the head scarp

could occur but that it would most likely be confined to the steep section of the slope or the immediate vicinity of the flatter area upslope.

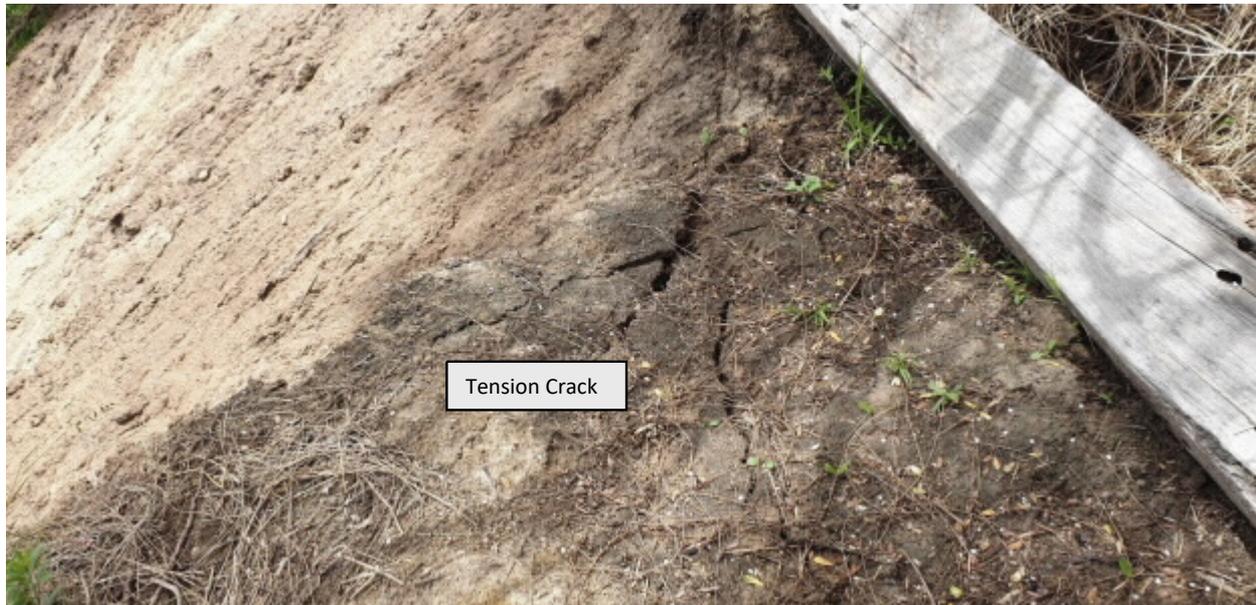
Figure 4-4: Tension crack on right flank

As shown in Figure 4-4 there is a tension crack on the right flank of the upper landslide. It appears to be confined to the immediate vicinity within 2-3m of the landslide. It is considered possible that the landslide could widen in this area by several metres.

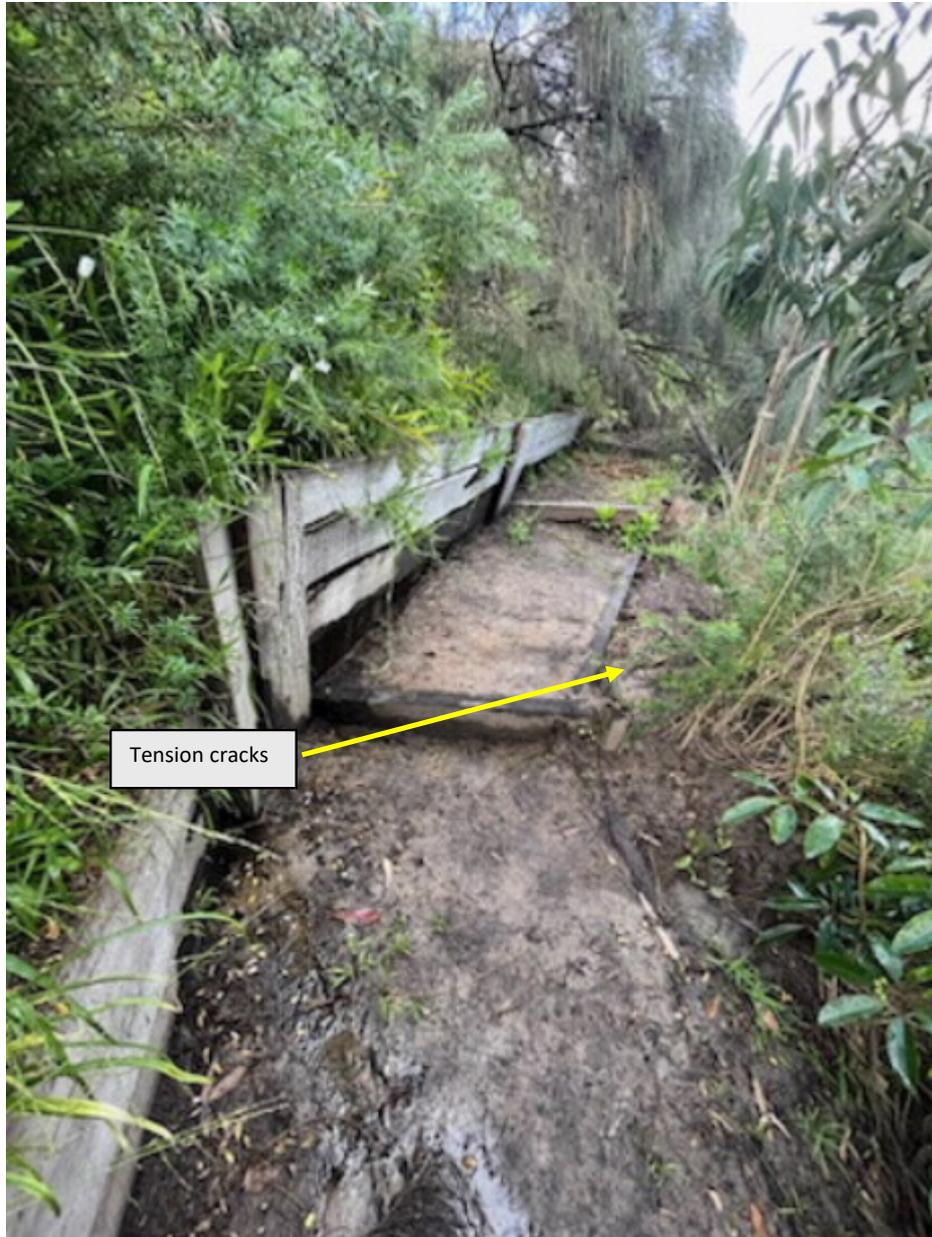
Figure 4-5: Leaning retaining wall and tension cracks on left flank

On the left flank there was an old timber retaining wall present. It was significant leaning and there was evidence of water seeping through the wall. To the front of these walls there were several tension cracks. These tension cracks appeared to be in two forms. One set of cracks appeared to indicate the rupture surface at the toe of movement further up slope while the second set of cracks appeared to indicate a developing head scarp of a landslide of the lower slope.

The tension cracks on the left flank appeared to extend approximately 5m from the existing landslide. This indicates that there is potential for widening of the existing landslide by several metres should heavy rainfall continue.

The retaining wall and tension cracks are shown in Figure 4-5.

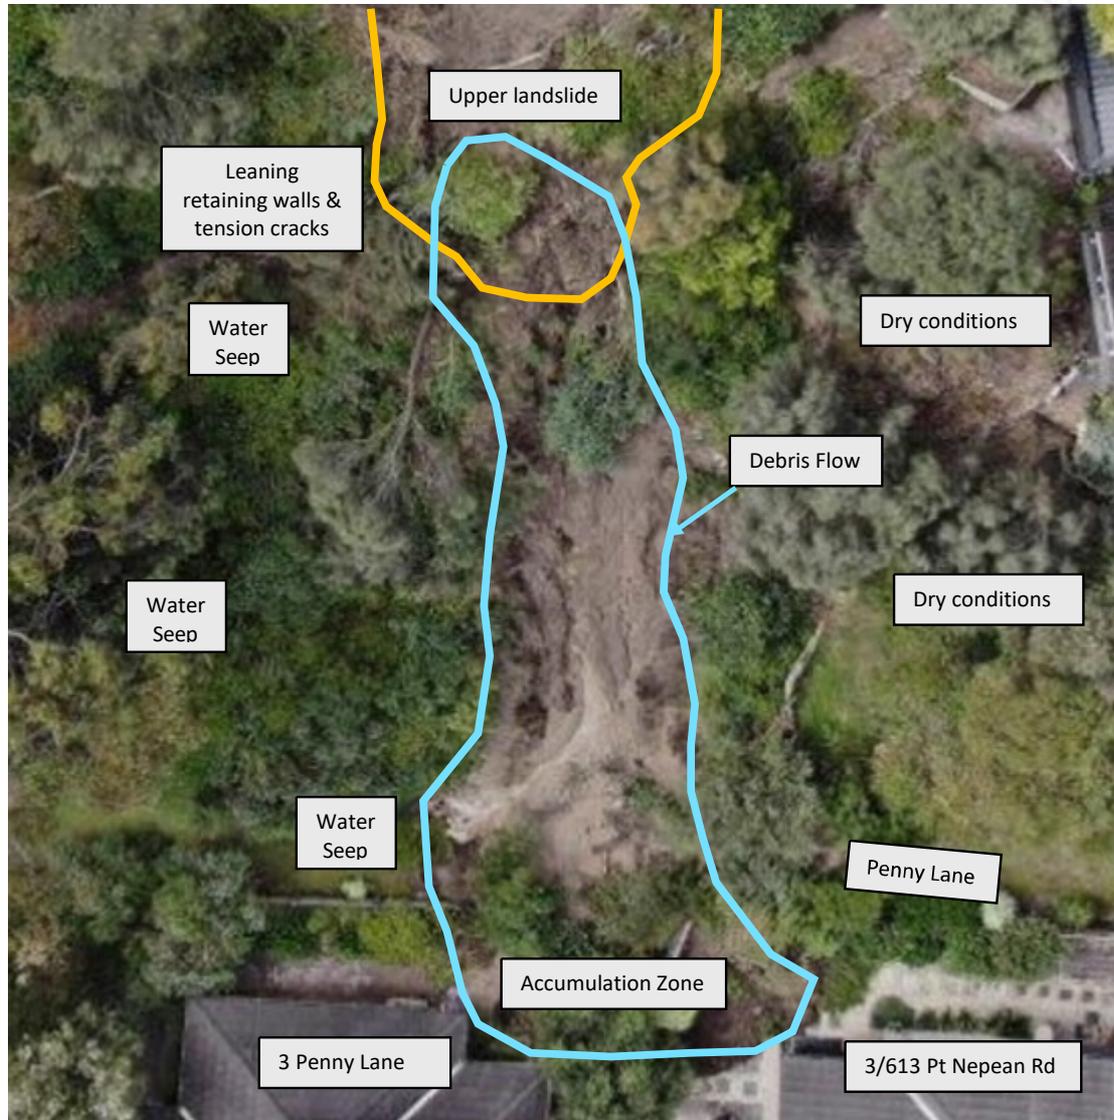
Figure 4-6: Aerial view of lower debris flow

The lower slope is dominated by a debris flow that has been initiated by a significant increase in ground moisture, most likely as a combination of significant rainfall and potentially the failure of an irrigation pipe after the upper landslide occurred. Figure 4-5 shows an aerial view of the site taken by Victoria Police drones. It shows the debris flow initiated within the accumulation zone of the upper landslide and then flowed downslope across Penny Lane and into the rear of the properties of 3 Penny Lane and 3/613 Pt Nepean Road.

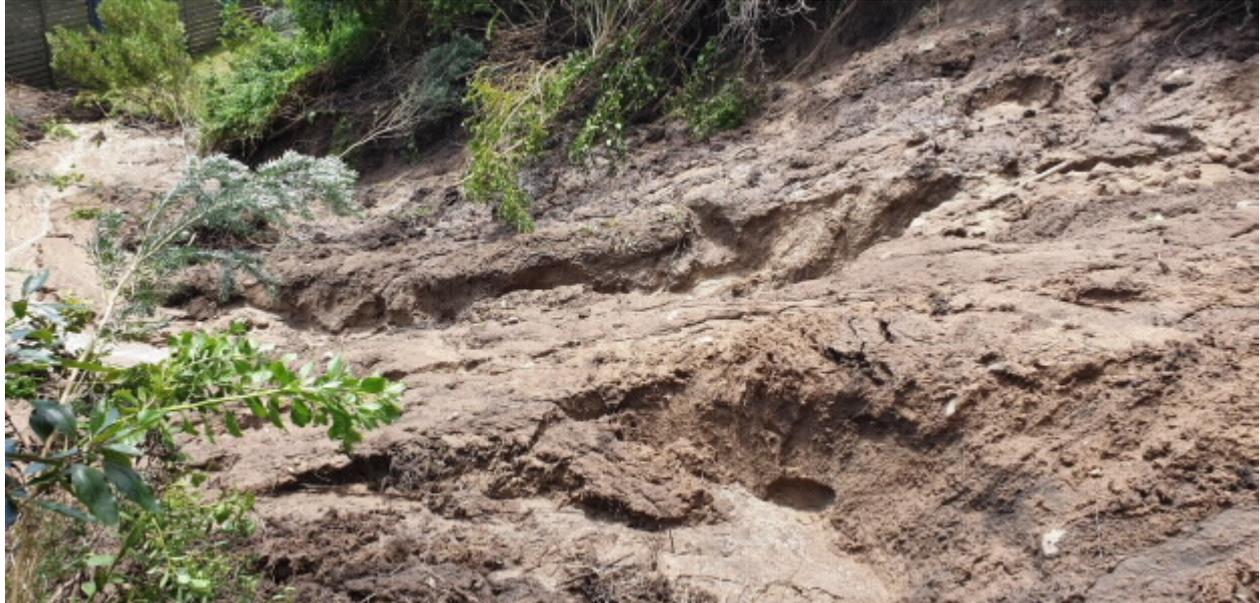
Figure 4-7: Debris flow path

Figure 4-6 shows the path of the debris flow. It can be seen that the upper vegetation has been stripped and that there has been some scour of the underlying soils. The deepest sections of scour have eroded down to the top of the extremely weathered granite.

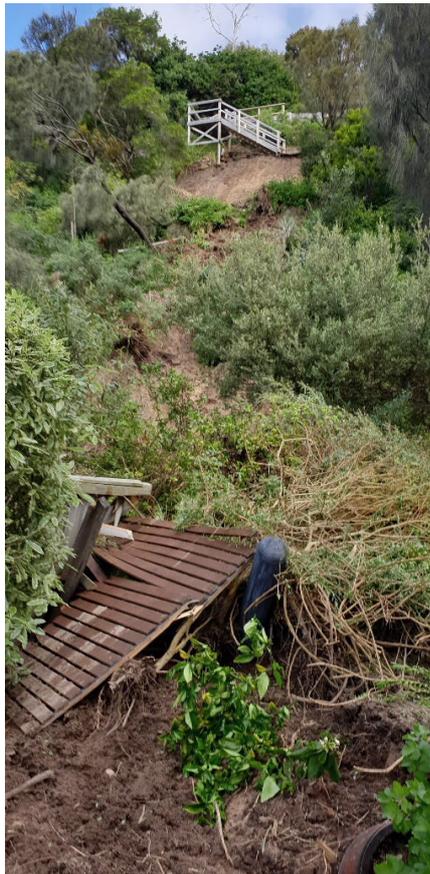
Figure 4-8: Accumulation zone of debris flow and view to top of landslide

Figure 4-7 shows the accumulation zone of the debris flow. It can be seen that the debris flow crossed over Penny Lane, which lies between 10-12 View Point Road and the houses along Pt Nepean Road, and into the rear of two properties.

While a large amount of the upper soils have already flowed down slope, it is considered that there is potential for additional debris flows to initiate in the accumulation zone of the landslide and impact on the area down slope.

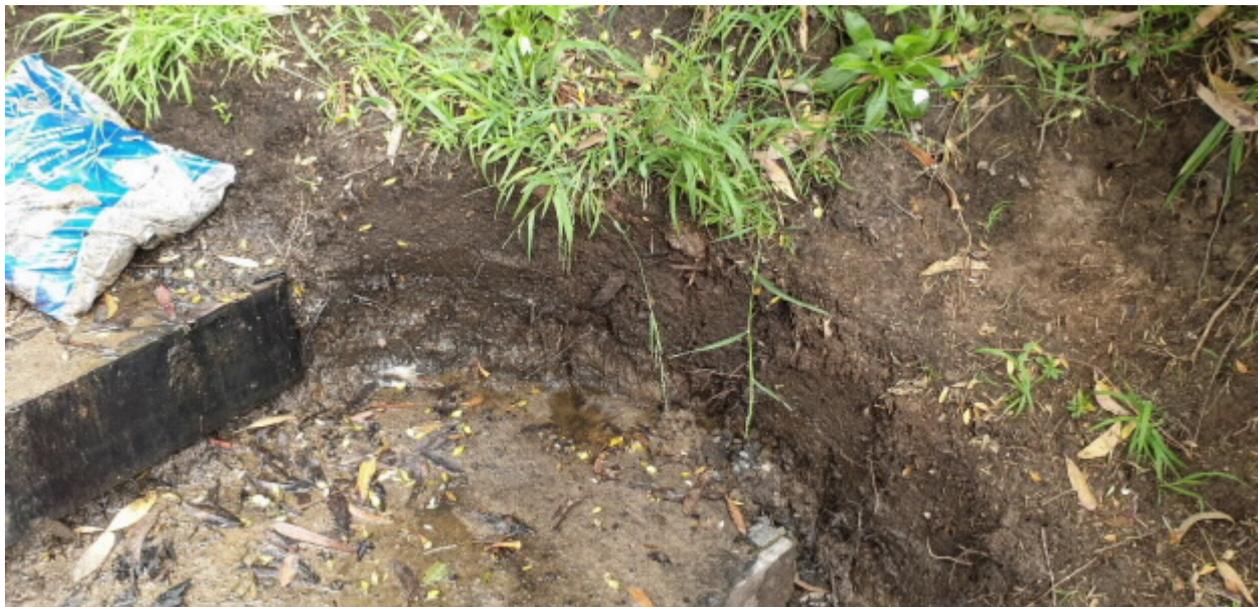
Figure 4-9: Water seepage on left side of site

The conditions on either side of where the debris flow occurred were observed to be significantly different. On the right (western) side the conditions were quite dry and there was no evidence of water seepage. However, on the left (eastern) side there were a number of water seeps observed. These water seeps were observed to be flowing freely more than 24 hours after the heavy rainfall event.

Based on the evidence of tension cracks up slope of this eastern area and that there are significant springs in the area, it is considered that there is potential for a landslide or debris flow to develop within the eastern area especially if there is another heavy rainfall event. However, such a landslide would be unlikely to extend as far east as the property at 2 Penny Lane.

An example of one of the water seeps is shown in Figure 4-8.

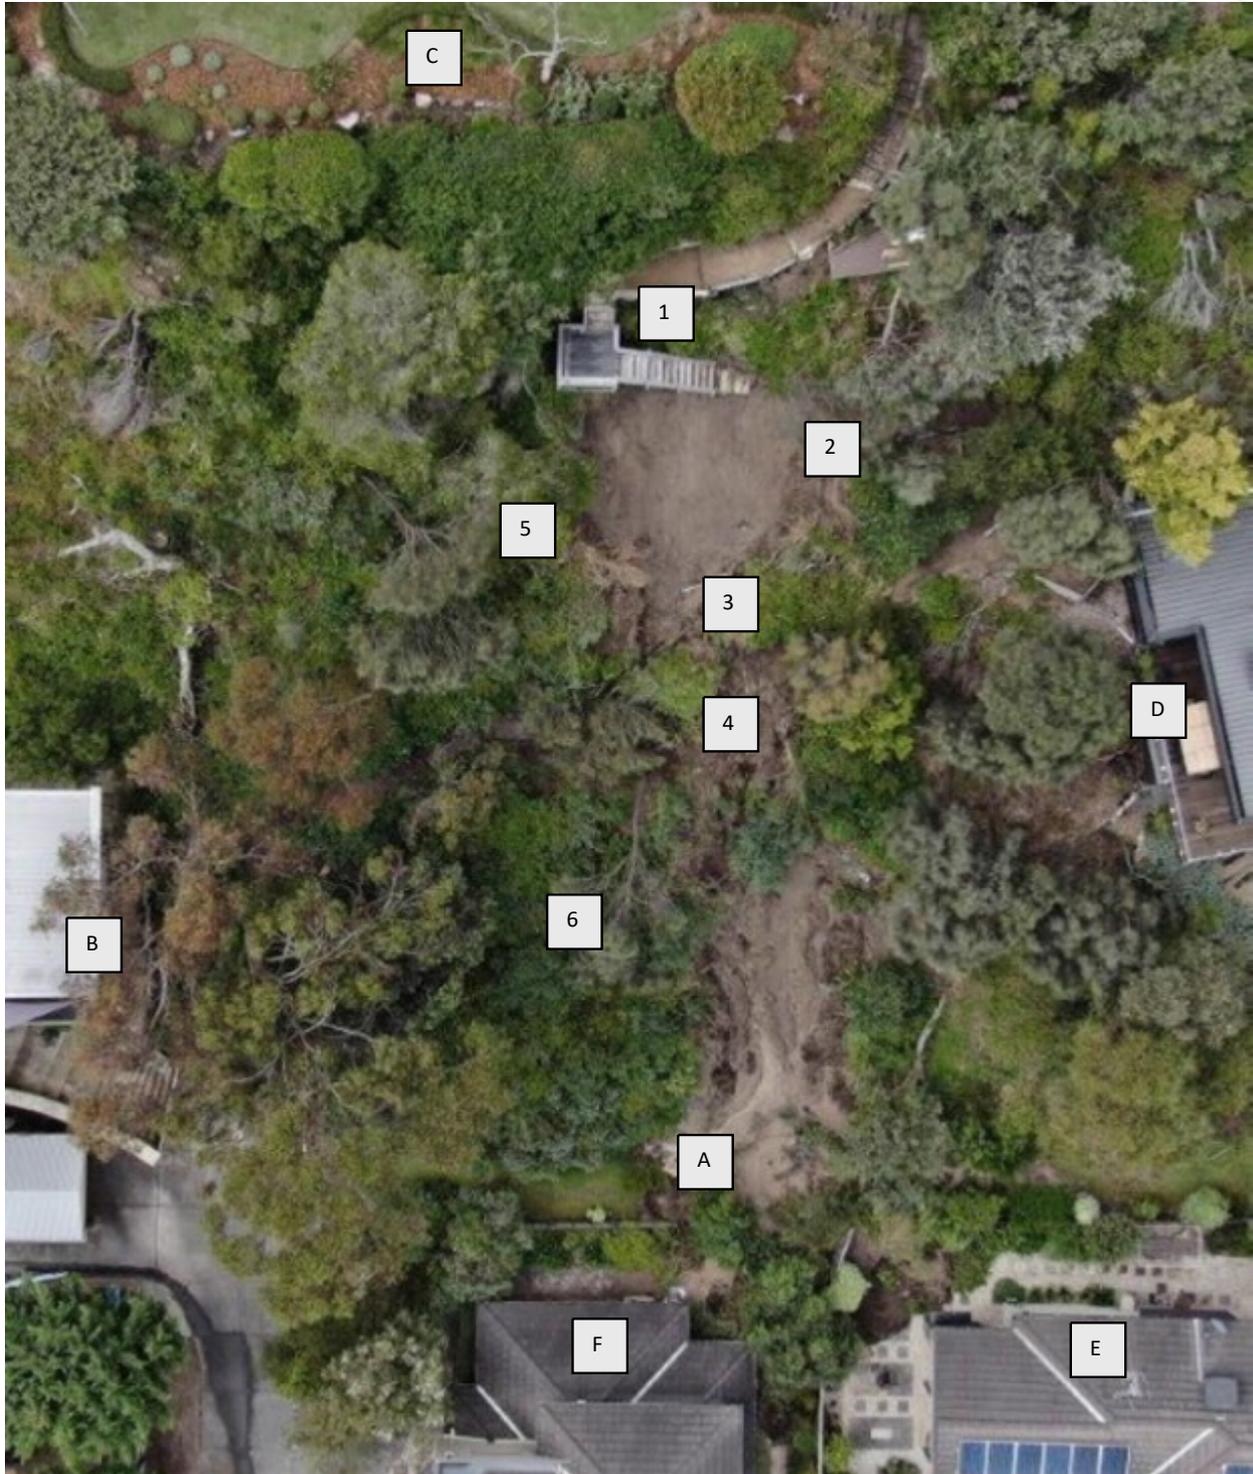
Figure 5-1: Potential Landslide Hazards and Properties at Risk

A number of different potential landslide hazards have been identified for the site. These are identified on Figure 5-1 as numbers 1 to 6 with a description provided below. The properties at risk are shown as letters A to F.

1. Recession of the head scarp of the upper landslide resulting in a translation landslide down slope. It is considered such a landslide would be similar to that which recently occurred on the upper slope such that material would most likely translate to a lower part of the slope but most likely not cross Penny Lane such that it remains within Property C. The landslide would most likely be moderate to rapid. While most likely people in the area would identify the landslide moving and move out of the way, there is potential some people would be impacted.

2. Widening of the landslide on the upper slope to the right of the existing landslide, where the tension cracks are currently located. It is considered such a landslide would be similar to that which recently occurred on the upper slope such that material would most likely translate to a lower part of the slope but most likely not cross Penny Lane. This landslide would predominantly be within Property C but could flow over the eastern edge of Property D. The landslide would most likely be moderate to rapid. While most likely people in the area would identify the landslide moving and move out of the way, there is potential some people would be impacted.

3. Reactivation of the upper landslide debris as a translational landslide. This landslide could occur due to moisture build up within the landslide debris resulting in this material translating down slope. It is considered that there is sufficient material that the landslide could flow into the rear of Property F and potentially Property E. The landslide would most likely be rapid to very rapid and as such people would have difficulty avoiding the landslide if they were engaged in other activities in the area at the time.

4. New debris flow similar that that which previously occurred. Due to the build up of material at the base of the upper landslide there is potential for this material to become saturated, especially if a heavy rainfall event occurred. Should a debris flow occur rather than a translational landslide then the event would be very rapid to extremely rapid and would flow into the rear of Property E and F with similar or greater impact than the recent debris flow.

5. Widening of the landslide on the upper slope to the left of the existing landslide. It is considered such a landslide would be similar to that which recently occurred on the upper slope such that material would most likely translate to a lower part of the slope but most likely not cross Penny Lane. This landslide would predominantly be with within Property D and would be unlikely to extend to Property B. The landslide would most likely be moderate to rapid. While most likely people in the area would identify the landslide moving and move out of the way, there is potential some people would be impacted.

6. Activation of a translational landslide on the lower slope to the left of the existing landslide. This area is very wet and showing some signs of movement. If such a landslide were to occur it could flow across Penny Lane and impact on the dwelling at Property F. It could also potentially flow as wide as the drive way of Property B. The landslide would most likely be rapid to very rapid and as such people would have difficulty avoiding the landslide if they were engaged in other activities in the area at the time.

- A. The Penny Lane Road Reserve
- B. 3 Penny Lane
- C. 10-12 View Point Road (Only considers area to north (rear) of house, house not at risk)
- D. 14-16 View Point Road
- E. 3/613 Pt Nepean Road
- F. 2 Penny Lane

The risk analysis has shown that the Risk to Life for Property B (3 Penny Lane) & Property D (14-16 View Point Lane) in the slope's current condition is Tolerable. As such it is considered that the occupiers of these two properties should be allowed open access to their properties provided they are made aware of good hillside practices as provided in AGS(2007e). A brief discussion was provided on site to the occupiers. However, it is recommended that the Shire provide the AGS(2007e) document for further reference.

The risk analysis has shown that the Risk to Life for Property A (the Penny Lane road reserve) is 'Not Tolerable' in the slope's current condition. The risk for Property A will continue to remain at this level of risk until appropriate remediation works have been conducted to reduce the risk. As such it is recommended that Penny Lane be barricaded off from the driveway of Property D through to the driveway of Property B. Barricading off the site will significantly reduce the temporary probability of people being impacted by the landslide such that the risk can be reduced to a 'Tolerable' level.

The risk analysis has shown that the Risk to Life for Property C (10-12 View Point Road) is 'Not Tolerable' in the slope's current condition. However, the 'Not Tolerable' is considered to only apply to the steep section of the site and the area within 5m of the crest of the slope. The area beyond 5m from the slope at the crest is considered to have a 'Tolerable' risk. As such it is recommended that the area within 5m of the crest of the slope be barricaded off to prevent access to the site. The barricade should extend from one side of the

property to the other and then down the boundaries with the neighbouring properties to Penny Lane. This will reduce the risk to a 'Tolerable' level for the occupiers of Property C provided that they do not enter the barricaded area. In addition, the occupiers should be provided with the AGS(2007e) so that they are aware of appropriate hillside practices. It is important to note that in order to conduct remediation works it will be necessary for workers to enter the affected area. Remediation works should include an appropriate safety plan that outlines methodologies and practices that will be adopted to reduce the risk to workers to an acceptable level as well as minimize the risk to the buildings of Properties E & F during these works.

The risk analysis has shown that the Risk to Life for Properties E (3/613 Pt Nepean Road) and F (3 Penny Lane) is 'Not Tolerable'. Unfortunately barricading off the properties is not considered sufficient to allow people to return. This is because the barricades would not prevent the landslides from occurring and the risk to people even within the houses would not be tolerable. As such it is recommended that the occupants of these two properties are not allowed to return to living in their homes until appropriate rectification works are undertaken. Limited access to the properties may be allowed for the properties to gather belongings etc. provided that it is conducted under the control of a Shire engineer who will need to inspect the site prior to the occupants entering the area and be on site while the occupants are on site.
