# Expert Opinion Report - Landslide Assessment

10-12 View Point Road, McCrae

PSM5226-006R Rev0      11 June 2024

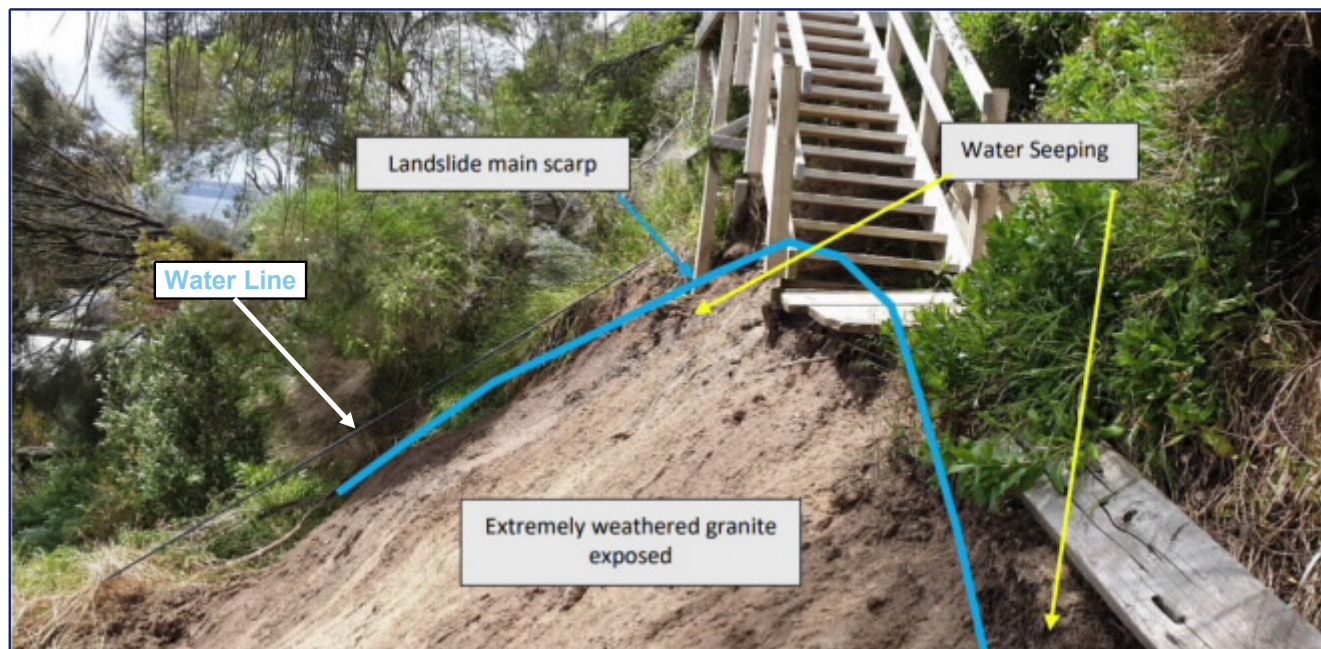
Figure 4-2 shows the main scarp of the landslide where it has undermined the existing stairs. It can be seen that the failure surface of the landslide runs parallel to the ground surface. The weathered granite is exposed in the failure surface. Looking at the side flank it can be seen that the thickness of soil that would have overlain the weathered granite is relatively shallow, possibly less than 0.5m.

Water was observed to be seeping from the head scarp at several locations more than 24 hours after the storm occurred. These seeps appear to be associated with natural springs further up slope.

**Inset 7: Figure 4-2 from the Stantec GA (pdf page 23 of the Brief), I have added my commentary in blue.**

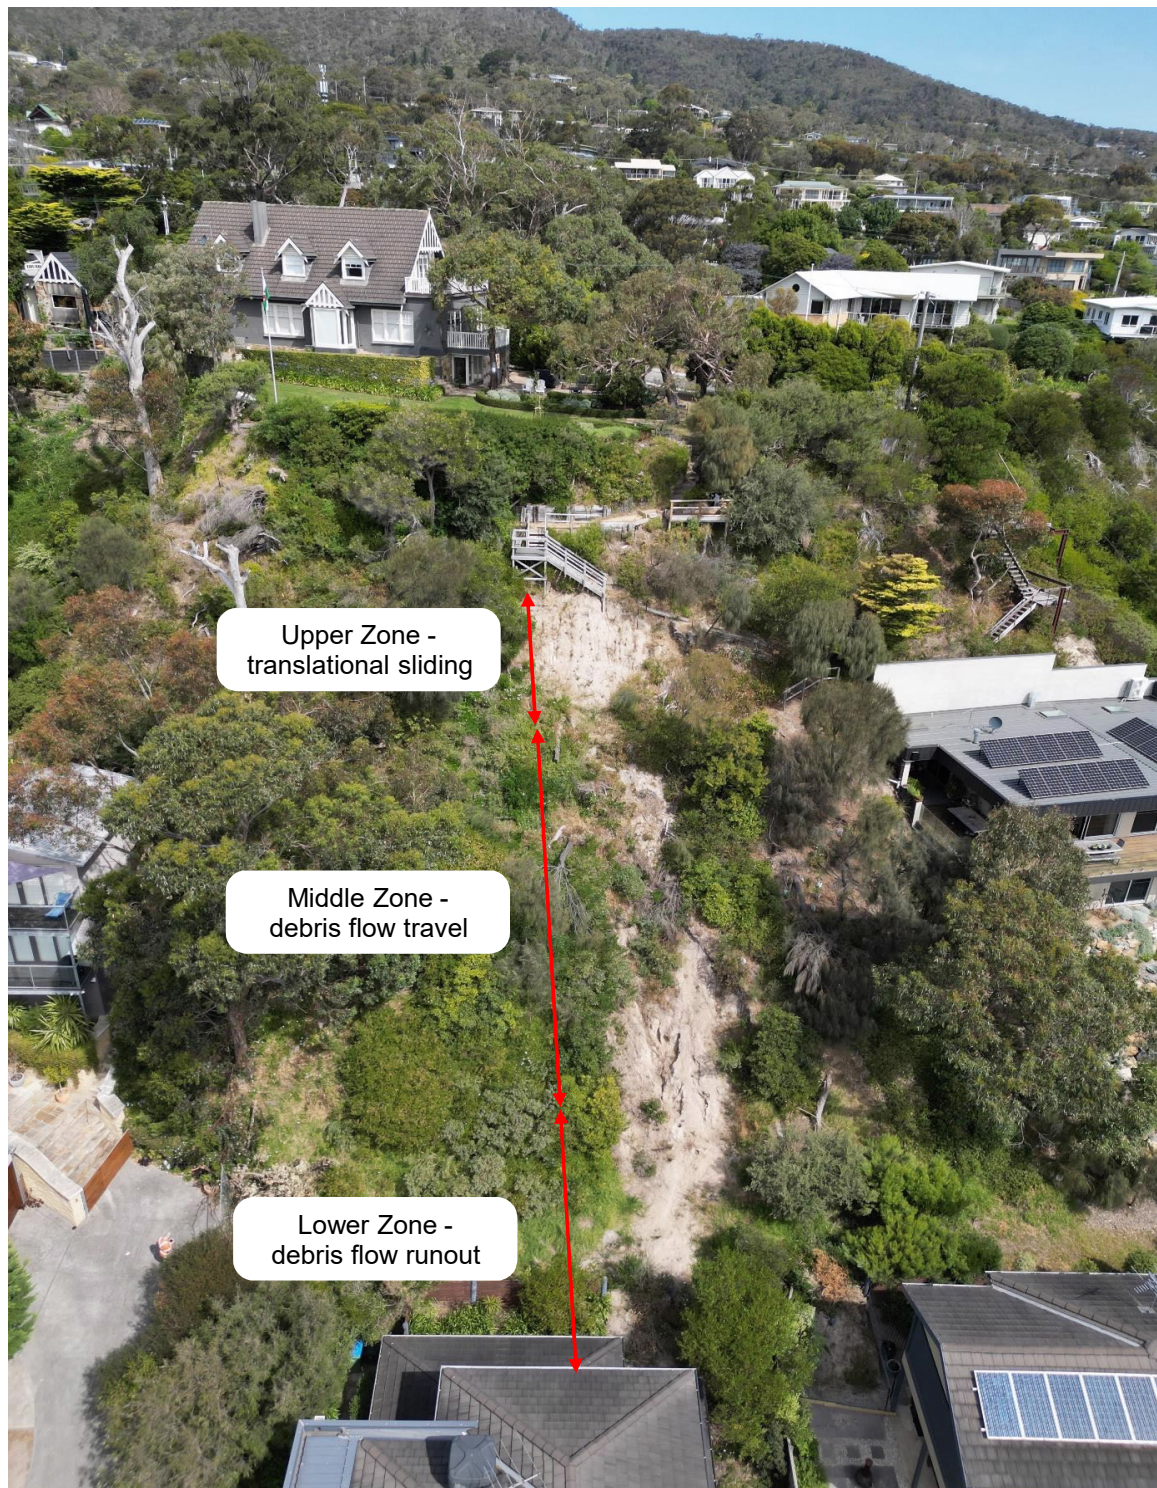
Photo 1 - Landslide Overview, with zones indicated

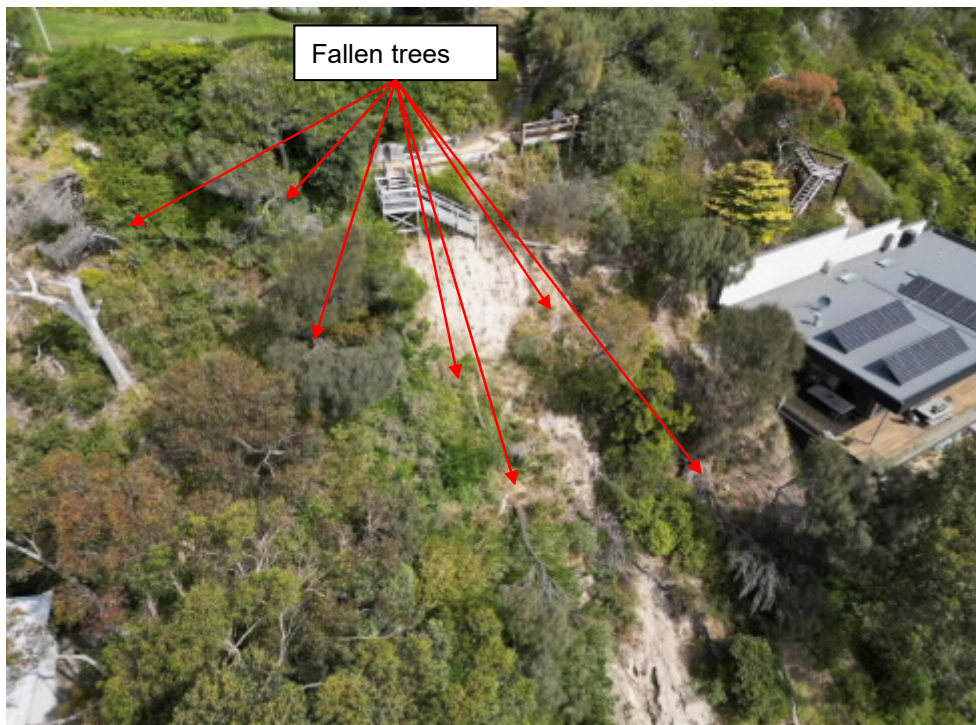
- (h) Numerous fallen trees were observed across the escarpment slope, Photo 11 Appendix E. I note that most of the failed trees appear to have failed from causes unrelated to the Landslide, i.e., wind or poor root embedment. I note at least one tree appears to have fallen because of the Landslide.

Photo 11 - Fallen trees

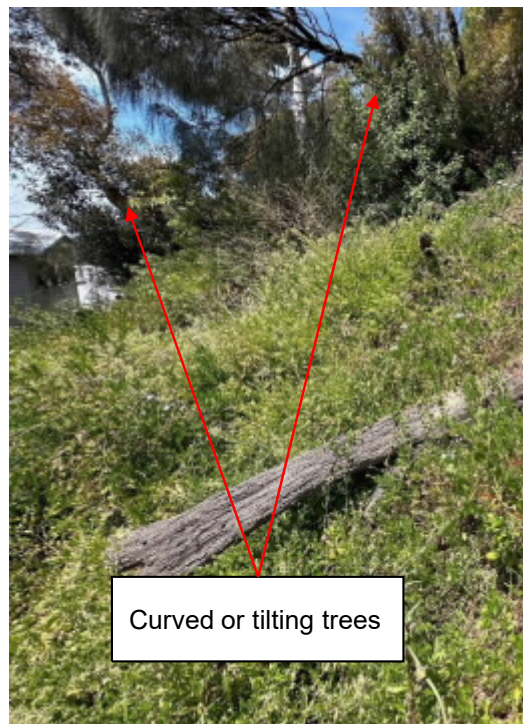
- (j) Leaning and curved trees were observed on the escarpment, suggesting possible creep movement of the slope, Photo 12 Appendix E.
43. Additional observations were made in the broader Site area to understand larger scale slope processes. These observations include:

Photo 12 - Curved or tilting trees

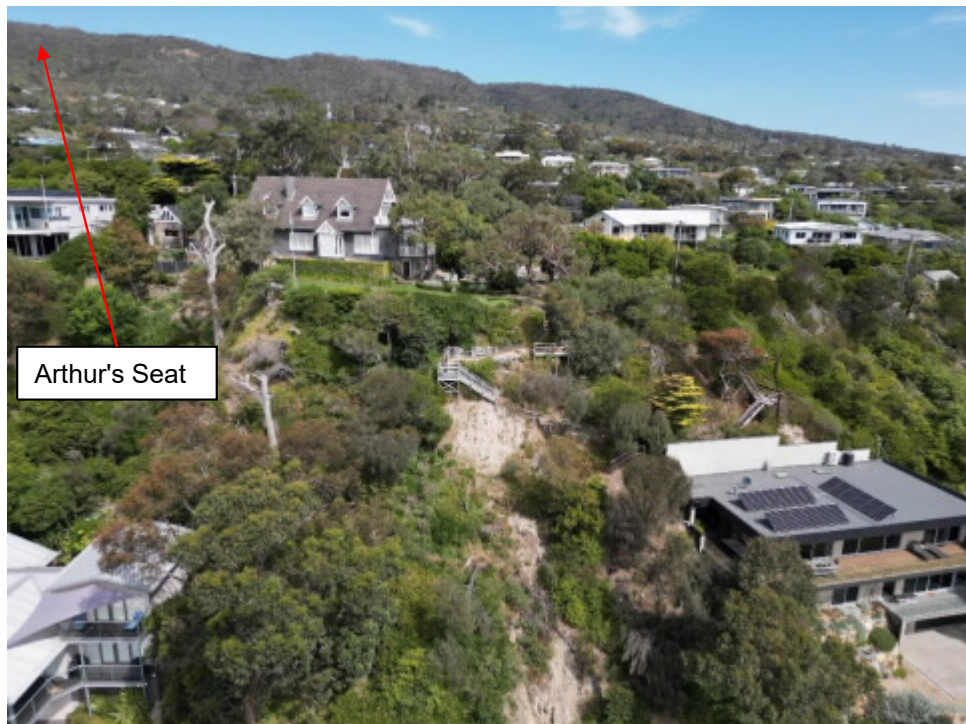
- iii. Granite rock is exposed in shore platform below the road.
    - iv. Steep to sub-vertical upper slopes is inferred to fail by undercutting and erosion of the lower slope leading to toppling/wedge style failures, Photo 15 Appendix E.

Photo 15 - Arthur's Seat in background
