Our Ref: PSM5226-002L

**RE: RISK ASSESSMENT. 10-12 VIEW POINT ROAD, MCRAE**

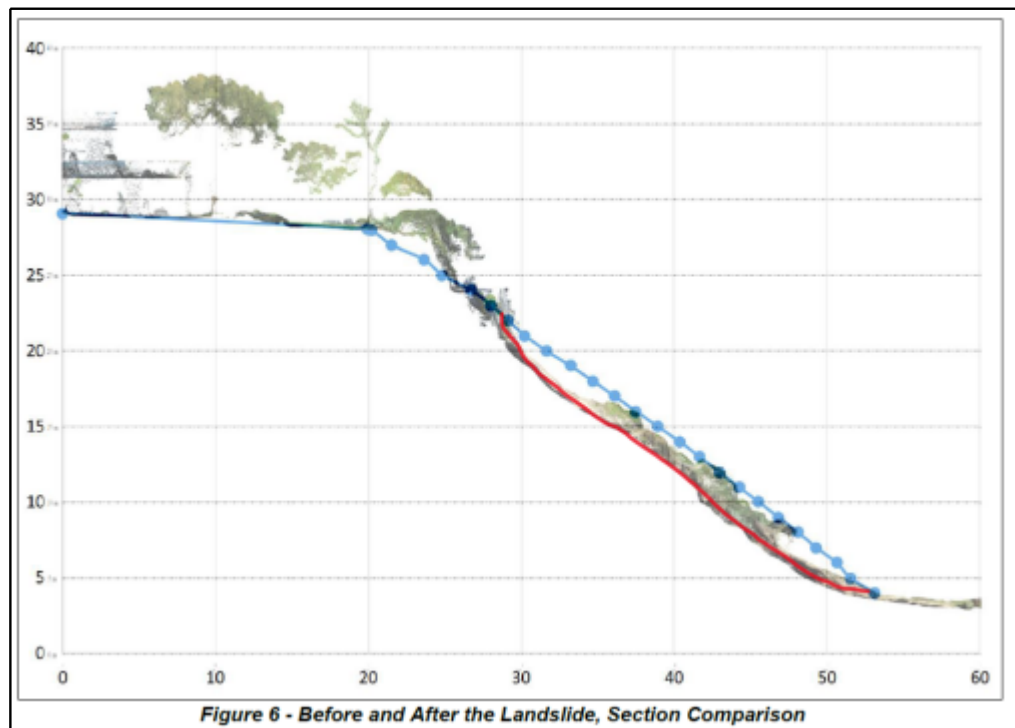
**Inset 1: Excerpt from CivilTest report 1222044-1 Issue 2 (5 December 2022)**

- A cross section from a drone survey, Inset 1.

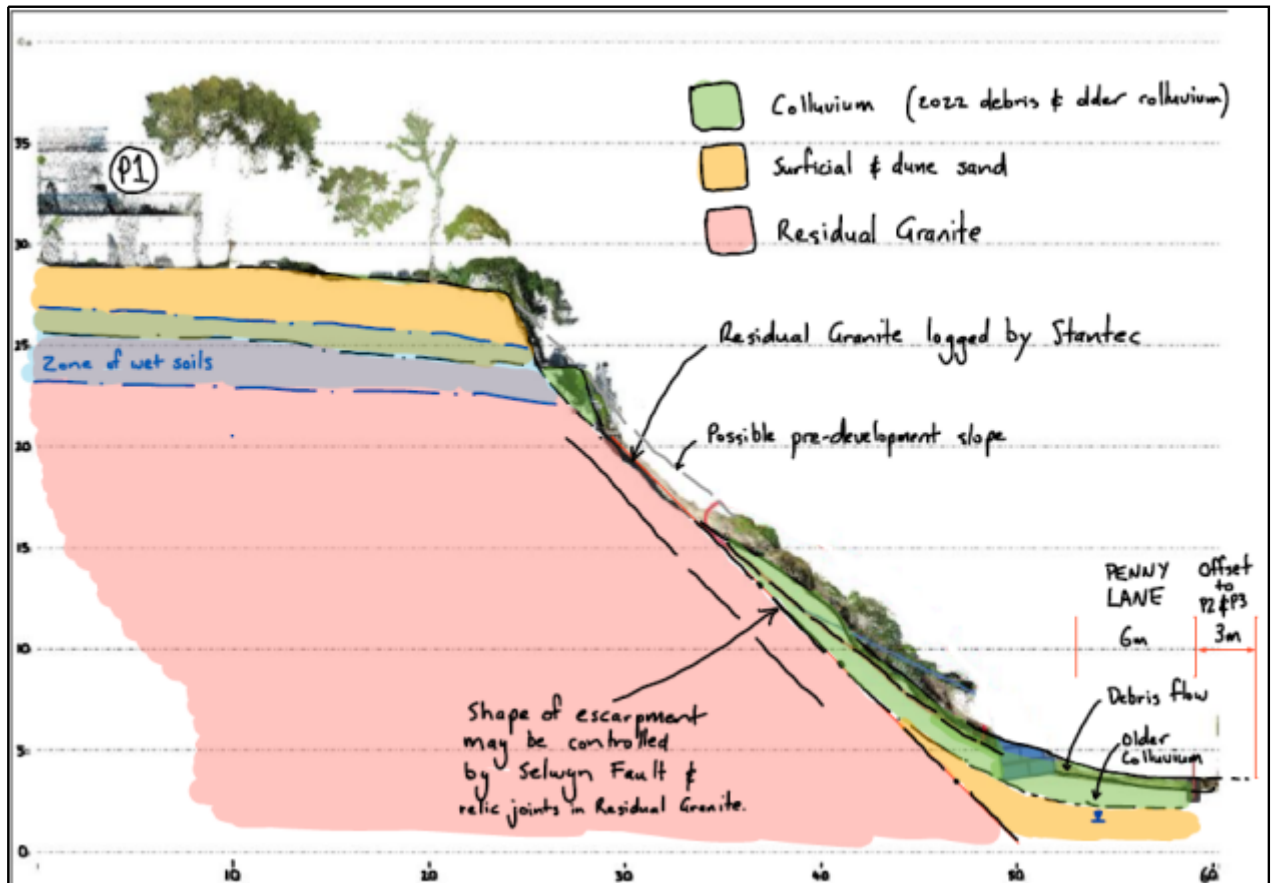
Inset 8: PSM geological model

Our interpretation of the geological conditions is presented in Inset 8. With regards to the geological model PSM notes the following key observations:

- There is uncertainty regarding the contact between the DUNE DEPOSITS and the RESIDUAL GRANITE owing to the likelihood of some of the parent material of the DUNE DEPOSITS being from wind driven erosion of the Dromana Granite. PSM has assumed that the wet soils are an indicator of the contact between the two geotechnical units.
- The laboratory testing indicates that all samples between 3 m and 19 m bgl have very similar Particle Size Distributions, Inset 9, and Atterberg limits indicate low plasticity CLAY fines.

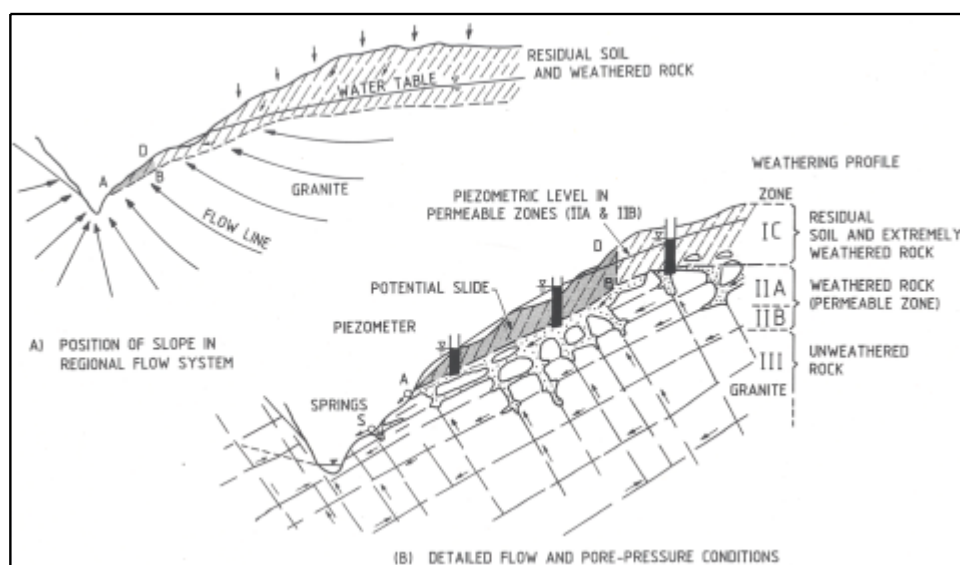
**Inset 10: Possible piezometric conditions in weathered granitic soils (Fell et al, 2004)<sup>1</sup>.**

PSM notes that wet soils were encountered in borehole 3 between 1.8 m and 5.2 m bgl in March 2023 and this was not during or following a period of high rainfall, Section 2.4.1. This observation is consistent with published groundwater models in weathered granitic profiles, Inset 10.

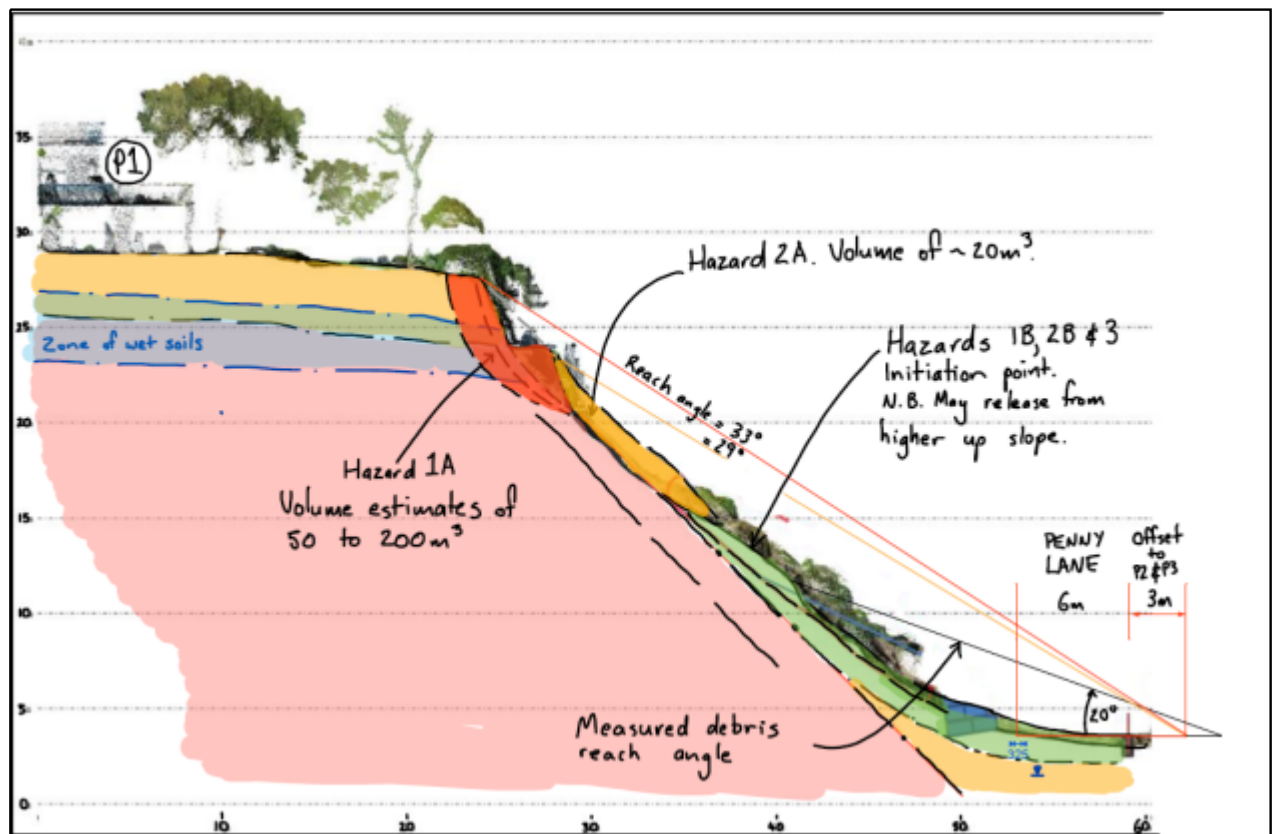
Inset 11: Landslide hazards

Table 3 provides a summary of the modes of failure and hazards. The hazards are presented on Inset 11. The November 2022 landslide had the following characteristics:

- Approximate dimensions of reported translational slide of 8 m wide x 5 m long x 0.5 m deep (parallel to slope).
- Approximate mobile translational slide volume of 20 m<sup>3</sup>.
- Approximate dimensions of reported debris flow of 4 m wide x 12 m long x less than 0.5 m deep (parallel to slope). Volume less than 24m<sup>3</sup>. Note that volume of water accumulated prior to failure is unknown and ignored.
- The reach angle of the debris flow was in the order of 20° from the source point of the debris flow, Figure A6 of Appendix A. This angle is similar to those published by Finlay et al (1999)<sup>(2)</sup> and Mostyn and Sullivan (2002)<sup>3</sup> for washout and liquefaction failures in fills, Inset 12.

- Spatial risks are high (1) when on or below the landslide hazards.
- It is anticipated that regression of the escarpment may impact a zone 2 to 5 m behind the escarpment, Inset 11.

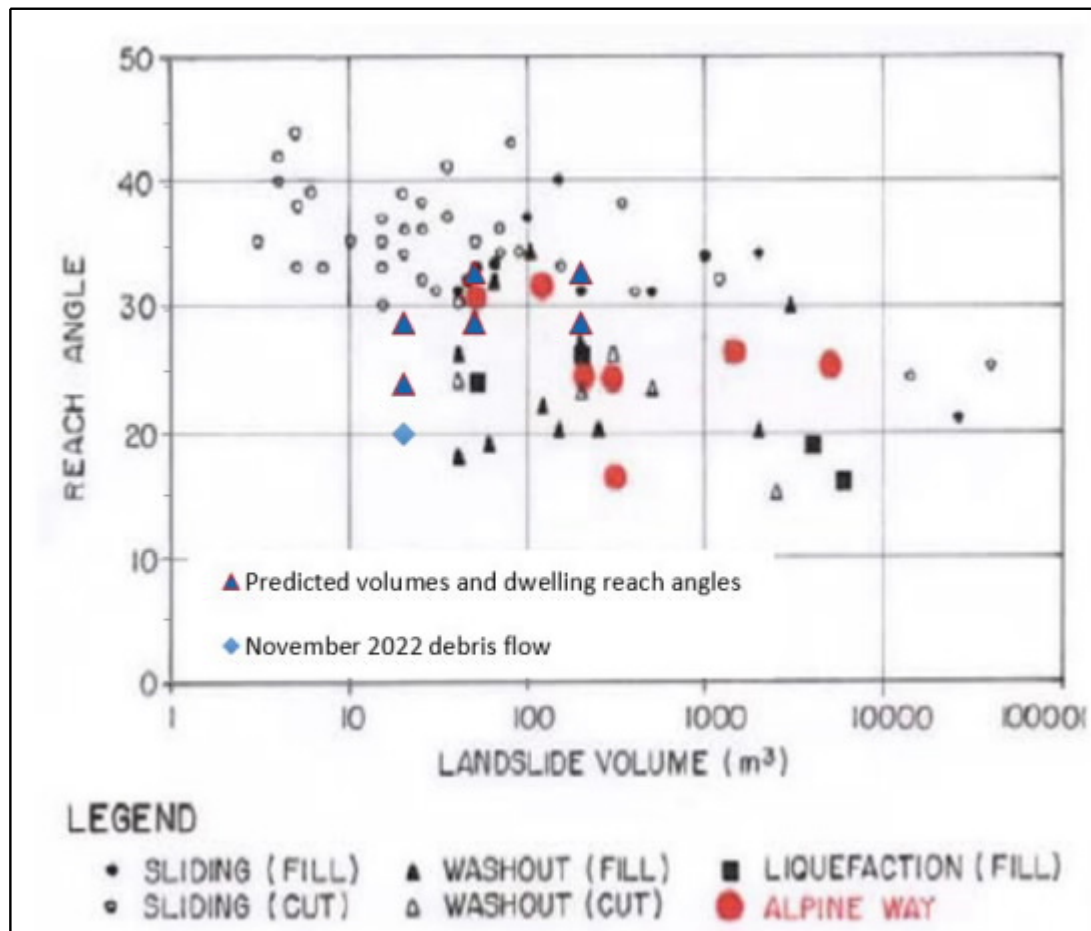
Inset 12: Predicted volumes and measured reach angles to P2 and P3, plotted on Mostyn and Sullivan (2002) landslide data

- Measured reach angles of the November 2022 landslide and those of the downslope dwellings to the respective hazards upslope are presented in Inset 11 and Inset 12.

- The measured reach angle between the hazards and the dwellings generally are between one and two standards deviations of the mean of the published Mostyn and Sullivan (2002) data set, Inset 12 (excluding the debris flow data point).

- Based on the comparison to published data sets and the measured debris flow the adopted  $P_{(S:H)}$  varies from 0.1 to 1.0.
- The debris flow run out angle was measured as 20° which exceeds the adopted hazard reach angle of 24° of the proposed debris flow hazards. The  $P_{(S:H)}$  for these scenarios is 1.

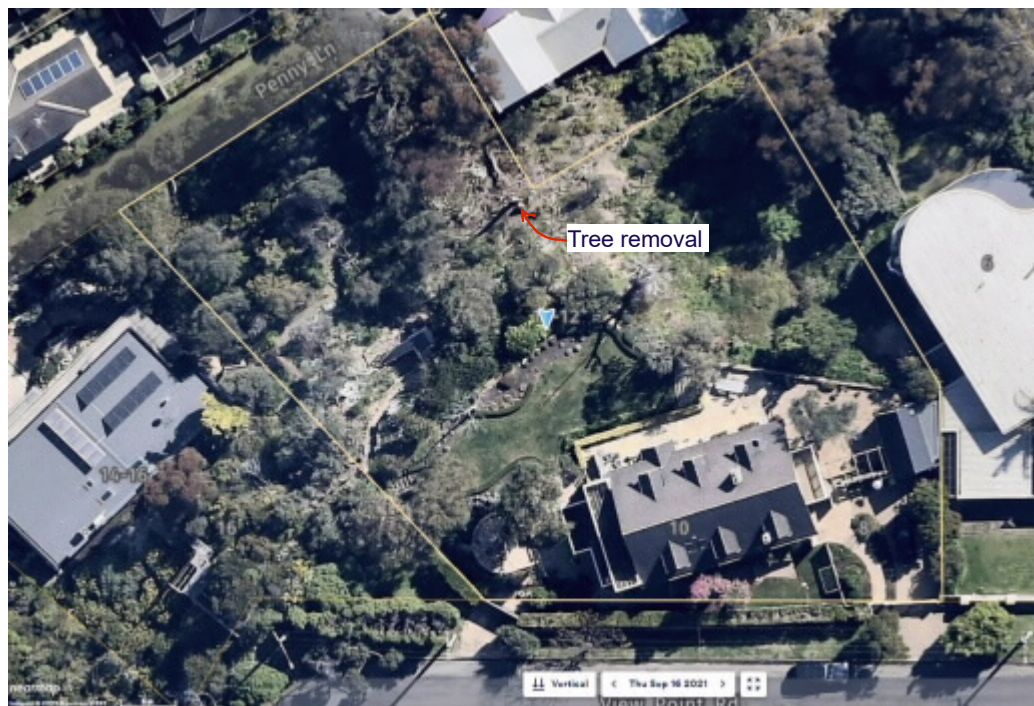
- A series of trees were removed on property P1 between April 2021 and September 2021, Appendix A1. This is supported by street view images between February 2018 and October 2022, Appendix A2.
- The translational slide scarp has approximate dimensions of 8 m x 5 m, Appendix A3.
- The debris flow:
  - Initiated from an area approximately 12m southeast of the property P1 northwestern boundary and was approximately 4 m wide.
  - Run out was approximately 5 m into properties P2 and P3, Appendix A3.

PSM notes that tree removal is a significant conditional event that has occurred at the Site and suction will change in the escarpment slopes over a period of 12 months to 5 years from tree removal (Richards, 1983)<sup>4</sup>. Trees have been removed in 2021 and further vegetation has been removed by the landslide. In PSM's experience it is common in Victoria for surficial soil landslides to follow tree/vegetation removal (either by fire, storm or physical removal).

Tree removal

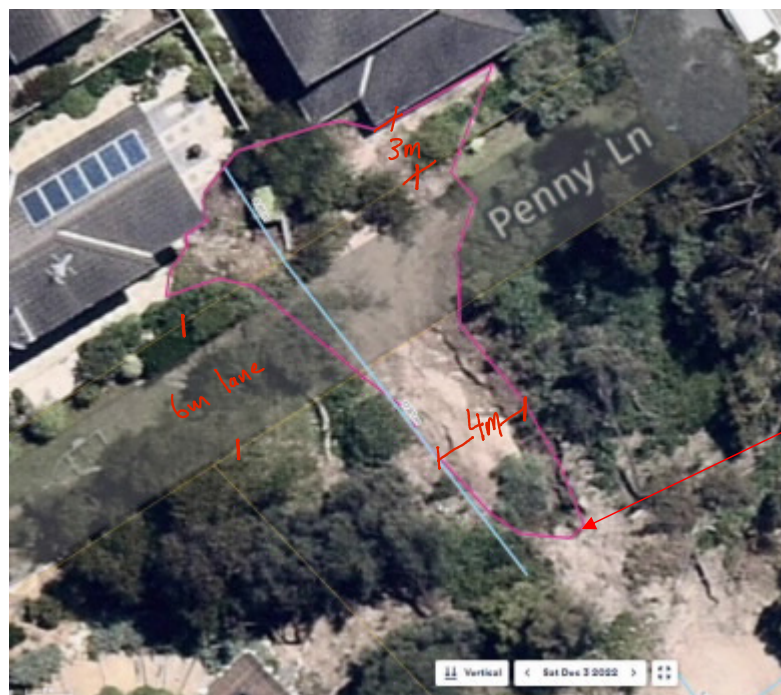
Figure A6: Nearmap 3/12/2022 approximate run out distances
