# Expert Opinion Report - Rectification

10-12 View Point Road, McCrae

PSM5226-005R 11 June 2024

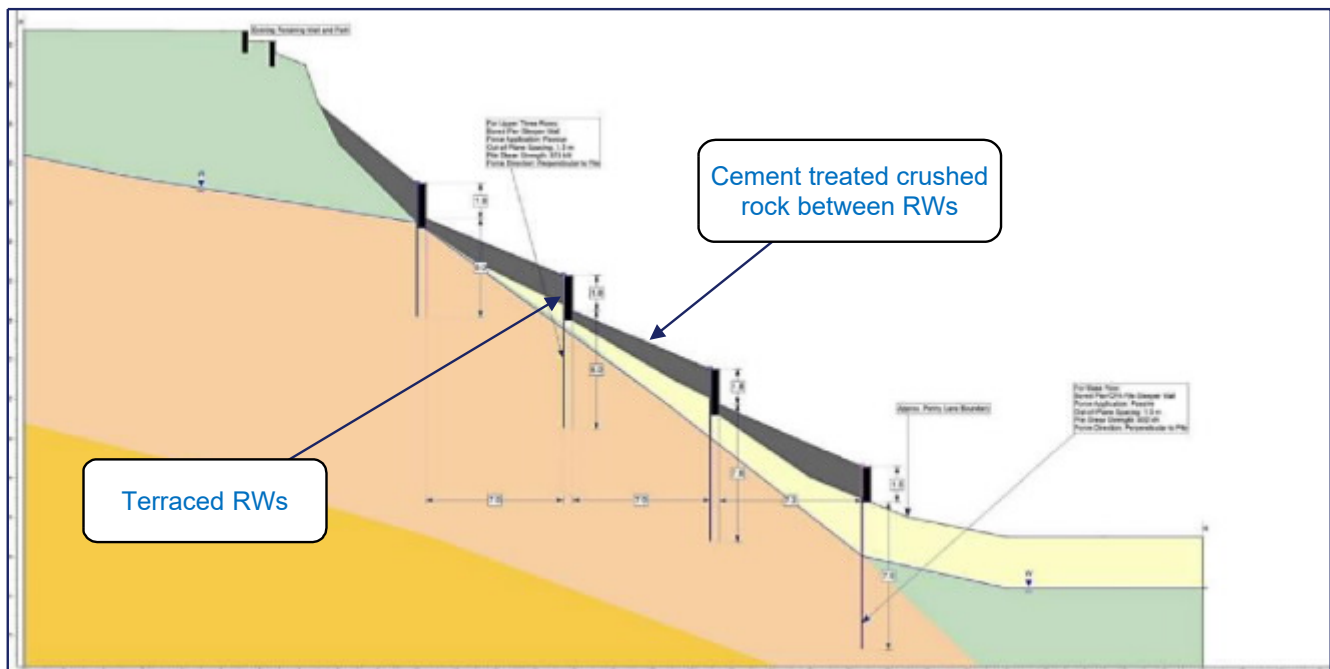
**Inset 4:** CivilTest section with proposed RW remediation (Document 12, pdf page 29). I have added my commentary in blue.

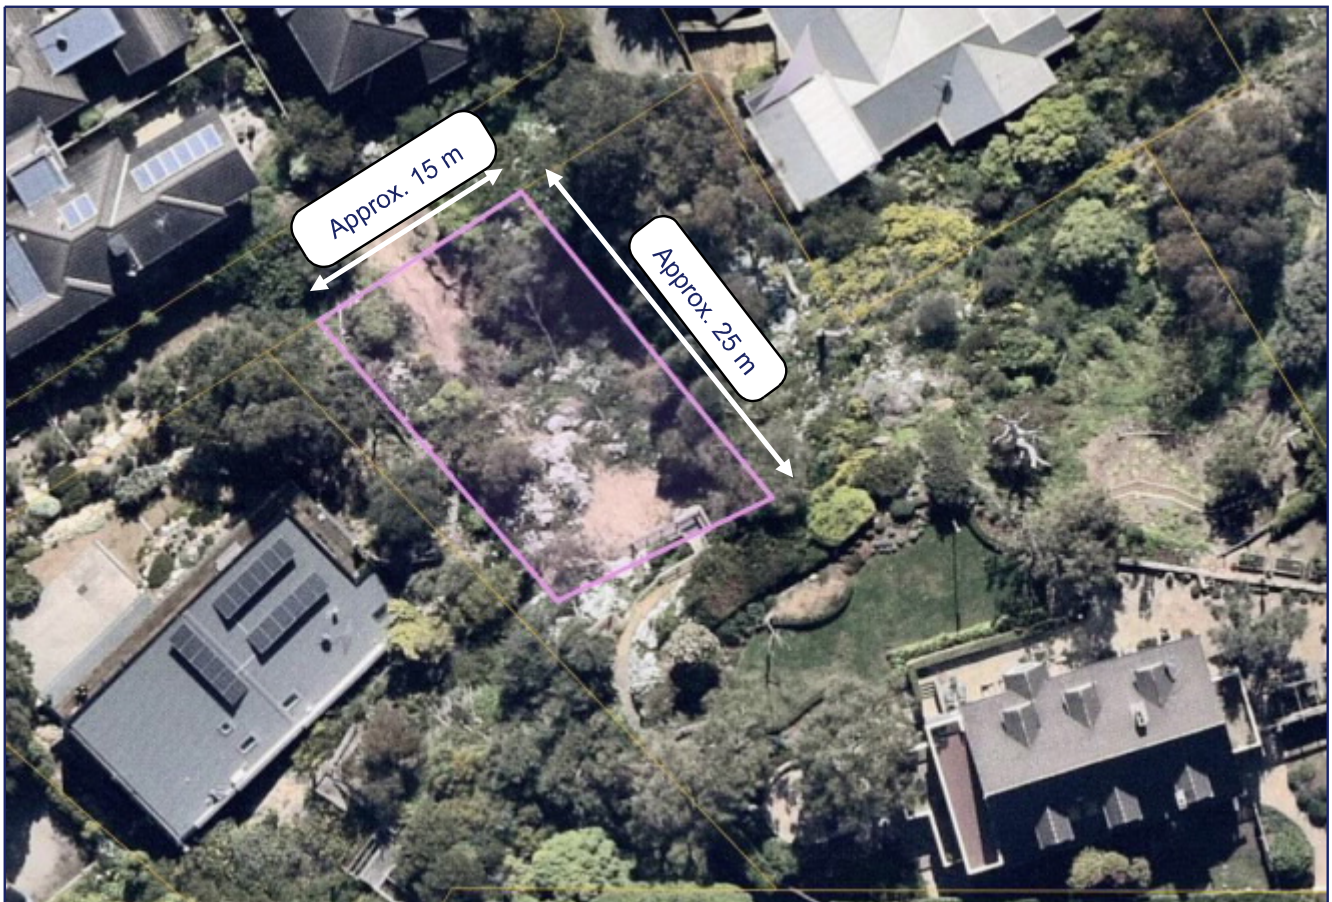
74. The approximate extent of rectification required is shown in Inset 16. The approximate extents in plan are 15 m wide by 25 m long with 370 m<sup>2</sup> of total area (in plan) to be rectified. I note that the angle of the slope will mean that the actual ground surface area to be rectified is approximately 480 m<sup>2</sup>.
75. The indicated area of rectification extends beyond the observed boundaries of the Landslide to provide stability to the flanks, and to allow for possible uncertainty in the extent of unstable ground (refer to paragraph [26(e)]).

**Inset 16:** Indicative extent of rectification shown in pink (Aerial image from Nearmap)

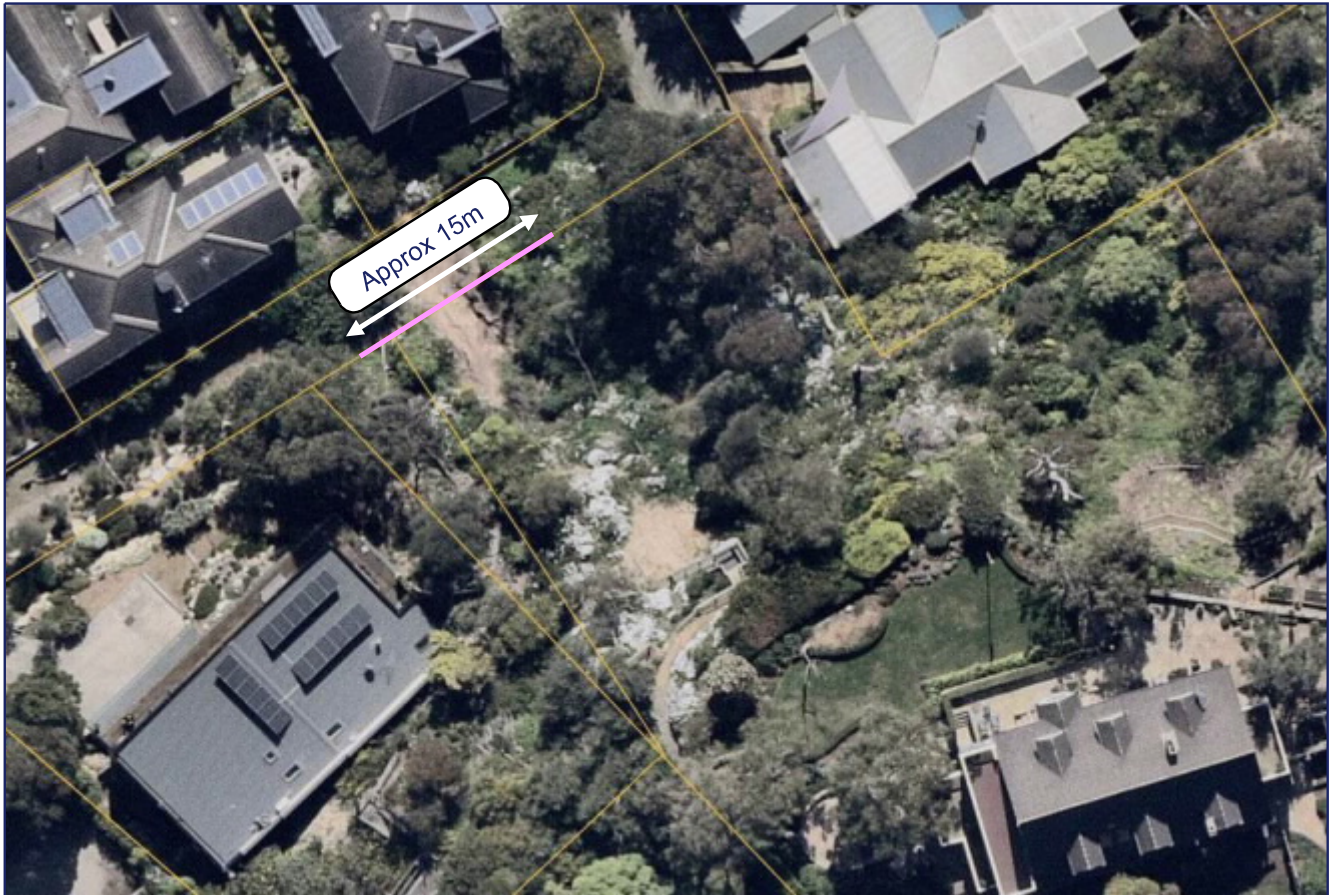
83. In my opinion the STS does not reduce risk to life and property for Property P1. As per paragraph [82], a debris fence does not prevent a landslide from occurring, therefore in my opinion landslides may still occur on Property P1. In my opinion a residual risk assessment post clean-up of Landslide and for:
- (a) A pedestrian on the slopes of P1 is likely to indicate an unacceptable risk to life for future landslide events as no controls have been introduced to control repeat landslides.
  - (b) The dwelling at P1 is likely to indicate a tolerable risk to the dwelling and occupants within the dwelling with risks unchanged owing to the offset to the Landslide.

**Inset 17: Assumed extent of debris fence shown in pink (Aerial image from Nearmap)**

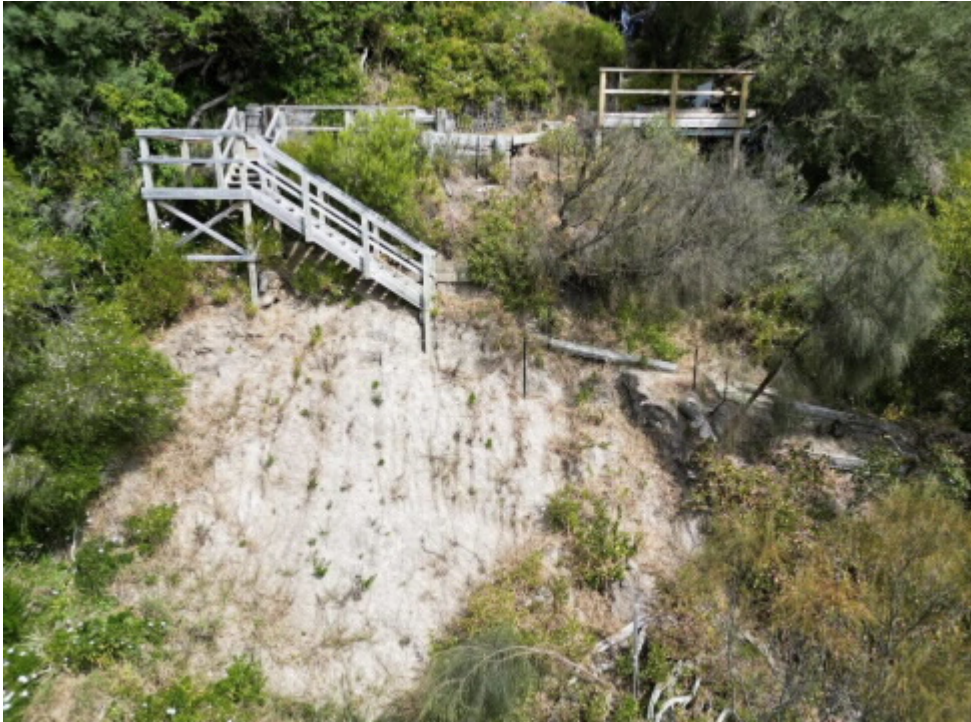
Photo 1 - Upper translational sliding area

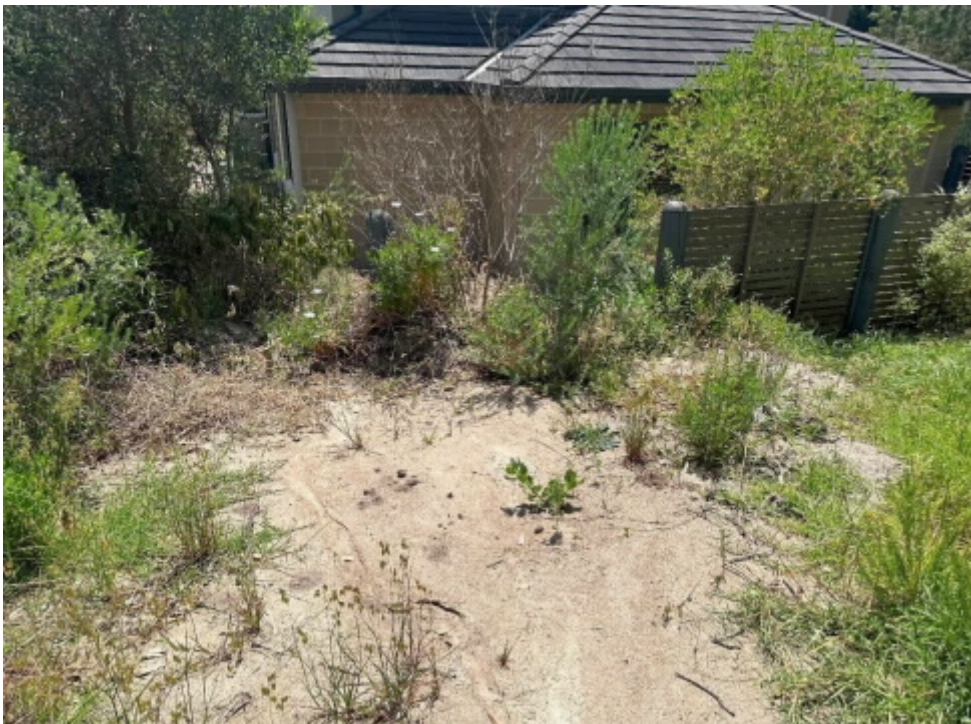
- (b) It was inferred to have initiated as a translational slide followed by mobilisation of failed material into a debris flow which was deposited at the toe of the slope, Photo 2 Appendix C.

Photo 2 - Debris flow runout area, Property P2 visible in background

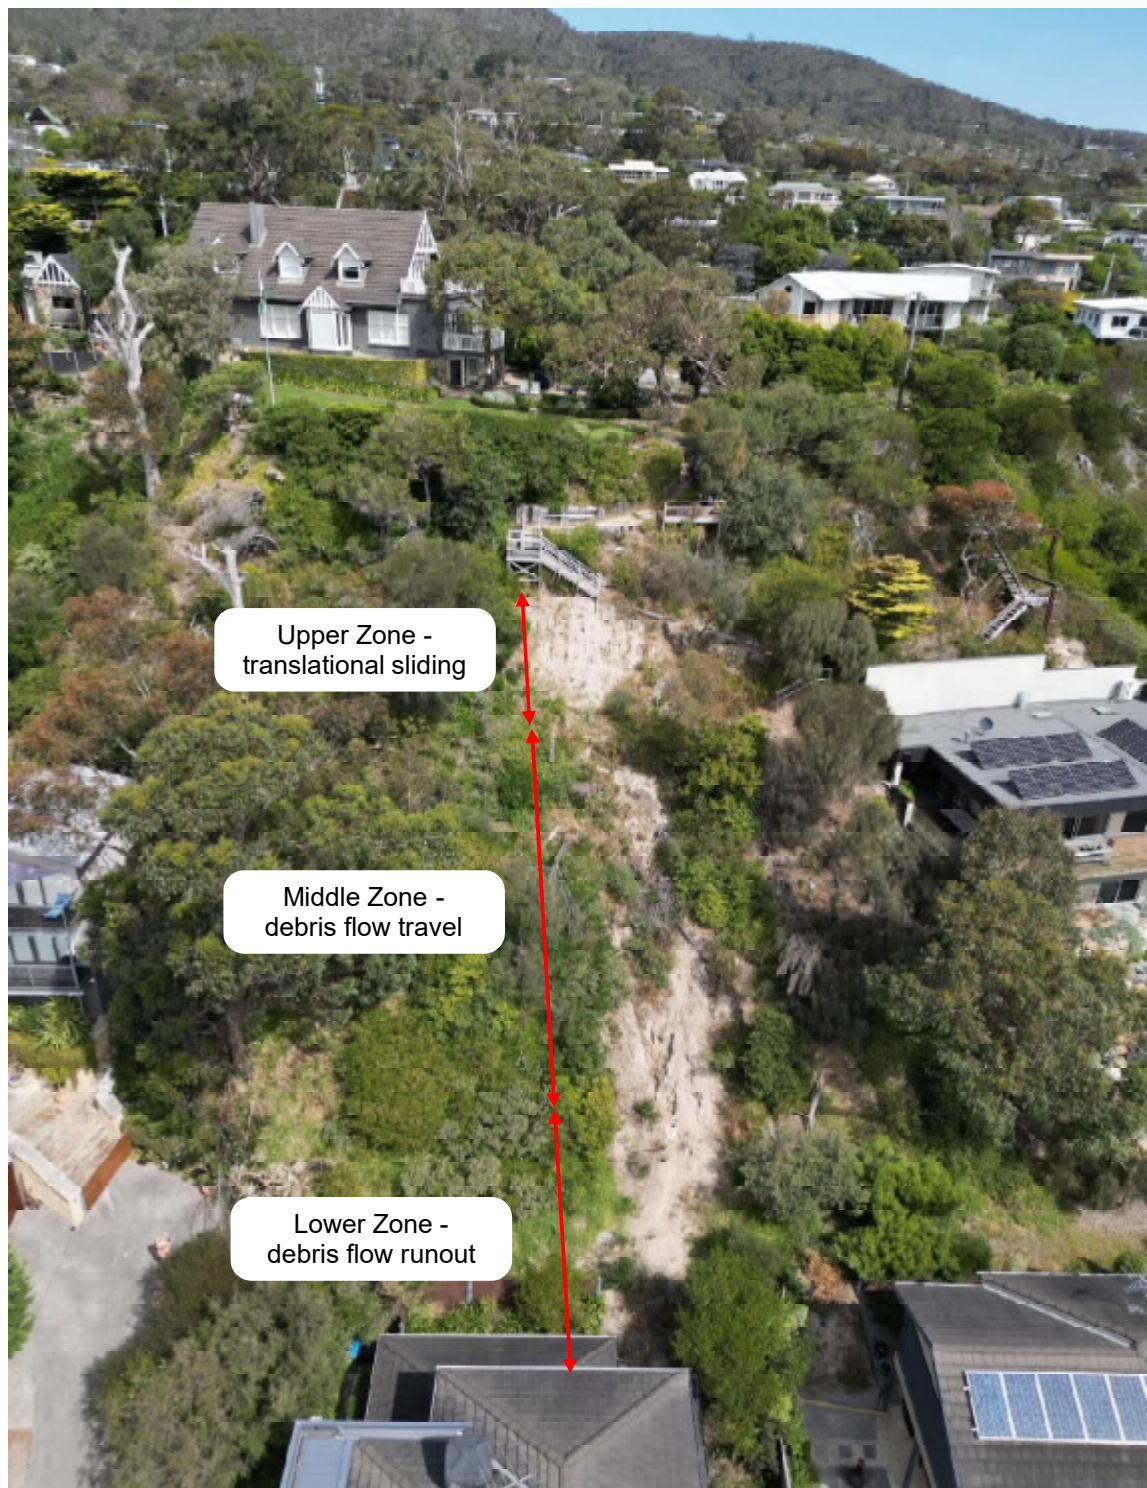
Photo 3 - Landslide Overview, with zones indicated

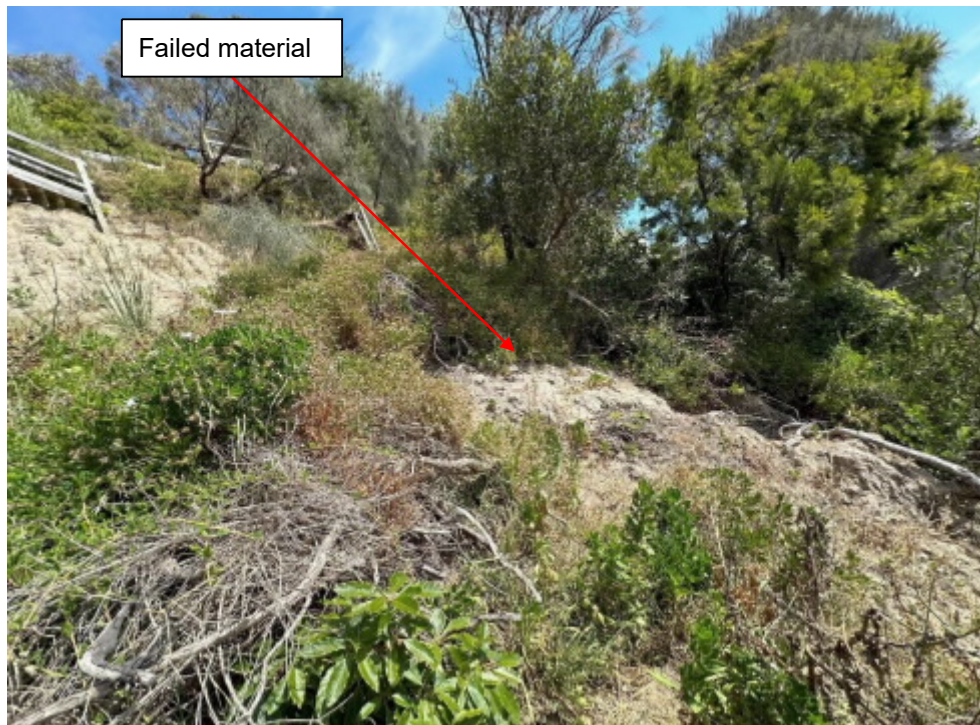
- (d) Disturbed ground that had undergone translational sliding but did not mobilise into a debris flow was observed on the right (western) flank of the Landslide, Photo 4 Appendix C.

Photo 4 - Failed material still on slope

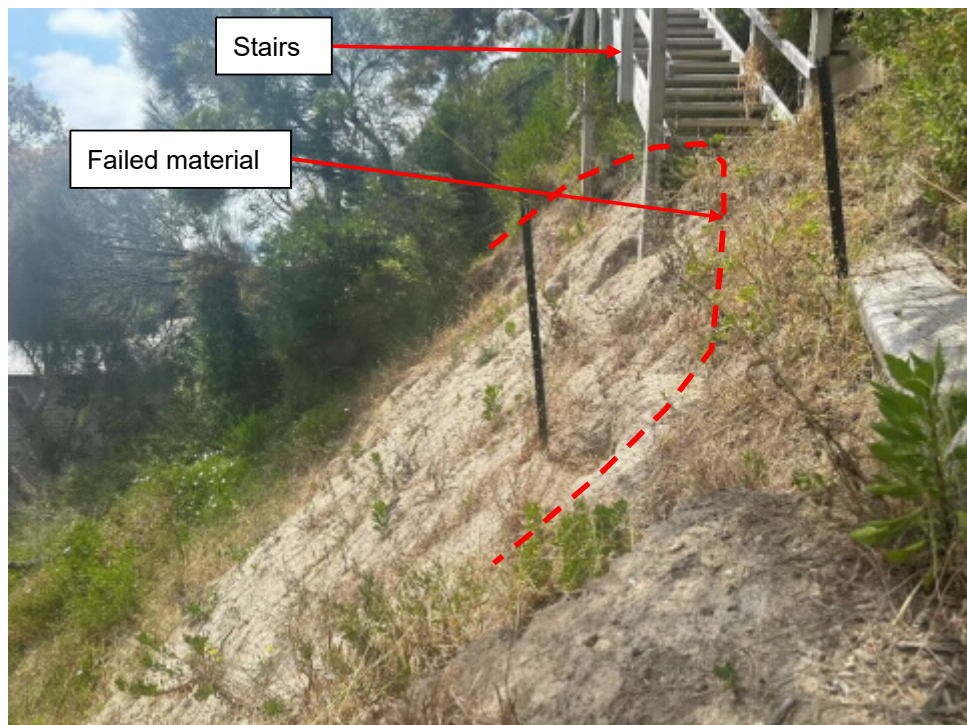
- (f) A lack of prominent backscarp, Photo 5 Appendix C, with minor steepening observed in the backscarp area and with a slope angle of approximately 45 degrees.

Photo 5 - Rear scarp of landslide, note lack of oversteepened backscarp

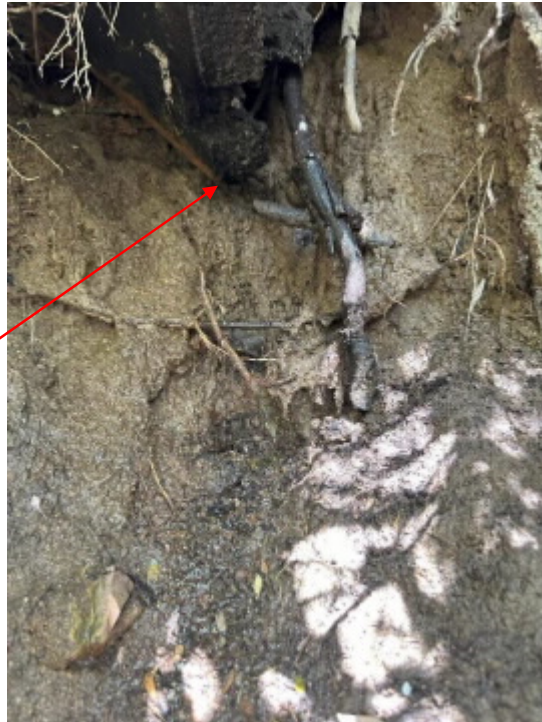
Photo 6 - Groundwater seepage

- (c) Groundwater was observed to be seeping from the slope to the east of the stairs, Photo 6 Appendix C
  - (d) A variety of water infrastructure was observed across the site, Photo 7 Appendix C including:

Groundwater seeping from slope

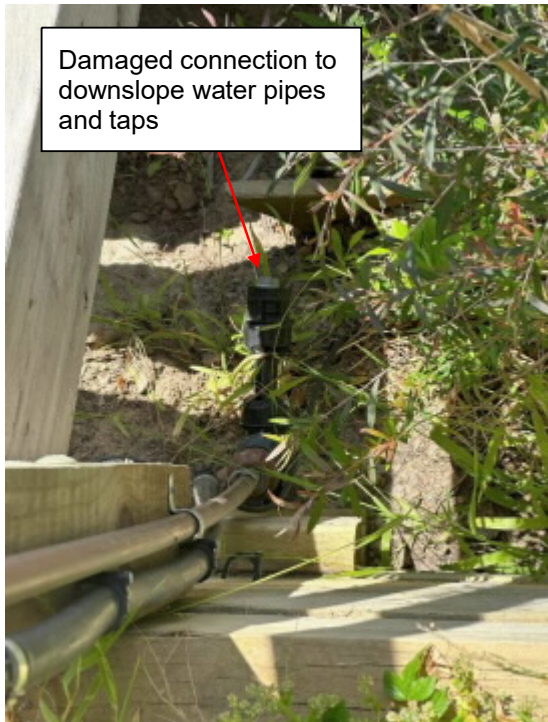
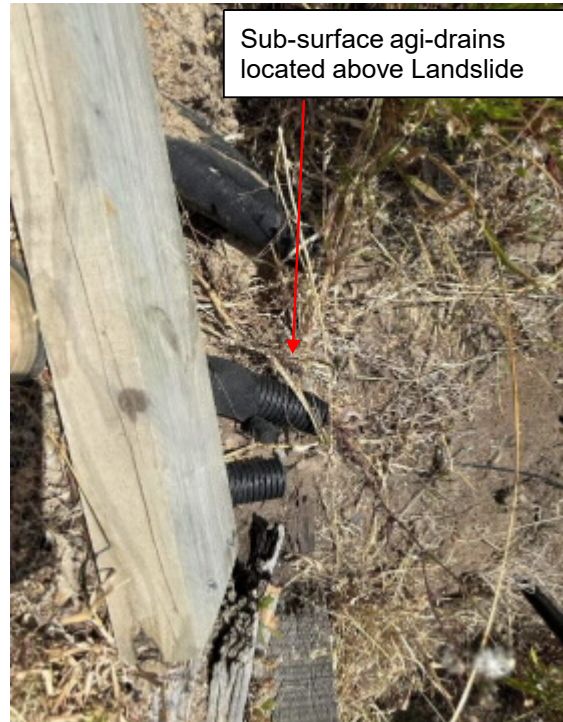
Photo 7 - Water infrastructure including water pipes (on left), and subsurface 'agi drains' (on right)

Damaged connection to downslope water pipes and taps

Sub-surface agi-drains located above Landslide

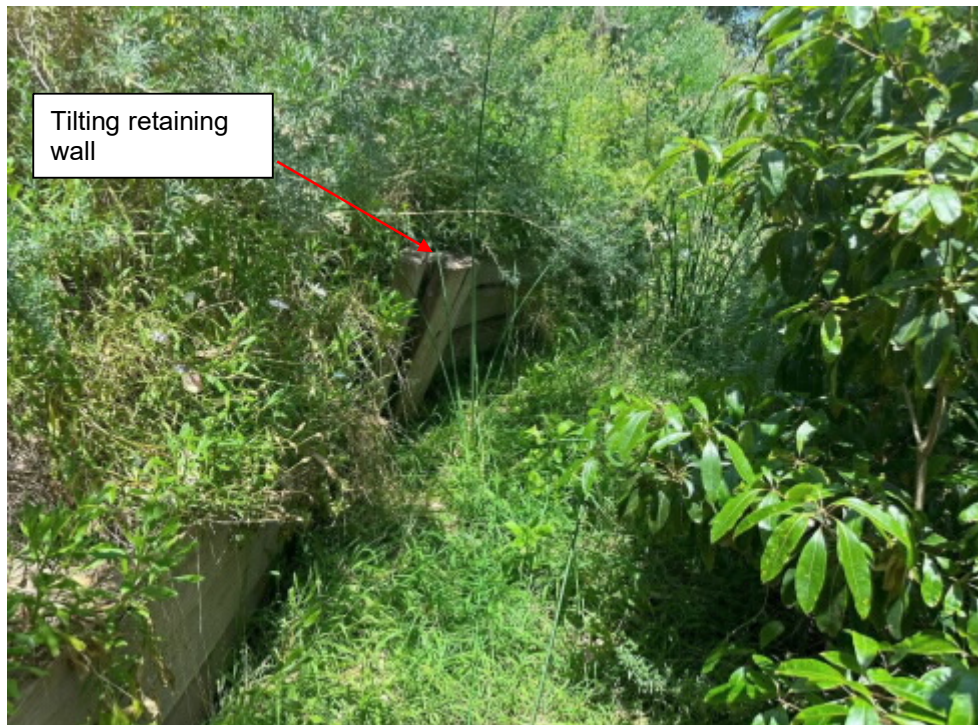
- (g) The condition of RWs across the Site was generally poor, with overturning and bulging RWs observed. A section of RW to the east of the Landslide had significant tilts. This indicates to me possible instability in the ground above the RW and possible structural or geotechnical failure of the RW, Photo 10 Appendix C.

Photo 10 - Tilting retaining walls on left side of Landslide

- (b) The stability of the Surficial Sand slopes above the existing stairs at the crest of the Landslide is excluded, as this is controlled by the performance of P1 RWs. Where the RWs are showing signs of failure, the owner of P1 should address this separately.

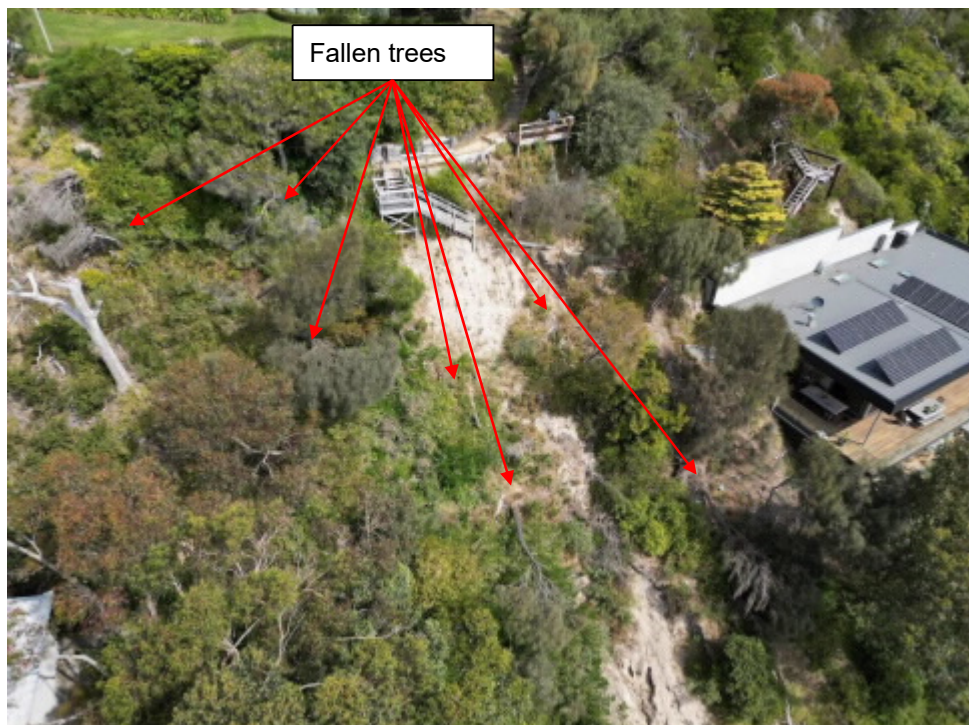
- (h) Numerous fallen trees were observed across the escarpment slope, Photo 11 Appendix C. I note that most of the failed trees appear to have failed from causes unrelated to the Landslide, i.e., wind or poor root embedment. I note at least one tree appears to have fallen because of the Landslide.

Photo 11 - Fallen trees

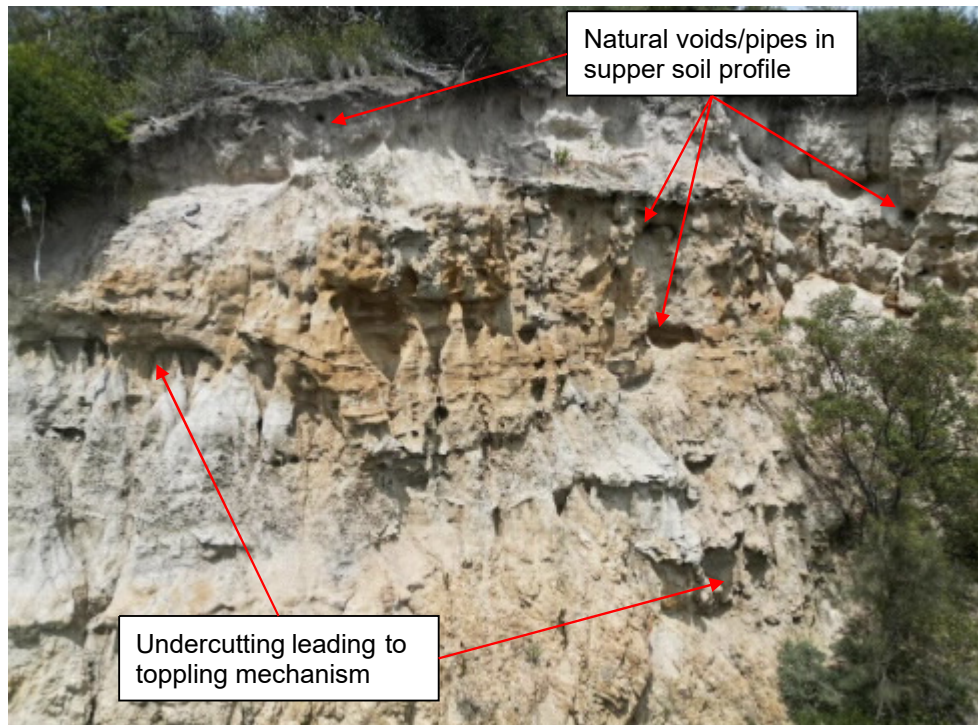
- iii. Granite rock is exposed in shore platform below the road.
    - iv. Steep to sub-vertical upper slopes are inferred to fail by undercutting and erosion of the lower slope leading to toppling style failures, Photo 12 Appendix C.

Photo 12 - Natural cliff profile near Anthony's Nose
