Expert Opinion Report - Rectification

10-12 View Point Road, McCrae

PSM5226-005R 11 June 2024

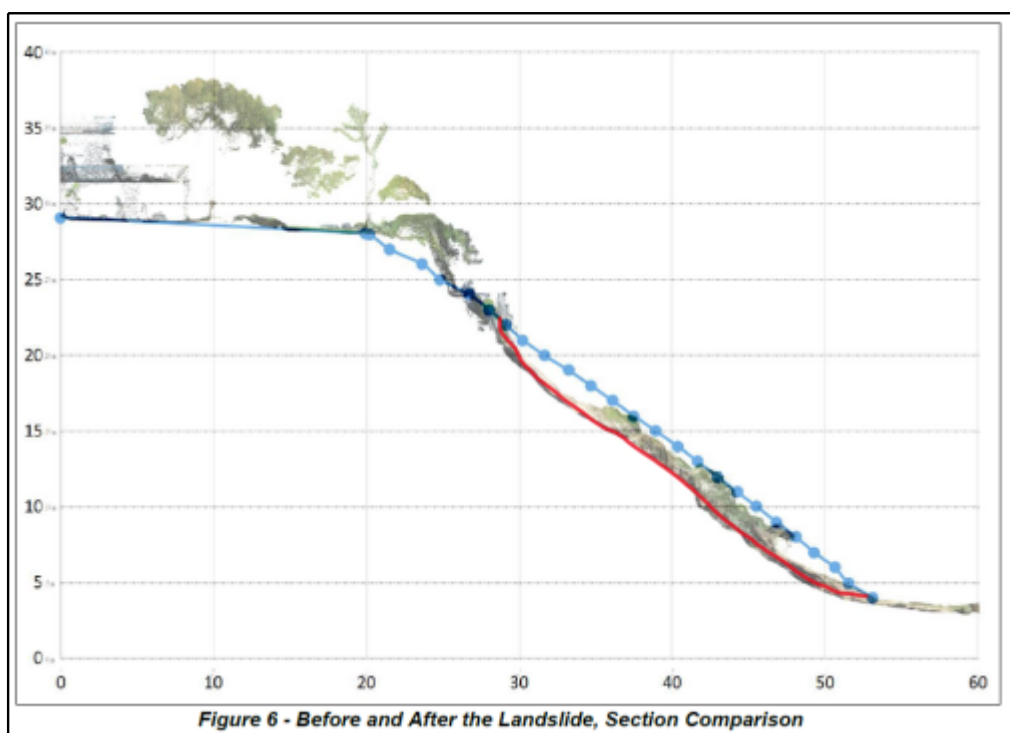
Inset 2: Excerpt from CivilTest report 1222044-1 Issue 2 (5 December 2022) (Document 2, pdf page 4)

- (c) The typical and maximum observed thickness of the Landslide was 0.3 m and 0.5 m respectively. The comparison between the CivilTest drone and feature survey, Inset 2, overestimates the thickness of the Landslide by as much as 1.5 m.

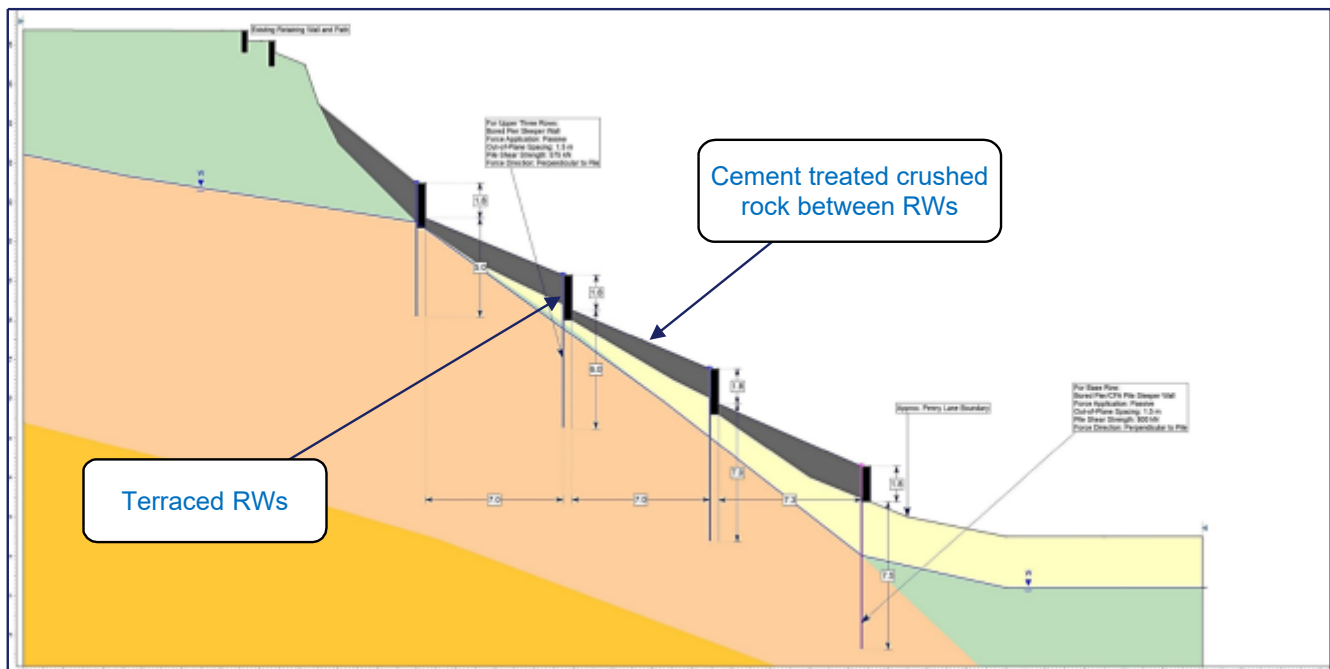
Inset 4: CivilTest section with proposed RW remediation (Document 12, pdf page 29). I have added my commentary in blue.

- ii. Cement treated crushed rock (CTCR) placed between retaining walls with a maximum 22 degree slope angle.
 - iii. *“Loose colluvium/landslip material should be removed from the slope”.*

- (b) Appendix E (pdf page 29) illustrates the proposed remedial works in section view, Inset 4.

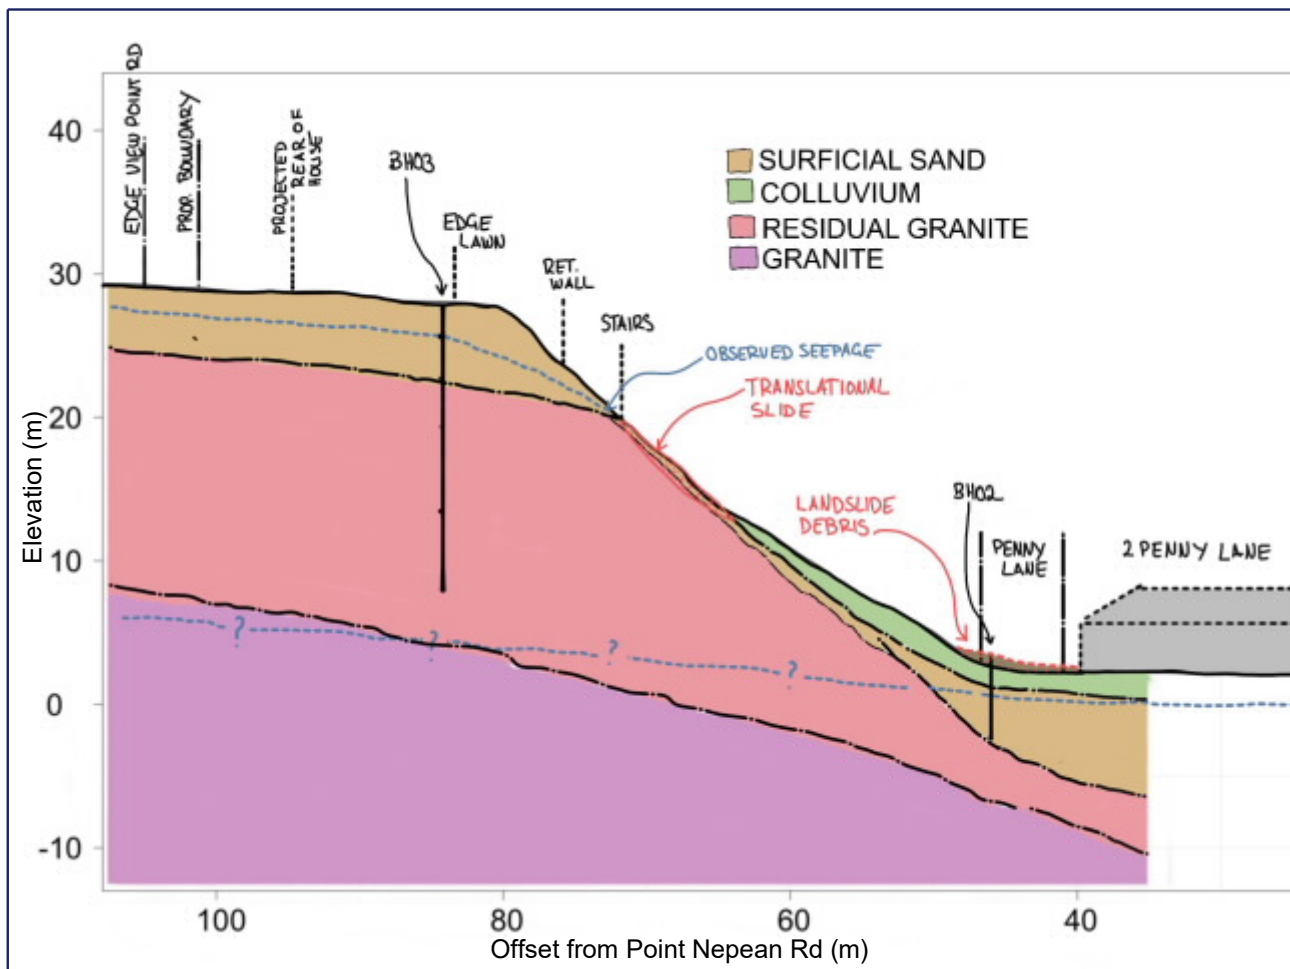
Inset 9: Cross section of my geotechnical model

38. My interpretation of the geological conditions is presented in Inset 9. With regards to the geotechnical model, I note the following key observations:
- (a) There is uncertainty regarding the contact between the SURFICIAL SAND and the RESIDUAL GRANITE owing to the likelihood of some of the parent material of the SURFICIAL SAND being derived from erosion of the Dromana Granite. I have assumed that the wet soils are an indicator of the contact between the two geotechnical units.
 - (b) The laboratory testing indicates that all samples between 3 m and 19 m bgl have very similar Particle Size Distributions, Inset 10, and Atterberg limits indicate low plasticity CLAY fines.

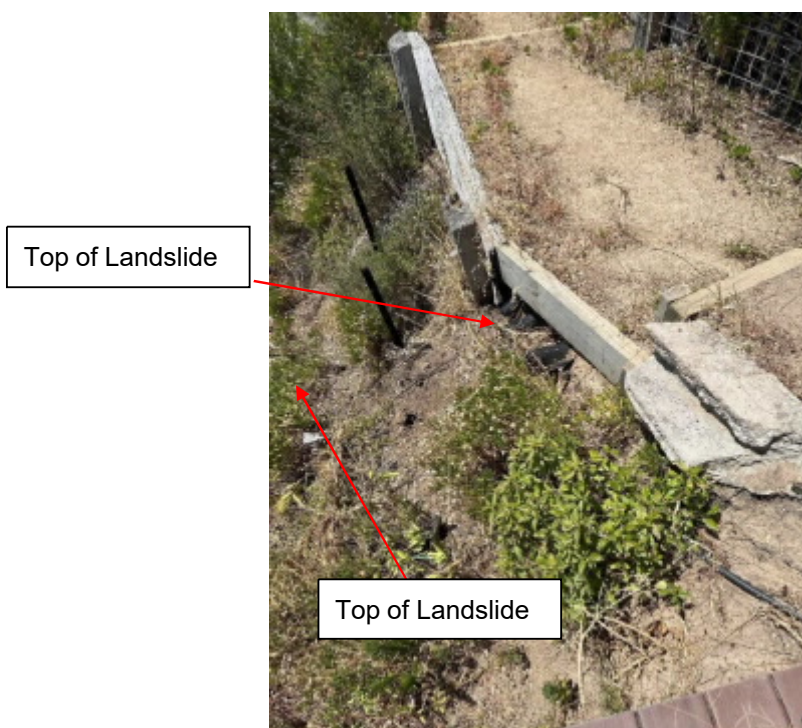
Photo 8 - Path above Landslide, note minor retaining walls and 'agi drains' from Photo 7

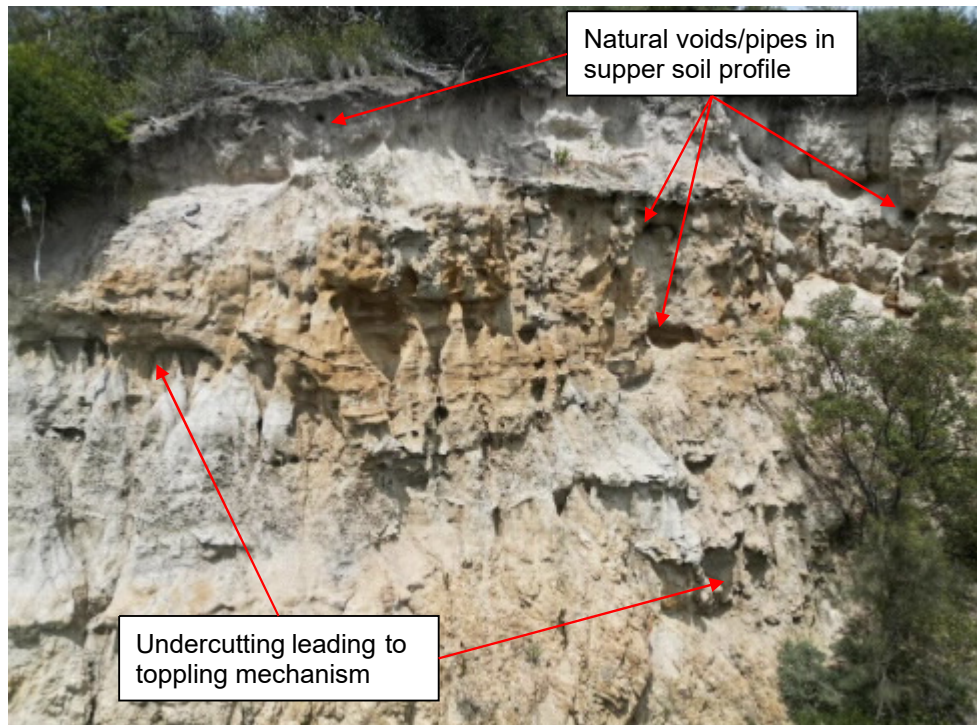
- iii. Granite rock is exposed in shore platform below the road.
 - iv. Steep to sub-vertical upper slopes are inferred to fail by undercutting and erosion of the lower slope leading to toppling style failures, Photo 12 Appendix C.

Photo 12 - Natural cliff profile near Anthony's Nose
