Expert Opinion Report - Rectification

10-12 View Point Road, McCrae

PSM5226-005R 11 June 2024

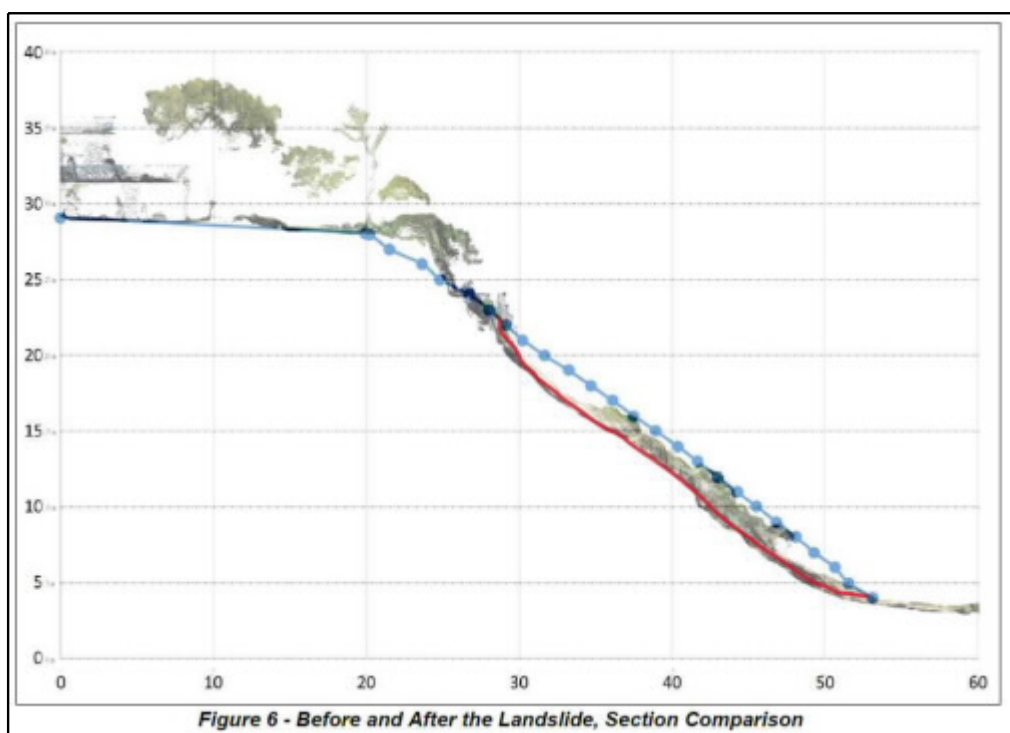
Inset 2: Excerpt from CivilTest report 1222044-1 Issue 2 (5 December 2022) (Document 2, pdf page 4)

9. I have reviewed a series of CivilTest Pty Ltd (**CivilTest**) documents. Document 2 of the Brief is the CivilTest report 1222044-1 Issue 2 (5 December 2022). The report provides:
- (a) A cross section from a drone and feature survey, Inset 2. I note that:
 - i. In my opinion the section cut from the drone survey point has too much width to understand the shape of the slope (i.e. the section includes trees and landscaping).
 - ii. In my opinion it is likely that vegetation is obscuring the true ground surface, and therefore the presented shape of the slope does not accurately reflect the actual site conditions.
 - iii. There is a significant difference between the feature survey (the blue line of Inset 2) and the drone survey.

- (c) The typical and maximum observed thickness of the Landslide was 0.3 m and 0.5 m respectively. The comparison between the CivilTest drone and feature survey, Inset 2, overestimates the thickness of the Landslide by as much as 1.5 m.

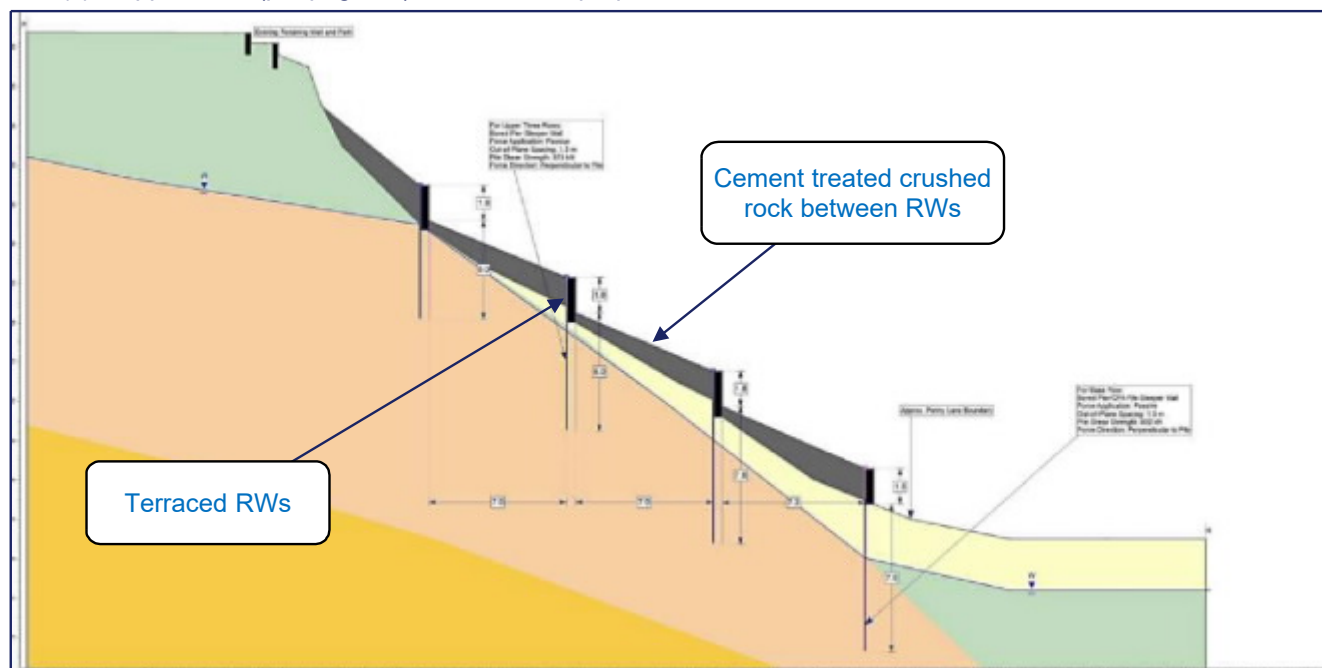
Inset 4: CivilTest section with proposed RW remediation (Document 12, pdf page 29). I have added my commentary in blue.

- ii. Cement treated crushed rock (CTCR) placed between retaining walls with a maximum 22 degree slope angle.
 - iii. *“Loose colluvium/landslip material should be removed from the slope”.*

- (b) Appendix E (pdf page 29) illustrates the proposed remedial works in section view, Inset 4.

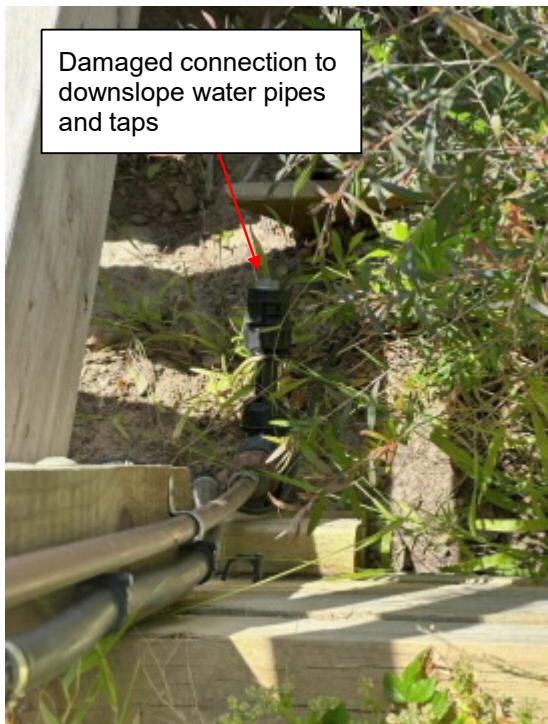
Damaged connection to downslope water pipes and taps

Photo 7 - Water infrastructure including water pipes (on left), and subsurface 'agi drains' (on right)

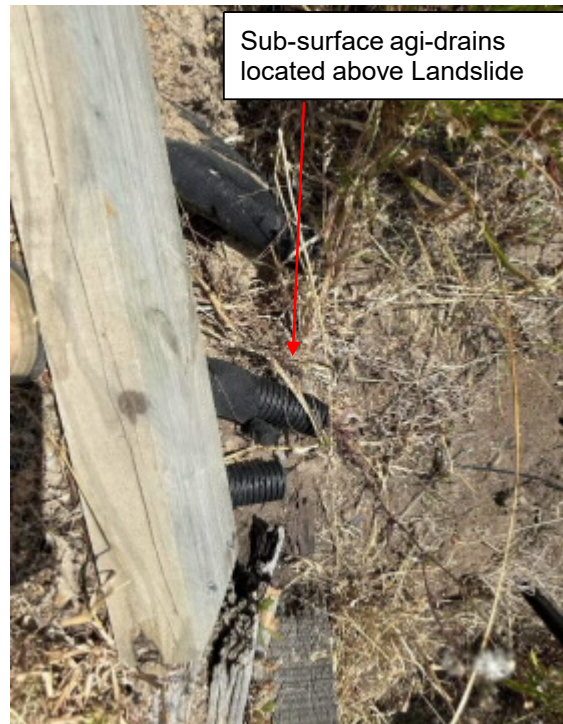
Sub-surface agi-drains located above Landslide
