McCrae Landslide 14 January 2025

Summary of Events

Subject Property: 10-12 View Point Road McCrae and 3 Penny Lane McCrae

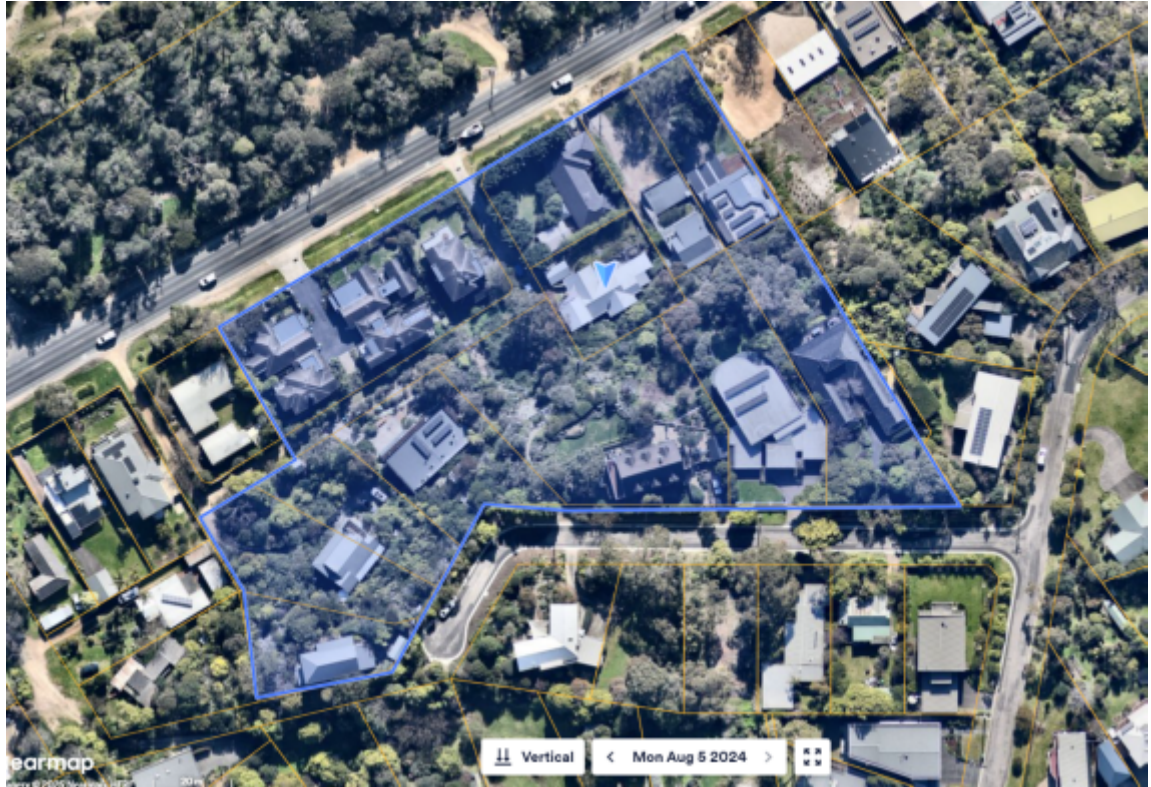
At approximately 3pm Jack called Dane Pope to discuss the exclusion zone. Rory and I were listening in to the conversation and Dane advised that he had completed a walk around of the area shown above.

Dane was asked if the exclusion zone should be extended until the appropriate investigations and monitoring had taken place. Dane advised that based on his observations it would not be unreasonable to evacuate additional properties that were not currently in the emergency services nominated evacuation zone and additional properties to the north. This was based on the following:

- The additional properties being located on the same escarpment as those evacuated and the escarpment showing similar characteristics to that of the failed area;
- The water issues including the unknown source of water and its path of travel down the slope are unknown.
- The observable characteristics of the additional properties being the slope, tall retaining walls etc are similar to the property on which the landslide occurred.

A decision was made to extend the evacuation zone in order to protect the life safety of the occupants until further information was available.

- 16 Prospect Hill Road
- 2 View Point Road (Which is already out due to the isolations on gas, power and water)
- 18-20 View Point Road.
- 22 View Point Road.
- 617 Point Nepean Road.
