INITIAL INSPECTION REPORT

Officer: Ben Essing Application No: EO-147/22

Property Address: 3/613 Point Nepean Road MCCRAE VIC 3938

Merit SR Date: 21/11/2022

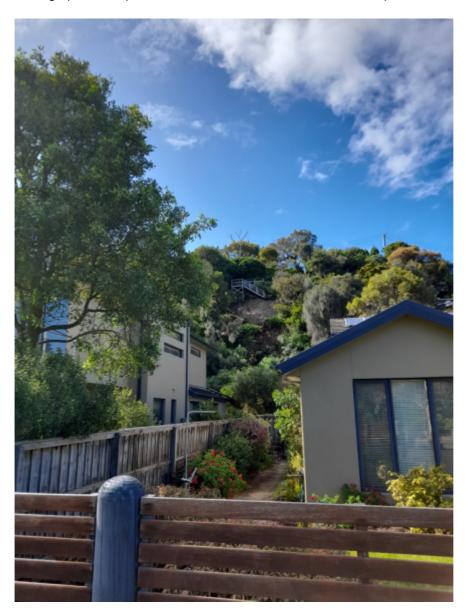
Photograph 1: The photo below is taken from the street Point Nepean Road, McCrae

I observed from Point Nepean road perspective the land slip up at the top of the crest to a number of properties that face another road at the top of the embankment. Soil has collapsed from the top crest embankment and has slid approx. halfway down the embankment bring vegetation down with the displaced soil/rock. Some of the soil that has been further displaced and descended to the natural ground level at the bottom of the hill has become liquified due to a bust water hose saturating the soil whereby the soil has fallen into the backyards of 2 Penny Lane and 3/613 Point Nepean rd McCrae.

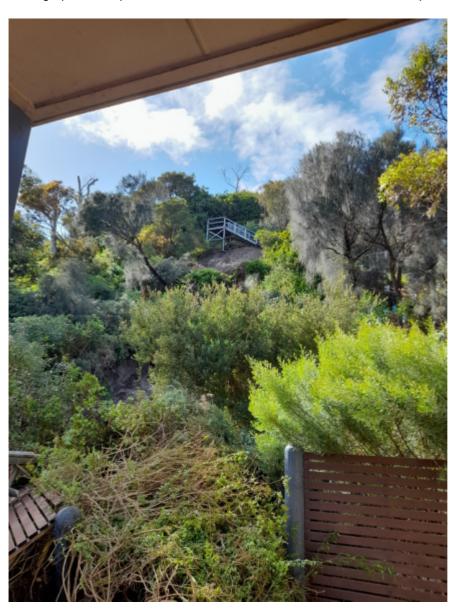
Photograph 2: The photo below is taken from the rear of 3/613 Point Nepean and 2 Penny Lane

There was built up soil against the rear external wall of the dwelling approx. 2 to 3 feet of soil in height at the time of inspection however as the unit is considered in the in line with the path of land slip it could be impacted if further land slip were to occur, A Geologist is expected to attend the land slip at 1:30pm today to survey land affected and to provide a report of the land slip impact.

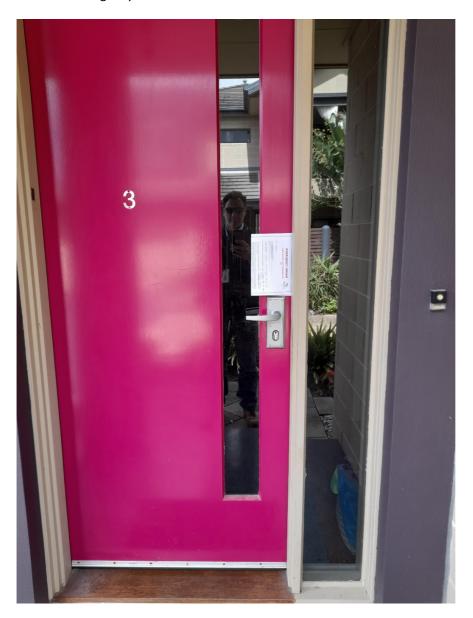
Photo of Emergency Order at front door

As there was no one home during my inspection I left an Emergency Order at the front door of the dwelling.

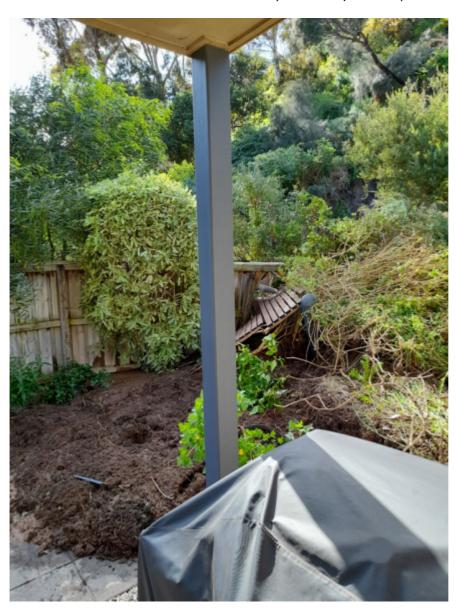
Photo taken of soil disbursement onto 2 Penny Lane rear yard with partial fence collapse.
