**GEOTECHNICAL INVESTIGATION OF
STABILITY OF GULLY BETWEEN
THE EYRIE & POINT NEPEAN ROAD,
MCCRAE**

**MORNINGTONPENINSULA SHIRE
COUNCIL**

SEPTEMBER 2007

REF NO: 207141Report01.1.doc

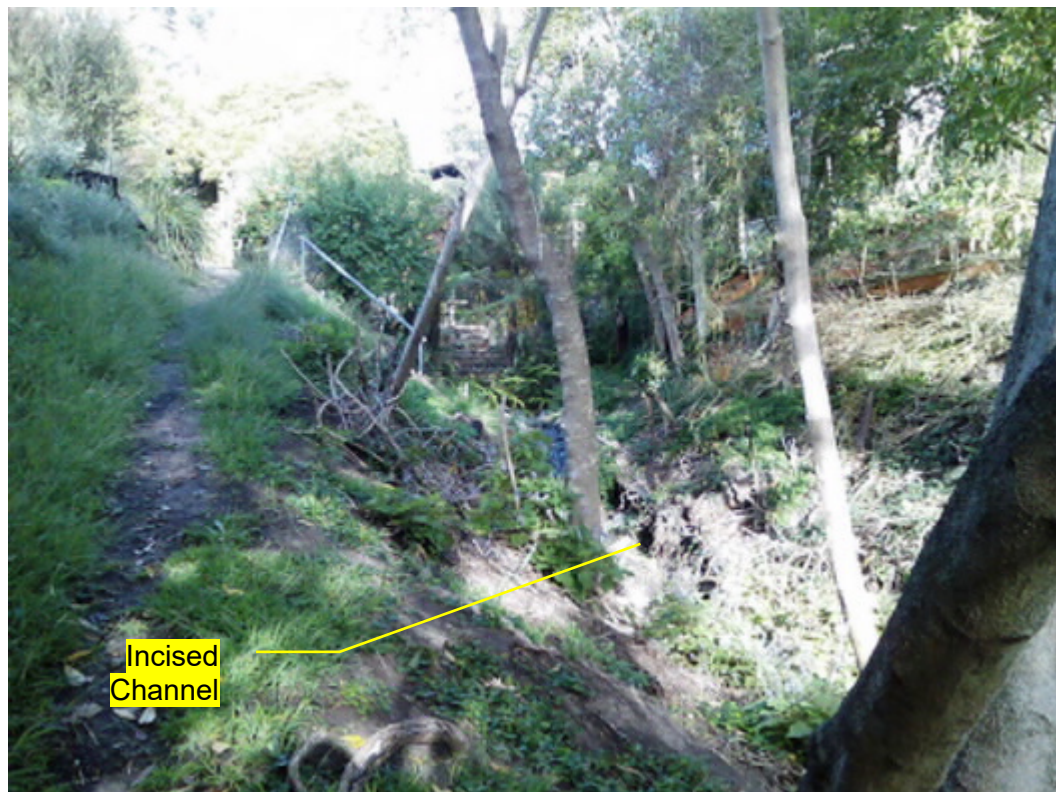
The water course in this area appears to run in an incised channel at the base of the gully, although at the time of the investigation the water course was not running. The channel is incised up to 1.0m below the general base of the gully.

This section of the gully appears relatively stable with the exception of some possible soil creep in the upper soils.

Plate 3.B: Upstream view in vicinity of Section D-D'

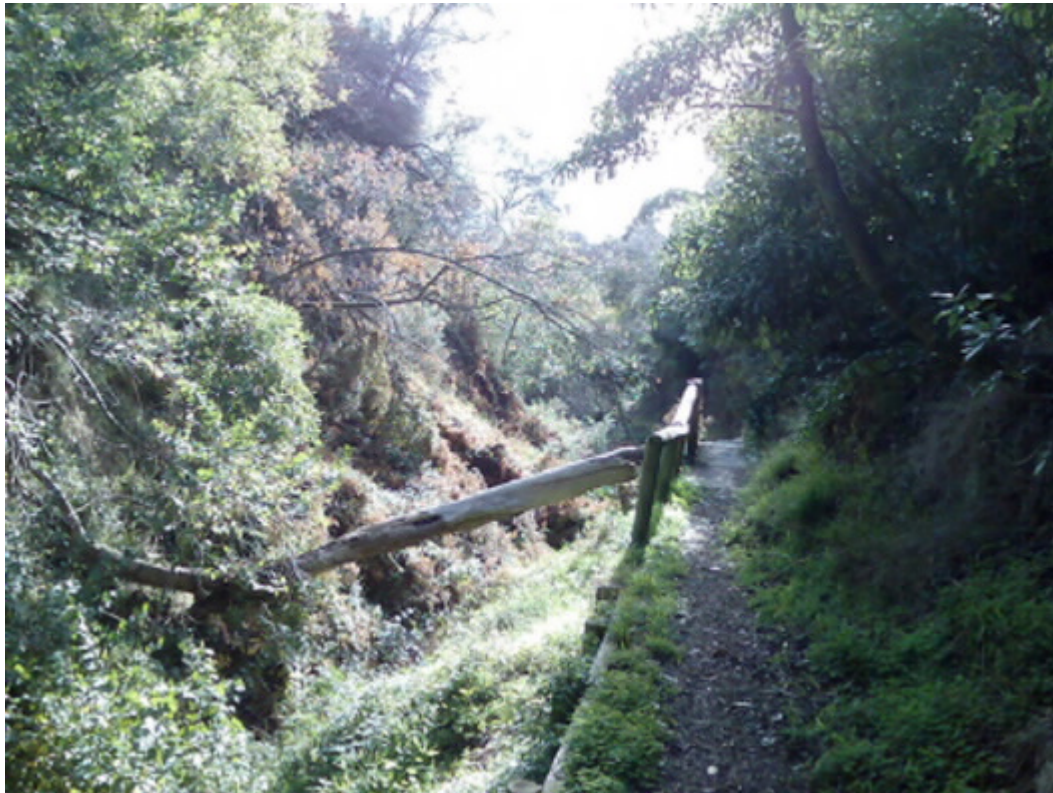
Downstream of the sewer pipe the gully significantly deepens to greater than 10m depth and the base of the gully widens to several metres. The grade of the gully also significantly increases. (Plate 3.C) The gully banks also have a slope of approximately 1V:1H. Significant erosion of the toe slope banks is occurring in this section resulting in the banks being undermined (Plate 3.D) and resultant collapses are occurring. In addition the walking path has been undermined in areas. This required the construction of a boardwalk. The boardwalk has subsequently collapsed. (Plate 3.E)

Plate 3.C: Downstream view looking towards Section C-C'

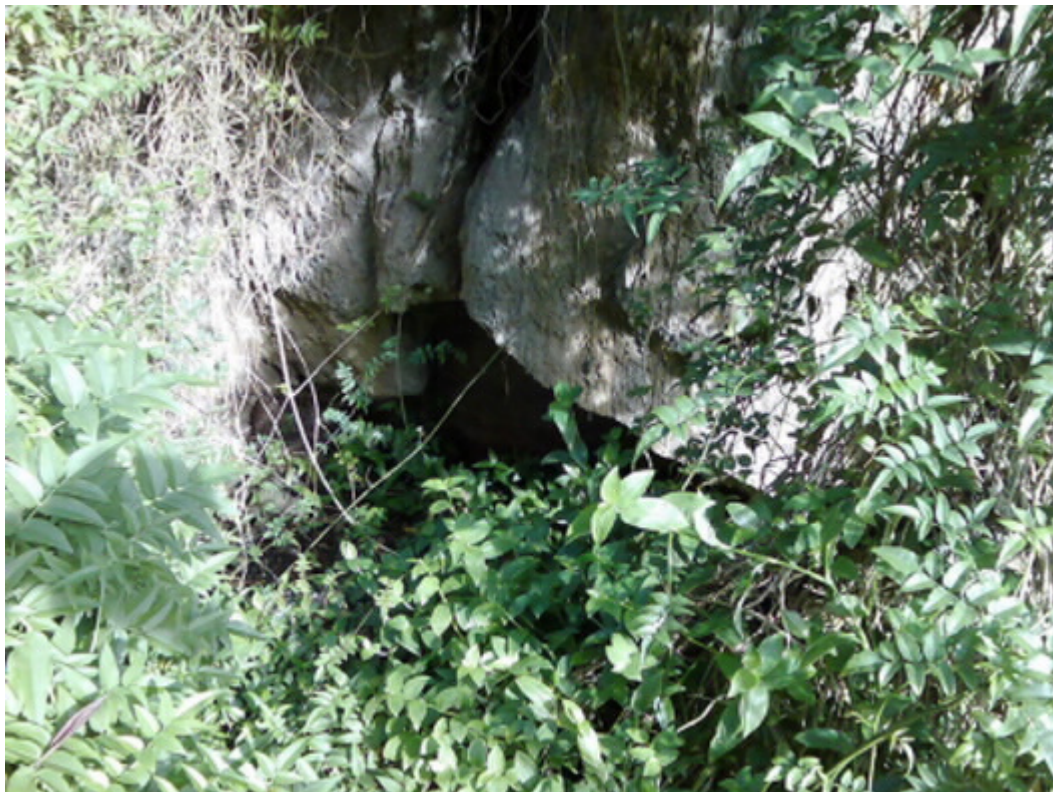
Plate 3.D: Undermined bank between sewer pipe and Section C-C'

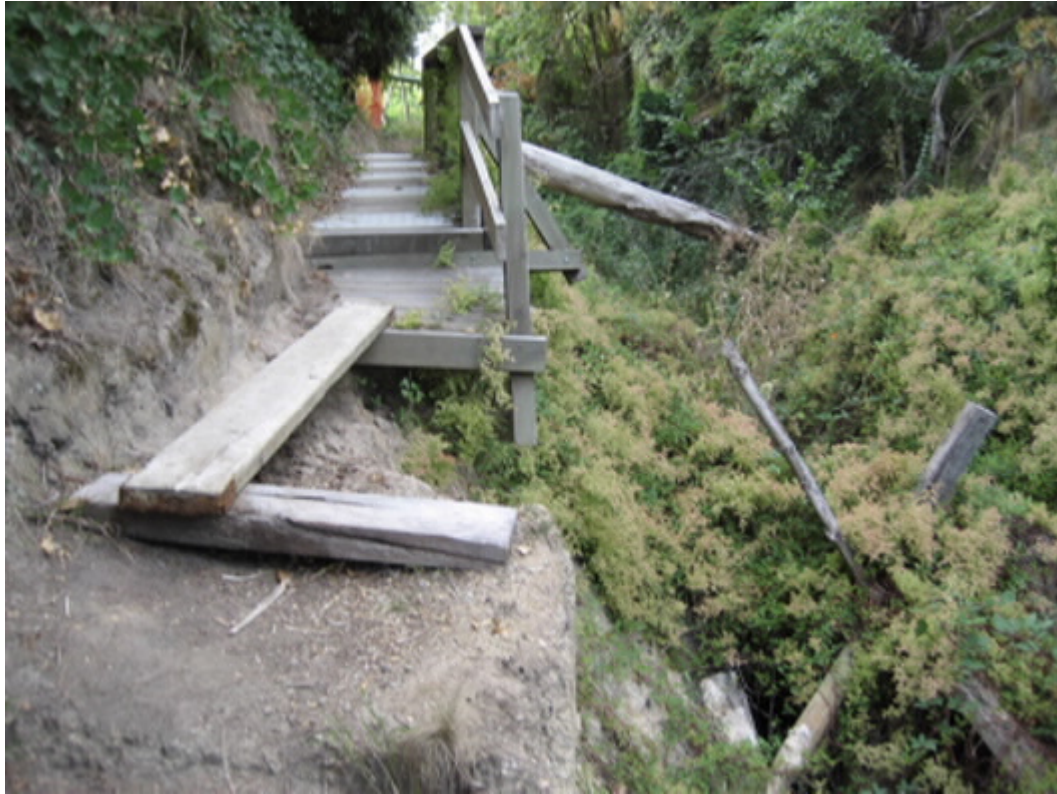
Plate 3.E: Collapsed Boardwalk in vicinity of Section C-C'

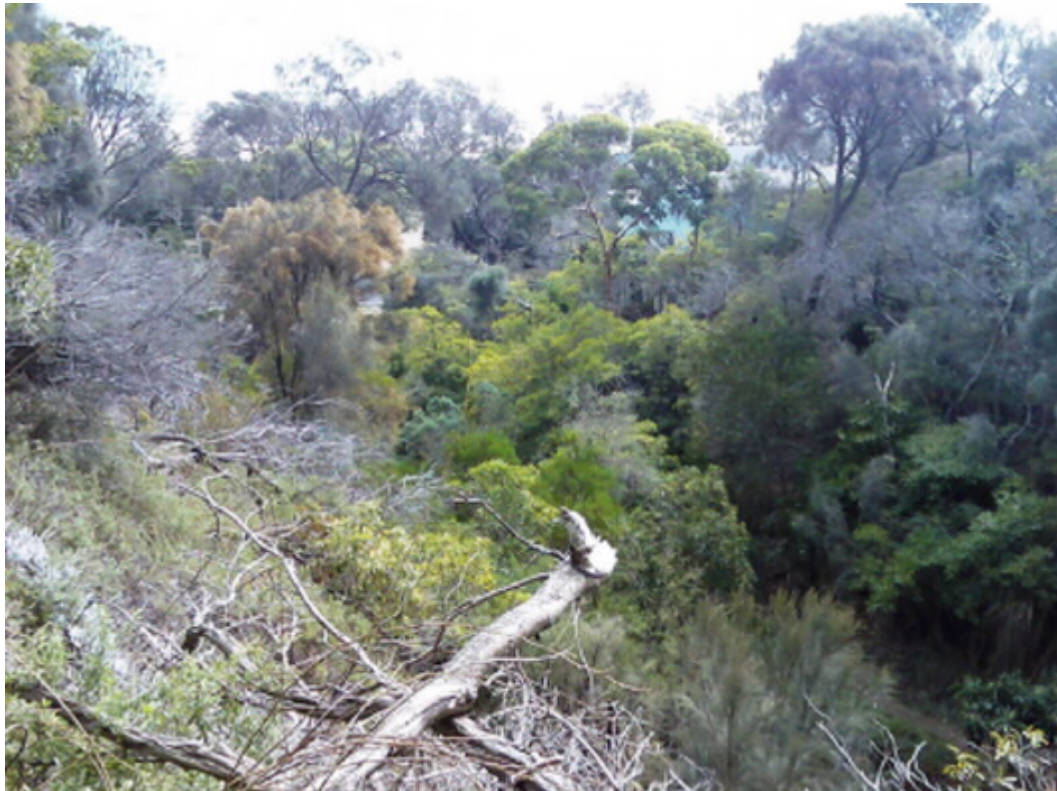
The banks of the gully are well vegetated with trees and a general groundcover. However there are numerous trees that are leaning or have fallen. (Plate 3.F)

Plate 3.F: View from south side of gully looking down towards Section B-B'

It is recommended that the removal of vegetation be minimised. Any unsafe trees such as leaning trees should be removed, but grubbing of the stump should not be carried out.

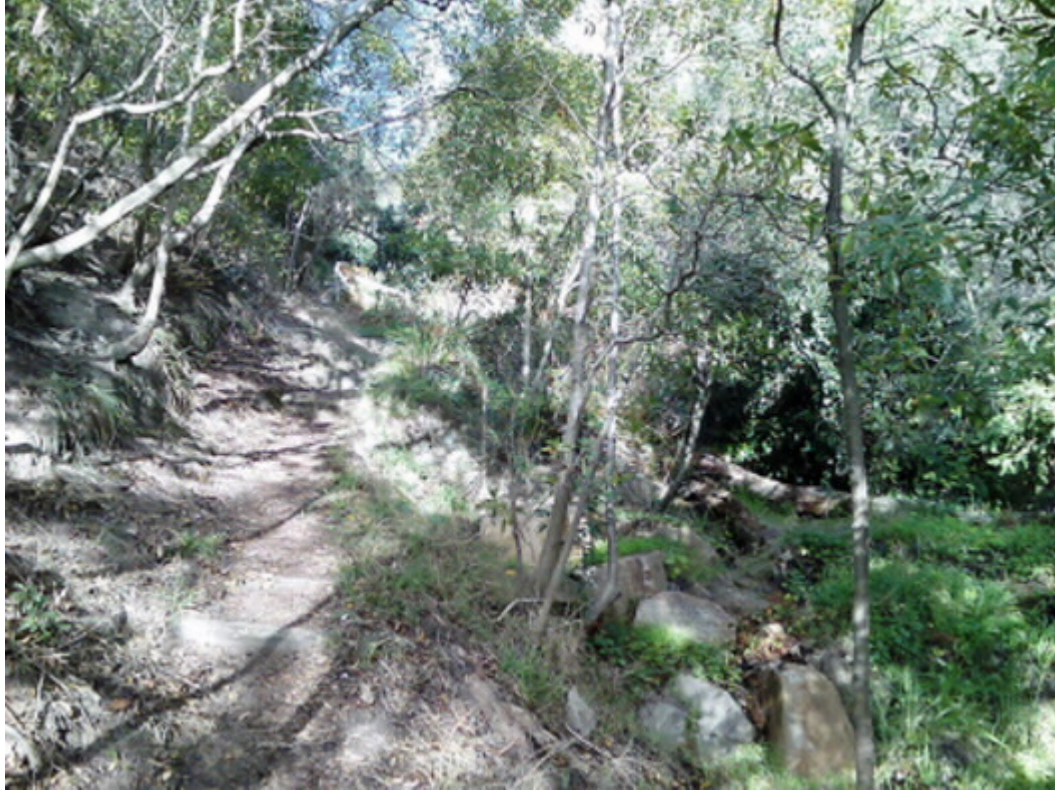
In the vicinity of Section B-B' the base of the gully begins to broaden and the slopes of the banks decrease to approximately 4V:5H. (Plate 3.G) The rock beaching starts in this area. Leaning trees in this area indicate that creep movement is occurring.

Plate 3.G: Upstream view between Sections A-A' and B-B' showing rock beaching

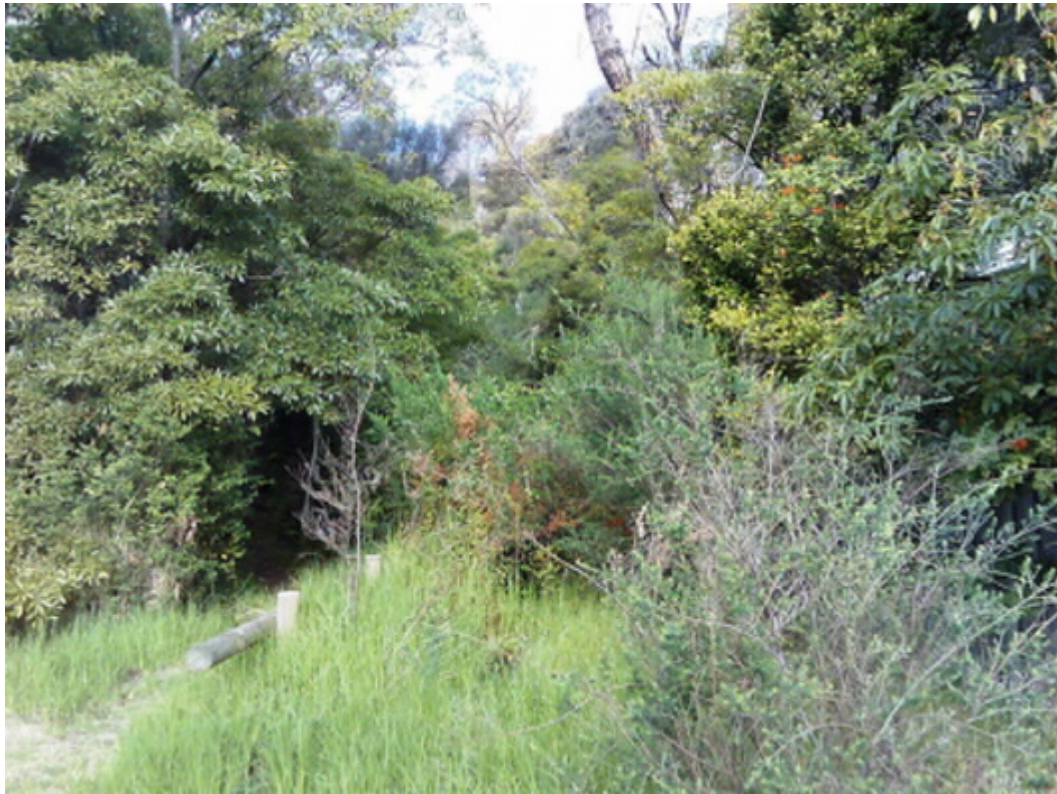
Below Section A-A' the gully begins to flatten out and the banks merge with the escarpment. At Point Nepean Road the grade becomes almost flat with a slight slope down towards the beach. (Plate 3.H)

Plate 3.H: Upstream view from Point Nepean Road

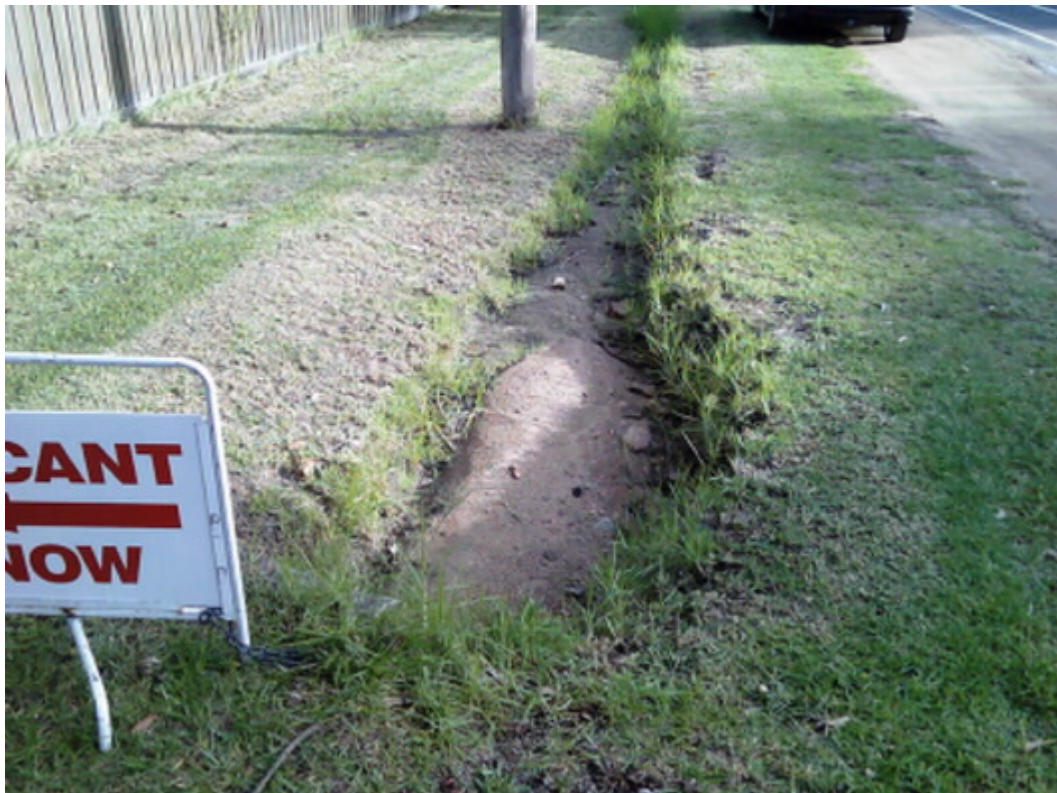
At Point Nepean Road the watercourse has a right angle bend to the south and joins the street drainage. The street drain often becomes blocked with soil washed down from the gully. (Plate 3.I) This, in combination with high water flow during significant storm events, can result in overflow of the drainage channel and water flow over the road.

Plate 3.I: Blocked street drainage on Point Nepean Road

It is recommended that the velocity dissipation structure near Point Nepean Road incorporate a sand and waste trap.
