Board of Inquiry into the McCrae Landslide

McCrae Landslide

Remediation and Mitigation Report

Our ref: PS224394-WSP-MEL-GEO-REP-003 Rev0

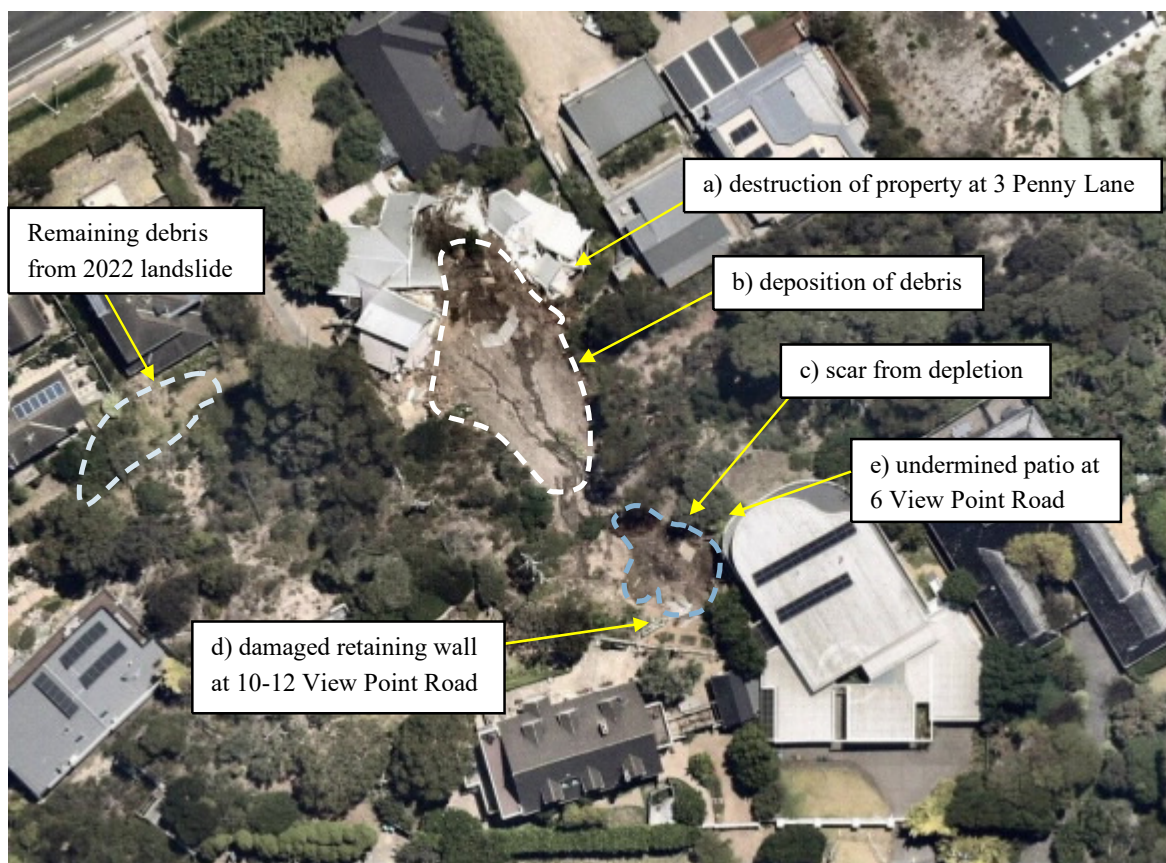
Figure 1.1 Annotated plan showing key damage caused by the January 2025 landslide

- 9) Based on our site observations, damage caused by the January 2025 landslide includes:
- The destruction of the house at 3 Penny Lane.
 - The deposition of debris including soil, building materials and vegetation at the toe of the slope below 10-12 View Point Road.
 - The scar formed within the zone of depletion which has caused a subvertical slope below 6 View Point Road and 10-12 View Point Road.
 - Damage to the retaining wall at 10-12 View Point Road.
 - Encroachment and near undermining of the patio area at 6 View Point Road.
- 10) An annotated plan showing the damage observed to have been caused by the January 2025 landslide is presented in Figure 1.1. For reference, the approximate area of remaining debris from the 2022 landslide is also shown on this figure.

- 11) The conceptual remediation and mitigation design set out in this report seeks to repair this damage and to reinstate the area affected by landslide, including returning the associated risks to a similar level they were prior to occurrence of the landslide.

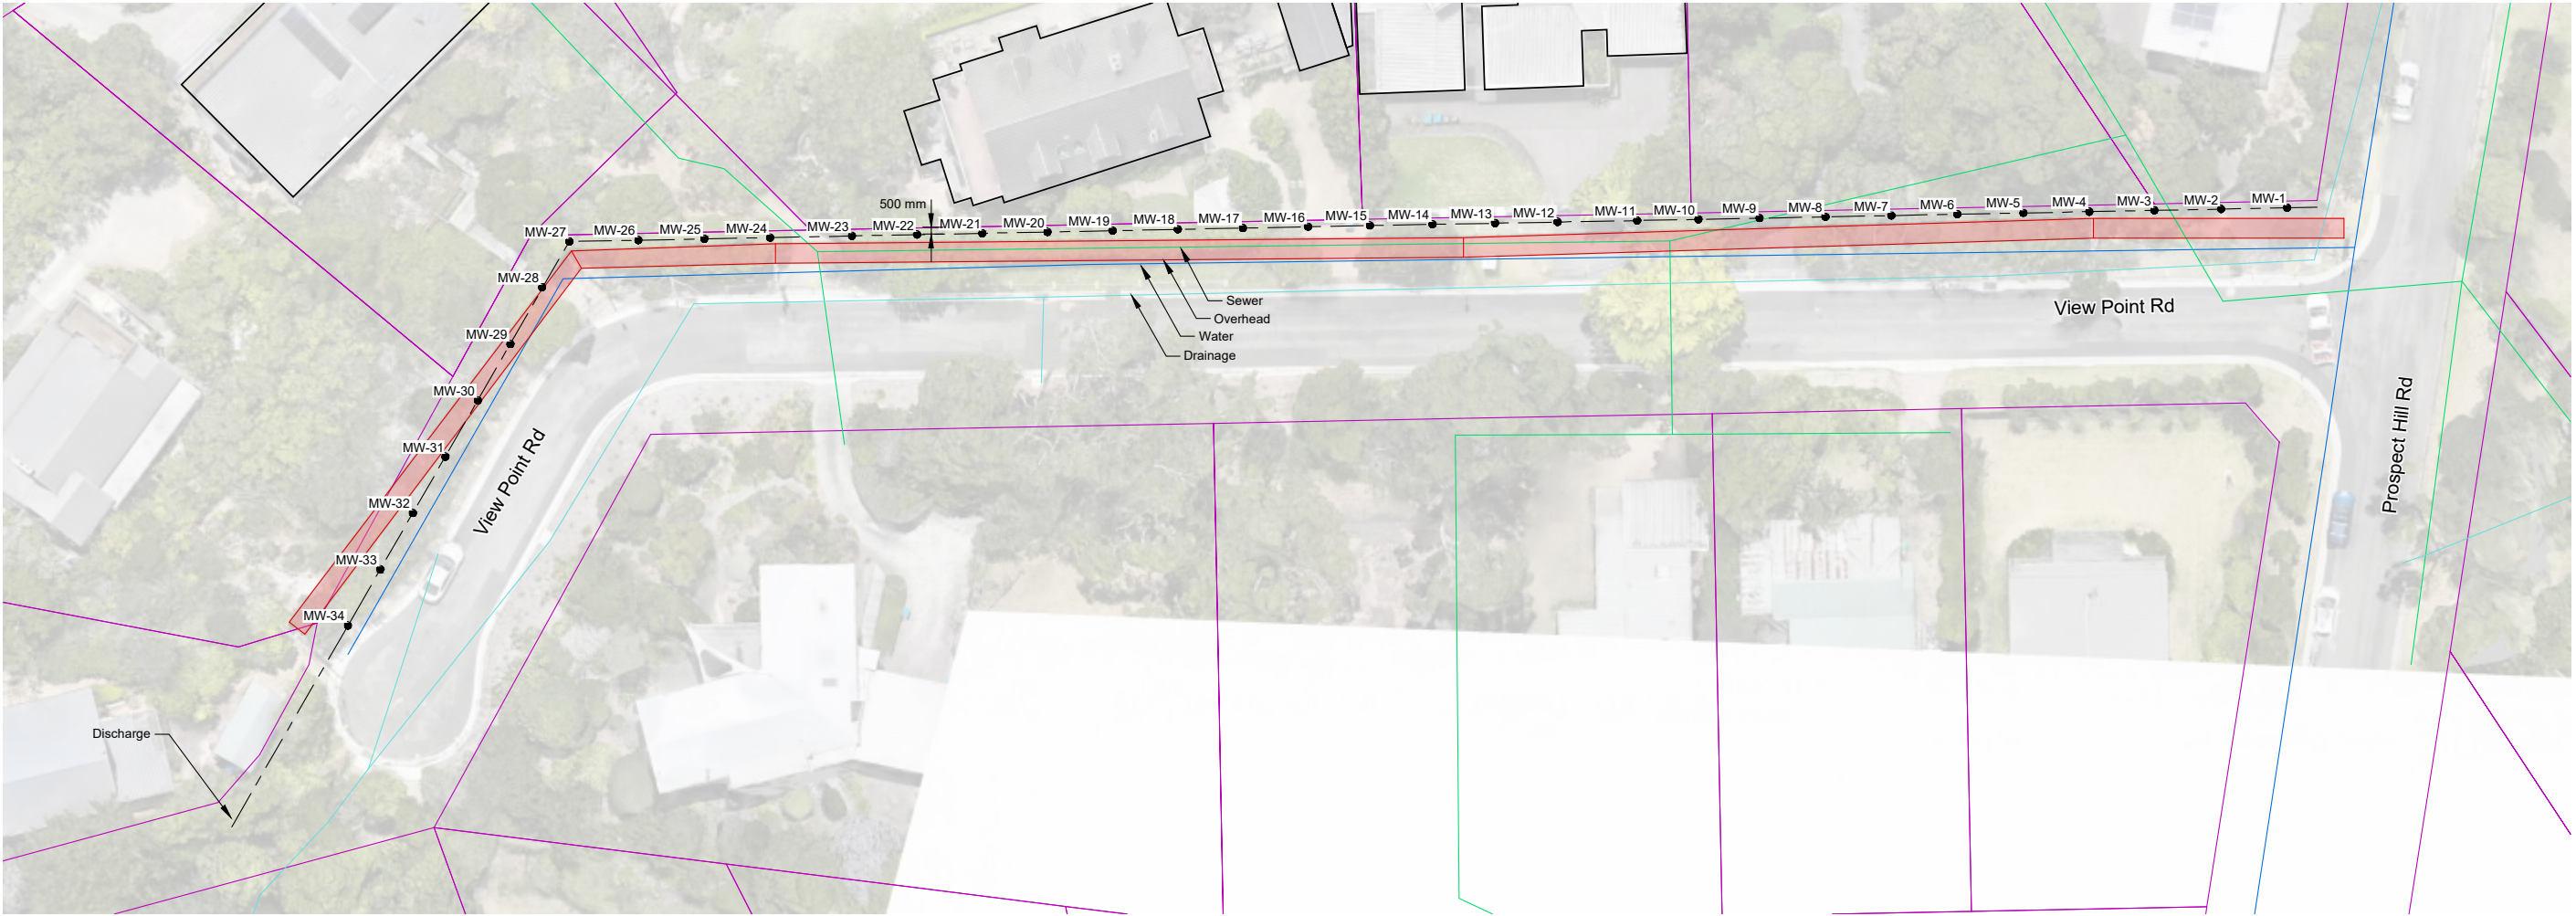
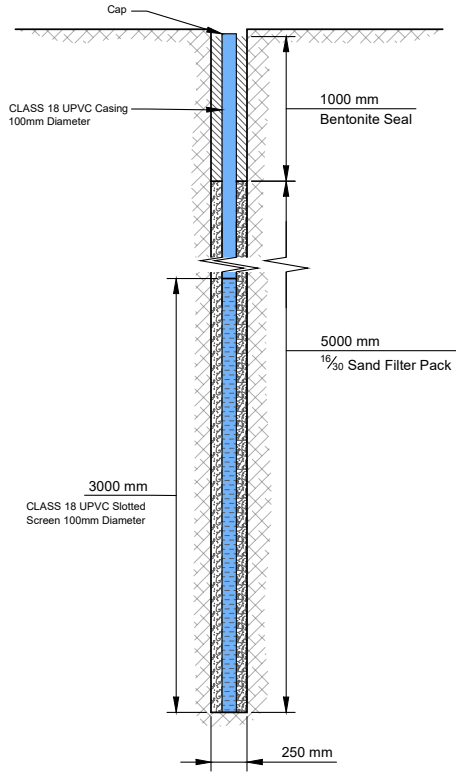
CLIENT McCrae Landslide Board of Inquiry		PROJECT McCrae Landslide Board of Inquiry	
CONSULTANT  	YYYY-MM-DD	2025-	TITLE groundwater extraction monitoring wells
	DESIGNED	DRP	
	PREPARED	CRG	
	REVIEWED	DRP	
	APPROVED		
PROJECT NO. PS224394	CONTROL SK-001	REV. A	FIGURE 010

- 26) Groundwater monitoring undertaken to date indicates that the elevated pore water pressure that triggered the January 2025 landslide was associated with a transient event, or temporary elevation of groundwater pressure.

- 25) Appendix A includes a sketch showing a system of groundwater wells installed on the northern side of View Point Road with the objective of intercepting water that could flow towards the escarpment via colluvial channels or service trenches. This sketch is a concept only, with final selection of the well spacing, diameter and locations requiring a more detailed assessment of site constraints and local hydrogeological characteristics.

- 27) A system of this type would be expected to have the following characteristics:
- a. Extraction wells installed to a depth of about 6 m or until they reach to a depth below the transported soils and penetrate into residual granite.
