# TECHNICAL MEMORANDUM

| <b>Project</b> | Penny Lane, McCrae | <b>Date</b> | 7/12/2022 |
| <b>Subject</b> | Geotechnical Assessment | <b>Ref No.</b> | V220600Report01.1 |

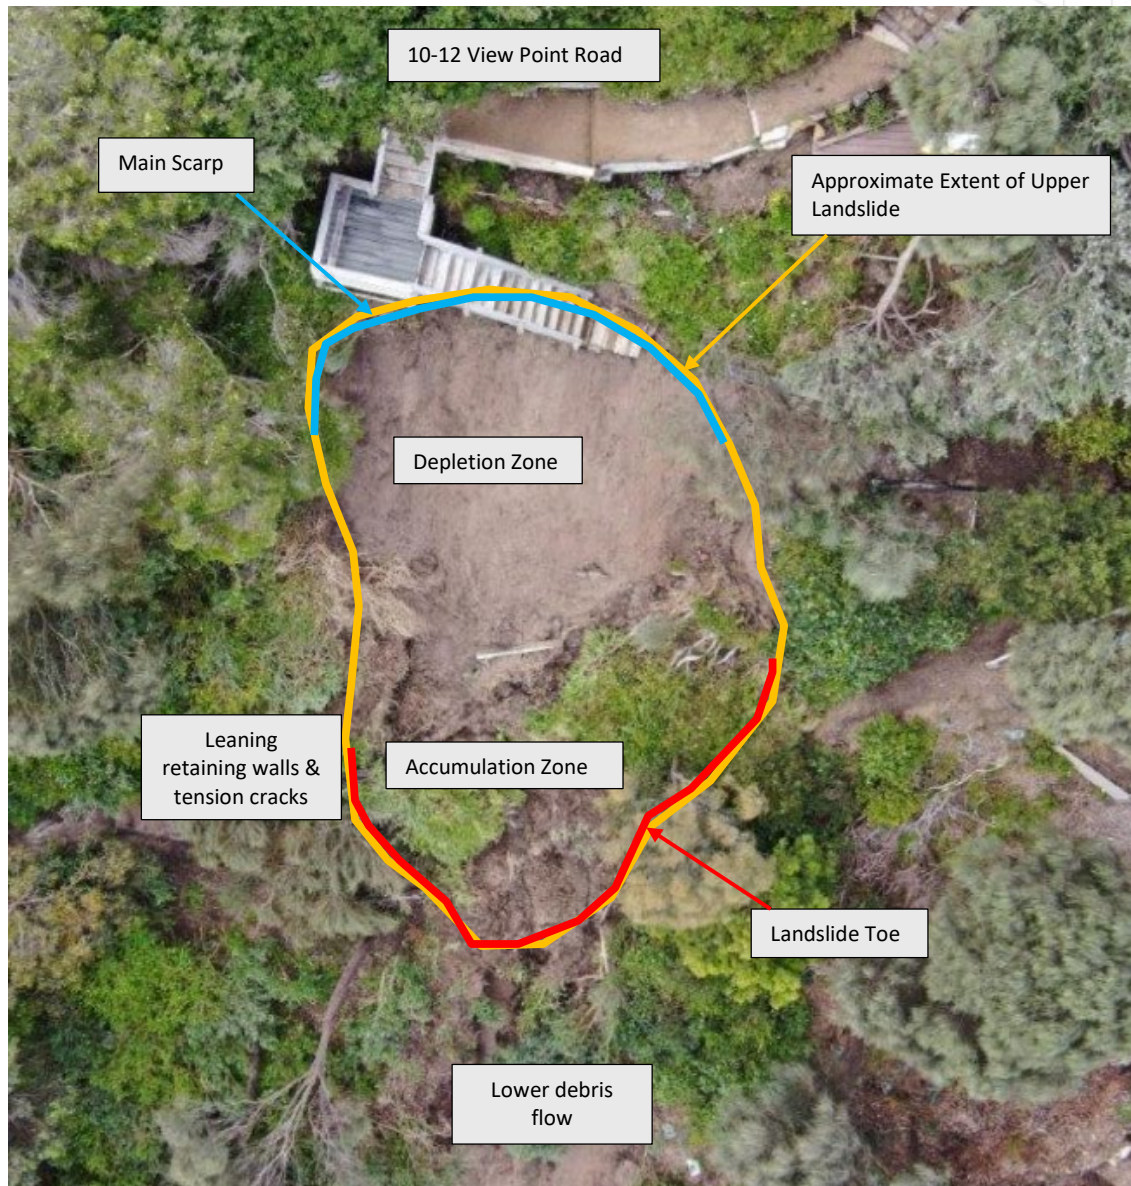
**Figure 4-1: Aerial view of upper slope**

The upper slope is dominated by a translational landslide that appears to have occurred in the upper soils overlying the underlying completely weathered granite. Across the area of the landslide a majority of the upper soils have translated downslope while the completely weathered granite has generally remained in place and is exposed in areas.

Figure 4-1 shows an aerial view of the site taken by Victoria Police drones. It shows the extent of the upper landslide and pertinent features associated with the landslide.

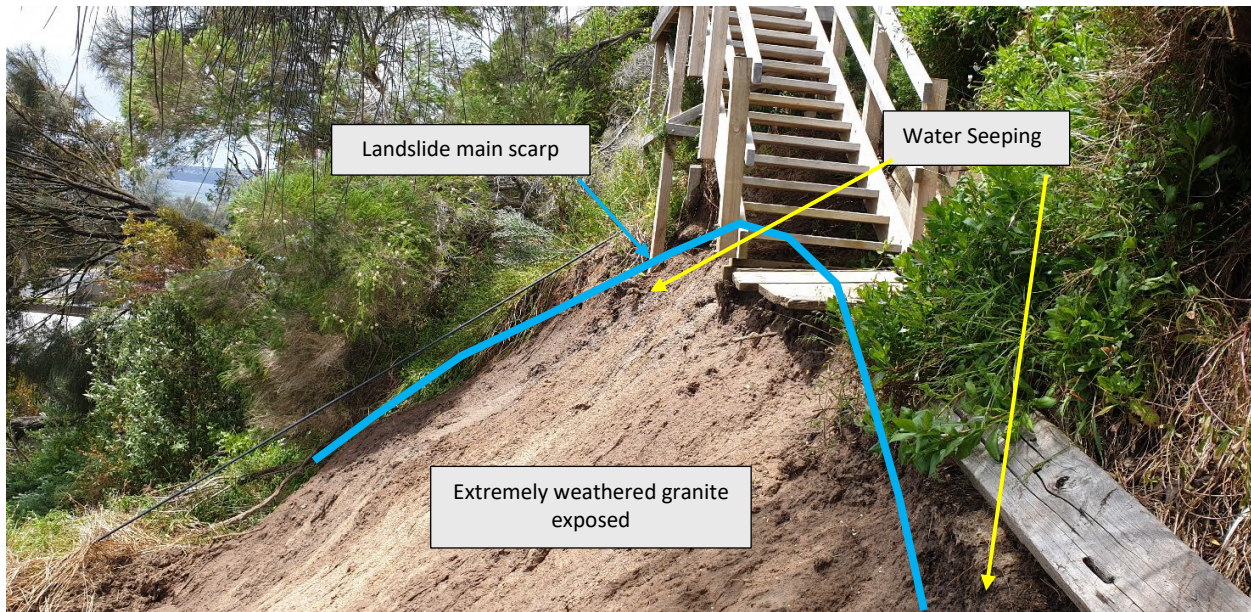
Figure 4-2: Main scarp of landslide

Figure 4-2 shows the main scarp of the landslide where it has undermined the existing stairs. It can be seen that the failure surface of the landslide runs parallel to the ground surface. The weathered granite is exposed in the failure surface. Looking at the side flank it can be seen that the thickness of soil that would have overlain the weathered granite is relatively shallow, possibly less than 0.5m.

Water was observed to be seeping from the head scarp at several locations more than 24 hours after the storm occurred. These seeps appear to be associated with natural springs further up slope.

The irrigation pipe that is likely to have failed during the initial landslide can be seen to be stretched tight in both figures.

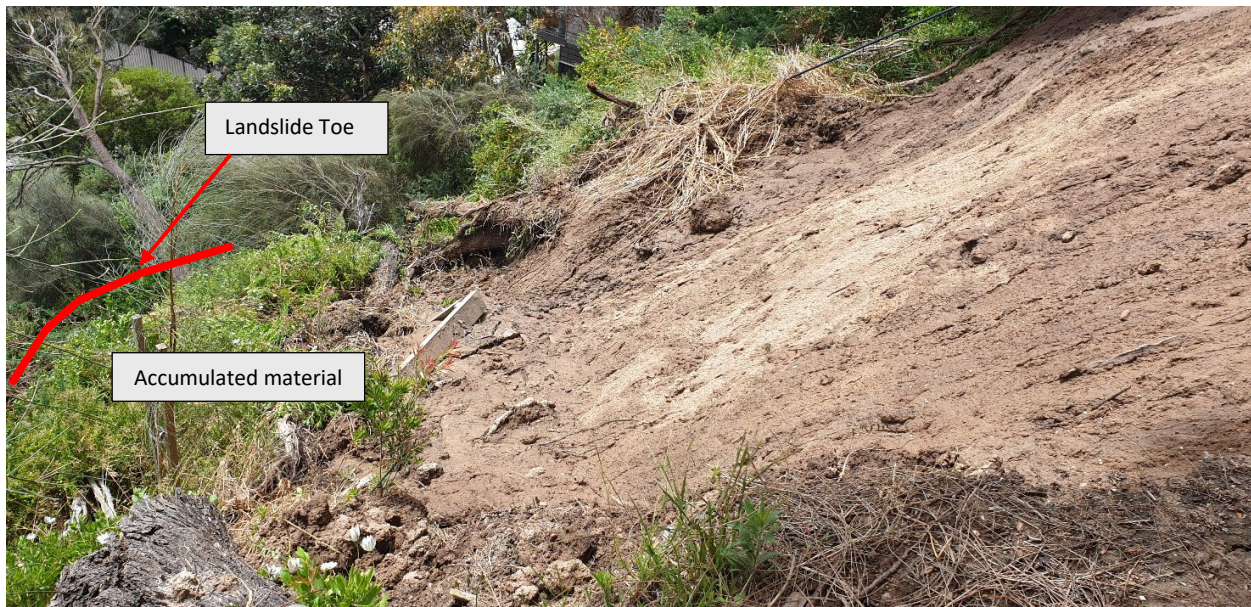
Figure 4-3: Accumulation zone of landslide

Figure 4-3 shows the accumulation zone of the upper landslide. It can be seen in the photograph that there is a significant volume of accumulated material and debris sitting at the toe of the landslide.

It is considered possible that with another significant rainfall event the material in the accumulation zone could remobilize and flow down slope. In addition, it is possible that some regression of the head scarp

could occur but that it would most likely be confined to the steep section of the slope or the immediate vicinity of the flatter area upslope.

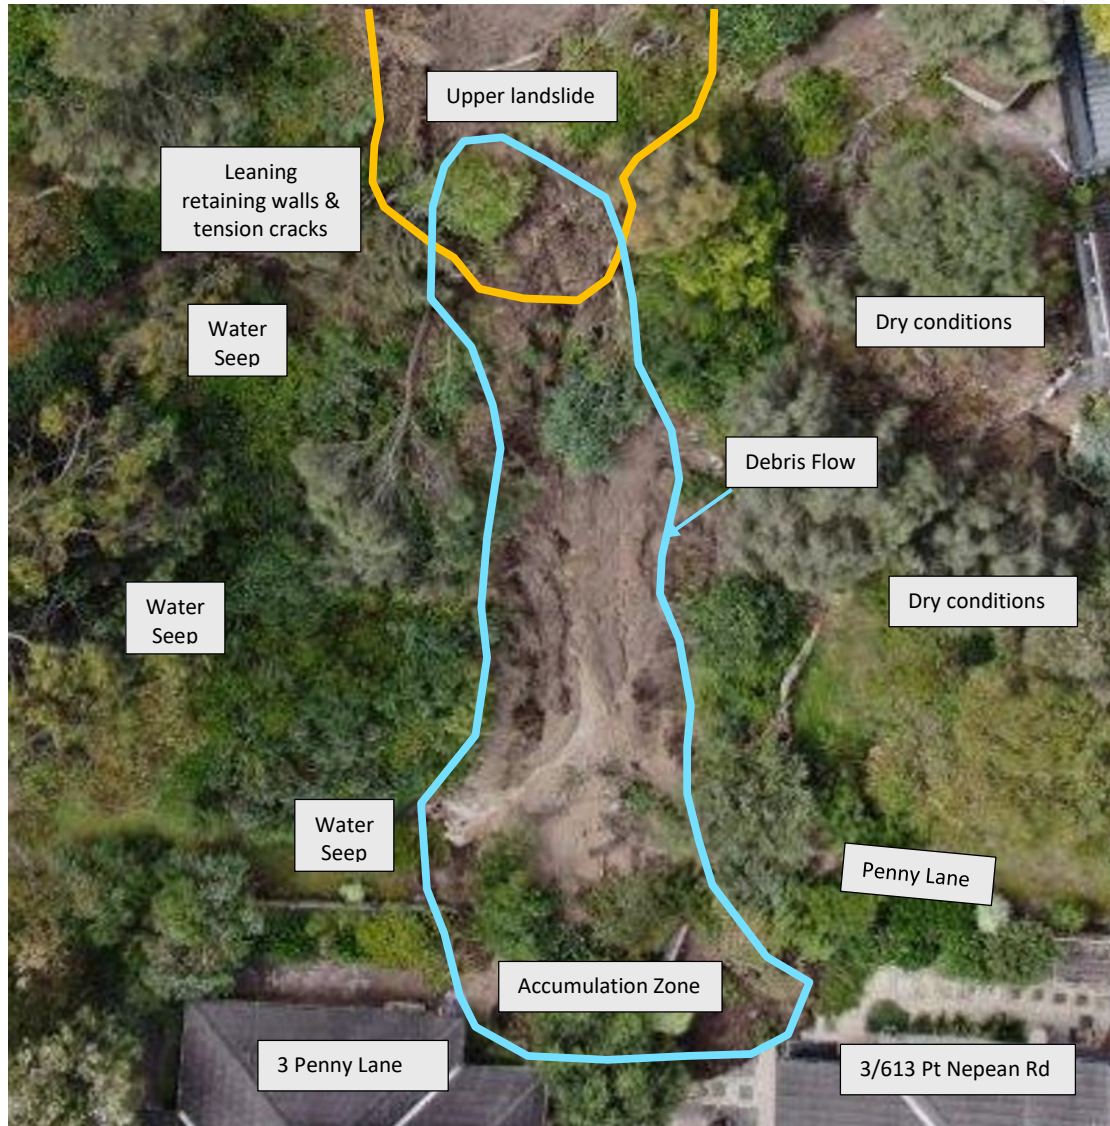
**Figure 4-6: Aerial view of lower debris flow**

The lower slope is dominated by a debris flow that has been initiated by a significant increase in ground moisture, most likely as a combination of significant rainfall and potentially the failure of an irrigation pipe after the upper landslide occurred. Figure 4-5 shows an aerial view of the site taken by Victoria Police drones. It shows the debris flow initiated within the accumulation zone of the upper landslide and then flowed downslope across Penny Lane and into the rear of the properties of 3 Penny Lane and 3/613 Pt Nepean Road.

Figure 4-6 shows the path of the debris flow. It can be seen that the upper vegetation has been stripped and that there has been some scour of the underlying soils. The deepest sections of scour have eroded down to the top of the extremely weathered granite.

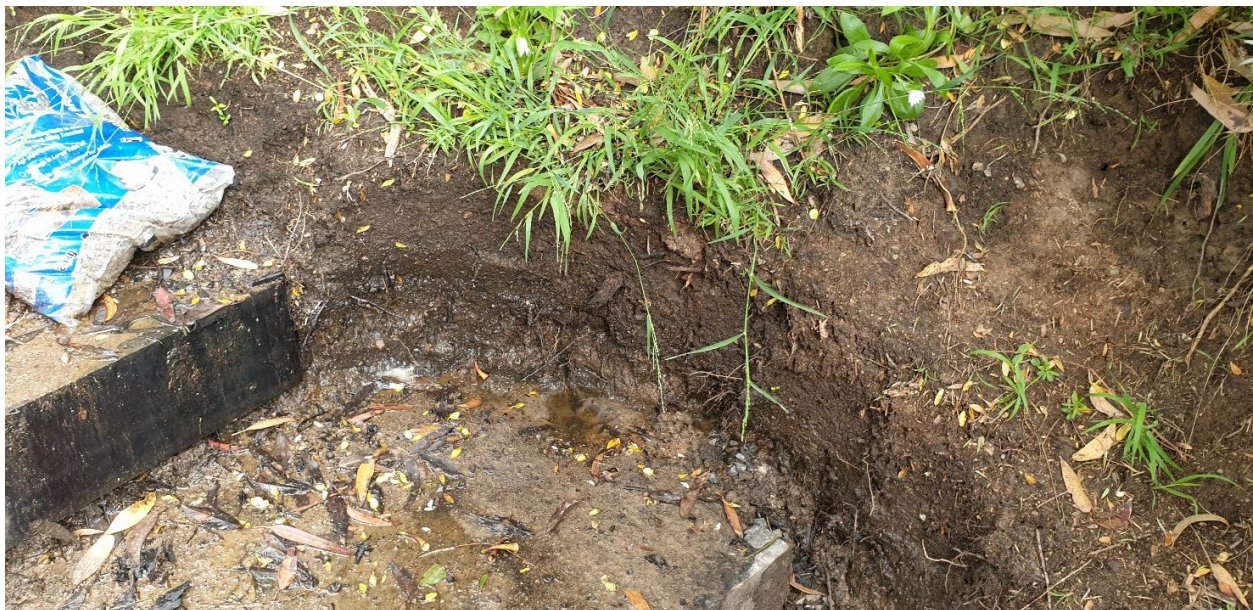
Figure 4-9: Water seepage on left side of site

The conditions on either side of where the debris flow occurred were observed to be significantly different. On the right (western) side the conditions were quite dry and there was no evidence of water seepage. However, on the left (eastern) side there were a number of water seeps observed. These water seeps were observed to be flowing freely more than 24 hours after the heavy rainfall event.

Based on the evidence of tension cracks up slope of this eastern area and that there are significant springs in the area, it is considered that there is potential for a landslide or debris flow to develop within the eastern area especially if there is another heavy rainfall event. However, such a landslide would be unlikely to extend as far east as the property at 2 Penny Lane.

An example of one of the water seeps is shown in Figure 4-8.
