# TECHNICAL MEMORANDUM

| <b>Project</b> | Penny Lane, McCrae | <b>Date</b> | 7/12/2022 |
| <b>Subject</b> | Geotechnical Assessment | <b>Ref No.</b> | V220600Report01.1 |

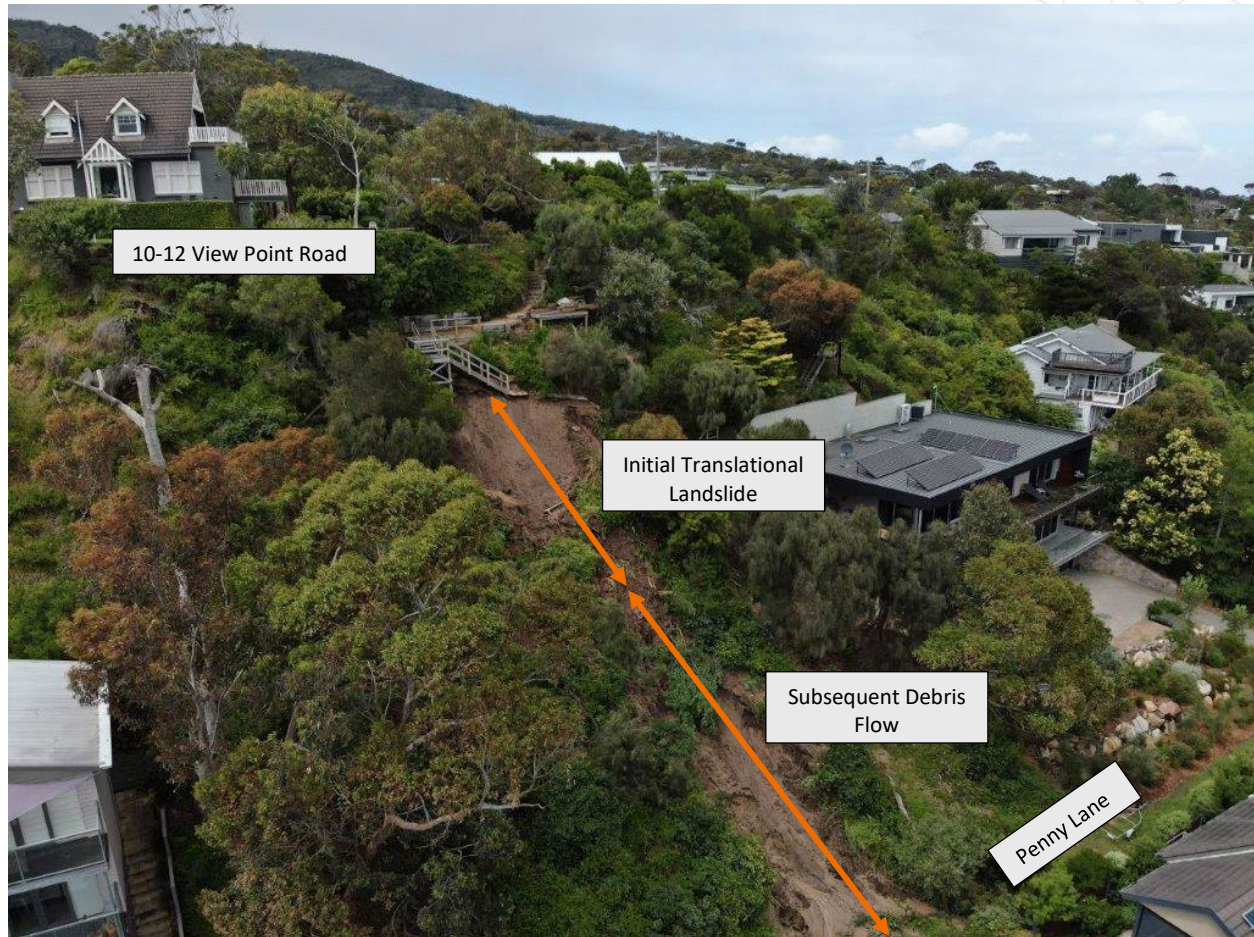
Figure 3-1: Oblique view of landslides

From the anecdotal discussions it is understood that an initial landslide is likely to have occurred in the late afternoon on Monday 14 November 2022. This day was a day of very heavy rain with approximately 80mm of rain recorded at the Bureau of Meteorology rain gauge located at Rosebud Country Club approximately 3-4km away. According to the data this was the highest single day of rainfall at that rain gauge since February 2005. This was coupled on top of what had already been a wet year. This landslide appears to have occurred as a translational landslide of the upper slope to the rear (north) of the house at 10-12 View Point Road.

Subsequently in the early morning of Tuesday 15 November 2022 a second landslide occurred. This landslide appears to have occurred as a debris flow from the middle part of the slope down to the toe resulting in impact on the dwelling at 3 Penny Lane as well as debris flowing into the yard of 3/613 Pt Nepean Road. From evidence on site, it appears that the debris flow may have been triggered by an irrigation pipe that could have been ruptured by the initial landslide.

While the initial landslide may have been relatively moderate to rapid in nature (i.e. in the order of metres per hour to metres per minute), it is likely that the subsequent debris flow would have been very rapid to extremely rapid (i.e. in the order of metres per second).

An oblique view of the site showing the locations of the two parts of the landslide is shown in Figure 3-1.

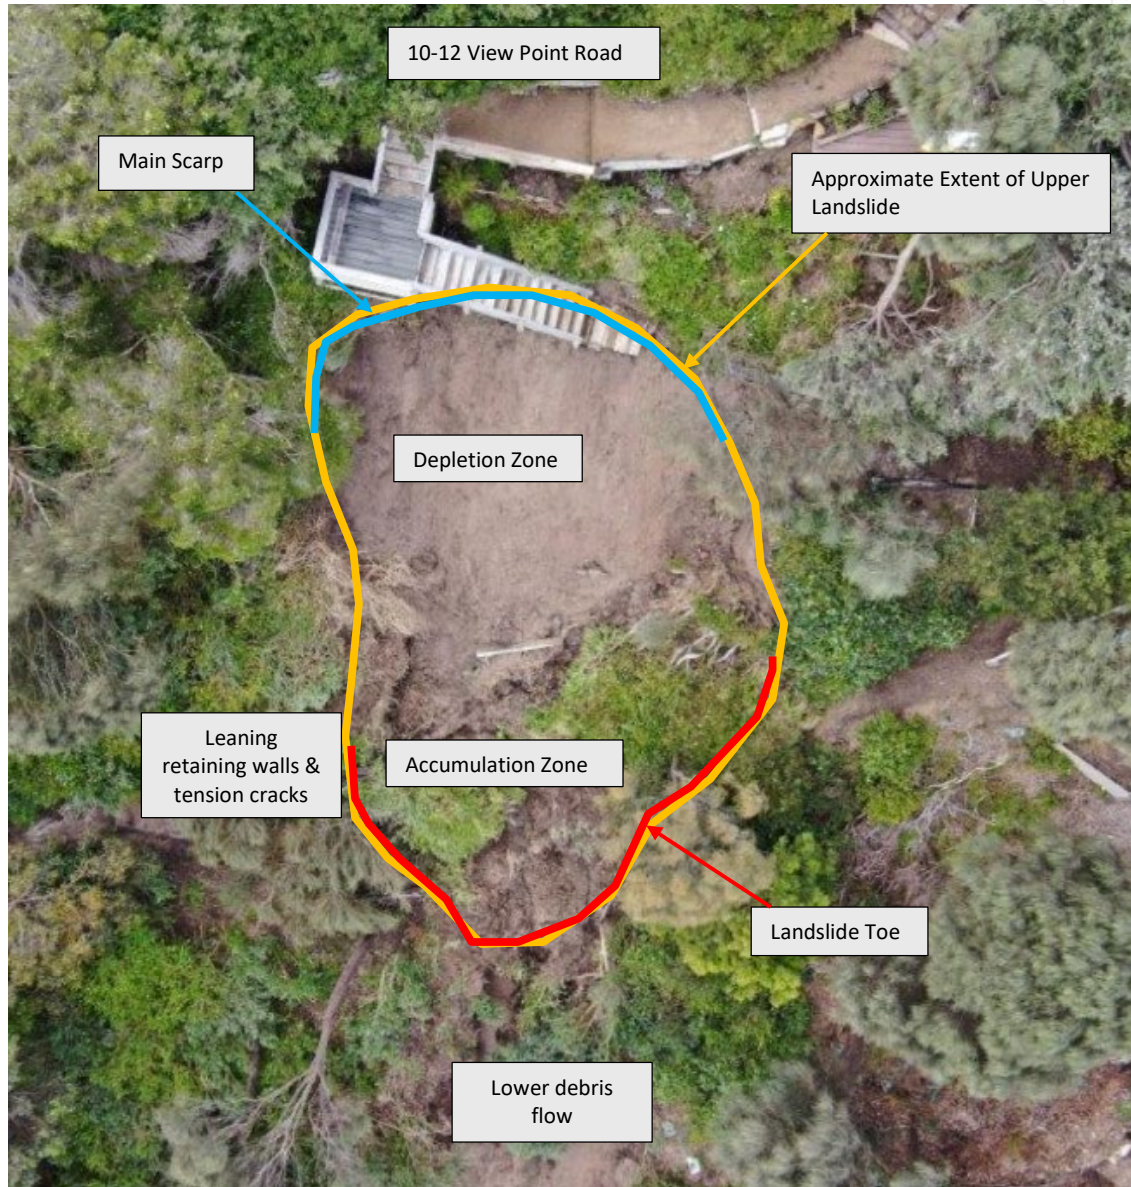
**Figure 4-1: Aerial view of upper slope**

The upper slope is dominated by a translational landslide that appears to have occurred in the upper soils overlying the underlying completely weathered granite. Across the area of the landslide a majority of the upper soils have translated downslope while the completely weathered granite has generally remained in place and is exposed in areas.

Figure 4-1 shows an aerial view of the site taken by Victoria Police drones. It shows the extent of the upper landslide and pertinent features associated with the landslide.

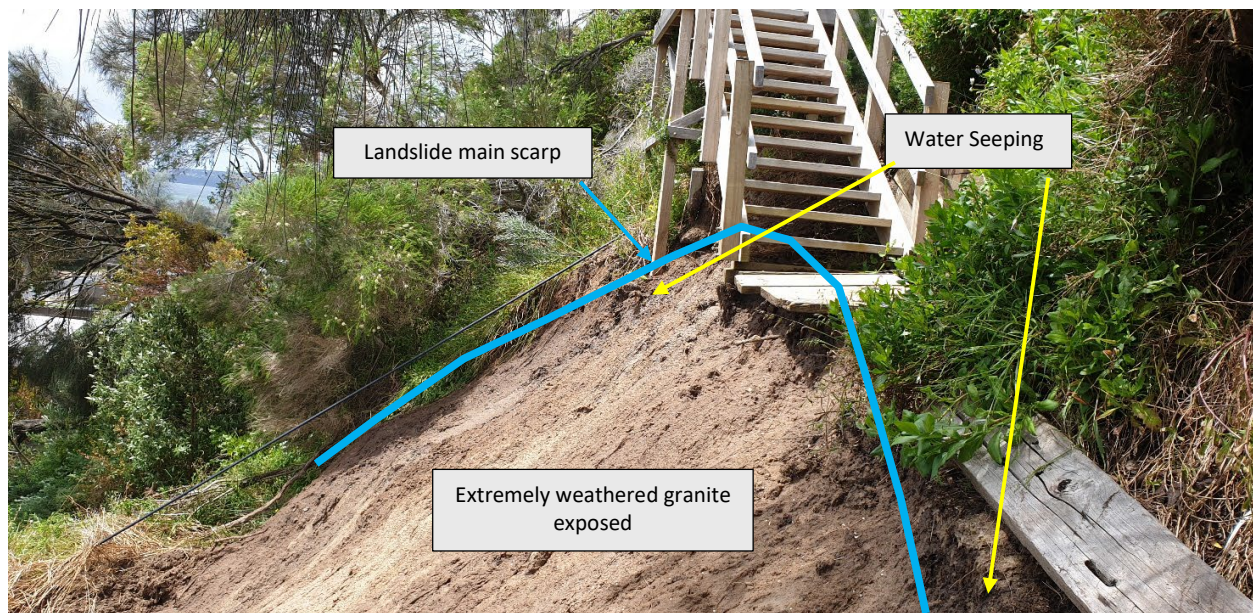
Figure 4-2: Main scarp of landslide

Figure 4-2 shows the main scarp of the landslide where it has undermined the existing stairs. It can be seen that the failure surface of the landslide runs parallel to the ground surface. The weathered granite is exposed in the failure surface. Looking at the side flank it can be seen that the thickness of soil that would have overlain the weathered granite is relatively shallow, possibly less than 0.5m.

Water was observed to be seeping from the head scarp at several locations more than 24 hours after the storm occurred. These seeps appear to be associated with natural springs further up slope.

The irrigation pipe that is likely to have failed during the initial landslide can be seen to be stretched tight in both figures.

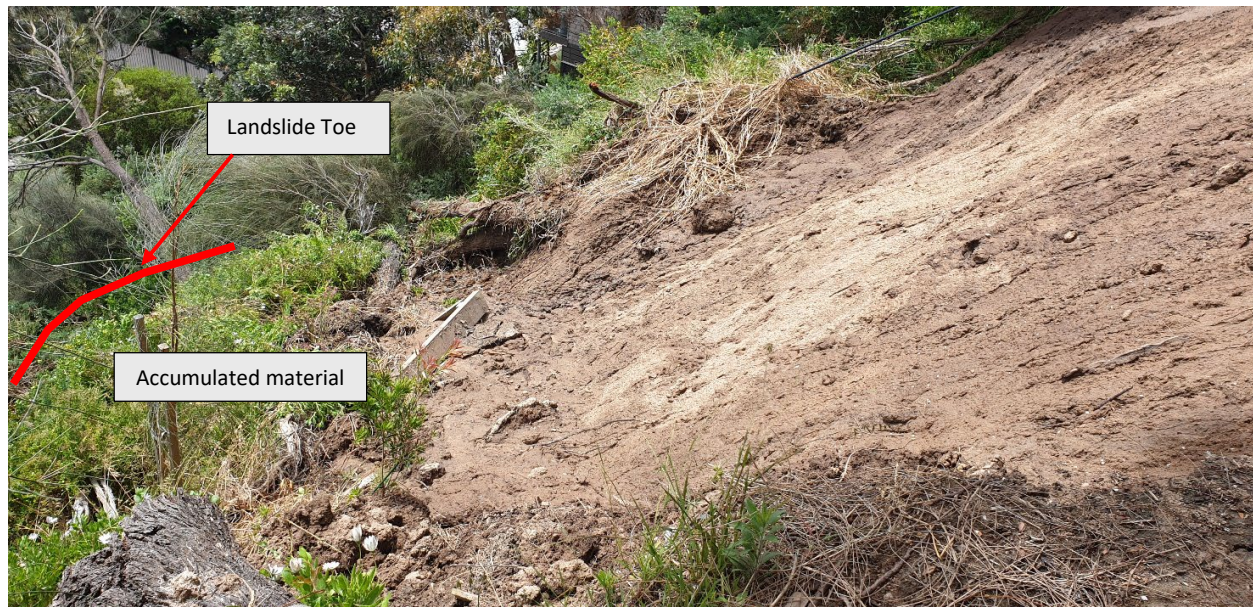
Figure 4-3: Accumulation zone of landslide

Figure 4-3 shows the accumulation zone of the upper landslide. It can be seen in the photograph that there is a significant volume of accumulated material and debris sitting at the toe of the landslide.

It is considered possible that with another significant rainfall event the material in the accumulation zone could remobilize and flow down slope. In addition, it is possible that some regression of the head scarp

could occur but that it would most likely be confined to the steep section of the slope or the immediate vicinity of the flatter area upslope.

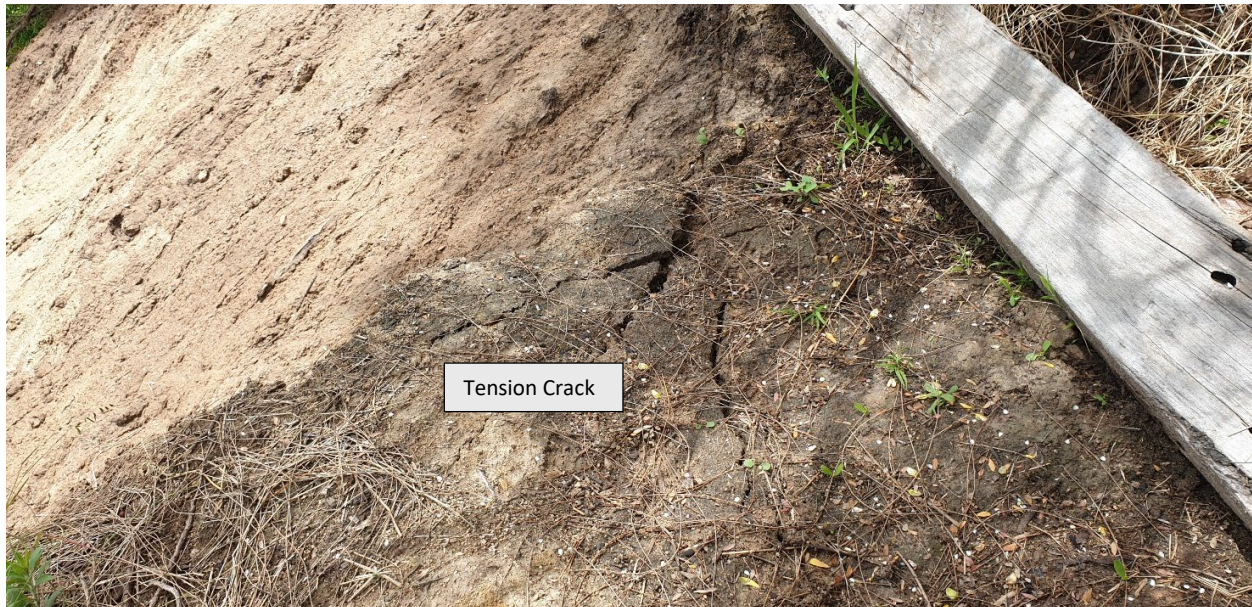
**Figure 4-4: Tension crack on right flank**

As shown in Figure 4-4 there is a tension crack on the right flank of the upper landslide. It appears to be confined to the immediate vicinity within 2-3m of the landslide. It is considered possible that the landslide could widen in this area by several metres.

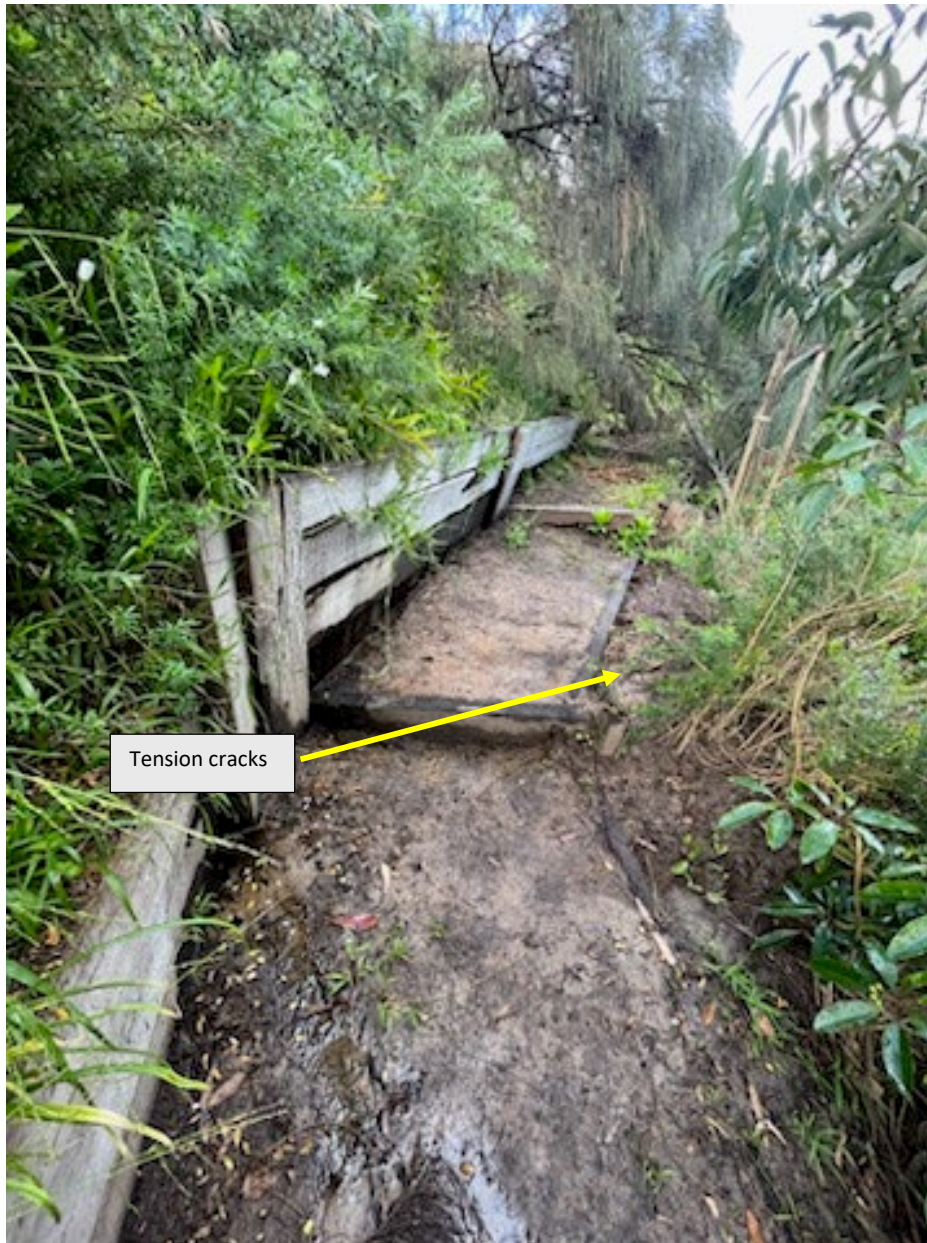
Figure 4-5: Leaning retaining wall and tension cracks on left flank

On the left flank there was an old timber retaining wall present. It was significant leaning and there was evidence of water seeping through the wall. To the front of these walls there were several tension cracks. These tension cracks appeared to be in two forms. One set of cracks appeared to indicate the rupture surface at the toe of movement further up slope while the second set of cracks appeared to indicate a developing head scarp of a landslide of the lower slope.

The tension cracks on the left flank appeared to extend approximately 5m from the existing landslide. This indicates that there is potential for widening of the existing landslide by several metres should heavy rainfall continue.

The retaining wall and tension cracks are shown in Figure 4-5.

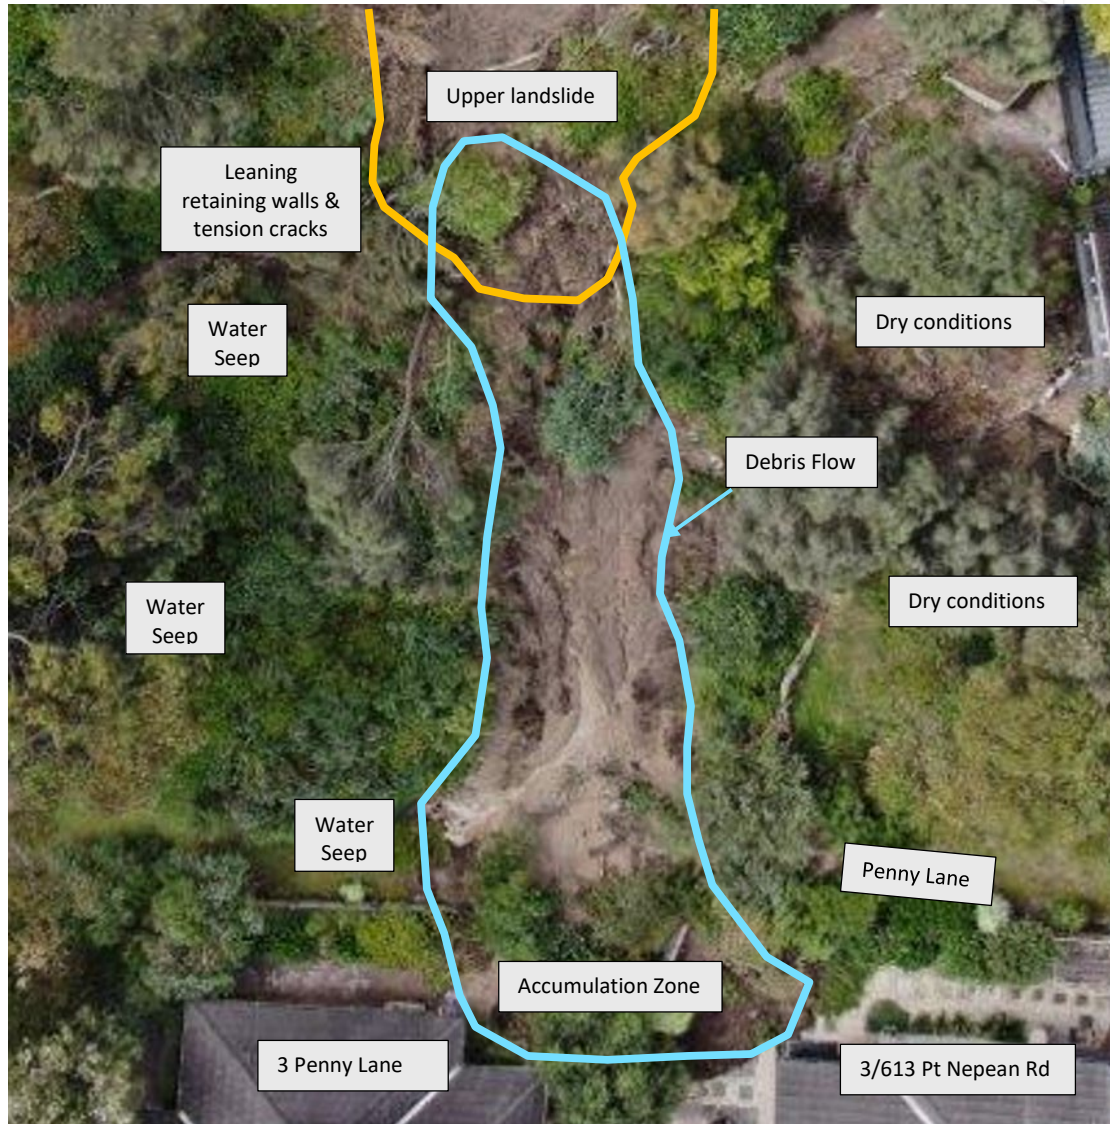
**Figure 4-6: Aerial view of lower debris flow**

The lower slope is dominated by a debris flow that has been initiated by a significant increase in ground moisture, most likely as a combination of significant rainfall and potentially the failure of an irrigation pipe after the upper landslide occurred. Figure 4-5 shows an aerial view of the site taken by Victoria Police drones. It shows the debris flow initiated within the accumulation zone of the upper landslide and then flowed downslope across Penny Lane and into the rear of the properties of 3 Penny Lane and 3/613 Pt Nepean Road.

Figure 4-6 shows the path of the debris flow. It can be seen that the upper vegetation has been stripped and that there has been some scour of the underlying soils. The deepest sections of scour have eroded down to the top of the extremely weathered granite.

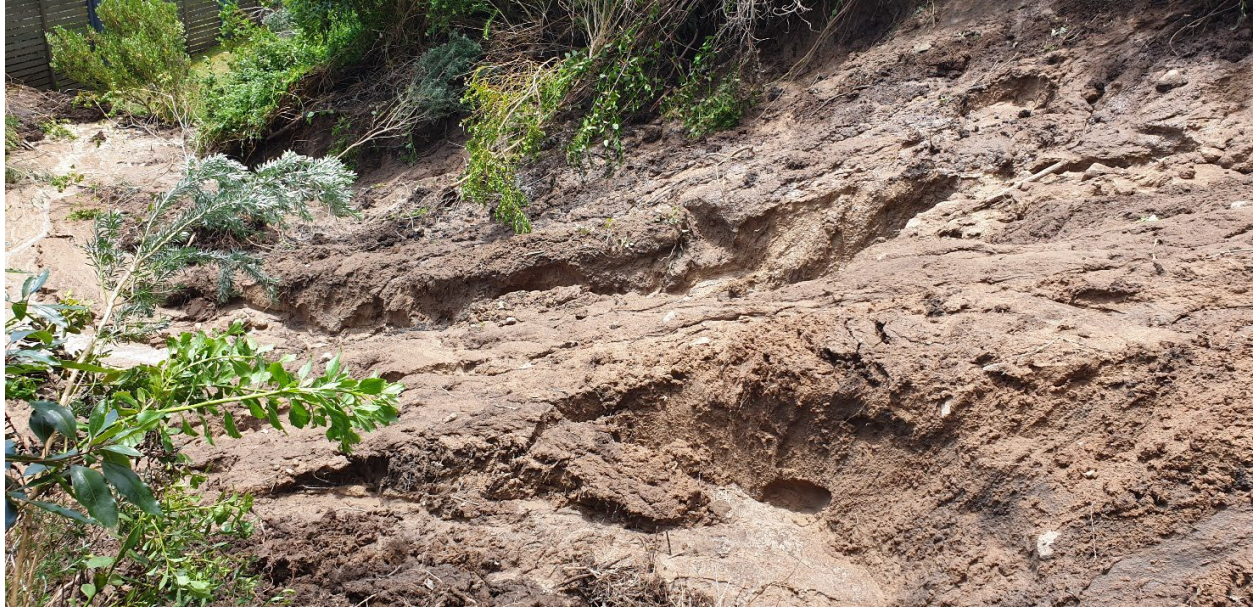
Figure 4-7: Debris flow path

Figure 4-7 shows the accumulation zone of the debris flow. It can be seen that the debris flow crossed over Penny Lane, which lies between 10-12 View Point Road and the houses along Pt Nepean Road, and into the rear of two properties.

While a large amount of the upper soils have already flowed down slope, it is considered that there is potential for addition debris flows to initiate in the accumulation zone of the landslide and impact on the area down slope.

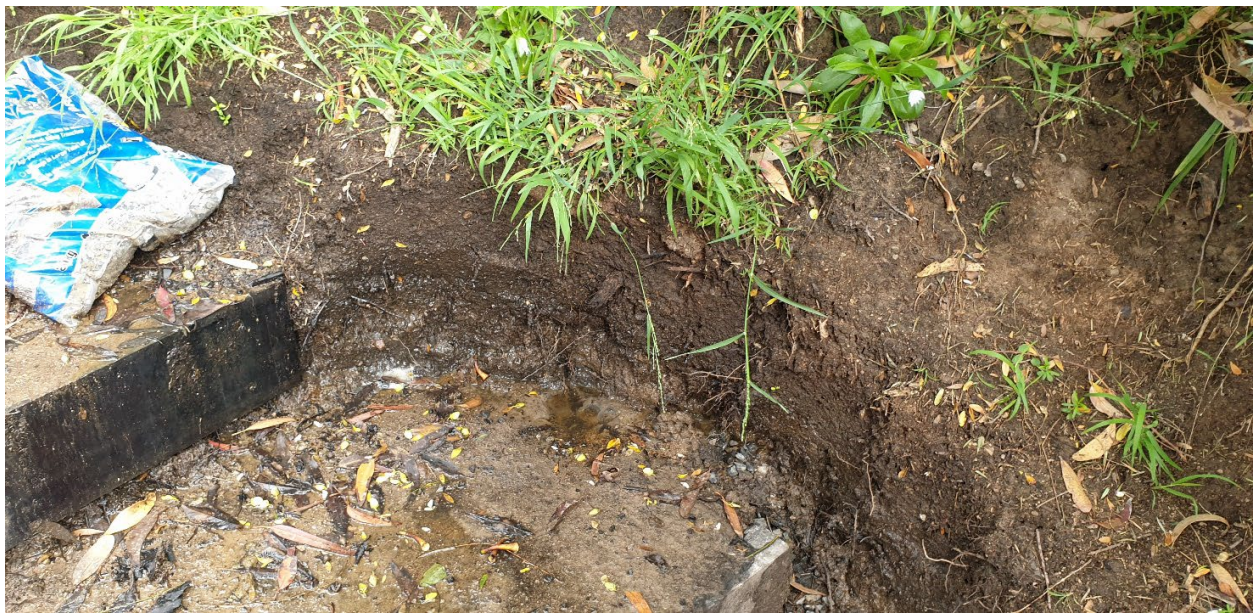
Figure 4-9: Water seepage on left side of site

The conditions on either side of where the debris flow occurred were observed to be significantly different. On the right (western) side the conditions were quite dry and there was no evidence of water seepage. However, on the left (eastern) side there were a number of water seeps observed. These water seeps were observed to be flowing freely more than 24 hours after the heavy rainfall event.

Based on the evidence of tension cracks up slope of this eastern area and that there are significant springs in the area, it is considered that there is potential for a landslide or debris flow to develop within the eastern area especially if there is another heavy rainfall event. However, such a landslide would be unlikely to extend as far east as the property at 2 Penny Lane.

An example of one of the water seeps is shown in Figure 4-8.

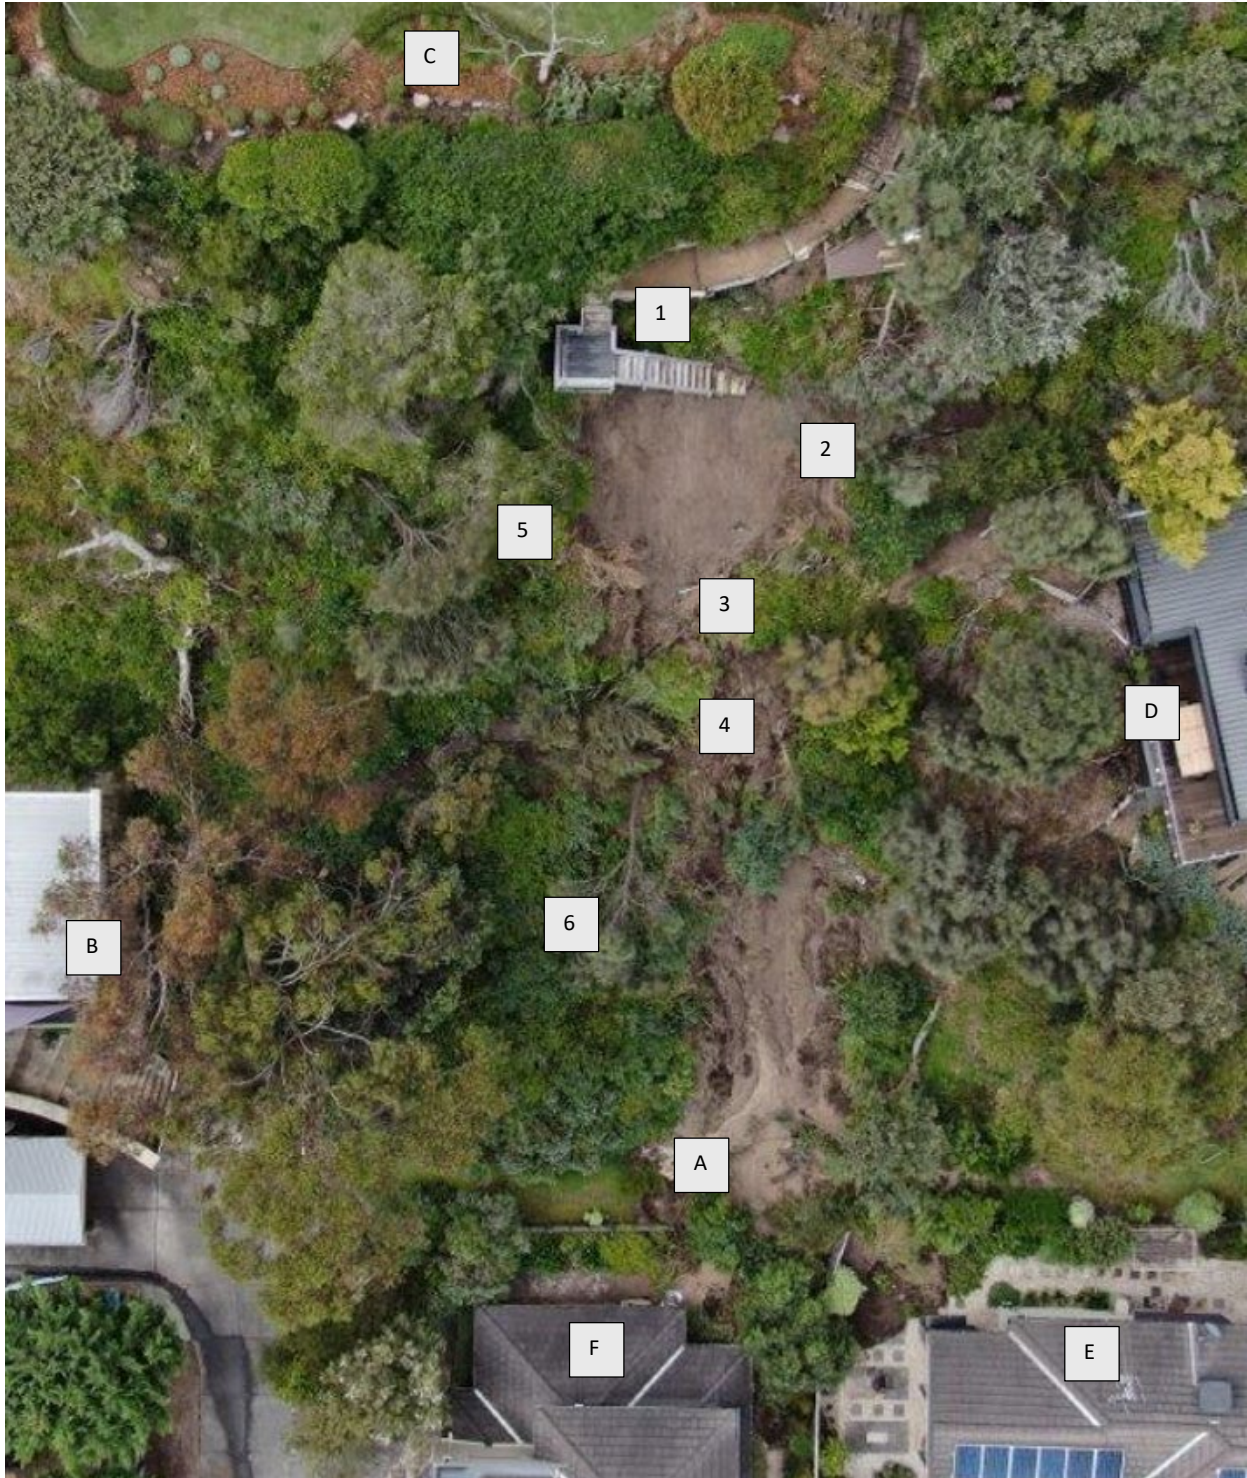
Figure 5-1: Potential Landslide Hazards and Properties at Risk

A number of different potential landslide hazards have been identified for the site. These are identified on Figure 5-1 as numbers 1 to 6 with a description provided below. The properties at risk are shown as letters A to F.

1. Recession of the head scarp of the upper landslide resulting in a translation landslide down slope. It is considered such a landslide would be similar to that which recently occurred on the upper slope such that material would most likely translate to a lower part of the slope but most likely not cross Penny Lane such that it remains within Property C. The landslide would most likely be moderate to rapid. While most likely people in the area would identify the landslide moving and move out of the way, there is potential some people would be impacted.

2. Widening of the landslide on the upper slope to the right of the existing landslide, where the tension cracks are currently located. It is considered such a landslide would be similar to that which recently occurred on the upper slope such that material would most likely translate to a lower part of the slope but most likely not cross Penny Lane. This landslide would predominantly be within Property C but could flow over the eastern edge of Property D. The landslide would most likely be moderate to rapid. While most likely people in the area would identify the landslide moving and move out of the way, there is potential some people would be impacted.

3. Reactivation of the upper landslide debris as a translational landslide. This landslide could occur due to moisture build up within the landslide debris resulting in this material translating down slope. It is considered that there is sufficient material that the landslide could flow into the rear of Property F and potentially Property E. The landslide would most likely be rapid to very rapid and as such people would have difficulty avoiding the landslide if they were engaged in other activities in the area at the time.

4. New debris flow similar that that which previously occurred. Due to the build up of material at the base of the upper landslide there is potential for this material to become saturated, especially if a heavy rainfall event occurred. Should a debris flow occur rather than a translational landslide then the event would be very rapid to extremely rapid and would flow into the rear of Property E and F with similar or greater impact than the recent debris flow.

5. Widening of the landslide on the upper slope to the left of the existing landslide. It is considered such a landslide would be similar to that which recently occurred on the upper slope such that material would most likely translate to a lower part of the slope but most likely not cross Penny Lane. This landslide would predominantly be with within Property D and would be unlikely to extend to Property B. The landslide would most likely be moderate to rapid. While most likely people in the area would identify the landslide moving and move out of the way, there is potential some people would be impacted.

6. Activation of a translational landslide on the lower slope to the left of the existing landslide. This area is very wet and showing some signs of movement. If such a landslide were to occur it could flow across Penny Lane and impact on the dwelling at Property F. It could also potentially flow as wide as the drive way of Property B. The landslide would most likely be rapid to very rapid and as such people would have difficulty avoiding the landslide if they were engaged in other activities in the area at the time.

- A. The Penny Lane Road Reserve
- B. 3 Penny Lane
- C. 10-12 View Point Road (Only considers area to north (rear) of house, house not at risk)
- D. 14-16 View Point Road
- E. 3/613 Pt Nepean Road
- F. 2 Penny Lane

The risk analysis has shown that the Risk to Life for Property A (the Penny Lane road reserve) is 'Not Tolerable' in the slope's current condition. The risk for Property A will continue to remain at this level of risk until appropriate remediation works have been conducted to reduce the risk. As such it is recommended that Penny Lane be barricaded off from the driveway of Property D through to the driveway of Property B. Barricading off the site will significantly reduce the temporary probability of people being impacted by the landslide such that the risk can be reduced to a 'Tolerable' level.

The risk analysis has shown that the Risk to Life for Property C (10-12 View Point Road) is 'Not Tolerable' in the slope's current condition. However, the 'Not Tolerable' is considered to only apply to the steep section of the site and the area within 5m of the crest of the slope. The area beyond 5m from the slope at the crest is considered to have a 'Tolerable' risk. As such it is recommended that the area within 5m of the crest of the slope be barricaded off to prevent access to the site. The barricade should extend from one side of the

property to the other and then down the boundaries with the neighbouring properties to Penny Lane. This will reduce the risk to a 'Tolerable' level for the occupiers of Property C provided that they do not enter the barricaded area. In addition, the occupiers should be provided with the AGS(2007e) so that they are aware of appropriate hillside practices. It is important to note that in order to conduct remediation works it will be necessary for workers to enter the affected area. Remediation works should include an appropriate safety plan that outlines methodologies and practices that will be adopted to reduce the risk to workers to an acceptable level as well as minimize the risk to the buildings of Properties E & F during these works.

The risk analysis has shown that the Risk to Life for Properties E (3/613 Pt Nepean Road) and F (3 Penny Lane) is 'Not Tolerable'. Unfortunately barricading off the properties is not considered sufficient to allow people to return. This is because the barricades would not prevent the landslides from occurring and the risk to people even within the houses would not be tolerable. As such it is recommended that the occupants of these two properties are not allowed to return to living to their homes until appropriate rectification works are undertaken. Limited access to the properties may be allowed to the properties to gather belonging etc. provided that it is conducted under the control of a Shire engineer who will need to inspect the site prior to the occupants entering the area and be on site while the occupants are on site.
