# Expert Opinion Report - Landslide Assessment

10-12 View Point Road, McCrae

PSM5226-006R Rev0      11 June 2024

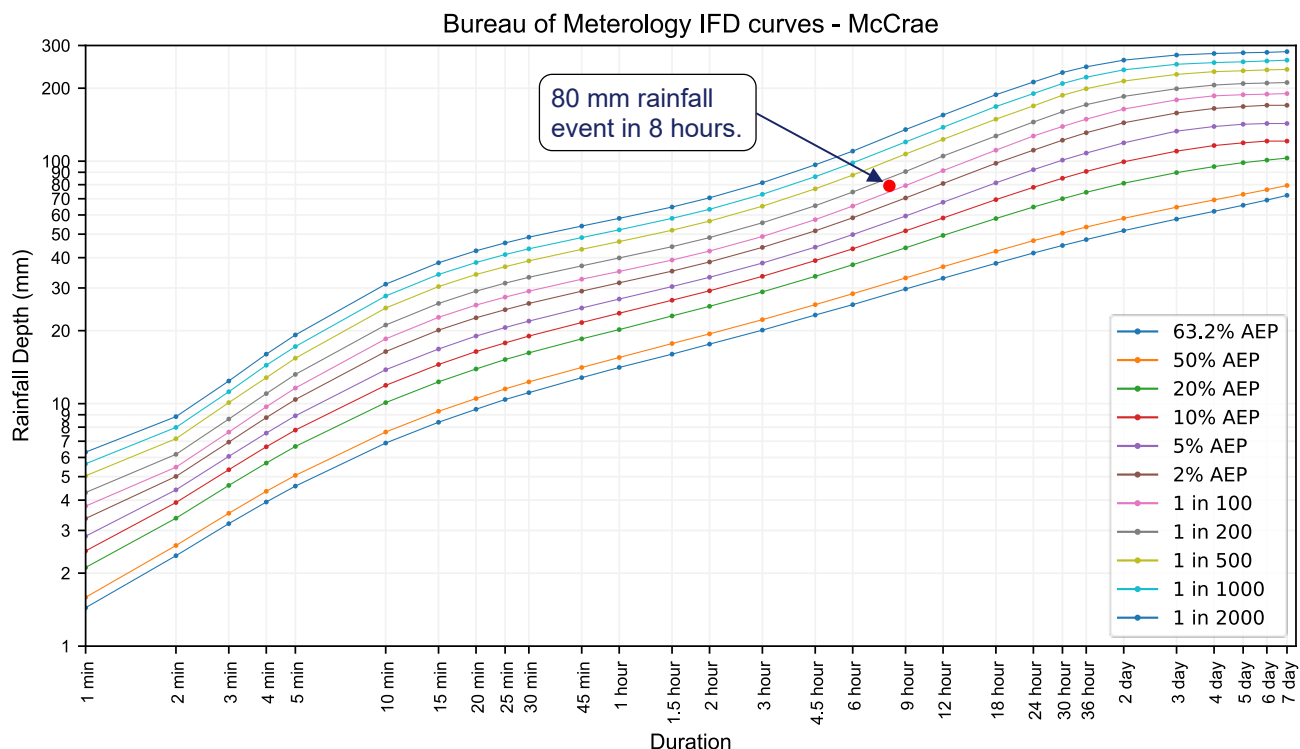
29. I have considered the Australian Rainfall and Runoff Intensity Frequency Duration (IFD) curves, published by BOM (<http://www.bom.gov.au/water/designRainfalls/revised-ifd/>, accessed 4 December 2023). These are presented in Inset 10.
30. These records indicate to me that:
- (a) The Rain Event intensity over the 8-hour period had 1 in 100 years to 1 in 200 years probability of occurring.
  - (b) 80 mm of rainfall in a 24-hour period has a 1 in 20 probability of occurring in any given year.
  - (c) The Rain Event was an infrequent and intense event.

**Inset 10: BOM IFD curves for McCrae, with Rain Event marked.**

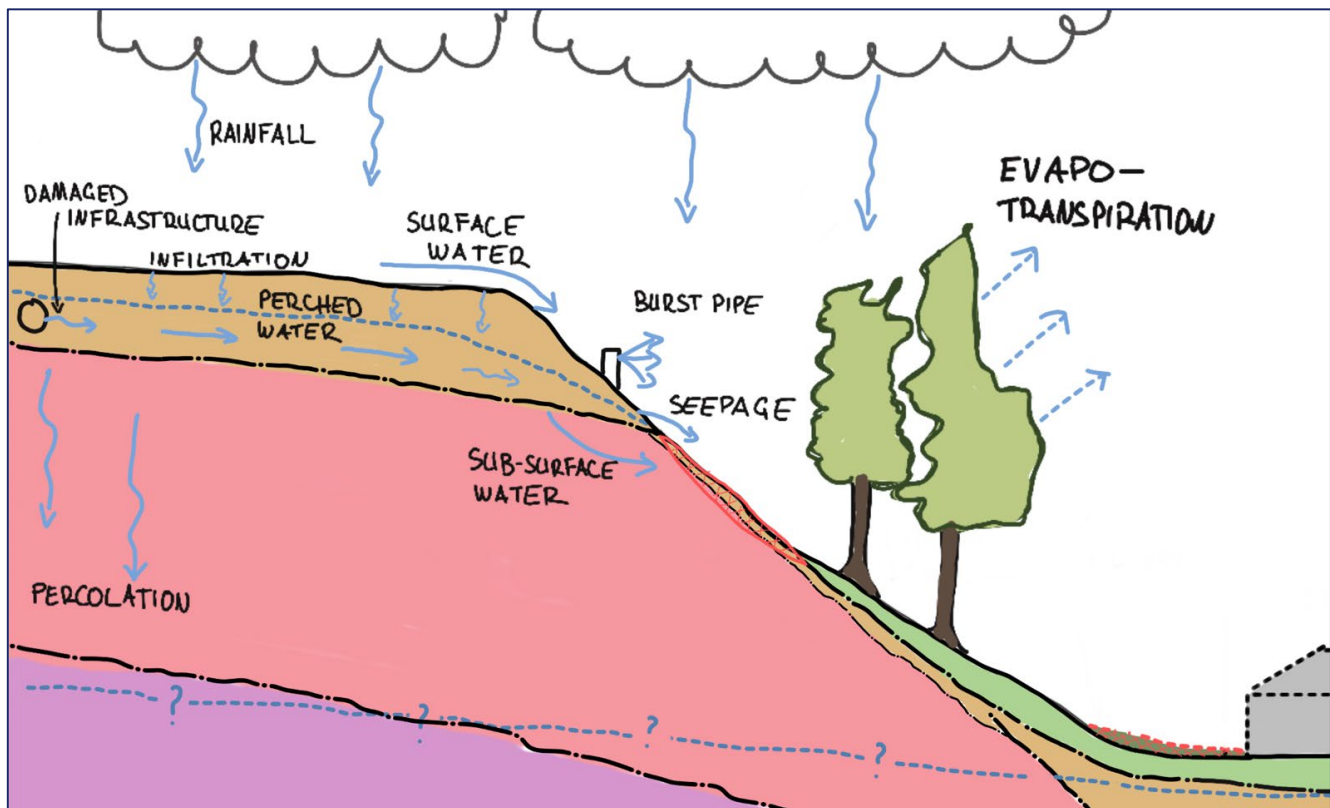
62. The soil water content in a slope change in response to the hydrologic processes of rainfall, infiltration, groundwater flow, evaporation, transpiration, and runoff. I have marked up my interpretation of the hydrologic process contributing to the soil water content of the slope, Inset 19. Based on engineering principles the shear strength of the unsaturated soil is not necessarily a fixed value and will change in response to variation in soil water content.

**Inset 19:** Conceptual illustration of hillslope hydrologic processes at the Site.

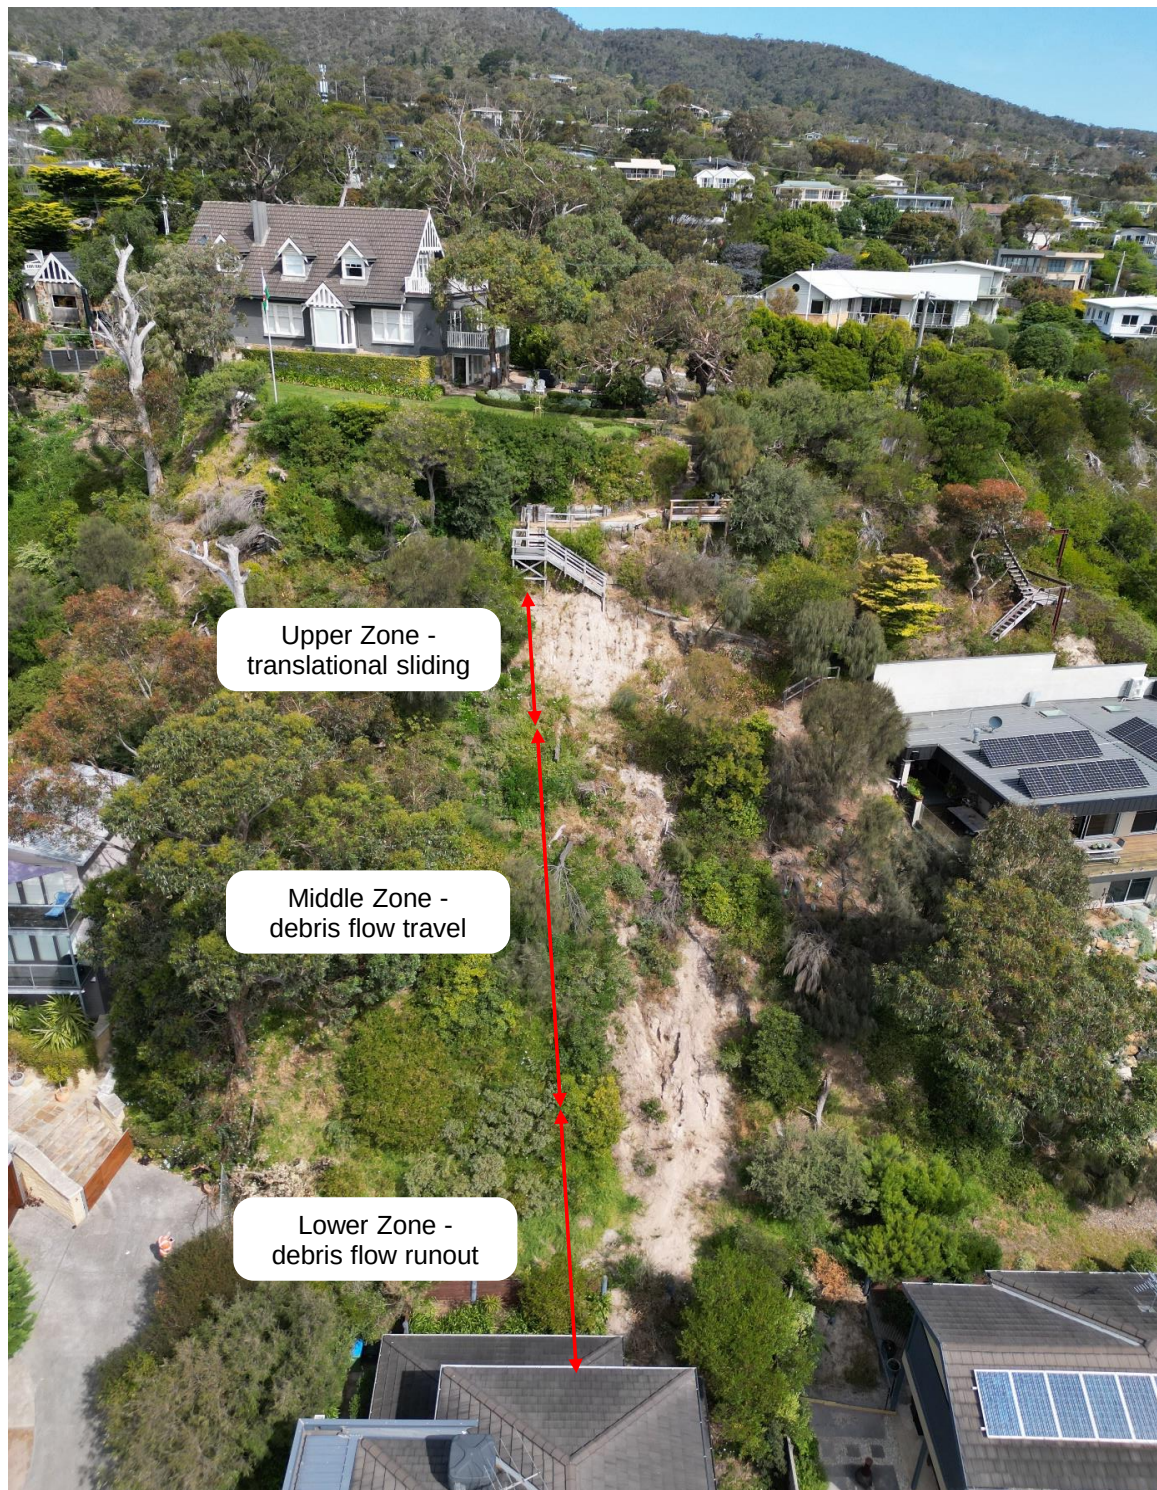
Photo 1 - Landslide Overview, with zones indicated

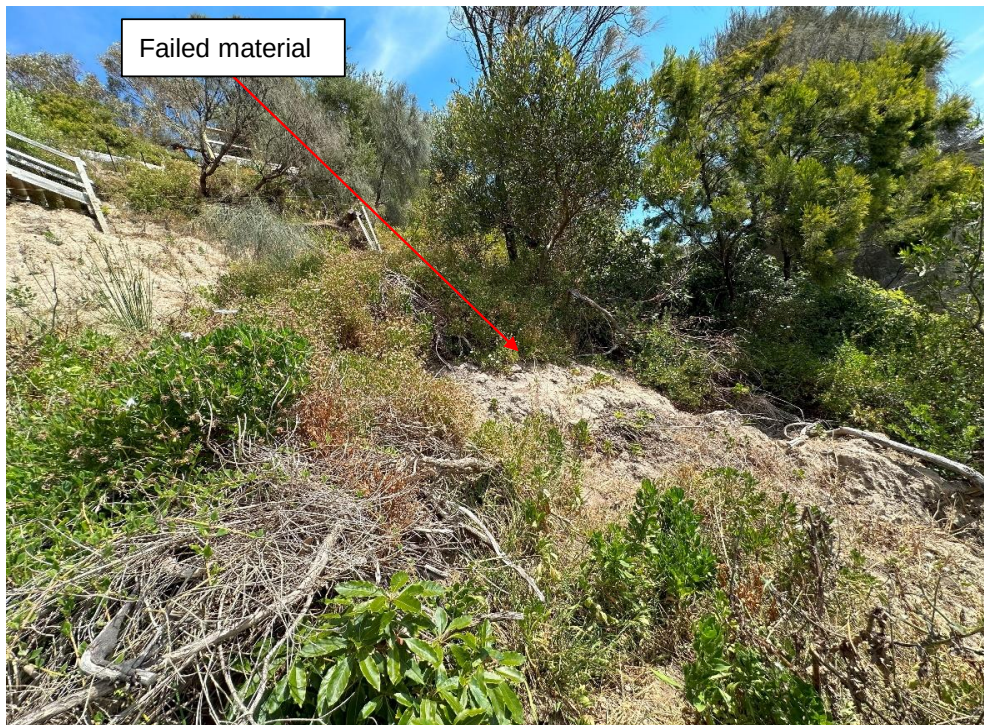
- (d) Disturbed ground that had undergone translational sliding but did not mobilise into a debris flow was observed on the right (western) flank of the Landslide, Photo 4 Appendix E.

Photo 4 - Failed material still on slope

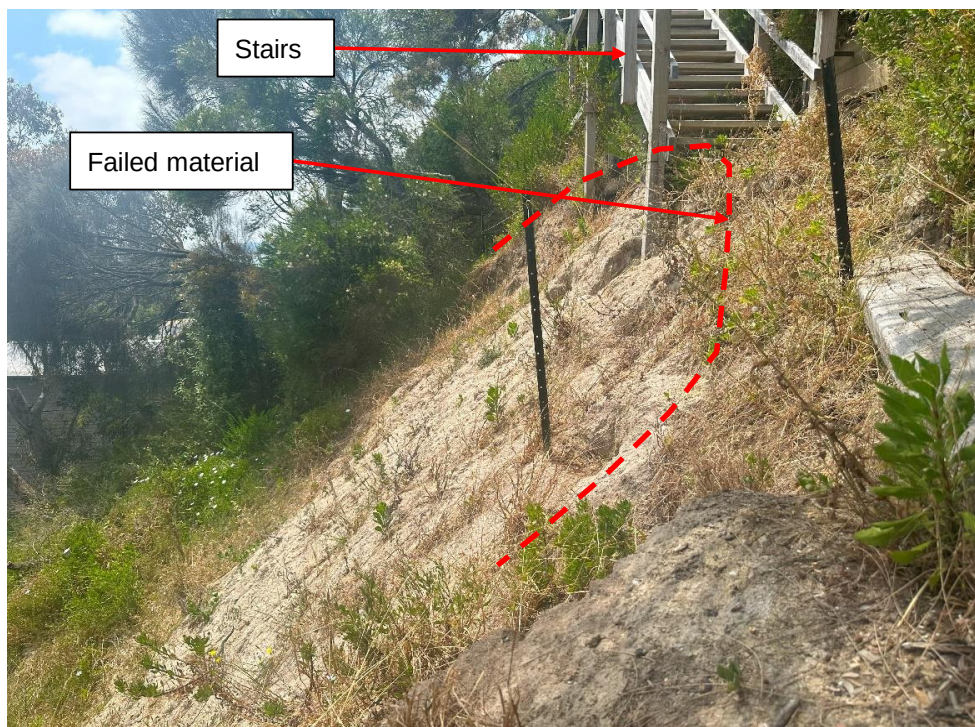
- (f) A lack of prominent backscarp, Photo 5 Appendix E, with minor steepening observed in the backscarp area and with a slope angle of approximately 45 degrees.

Photo 5 - Rear scarp of landslide, note lack of oversteepened backscarp

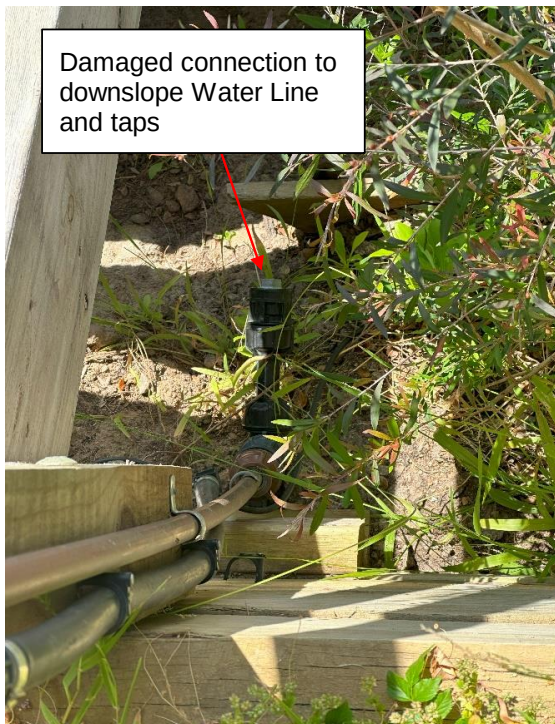
- (d) A variety of water infrastructure was observed across the Site, Photo 7 Appendix E including:
    - i. Subsurface 'agi-drains'
    - ii. Water pipes including taps. A 20 mm to 25 mm diameter blue line polyethylene pipe with a damaged connection was observed near the top of the stairs, immediately above the rear scarp of the landslide.

Damaged connection to  
downslope Water Line  
and taps

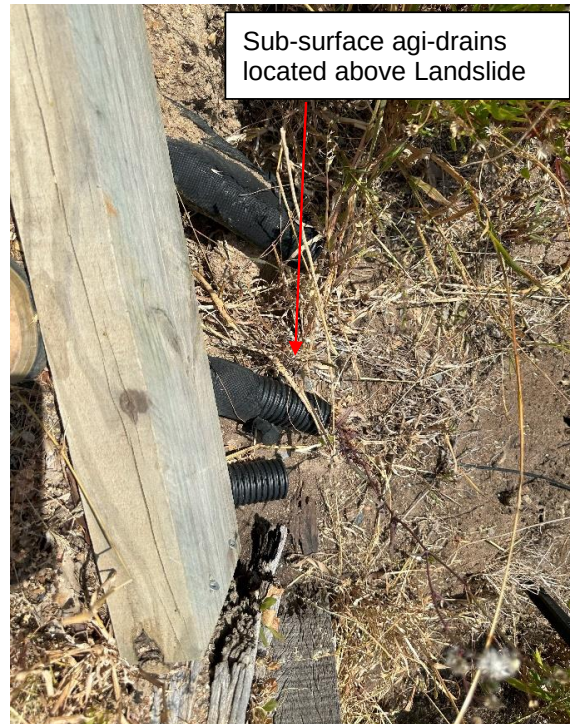
Sub-surface agi-drains  
located above Landslide

Photo 7 - Water infrastructure including water pipes (on left), and subsurface 'agi drains' (on right)

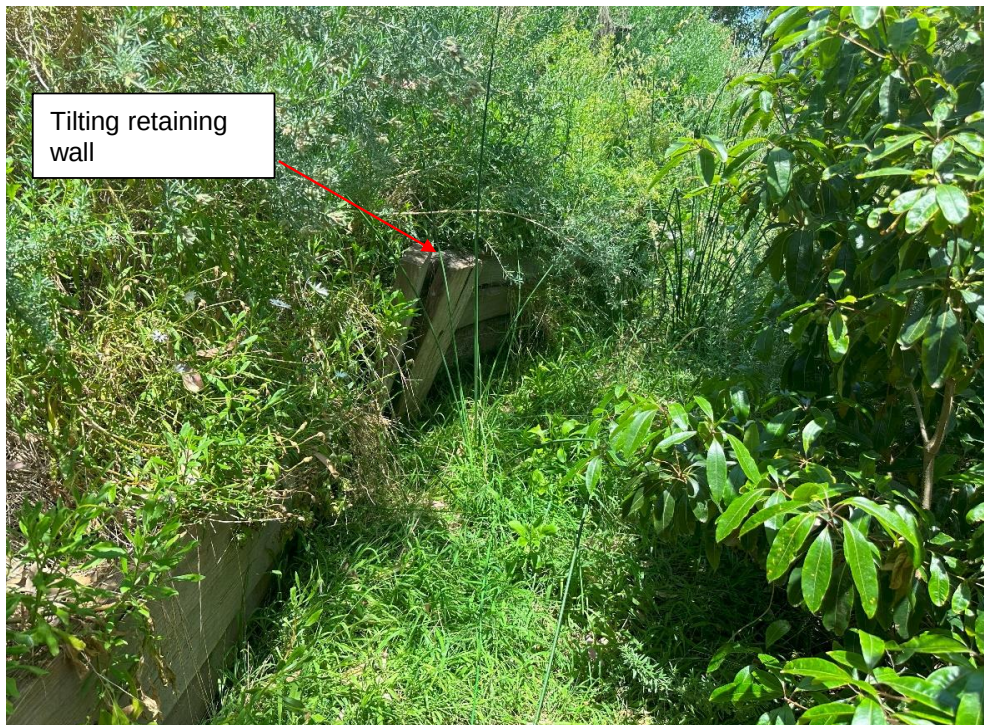
- (g) The condition of RWs across the Site was generally poor, with overturning and bulging RWs observed. A section of RW to the east of the Landslide had significant tilts. This indicates to me possible instability in the ground above the RW and possible structural or geotechnical failure of the RW, Photo 10 Appendix E. I note the RWs appear to be leaning more than as documented by Stantec (refer paragraph [20]).

Photo 10 - Tilting retaining walls on left side of Landslide

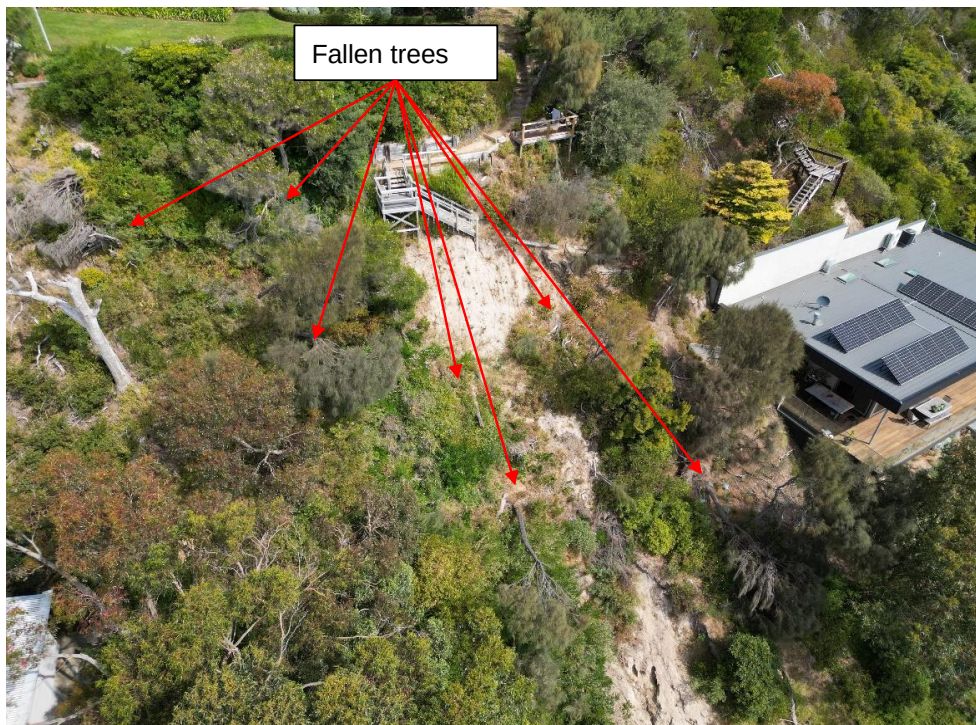
- (h) Numerous fallen trees were observed across the escarpment slope, Photo 11 Appendix E. I note that most of the failed trees appear to have failed from causes unrelated to the Landslide, i.e., wind or poor root embedment. I note at least one tree appears to have fallen because of the Landslide.

Photo 11 - Fallen trees

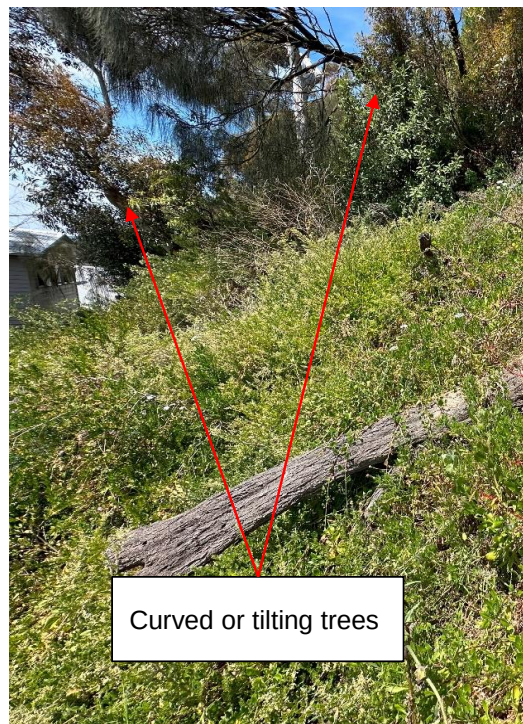
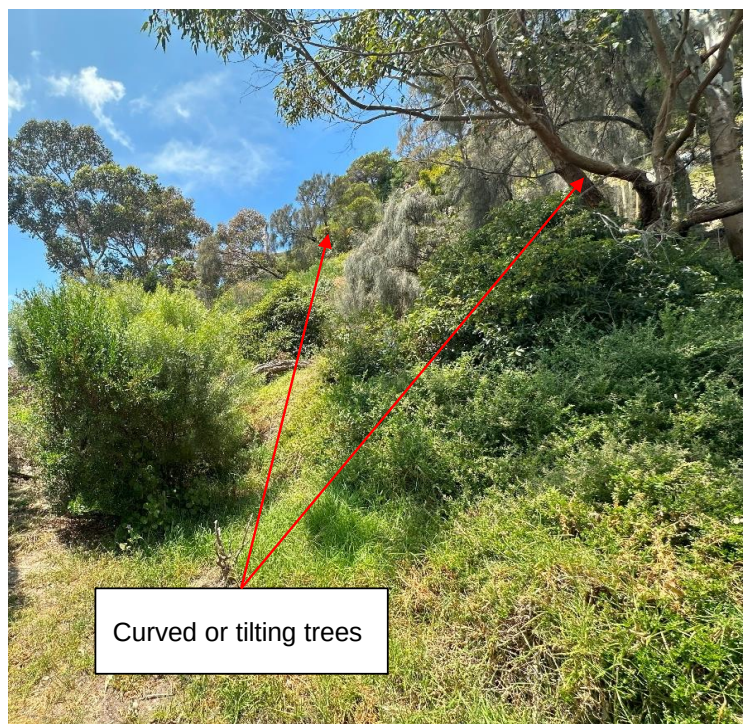
- (j) Leaning and curved trees were observed on the escarpment, suggesting possible creep movement of the slope, Photo 12 Appendix E.
43. Additional observations were made in the broader Site area to understand larger scale slope processes. These observations include:

Photo 12 - Curved or tilting trees

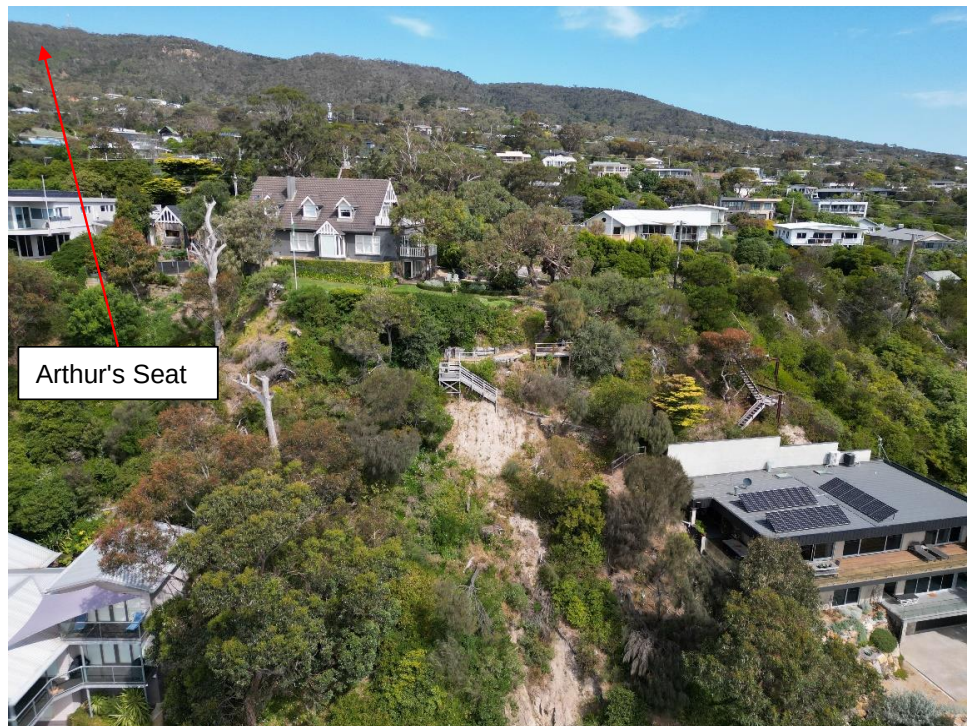
- iii. Granite rock is exposed in shore platform below the road.
    - iv. Steep to sub-vertical upper slopes is inferred to fail by undercutting and erosion of the lower slope leading to toppling/wedge style failures, Photo 15 Appendix E.

Photo 15 - Arthur's Seat in background
