# Expert Opinion Report - Landslide Assessment

10-12 View Point Road, McCrae

PSM5226-006R Rev0      11 June 2024

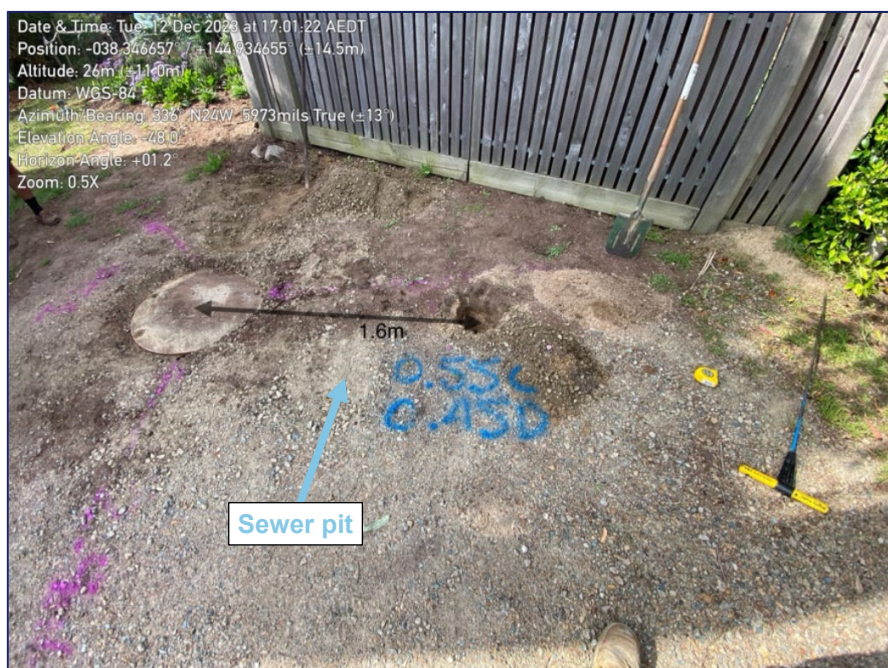
- Sewer, gas, water, and stormwater sub-surface utilities were identified in the nature strip, Inset 5.
13. I note that I have not observed any direct evidence of connectivity between this "void" and the Landslide.

**Inset 4:** Figure 3 of Safety Scan scanning report showing location of identified void. I have added my commentary in blue

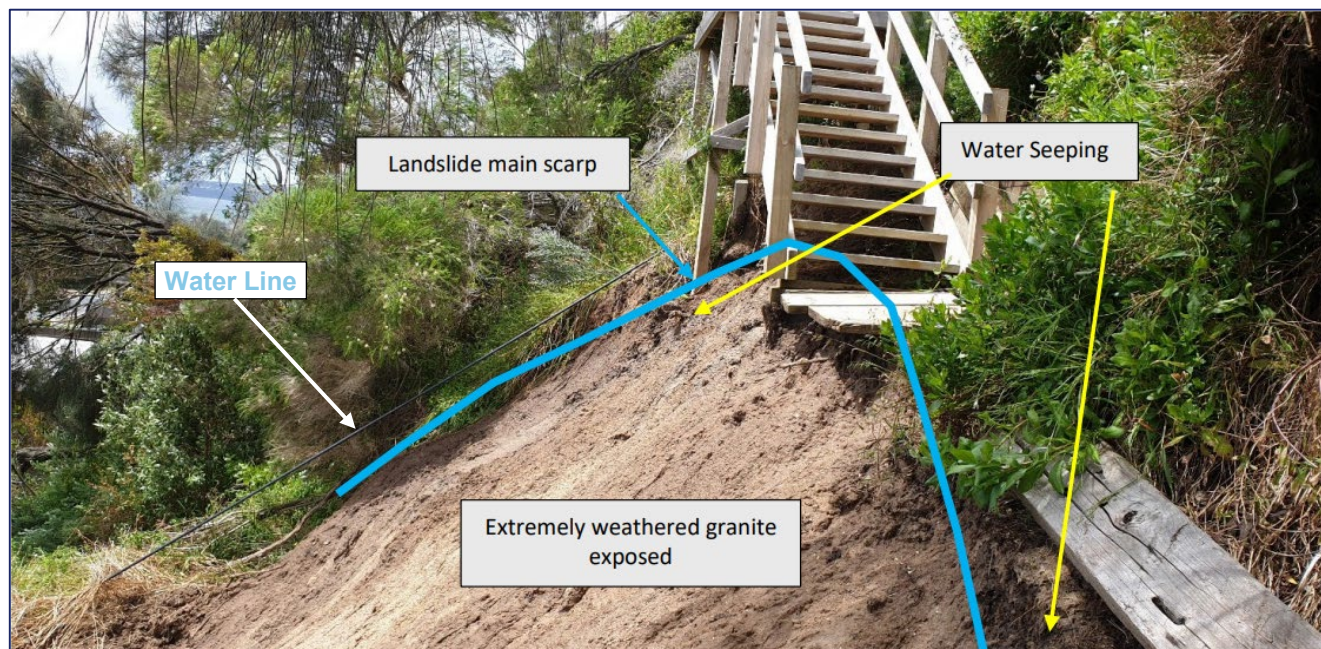
Figure 4-2 shows the main scarp of the landslide where it has undermined the existing stairs. It can be seen that the failure surface of the landslide runs parallel to the ground surface. The weathered granite is exposed in the failure surface. Looking at the side flank it can be seen that the thickness of soil that would have overlain the weathered granite is relatively shallow, possibly less than 0.5m.

Water was observed to be seeping from the head scarp at several locations more than 24 hours after the storm occurred. These seeps appear to be associated with natural springs further up slope.

**Inset 7: Figure 4-2 from the Stantec GA (pdf page 23 of the Brief), I have added my commentary in blue.**

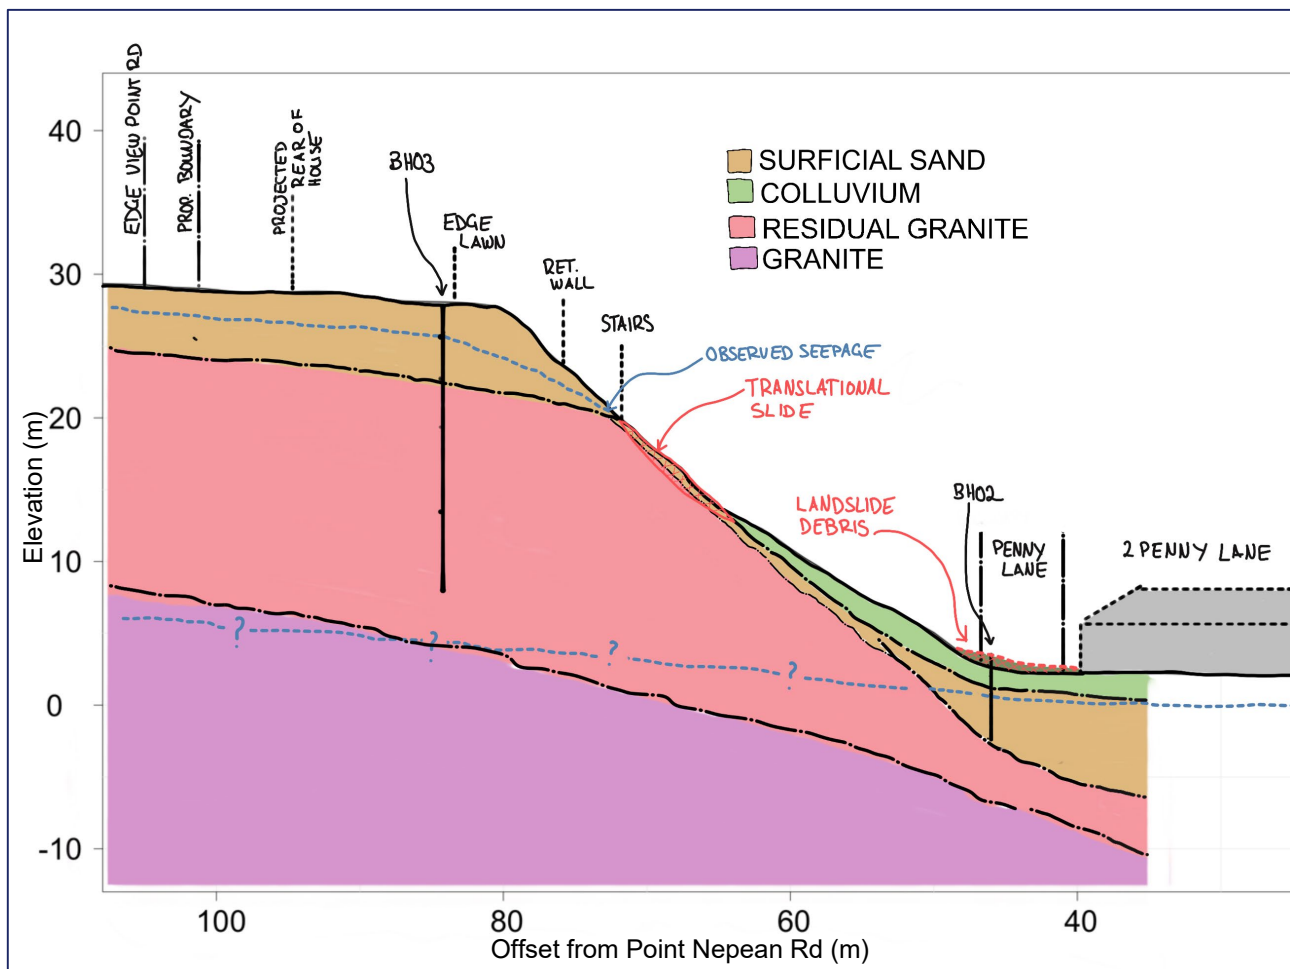
53. My interpretation of the geological conditions is presented in Inset 15. With regards to the geotechnical model, I note the following key observations:
- (a) There is uncertainty regarding the contact between the SURFICIAL SAND and the RESIDUAL GRANITE owing to the likelihood of some of the parent material of the SURFICIAL SAND being derived from erosion of the Dromana Granite. I have assumed that the wet soils are an indicator of the contact between the two geotechnical units.
  - (b) The laboratory testing indicates that all samples between 3 m and 19 m bgl have very similar Particle Size Distributions, Inset 16, and Atterberg limits indicate low plasticity CLAY fines.

Inset 15: Cross section of my geotechnical model.

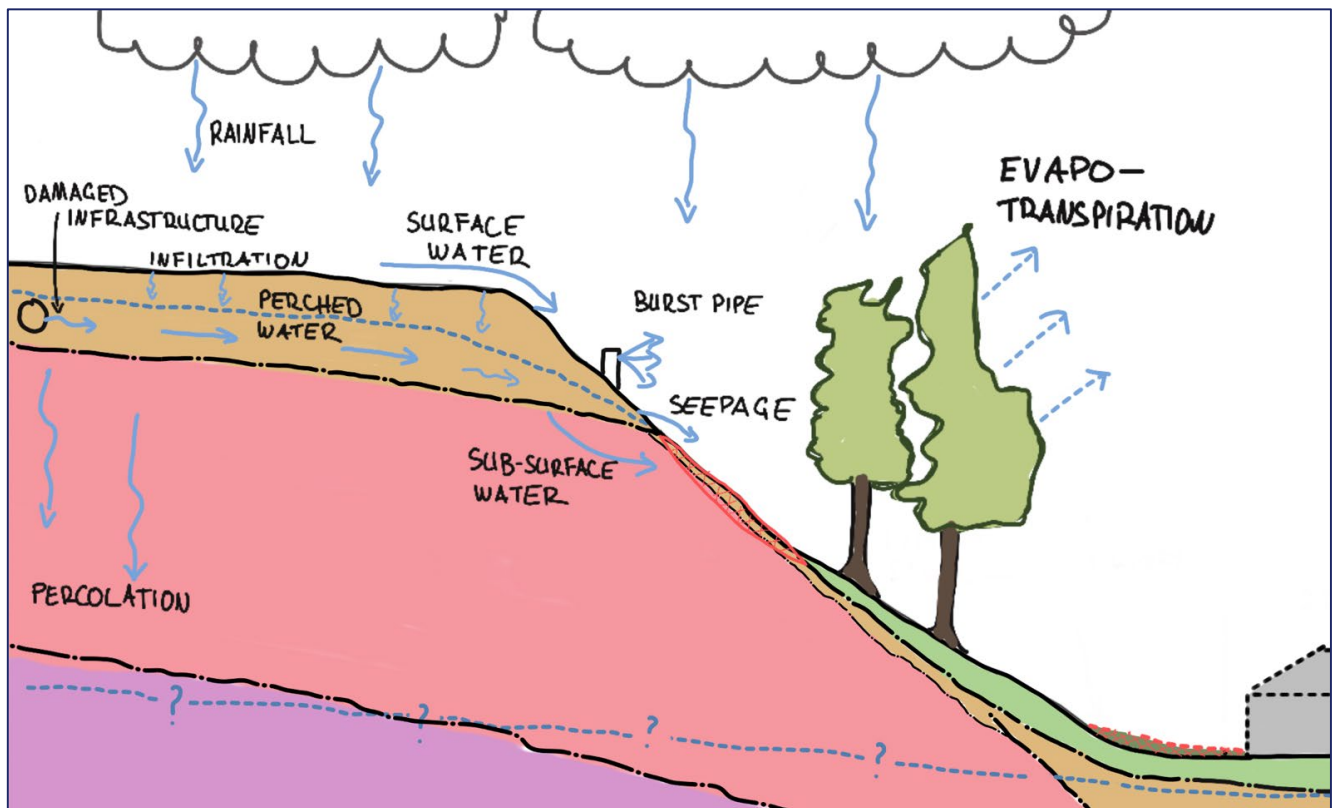
62. The soil water content in a slope change in response to the hydrologic processes of rainfall, infiltration, groundwater flow, evaporation, transpiration, and runoff. I have marked up my interpretation of the hydrologic process contributing to the soil water content of the slope, Inset 19. Based on engineering principles the shear strength of the unsaturated soil is not necessarily a fixed value and will change in response to variation in soil water content.

**Inset 19:** Conceptual illustration of hillslope hydrologic processes at the Site.

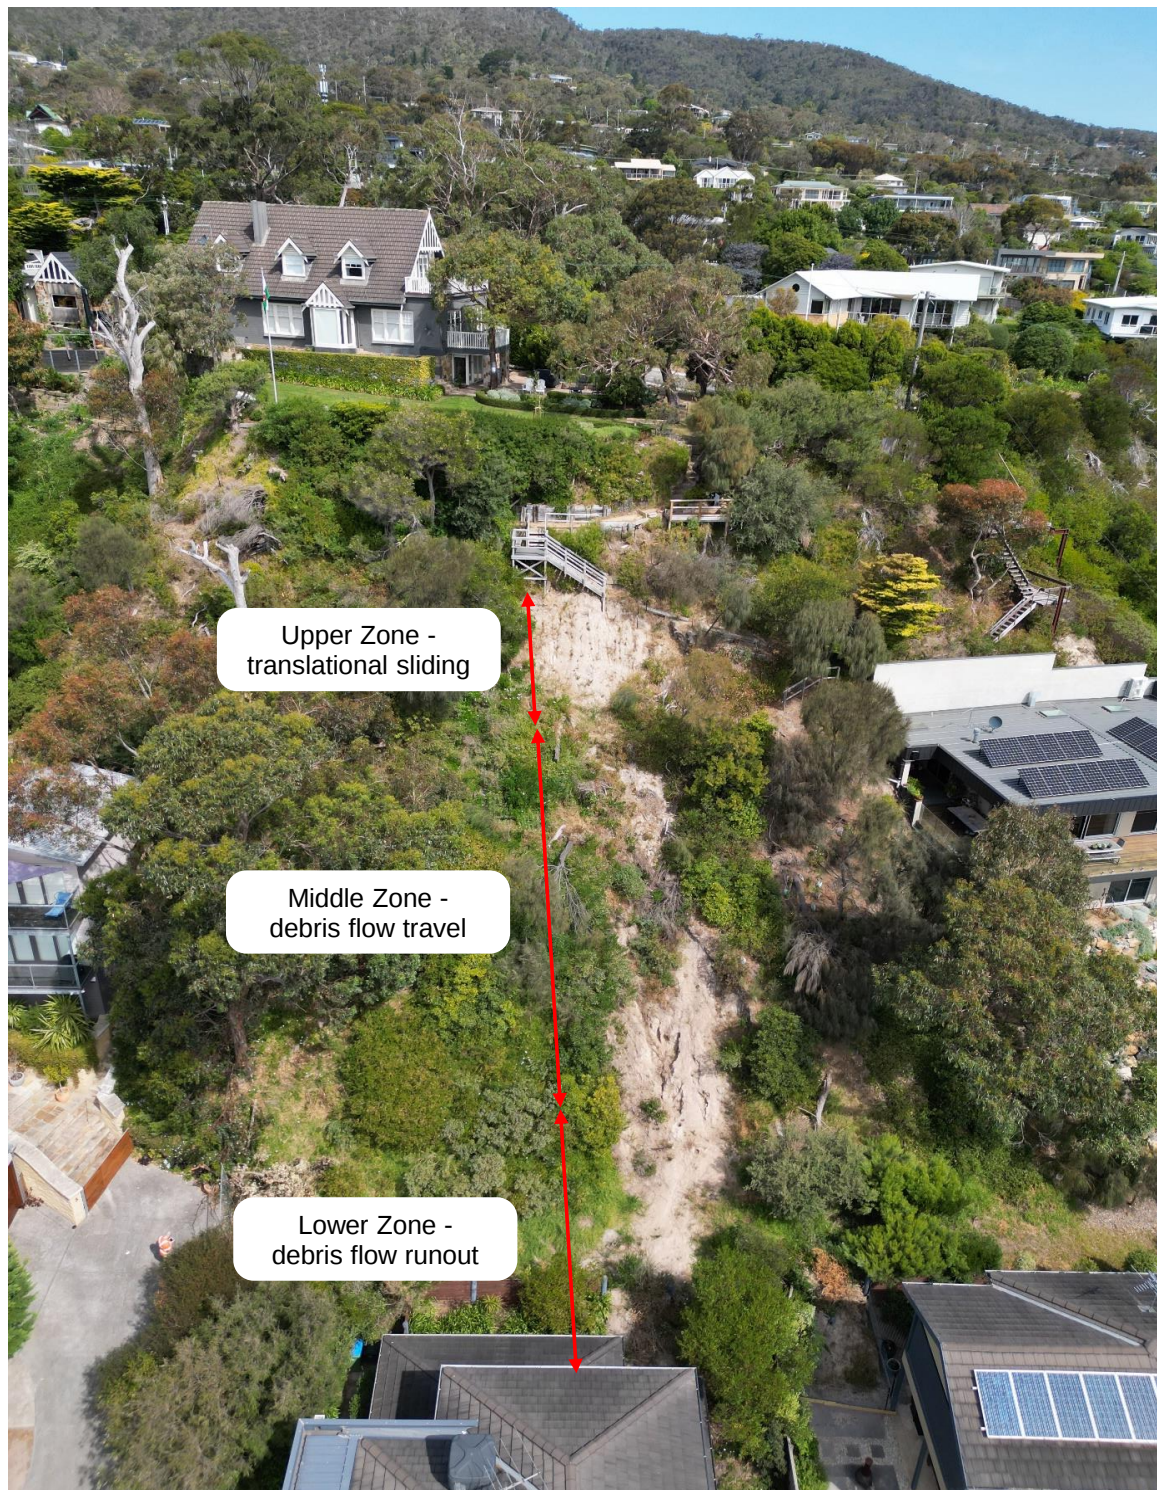
- (b) It was inferred to have initiated as a translational slide followed by mobilisation of failed material into a debris flow which was deposited at the toe of the slope, Photo 2 Appendix E.

Photo 1 - Landslide Overview, with zones indicated

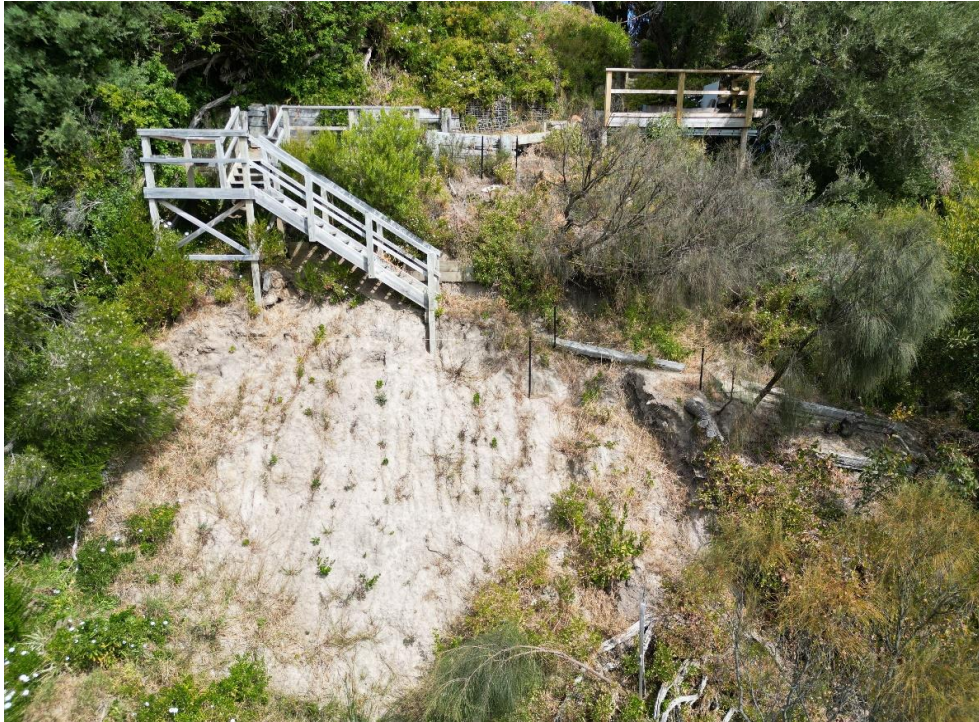
Photo 3 - Upper translational sliding area

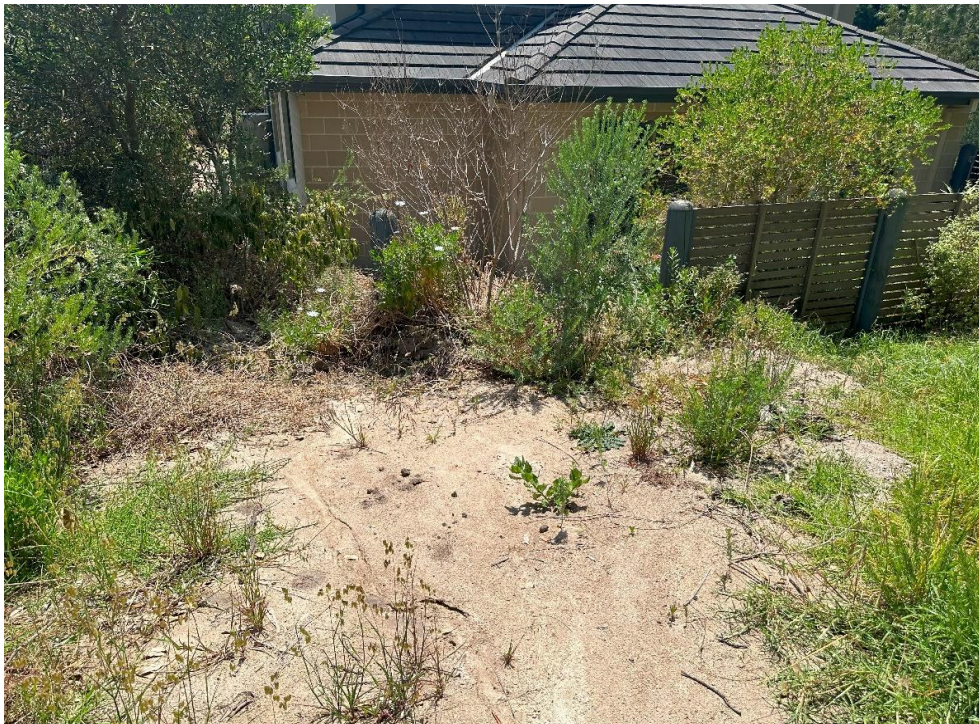
Photo 4 - Debris flow runout area, Property P2 visible in background

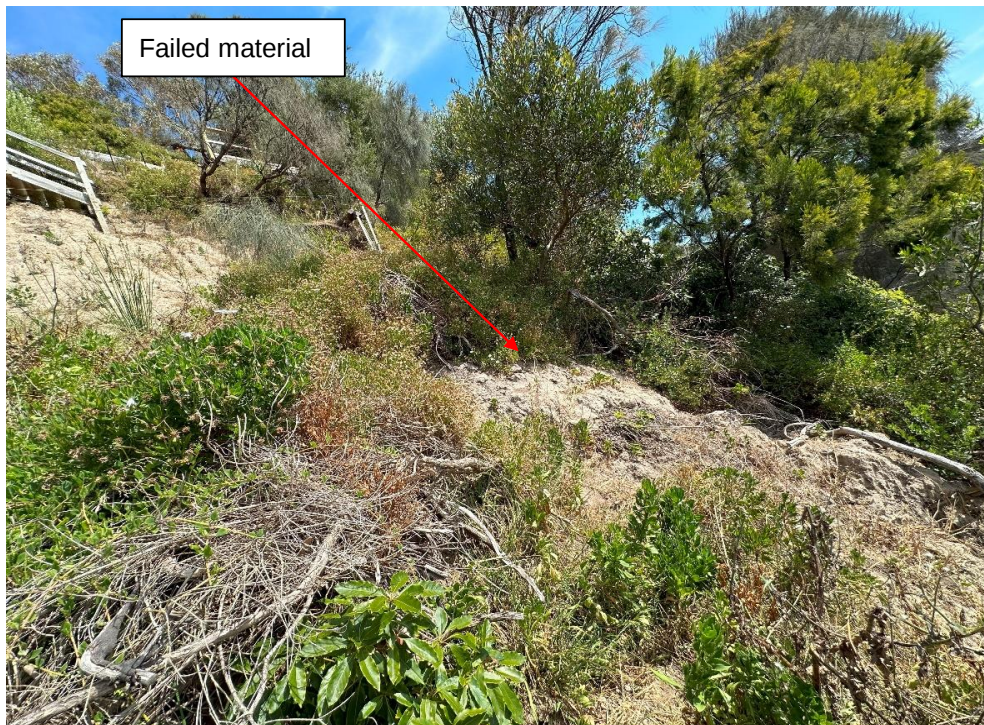
- (d) Disturbed ground that had undergone translational sliding but did not mobilise into a debris flow was observed on the right (western) flank of the Landslide, Photo 4 Appendix E.

Photo 4 - Failed material still on slope

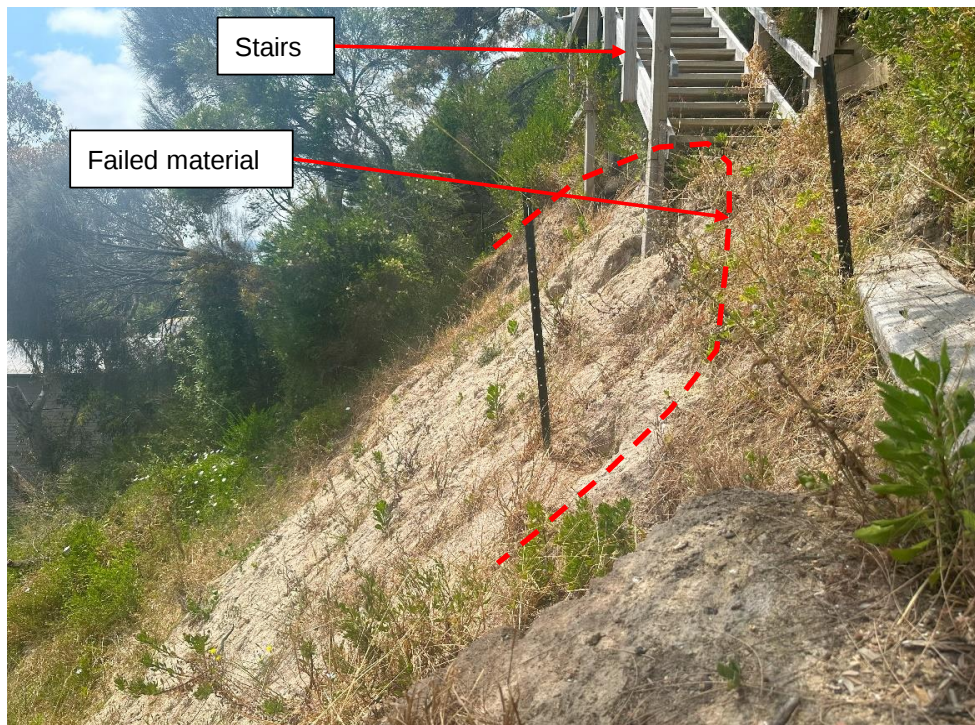
- (f) A lack of prominent backscarp, Photo 5 Appendix E, with minor steepening observed in the backscarp area and with a slope angle of approximately 45 degrees.

Photo 5 - Rear scarp of landslide, note lack of oversteepened backscarp

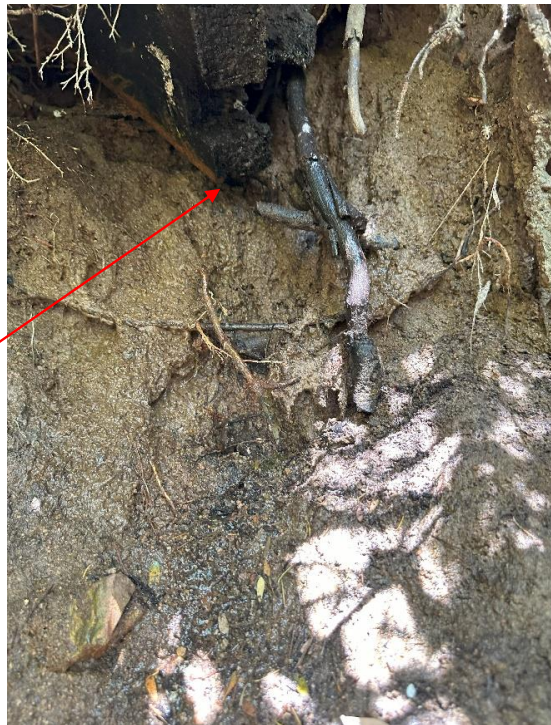
- (c) Groundwater was observed to be seeping from the slope to the east of the stairs, Photo 6 Appendix E. This location has been marked on Figure 1. I note this location is different from the headscarp seepage noted in the Stantec GA, refer paragraph [14(c)], however is consistent with Seepage on the eastern portion of the slope noted by Stantec GA, refer paragraph [14(d)].

Groundwater seeping from slope

Photo 6 - Groundwater seepage

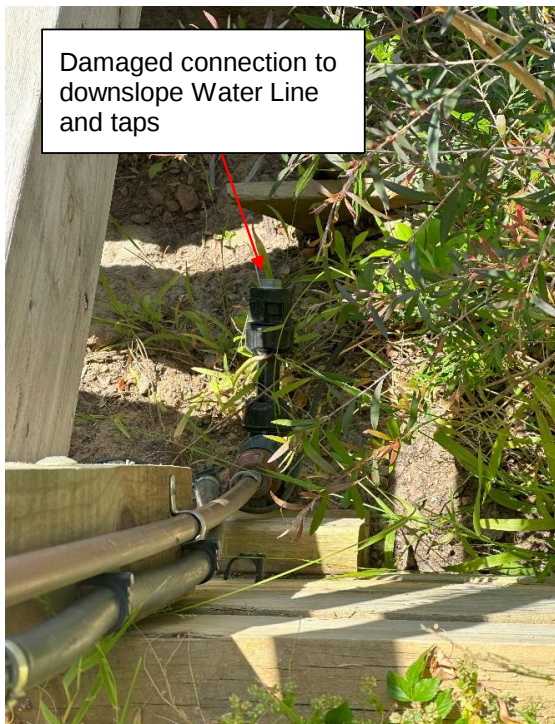
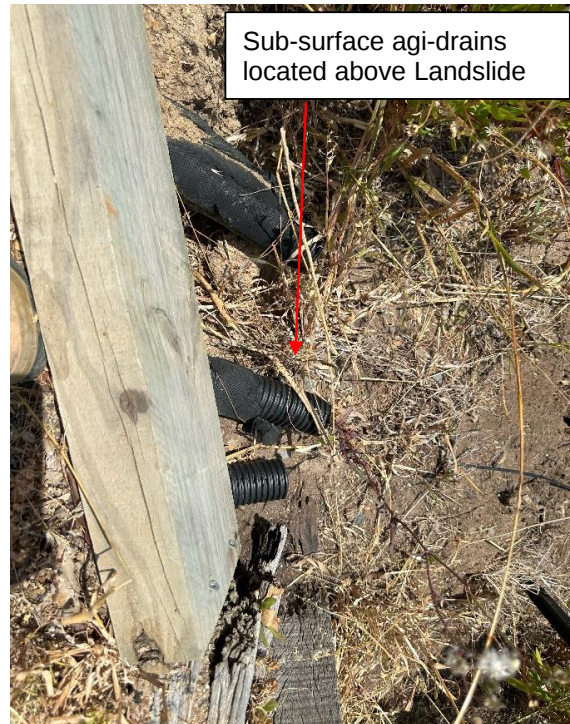
- (d) A variety of water infrastructure was observed across the Site, Photo 7 Appendix E including:
    - i. Subsurface 'agi-drains'
    - ii. Water pipes including taps. A 20 mm to 25 mm diameter blue line polyethylene pipe with a damaged connection was observed near the top of the stairs, immediately above the rear scarp of the landslide.

Damaged connection to downslope Water Line and taps

Sub-surface agri-drains located above Landslide

Photo 7 - Water infrastructure including water pipes (on left), and subsurface 'agri drains' (on right)

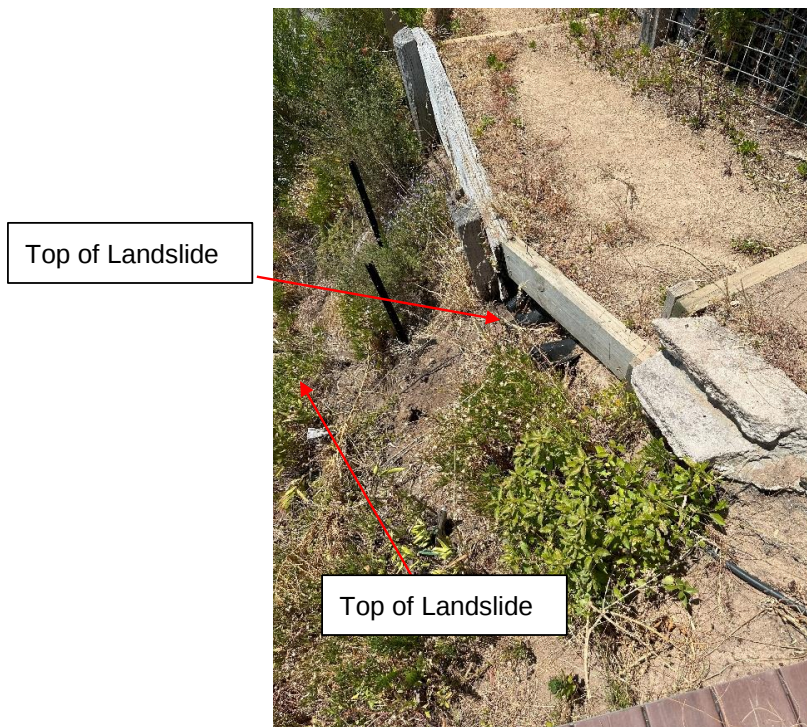
Photo 8 - Path above Landslide, note minor retaining walls and 'agi drains' from Photo 7

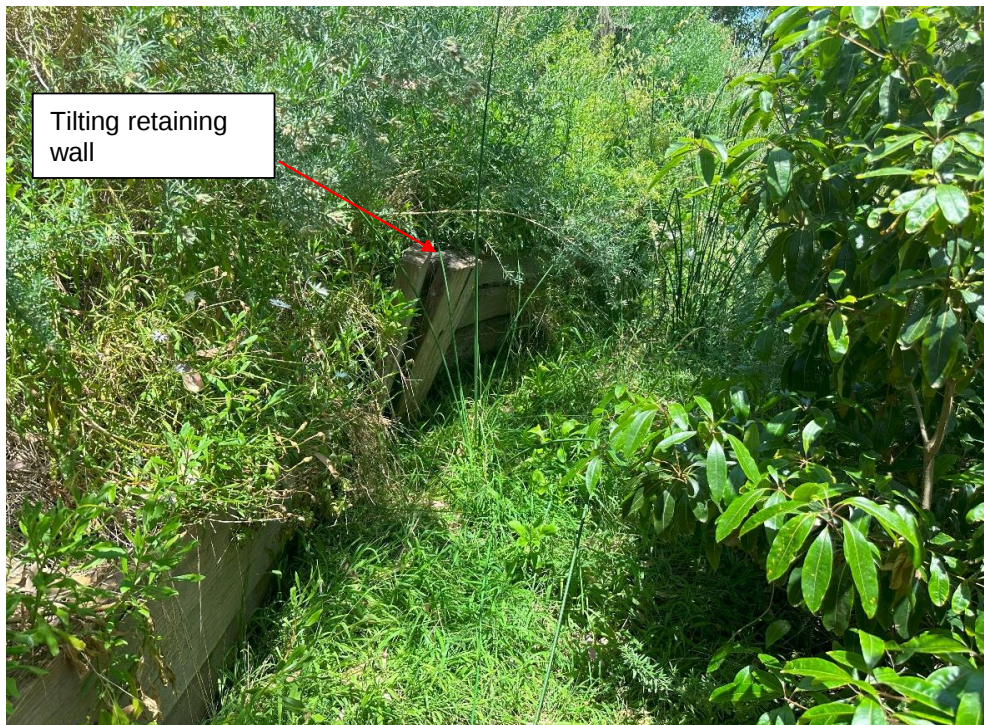
- (g) The condition of RWs across the Site was generally poor, with overturning and bulging RWs observed. A section of RW to the east of the Landslide had significant tilts. This indicates to me possible instability in the ground above the RW and possible structural or geotechnical failure of the RW, Photo 10 Appendix E. I note the RWs appear to be leaning more than as documented by Stantec (refer paragraph [20]).

Photo 10 - Tilting retaining walls on left side of Landslide

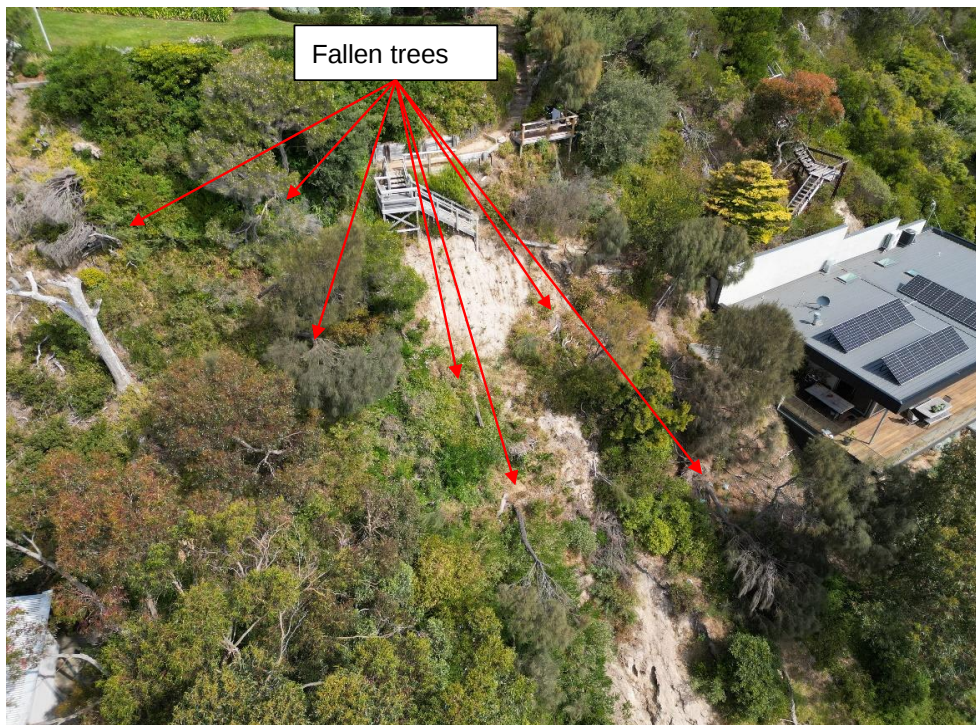
- (h) Numerous fallen trees were observed across the escarpment slope, Photo 11 Appendix E. I note that most of the failed trees appear to have failed from causes unrelated to the Landslide, i.e., wind or poor root embedment. I note at least one tree appears to have fallen because of the Landslide.

Photo 11 - Fallen trees

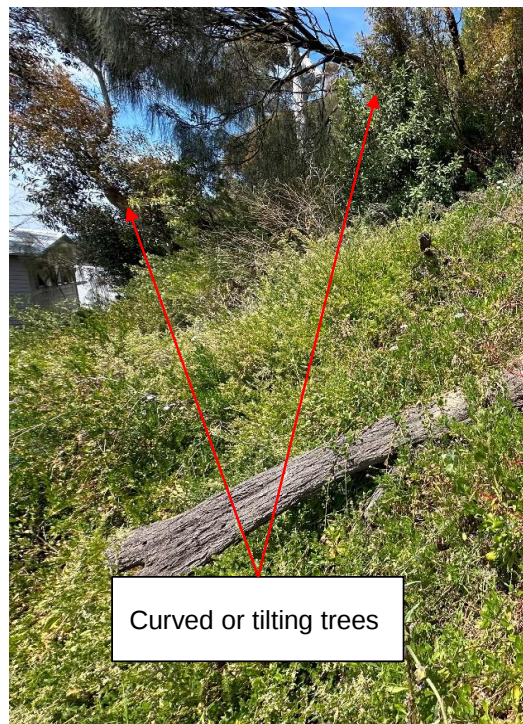
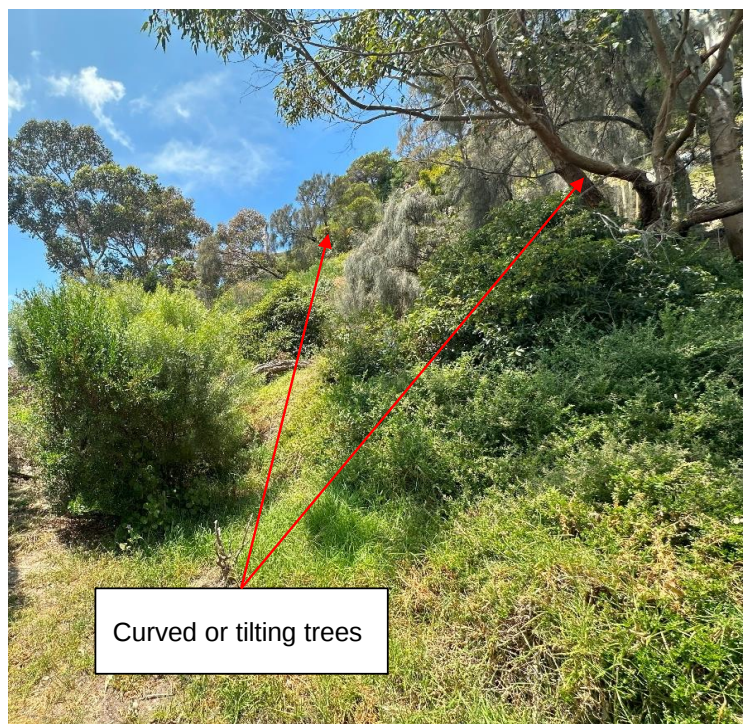
- (j) Leaning and curved trees were observed on the escarpment, suggesting possible creep movement of the slope, Photo 12 Appendix E.
43. Additional observations were made in the broader Site area to understand larger scale slope processes. These observations include:

Curved or tilting trees

Photo 12 - Curved or tilting trees

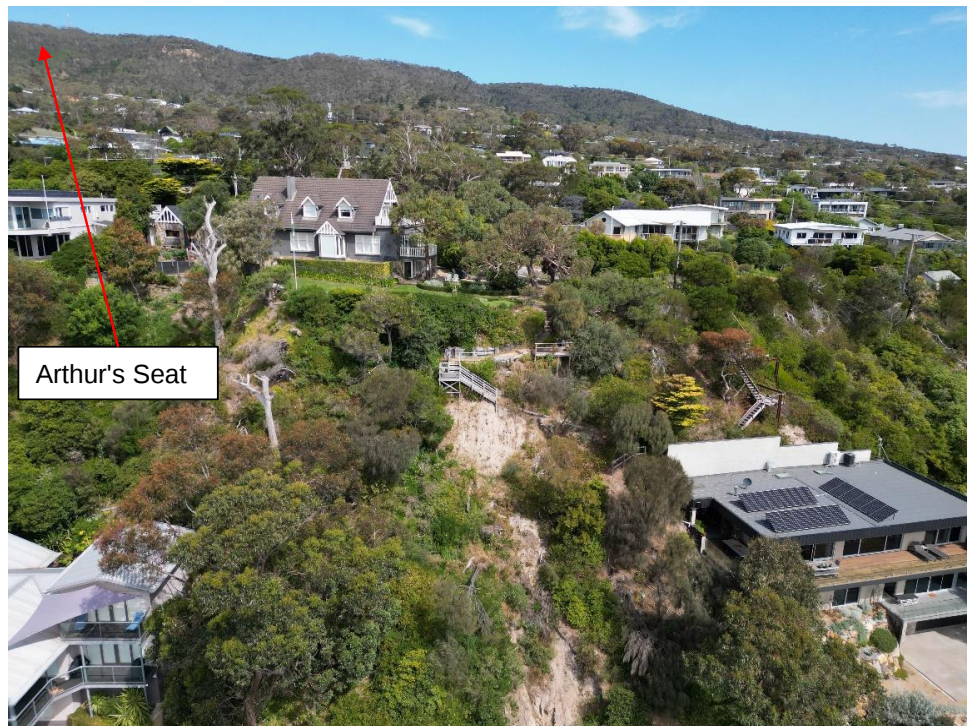
- iii. Granite rock is exposed in shore platform below the road.
    - iv. Steep to sub-vertical upper slopes is inferred to fail by undercutting and erosion of the lower slope leading to toppling/wedge style failures, Photo 15 Appendix E.

Photo 15 - Arthur's Seat in background
