# Expert Opinion Report - Landslide Assessment

10-12 View Point Road, McCrae

PSM5226-006R Rev0      11 June 2024

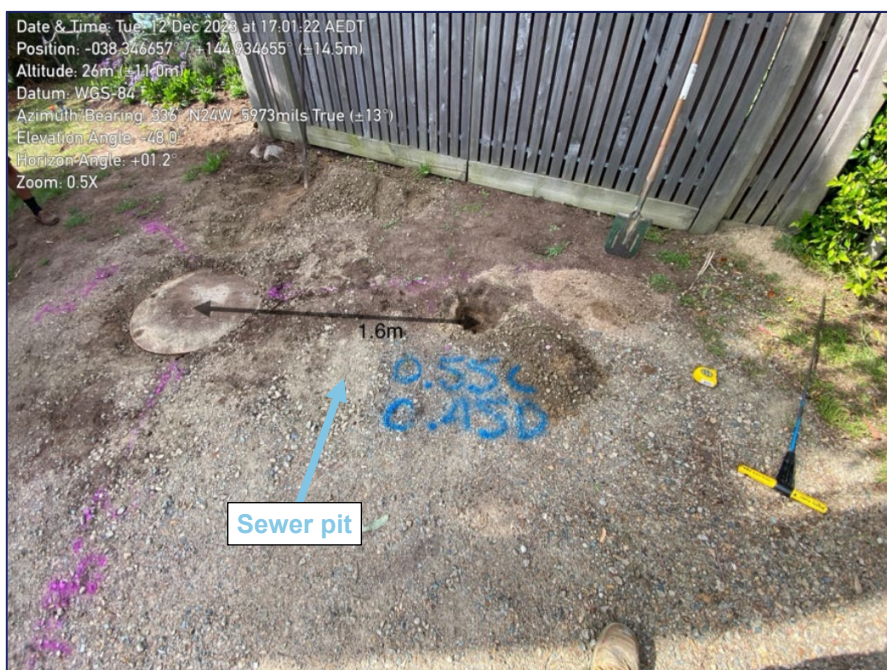
- The property owner of 10-12 View Point road observed a void during excavations for MPSC stormwater upgrade works in View Point Road. I have observed a low-resolution video of this inferred void. Based on the CivilTest report and the provided video I have marked on Figure 1 the approximate location of this void.

- Sewer, gas, water, and stormwater sub-surface utilities were identified in the nature strip, Inset 5.
13. I note that I have not observed any direct evidence of connectivity between this "void" and the Landslide.

**Inset 4:** Figure 3 of Safety Scan scanning report showing location of identified void. I have added my commentary in blue

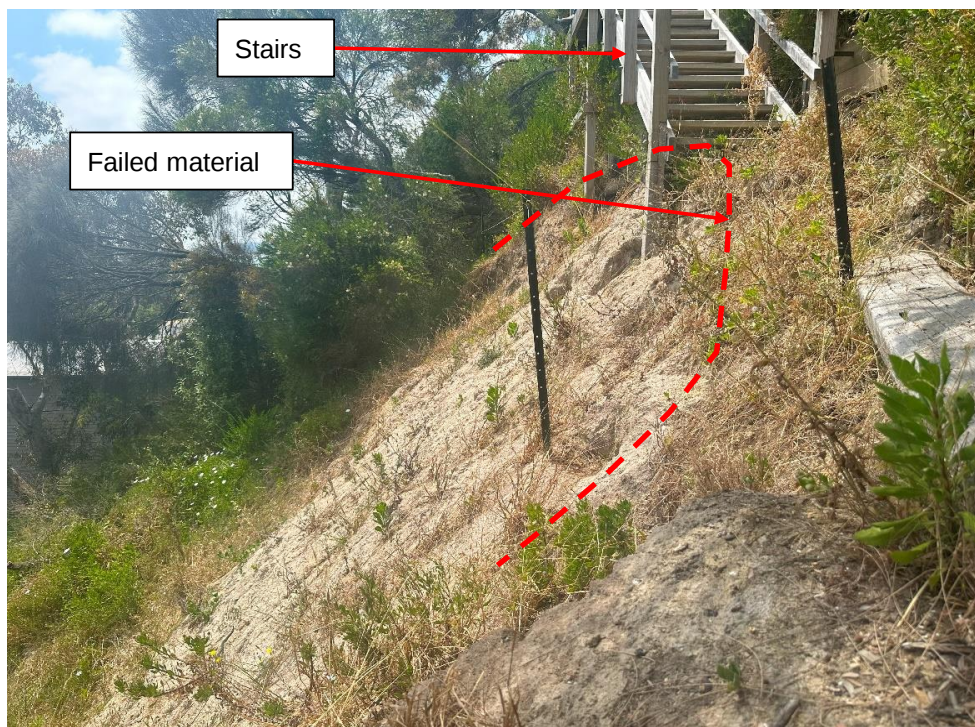
- (f) A lack of prominent backscarp, Photo 5 Appendix E, with minor steepening observed in the backscarp area and with a slope angle of approximately 45 degrees.

Photo 5 - Rear scarp of landslide, note lack of oversteepened backscarp
