Our Ref: PSM5226-002L

3 November 2023

RE: RISK ASSESSMENT. 10-12 VIEW POINT ROAD, MCRAE

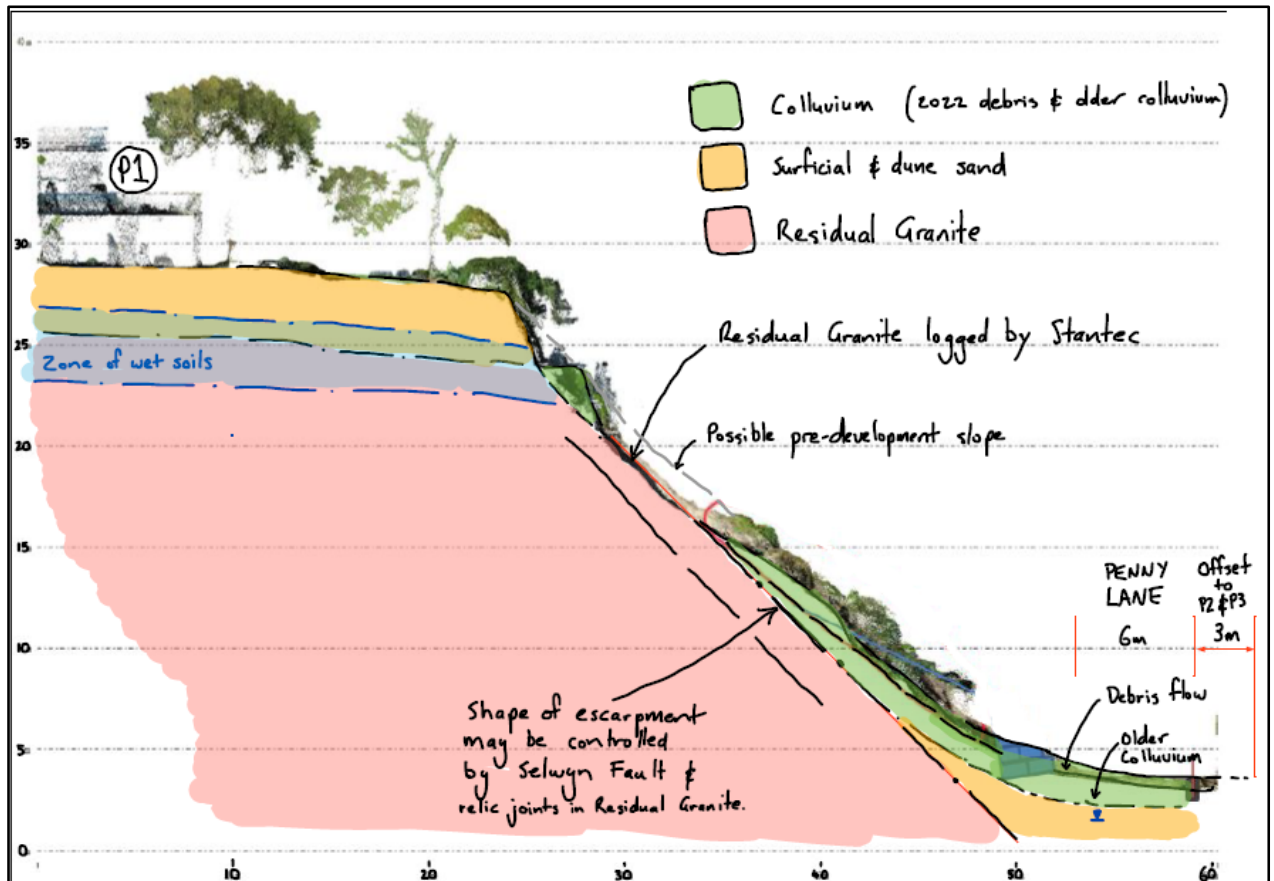
Inset 8: PSM geological model

Our interpretation of the geological conditions is presented in Inset 8. With regards to the geological model PSM notes the following key observations:

- There is uncertainty regarding the contact between the DUNE DEPOSITS and the RESIDUAL GRANITE owing to the likelihood of some of the parent material of the DUNE DEPOSITS being from wind driven erosion of the Dromana Granite. PSM has assumed that the wet soils are an indicator of the contact between the two geotechnical units.
- The laboratory testing indicates that all samples between 3 m and 19 m bgl have very similar Particle Size Distributions, Inset 9, and Atterberg limits indicate low plasticity CLAY fines.

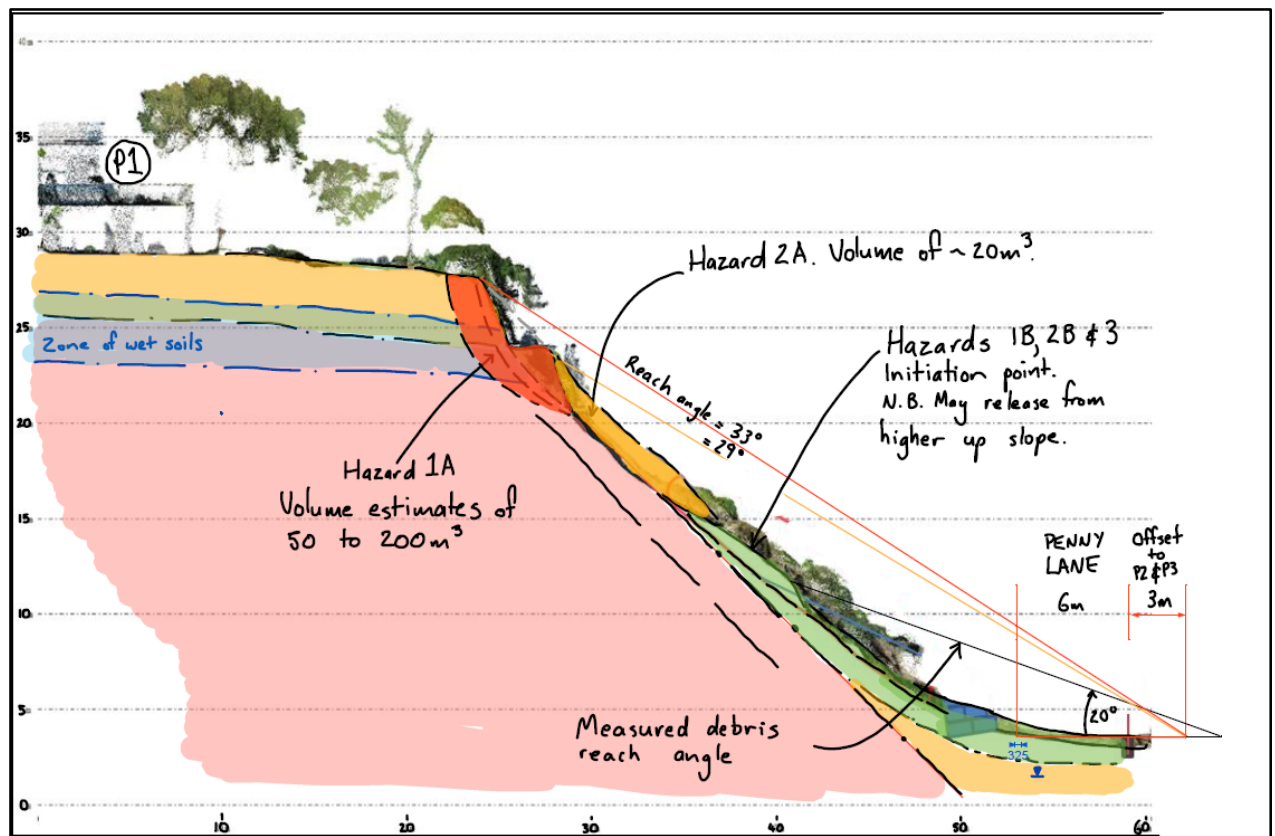
Inset 11: Landslide hazards

Table 3 provides a summary of the modes of failure and hazards. The hazards are presented on Inset 11. The November 2022 landslide had the following characteristics:

- Approximate dimensions of reported translational slide of 8 m wide x 5 m long x 0.5 m deep (parallel to slope).
- Approximate mobile translational slide volume of 20 m³.
- Approximate dimensions of reported debris flow of 4 m wide x 12 m long x less than 0.5 m deep (parallel to slope). Volume less than 24m³. Note that volume of water accumulated prior to failure is unknown and ignored.
- The reach angle of the debris flow was in the order of 20° from the source point of the debris flow, Figure A6 of Appendix A. This angle is similar to those published by Finlay et al (1999)⁽²⁾ and Mostyn and Sullivan (2002)³ for washout and liquefaction failures in fills, Inset 12.

- Spatial risks are high (1) when on or below the landslide hazards.
- It is anticipated that regression of the escarpment may impact a zone 2 to 5 m behind the escarpment, Inset 11.

- Measured reach angles of the November 2022 landslide and those of the downslope dwellings to the respective hazards upslope are presented in Inset 11 and Inset 12.

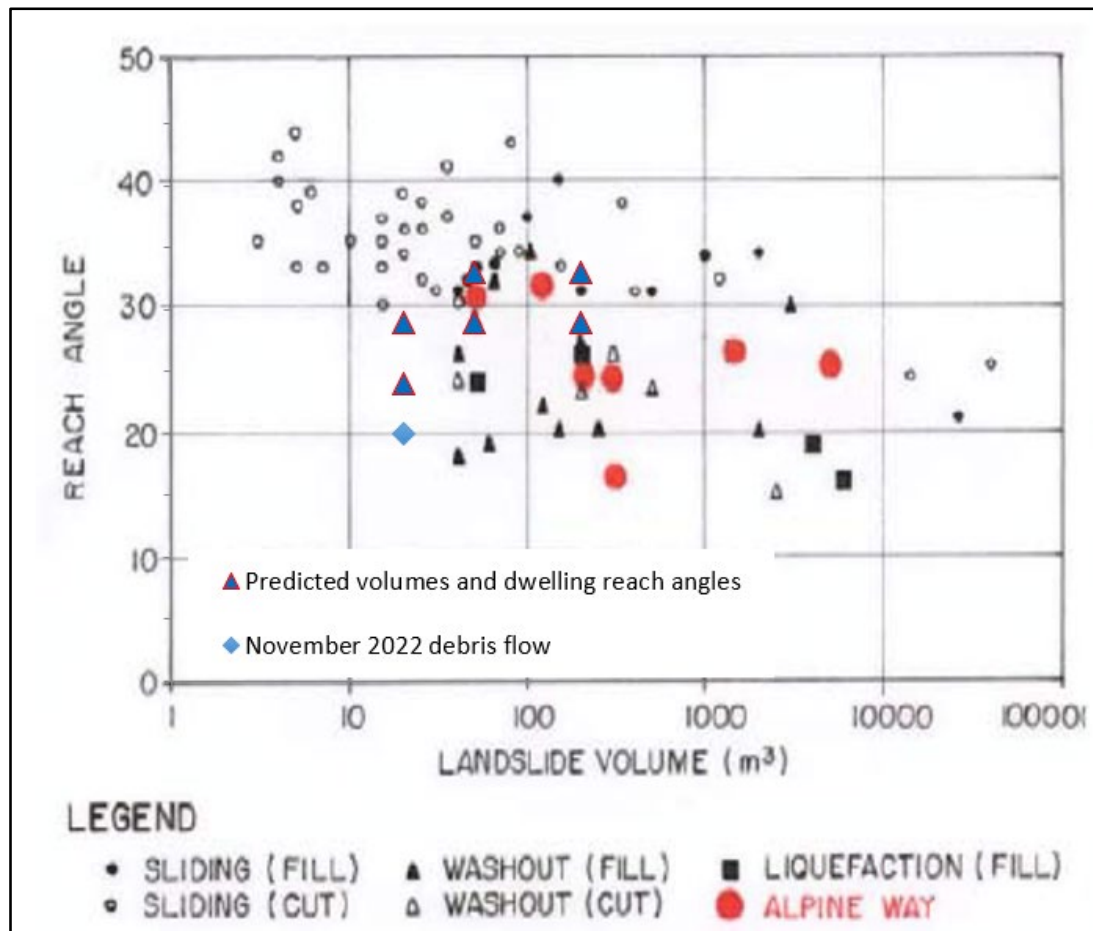
Inset 12: Predicted volumes and measured reach angles to P2 and P3, plotted on Mostyn and Sullivan (2002) landslide data

- The measured reach angle between the hazards and the dwellings generally are between one and two standards deviations of the mean of the published Mostyn and Sullivan (2002) data set, Inset 12 (excluding the debris flow data point).

- Based on the comparison to published data sets and the measured debris flow the adopted $P_{(S:H)}$ varies from 0.1 to 1.0.
- The debris flow run out angle was measured as 20° which exceeds the adopted hazard reach angle of 24° of the proposed debris flow hazards. The $P_{(S:H)}$ for these scenarios is 1.

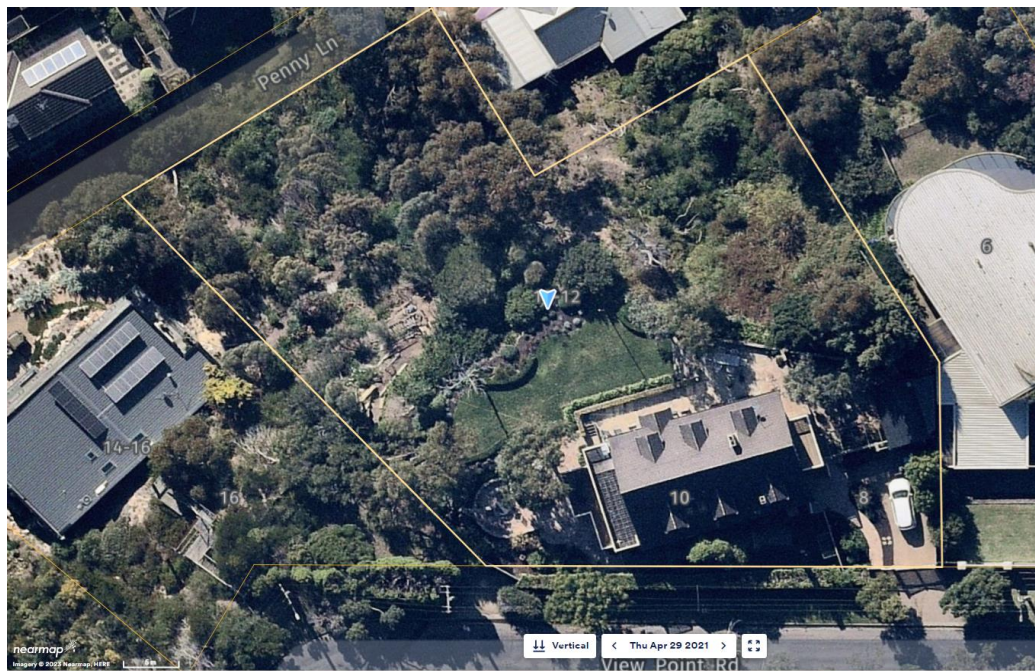
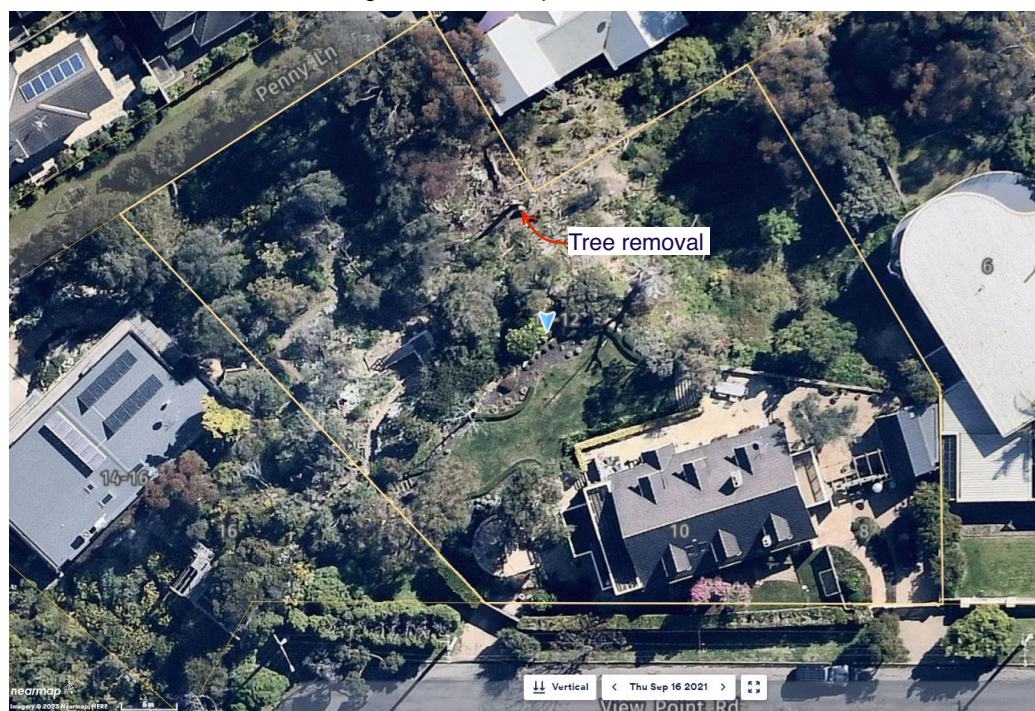
Figure A1: Nearmap 29/04/2021

- A series of trees were removed on property P1 between April 2021 and September 2021, Appendix A1. This is supported by street view images between February 2018 and October 2022, Appendix A2.
- The translational slide scarp has approximate dimensions of 8 m x 5 m, Appendix A3.
- The debris flow:
 - Initiated from an area approximately 12m southeast of the property P1 northwestern boundary and was approximately 4 m wide.
 - Run out was approximately 5 m into properties P2 and P3, Appendix A3.

PSM notes that tree removal is a significant conditional event that has occurred at the Site and suction will change in the escarpment slopes over a period of 12 months to 5 years from tree removal (Richards, 1983)⁴. Trees have been removed in 2021 and further vegetation has been removed by the landslide. In PSM's experience it is common in Victoria for surficial soil landslides to follow tree/vegetation removal (either by fire, storm or physical removal).
