Our Ref: PSM5226-002L

**RE: RISK ASSESSMENT. 10-12 VIEW POINT ROAD, MCRAE**

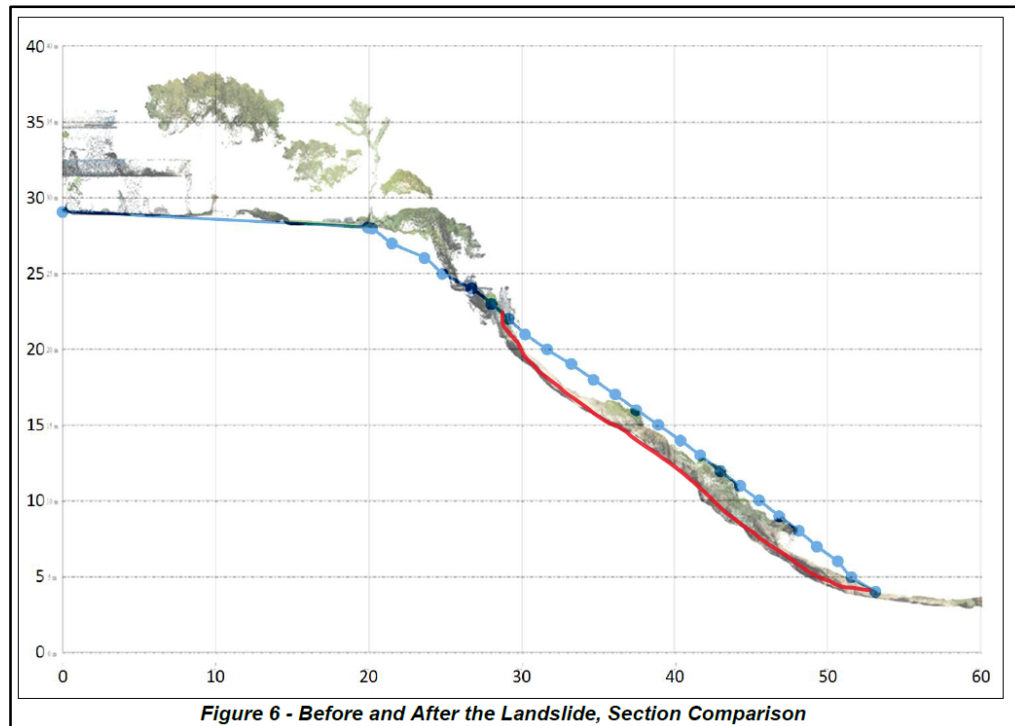
**Inset 1: Excerpt from CivilTest report 1222044-1 Issue 2 (5 December 2022)**

- A cross section from a drone survey, Inset 1.

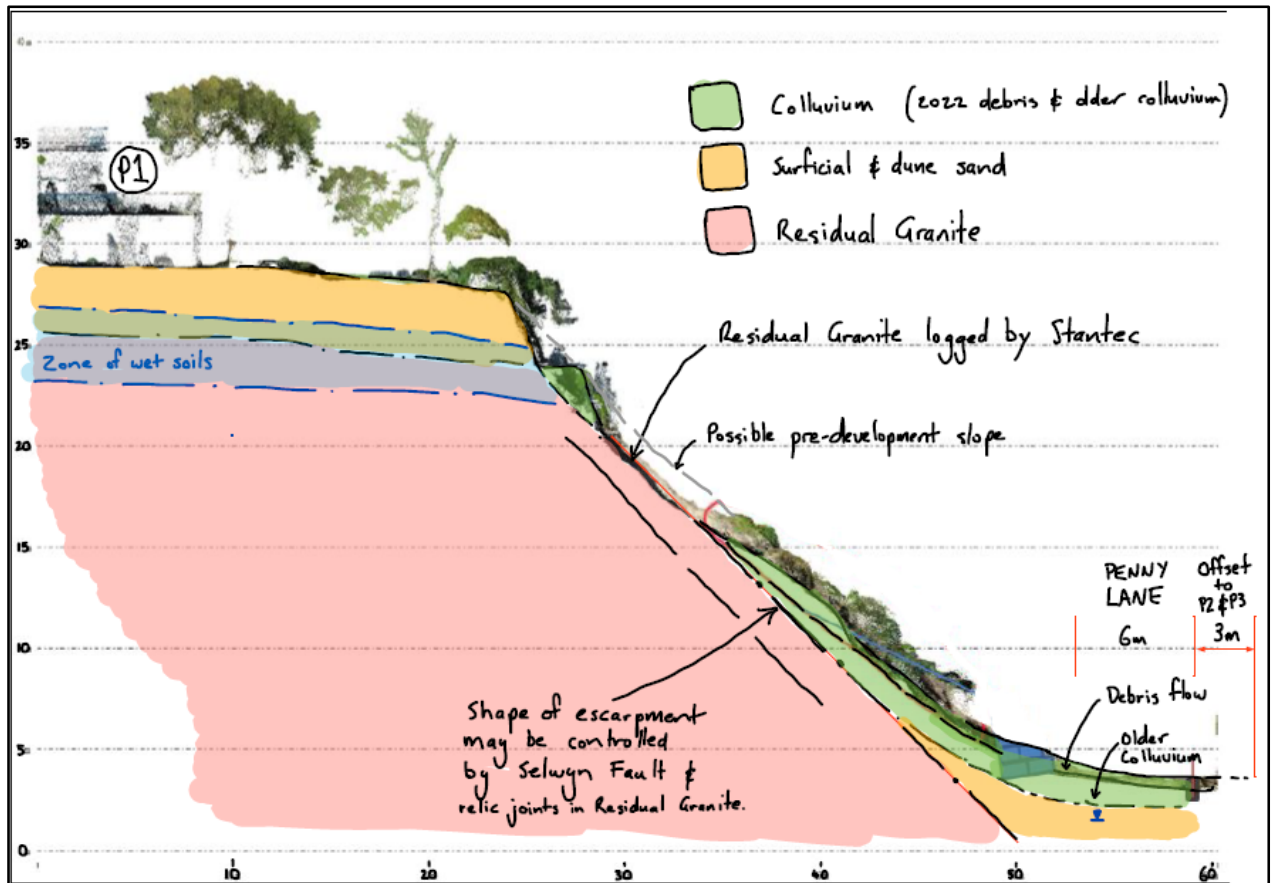
Inset 8: PSM geological model

Our interpretation of the geological conditions is presented in Inset 8. With regards to the geological model PSM notes the following key observations:

- There is uncertainty regarding the contact between the DUNE DEPOSITS and the RESIDUAL GRANITE owing to the likelihood of some of the parent material of the DUNE DEPOSITS being from wind driven erosion of the Dromana Granite. PSM has assumed that the wet soils are an indicator of the contact between the two geotechnical units.
- The laboratory testing indicates that all samples between 3 m and 19 m bgl have very similar Particle Size Distributions, Inset 9, and Atterberg limits indicate low plasticity CLAY fines.

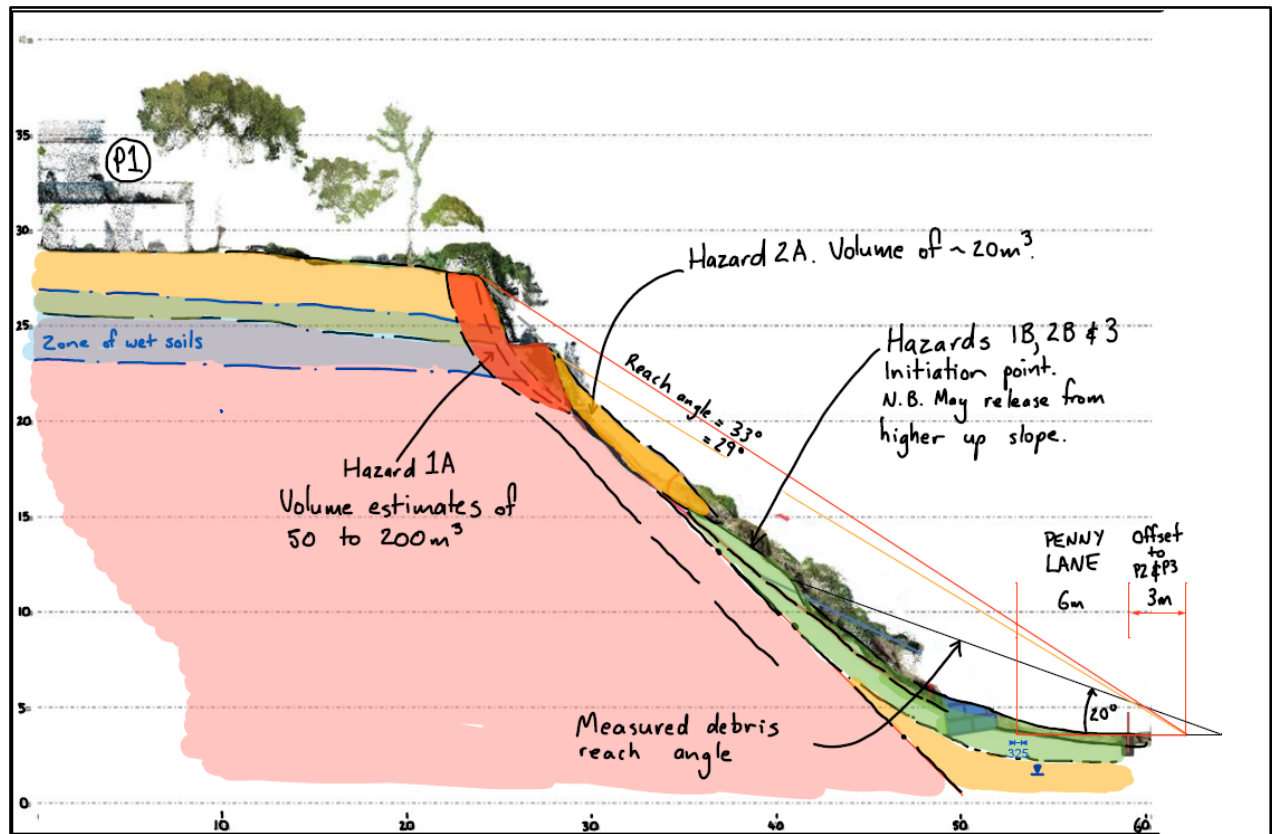
Inset 11: Landslide hazards

Table 3 provides a summary of the modes of failure and hazards. The hazards are presented on Inset 11. The November 2022 landslide had the following characteristics:

- Approximate dimensions of reported translational slide of 8 m wide x 5 m long x 0.5 m deep (parallel to slope).
- Approximate mobile translational slide volume of 20 m<sup>3</sup>.
- Approximate dimensions of reported debris flow of 4 m wide x 12 m long x less than 0.5 m deep (parallel to slope). Volume less than 24m<sup>3</sup>. Note that volume of water accumulated prior to failure is unknown and ignored.
- The reach angle of the debris flow was in the order of 20° from the source point of the debris flow, Figure A6 of Appendix A. This angle is similar to those published by Finlay et al (1999)<sup>(2)</sup> and Mostyn and Sullivan (2002)<sup>3</sup> for washout and liquefaction failures in fills, Inset 12.

| Hazard ID | Mode of Failure | Discussion | Estimated $P_{(H)}$ |
|---|---|---|---|
| 1A | Translational slide – regression of escarpment | <p>Volume estimate = 50 m<sup>3</sup> (favourable) to 200 m<sup>3</sup> (unfavourable). Adopt 100m<sup>3</sup></p> <p>Failure may impact zone 2 m (typical) to 5 m (adverse) behind the escarpment</p> <p>1% AEP event may trigger the failure.</p> <p>Recent failure has removed some passive support and stabilising vegetation from the slope.</p> <p>Table 7 of RMS (2014):</p> <ul style="list-style-type: none"> <li>• <i>Potential mechanism is apparent.</i></li> <li>• <i>Evidence of earlier failures (over period &gt; 30 years).</i></li> </ul> <p>AGS (2007c):</p> <ul style="list-style-type: none"> <li>• <i>The event will probably occur under adverse conditions over the design life.</i></li> </ul> | 1x10 <sup>-2</sup> |
| 1B | Debris flow following 1A | <p>Half of 1A. Volume estimate = 25 to 100m<sup>3</sup></p> <p>Adopt 50m<sup>3</sup>.</p> <p>Triggers as per 1A.</p> <p>Assumed to initiate from similar slope location (with reach angle of ~24° to dwellings P2 and P3). N.B. could initiate from higher and have greater energy.</p> | 1x10 <sup>-2</sup> |
| 2A | Translational slide of flanks of landslide scarp | <p>Volume estimate = 20 m<sup>3</sup></p> <p>Table 7 of RMS (2014):</p> <ul style="list-style-type: none"> <li>• <i>Detachment mechanism is active</i></li> </ul> <p>AGS (2007c):</p> <ul style="list-style-type: none"> <li>• <i>The event is expected to occur over the design life.</i></li> </ul> | 5x10 <sup>-1</sup> |
| 2B | Debris flow following 2A | <p>Volume estimate = 20 m<sup>3</sup></p> <p>Similar rainfall event to November 2022 event and occurring between 8 to 24 hours considered a likely trigger.</p> <p>Initiates as per 1B</p> | 5x10 <sup>-2</sup> to 1x10 <sup>-2</sup> |
| 3 | Debris flow of existing debris | <p>Volume estimate less than 20 m<sup>3</sup></p> <p>Similar rainfall event to November 2022 event in a day considered a likely trigger.</p> <p>Initiates as per 1B</p> | 5x10 <sup>-2</sup> |

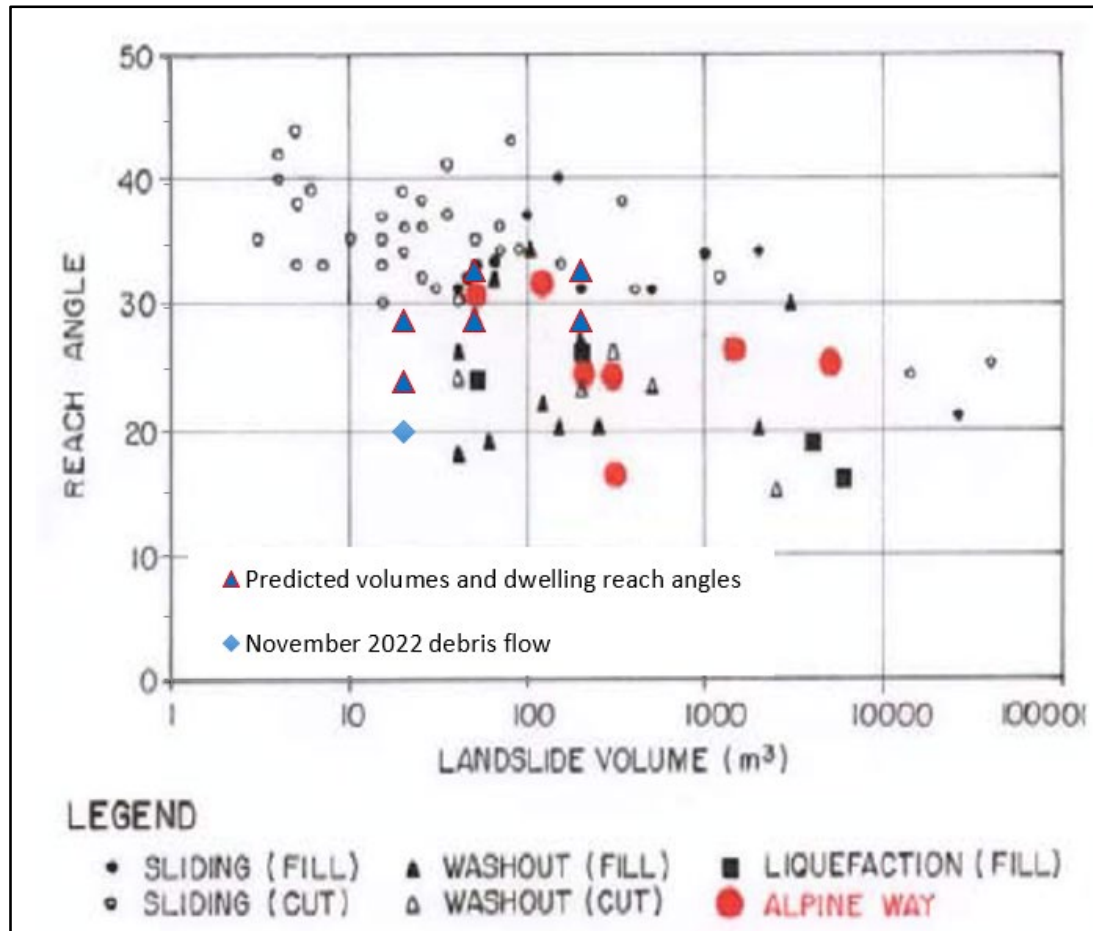
Inset 12: Predicted volumes and measured reach angles to P2 and P3, plotted on Mostyn and Sullivan (2002) landslide data

- Measured reach angles of the November 2022 landslide and those of the downslope dwellings to the respective hazards upslope are presented in Inset 11 and Inset 12.

- The measured reach angle between the hazards and the dwellings generally are between one and two standards deviations of the mean of the published Mostyn and Sullivan (2002) data set, Inset 12 (excluding the debris flow data point).

- Based on the comparison to published data sets and the measured debris flow the adopted  $P_{(S:H)}$  varies from 0.1 to 1.0.
- The debris flow run out angle was measured as 20° which exceeds the adopted hazard reach angle of 24° of the proposed debris flow hazards. The  $P_{(S:H)}$  for these scenarios is 1.

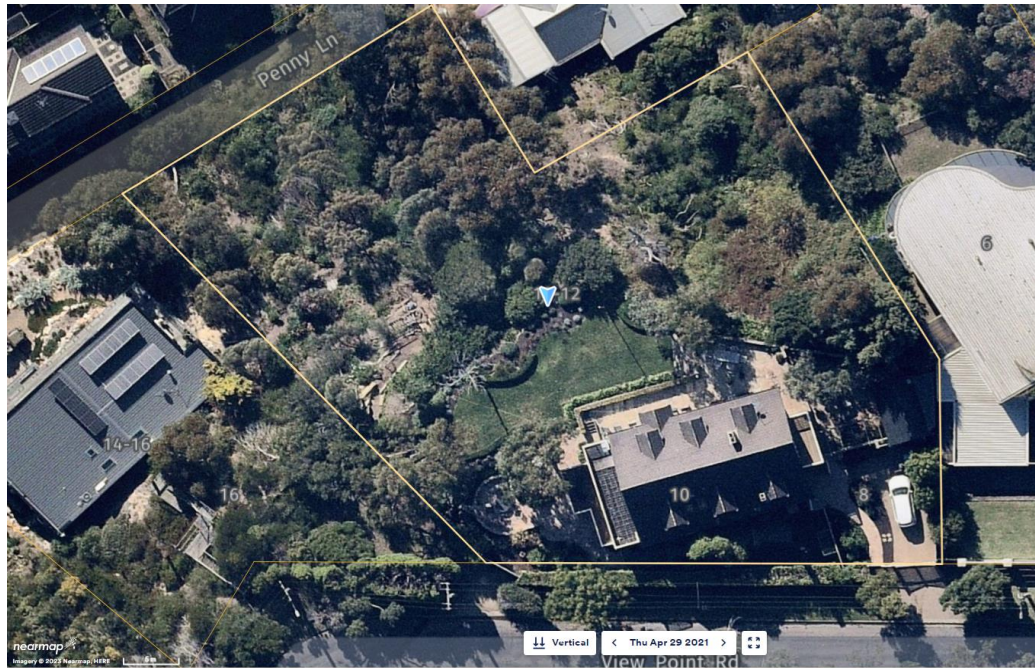
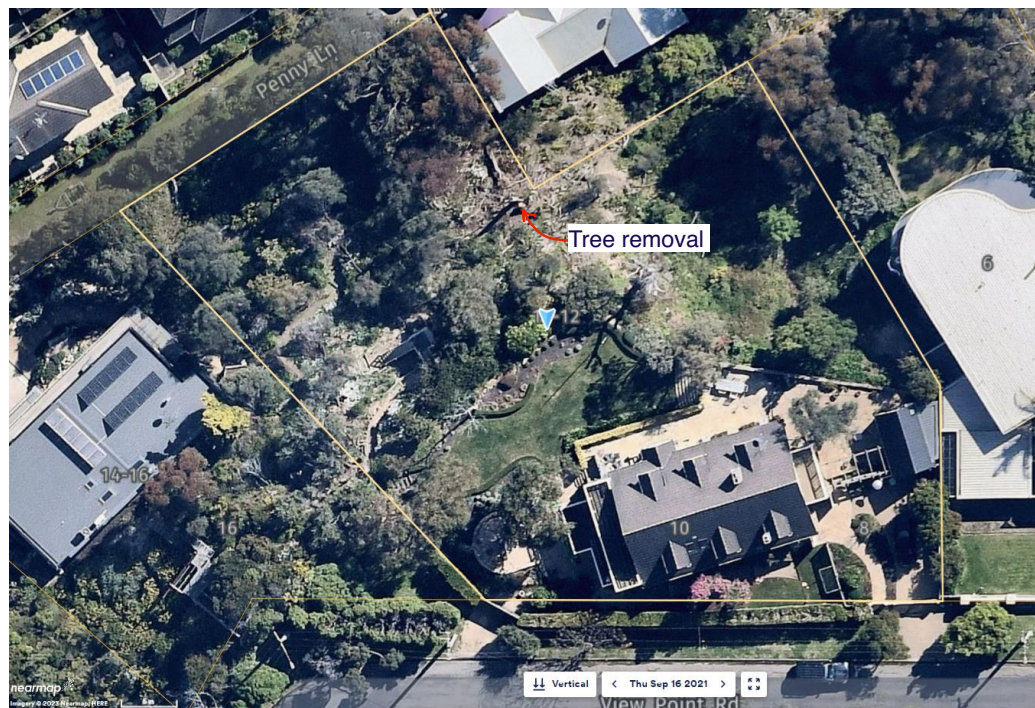
- A series of trees were removed on property P1 between April 2021 and September 2021, Appendix A1. This is supported by street view images between February 2018 and October 2022, Appendix A2.
- The translational slide scarp has approximate dimensions of 8 m x 5 m, Appendix A3.
- The debris flow:
  - Initiated from an area approximately 12m southeast of the property P1 northwestern boundary and was approximately 4 m wide.
  - Run out was approximately 5 m into properties P2 and P3, Appendix A3.

PSM notes that tree removal is a significant conditional event that has occurred at the Site and suction will change in the escarpment slopes over a period of 12 months to 5 years from tree removal (Richards, 1983)<sup>4</sup>. Trees have been removed in 2021 and further vegetation has been removed by the landslide. In PSM's experience it is common in Victoria for surficial soil landslides to follow tree/vegetation removal (either by fire, storm or physical removal).

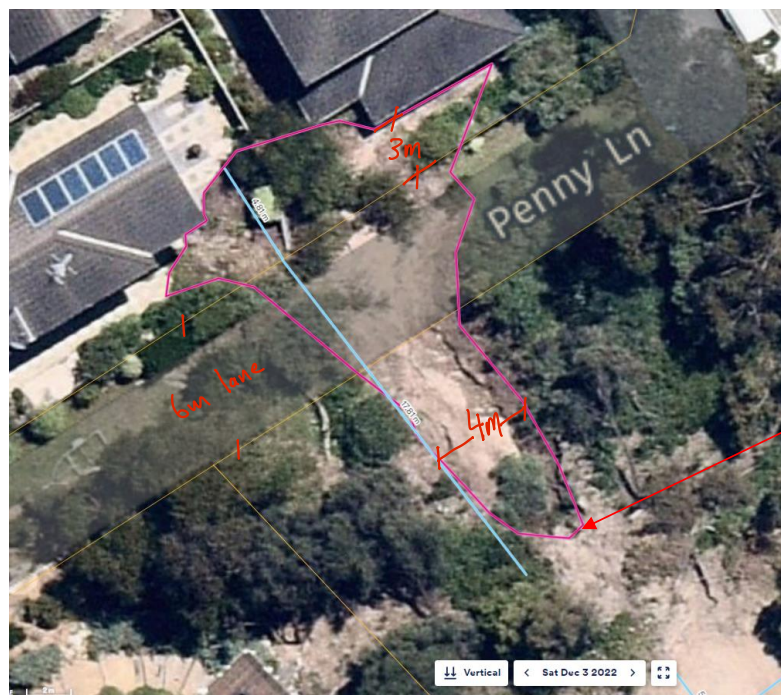
Figure A6: Nearmap 3/12/2022 approximate run out distances

- The November 2022 translational slide did not reach P2 and P3. However, the debris slide reached P2 and P3 and created a preferential flow path with significantly less obstructions for future landslides and increased the slope angle at the toe of the slope.
