Our Ref: PSM5226-002L Rev1

**RE: RISK ASSESSMENT. 10-12 VIEW POINT ROAD, MCRAE**

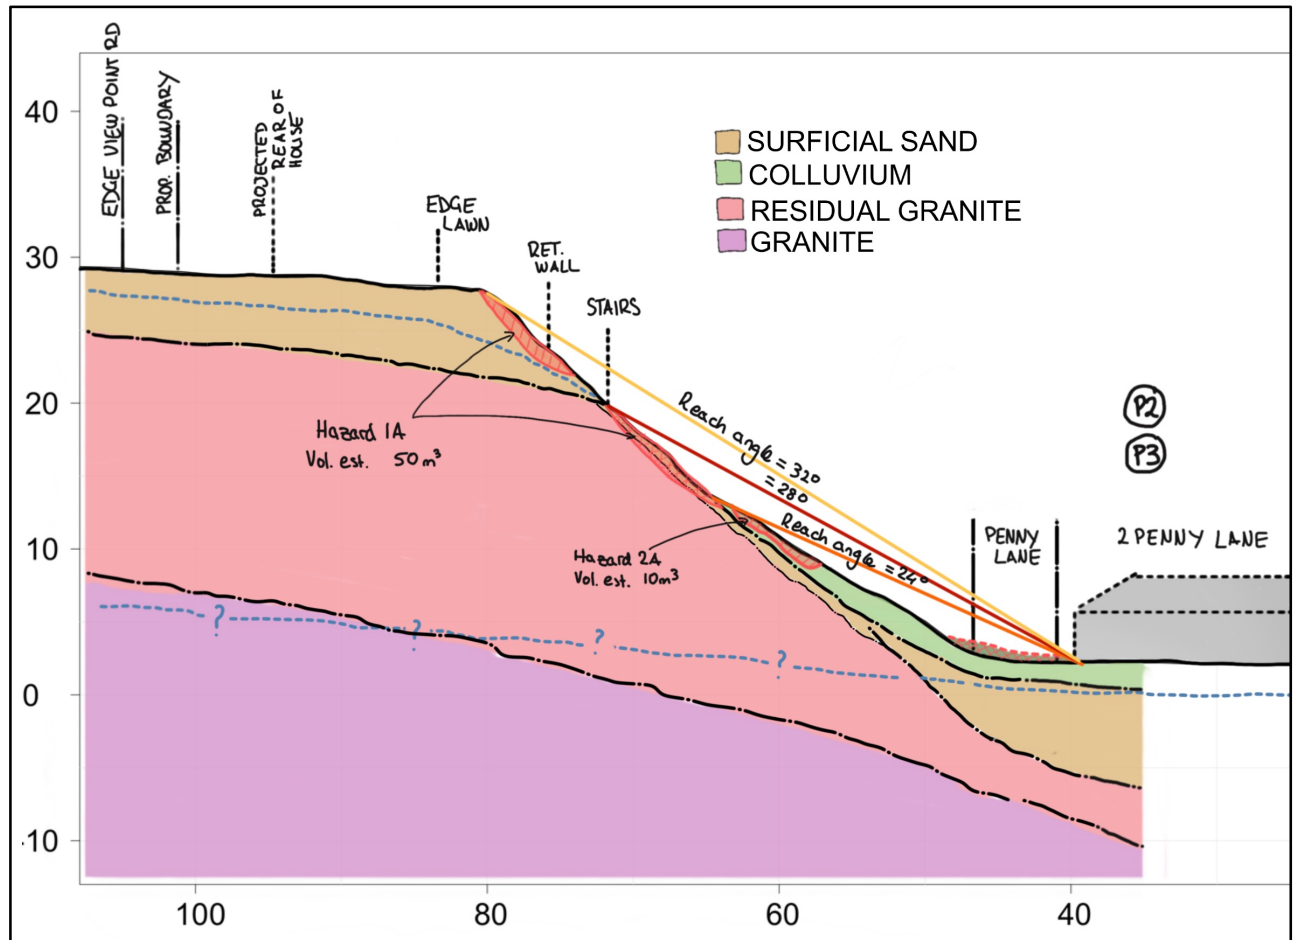
Inset 10: Landslide hazards

| Hazard ID | Mode of Failure | Discussion | Estimated $P_{(H)}$ |
|---|---|---|---|
| 1A | Translational slide – New landslide outside of area affected by 2022 landslide | <p>Volume estimate = 20 to 50 m<sup>3</sup></p> <p>Table 7 of RMS (2014):</p> <ul style="list-style-type: none"> <li>• Detachment mechanism is apparent, but failure does not appear imminent.</li> <li>• Triggering could be expected to required severe event.</li> </ul> <p>AGS (2007c):</p> <p><i>The event will probably occur under adverse conditions over the design life</i></p> <p>Assumed to initiate from upper slope areas not affected by November 2022 landslide.</p> | 1x10 <sup>-2</sup> to 5x10 <sup>-3</sup> |
| 1B | Debris flow following 1A | <p>Volume estimate = 20 m<sup>3</sup></p> <p>Similar rainfall event to November 2022 rain event and occurring between 8 to 24 hours considered a likely trigger or possible infrastructure damage following 1A.</p> <p>Adopt 50% conditional probability of infrastructure damage or ponding water in debris from other source</p> | 1x10 <sup>-2</sup> to 5x10 <sup>-3</sup> |

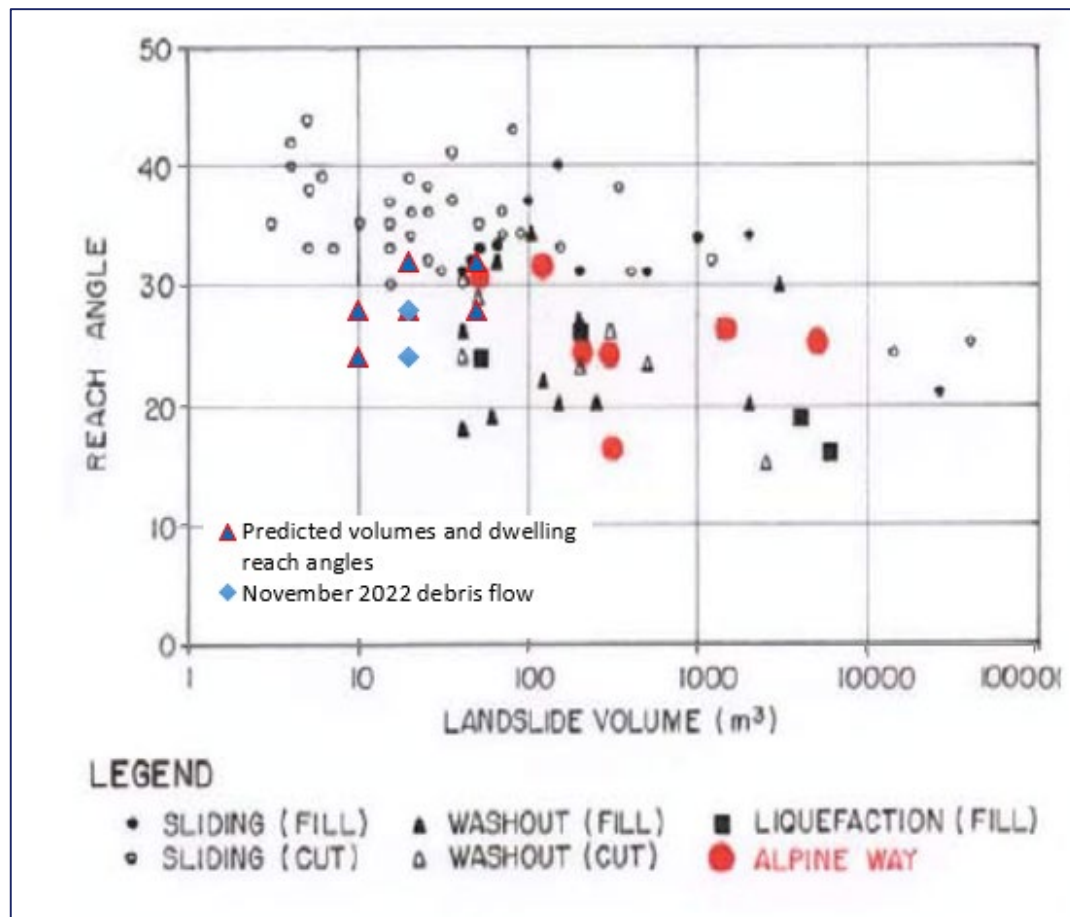
- The measured reach angle between the hazards and the dwellings generally are between one and two standards deviations of the mean of the published Mostyn and Sullivan (2002) data set, Inset 11 (excluding the debris flow data point).

**Inset 11: Predicted volumes and measured reach angles to P2 and P3, plotted on Mostyn and Sullivan (2002) landslide data**

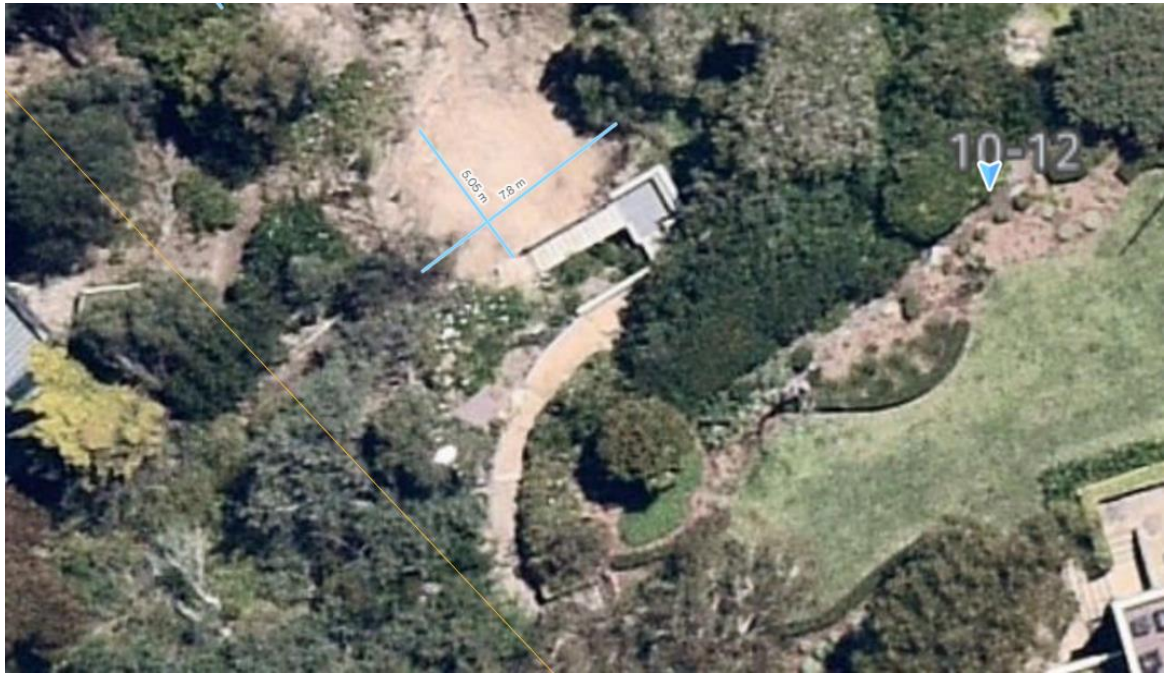
Figure A5: Nearmap 3/12/2022 approximate head scarp dimensions

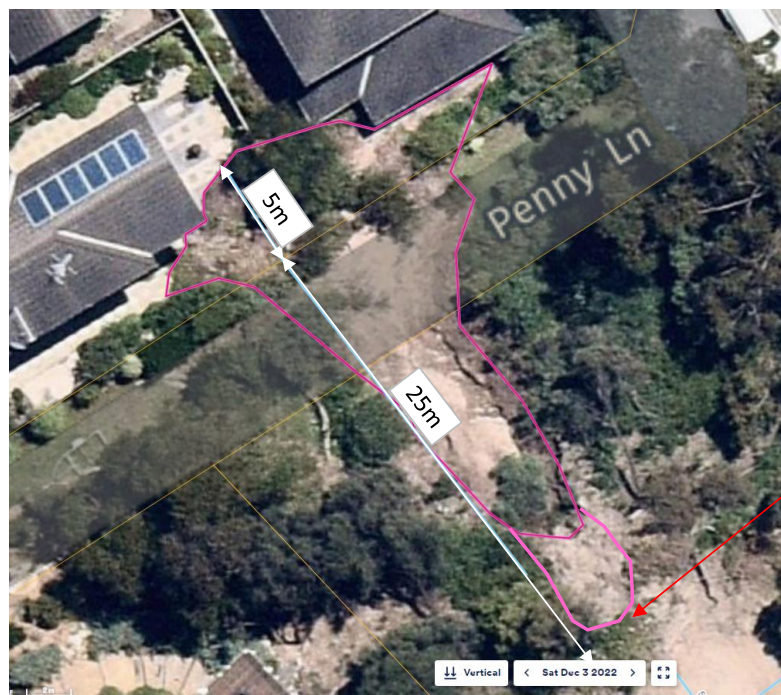
- A series of trees were removed on property P1 between April 2021 and September 2021, Appendix A1 & A2. This is supported by street view images between February 2018 and October 2022, Appendix A3 & A4.
- The translational slide scarp has approximate dimensions of 8 m x 5 m (in plan), Appendix A5.
- The debris flow:
  - Initiated from an area approximately 20m southeast of the property P1 northwestern boundary and was approximately 5 m wide.
  - Run out was approximately 5 m into properties P2 and P3, Appendix A6.

Figure A6: Nearmap 3/12/2022 approximate run out distances

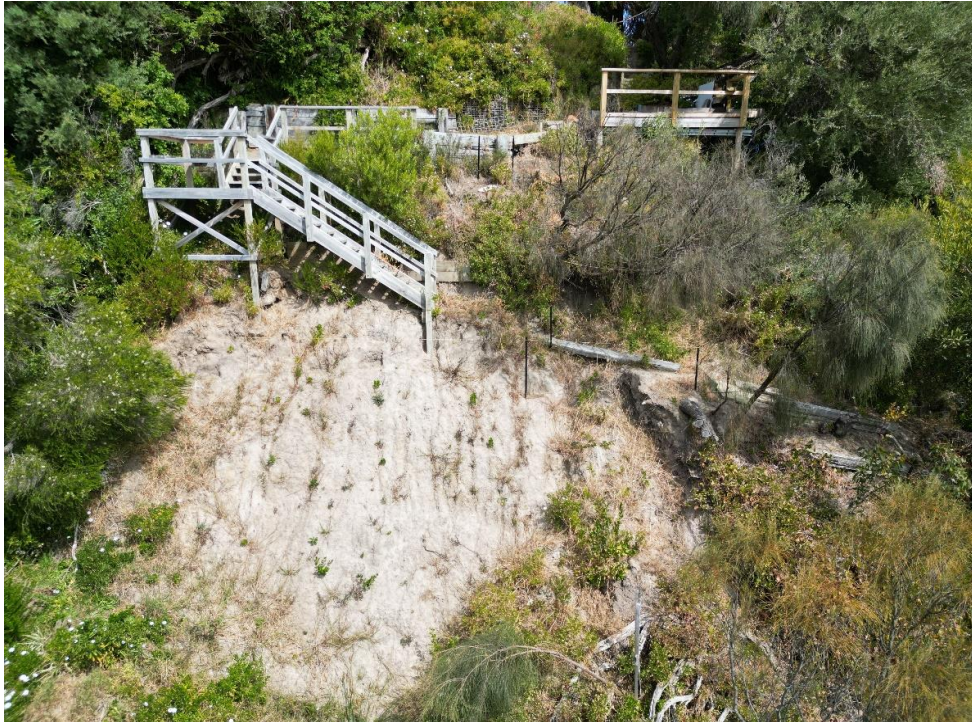
- It initiated in the upper to middle portion of the slope, with the rear scarp approximately at the base of the Stairs, Photo 1 Appendix B
- It was inferred to have initiated as a translational slide followed by mobilisation of failed material into a debris flow which was deposited at the toe of the slope, Photo 2 Appendix B
- The Landslide had three distinct zones being:

Photo 1 - Upper translational sliding area

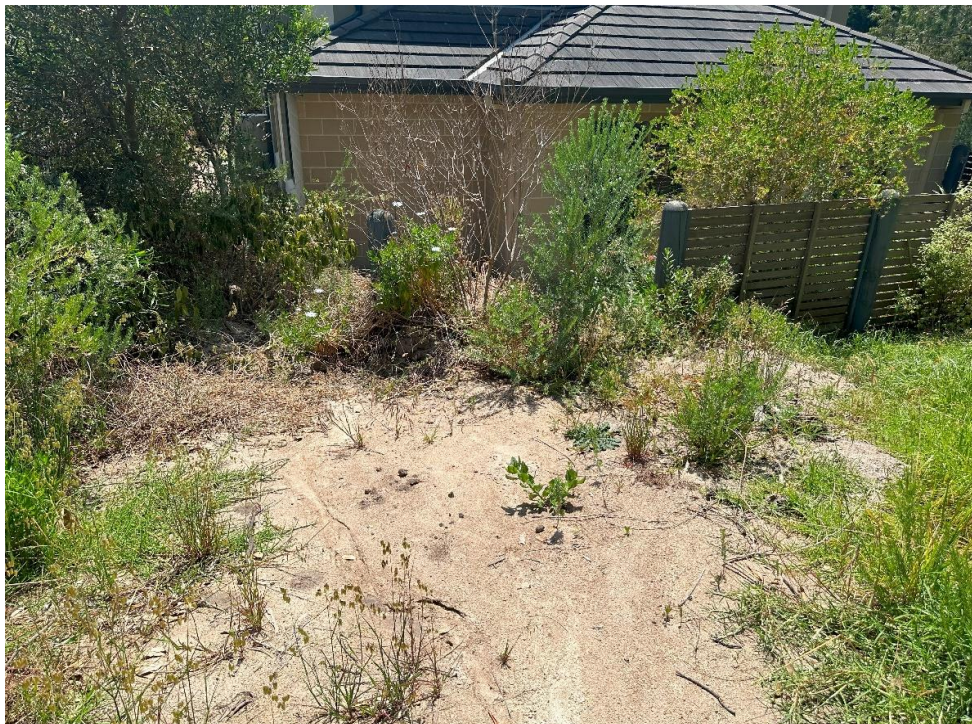
Photo 2 - Debris flow runout area, Property P2 visible in background

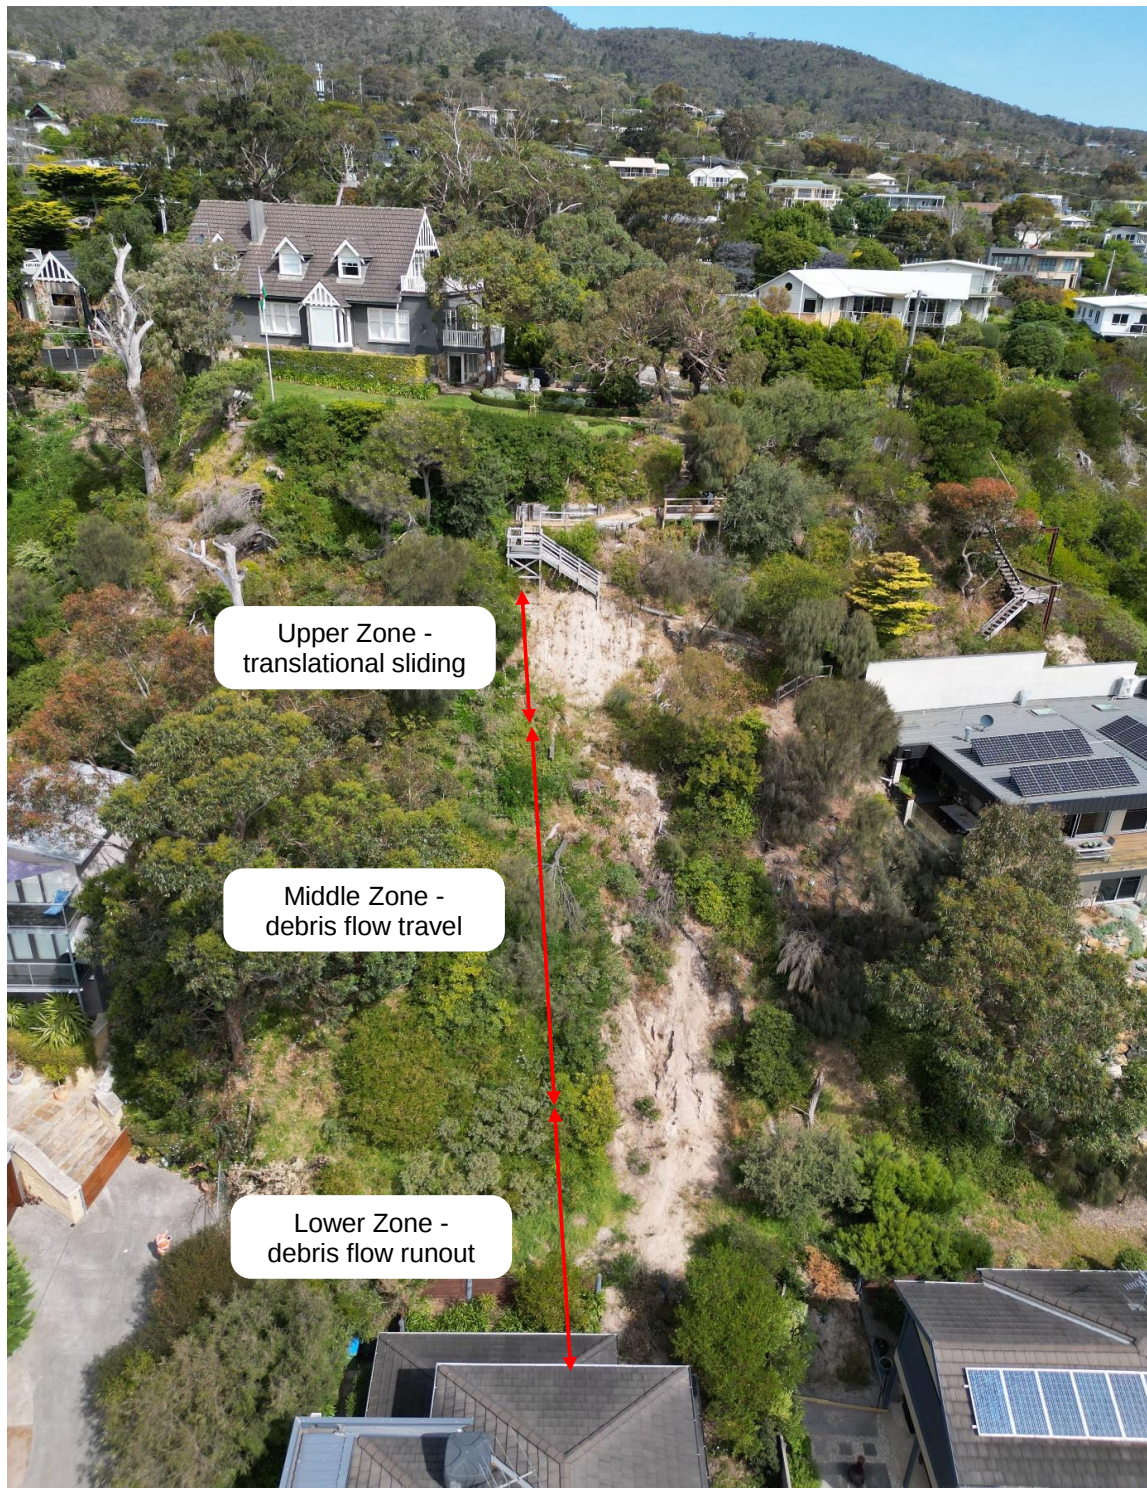
Photo 3 - Landslide Overview, with zones indicated

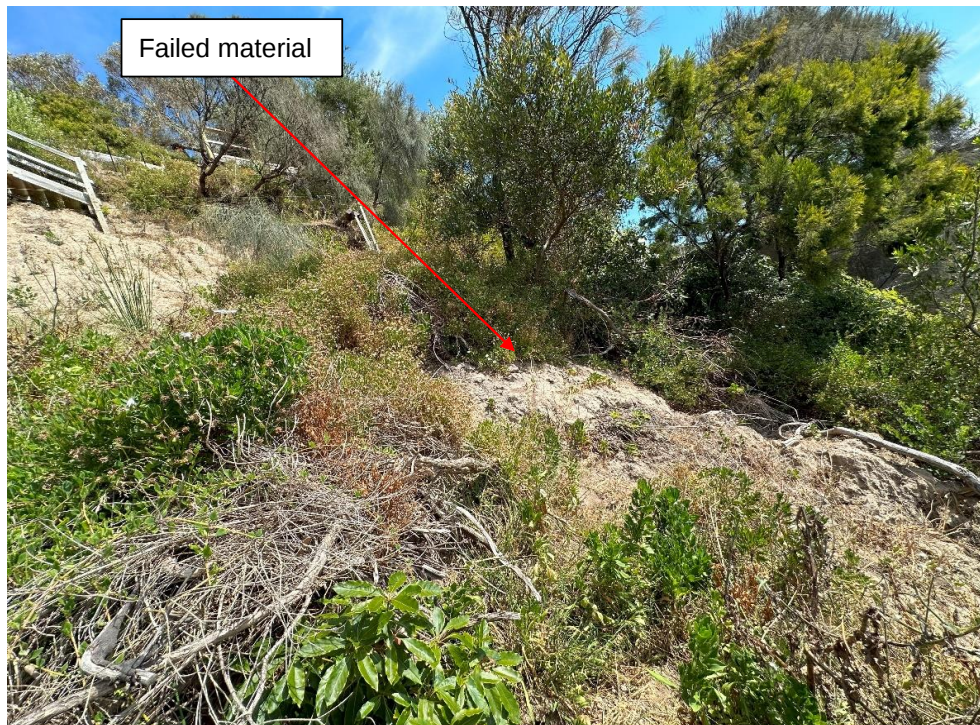
- Disturbed ground that had undergone translational sliding but did not mobilise into a debris flow was observed on the right (western) flank of the Landslide, Photo 4 Appendix B

Photo 4 - Failed material still on slope

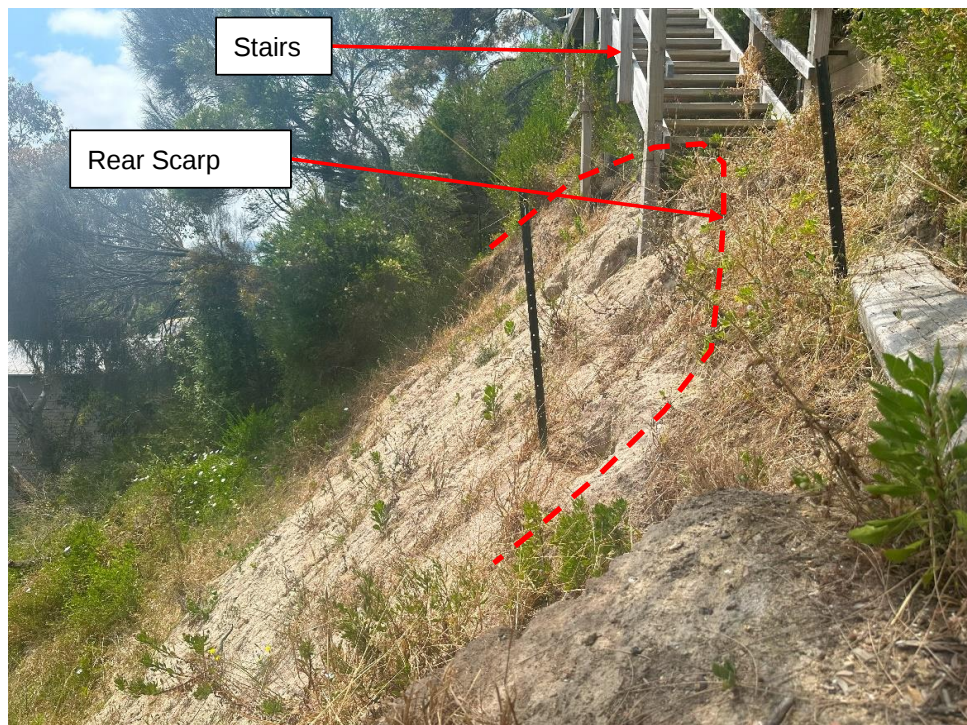
- A lack of prominent backscarp, Photo 5 Appendix B, with minor steepening observed in the backscarp area and with a slope angle of approximately 45 degrees.

Photo 5 - Rear scarp of landslide, note lack of oversteepened backscarp

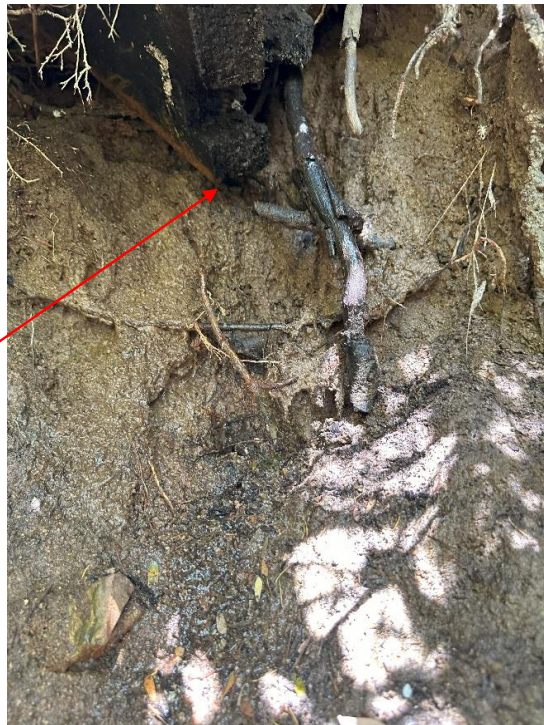
- Groundwater was observed to be seeping from the slope to the east of the stairs, Photo 6 Appendix B.
- A variety of water infrastructure was observed across the Site, Photo 7 Appendix B, including:

Groundwater  
seeping from slope

Photo 6 - Groundwater seepage

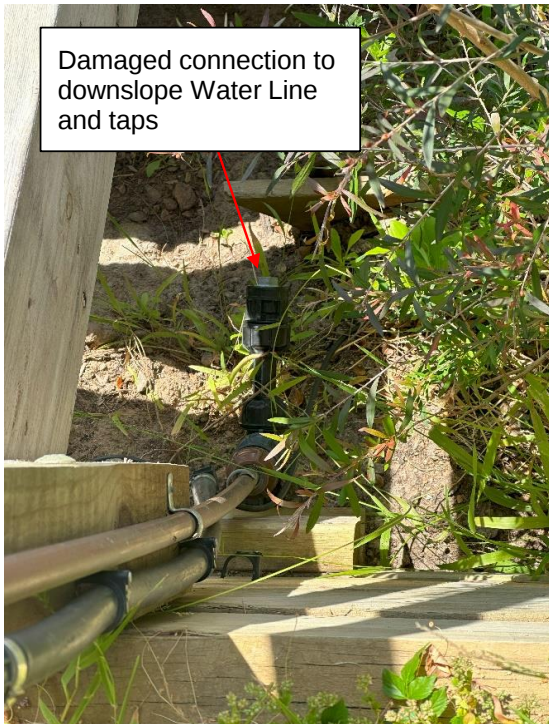
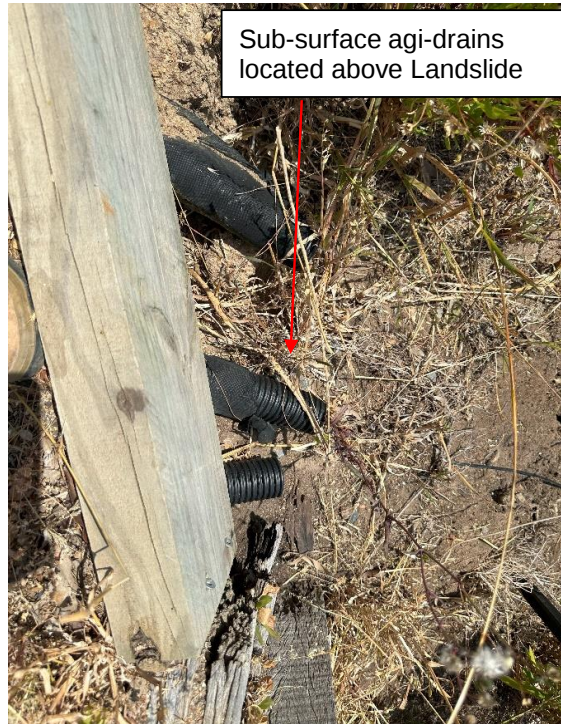
- Subsurface ‘agi-drains’
  - Water pipes including taps. A 20 to 25 mm diameter blue line polyethylene pipe with a damaged connection was observed near the top of the stairs, immediately above the rear scarp of the landslide.

Damaged connection to  
downslope Water Line  
and taps

Sub-surface agi-drains  
located above Landslide

Photo 7 - Water infrastructure including water pipes (on left), and subsurface 'agi drains' (on right)

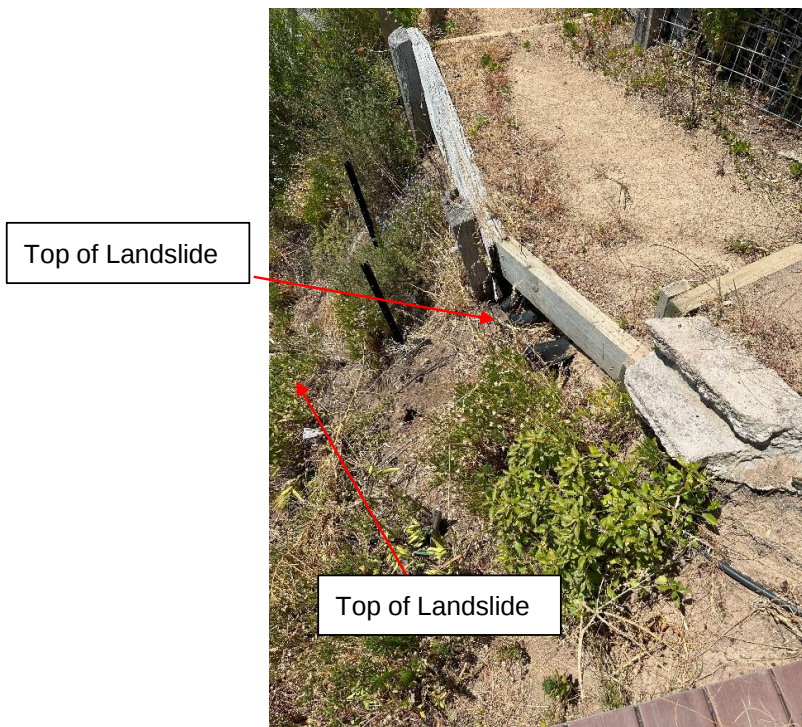
Photo 8 - Path above Landslide, note minor retaining walls and 'agi drains' from Photo 7

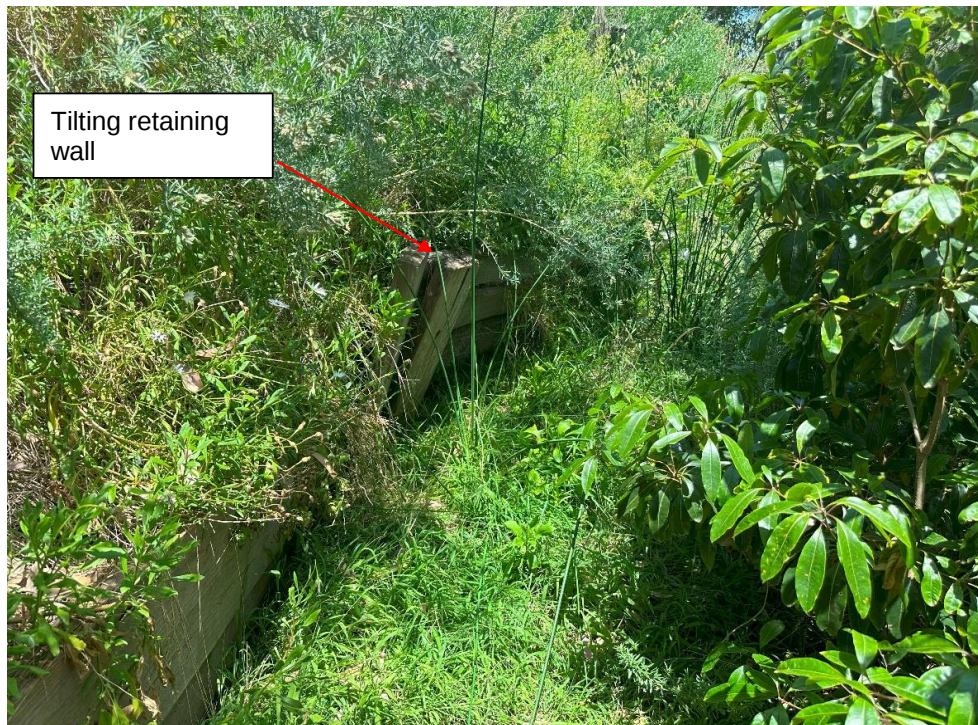
- The condition of RWs across the Site was generally poor, with overturning and bulging RWs observed. A section of RW to the east of the Landslide had significant tilts. This indicates possible instability in the ground above the RW and possible structural or geotechnical failure of the RW, Photo 10 Appendix B. RWs appear to be leaning more than as documented by Stantec (refer Section 2.2).

Photo 10 - Tilting retaining walls on left side of Landslide

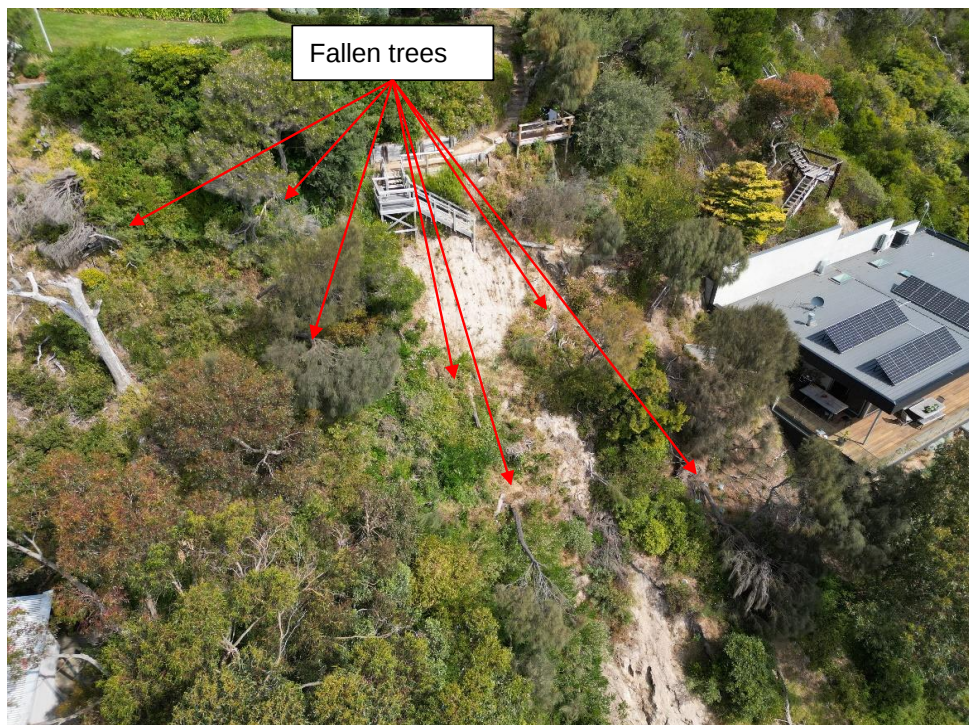
- Numerous fallen trees were observed across the escarpment slope, Photo 11 Appendix B. Most of the failed trees appear to have failed from causes unrelated to the Landslide, i.e., wind or poor root embedment. At least one tree appears to have fallen because of the Landslide.

Photo 11 - Fallen trees

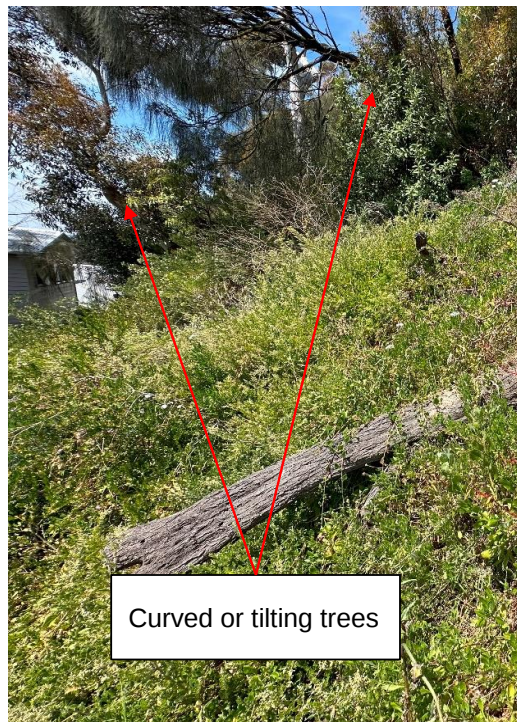
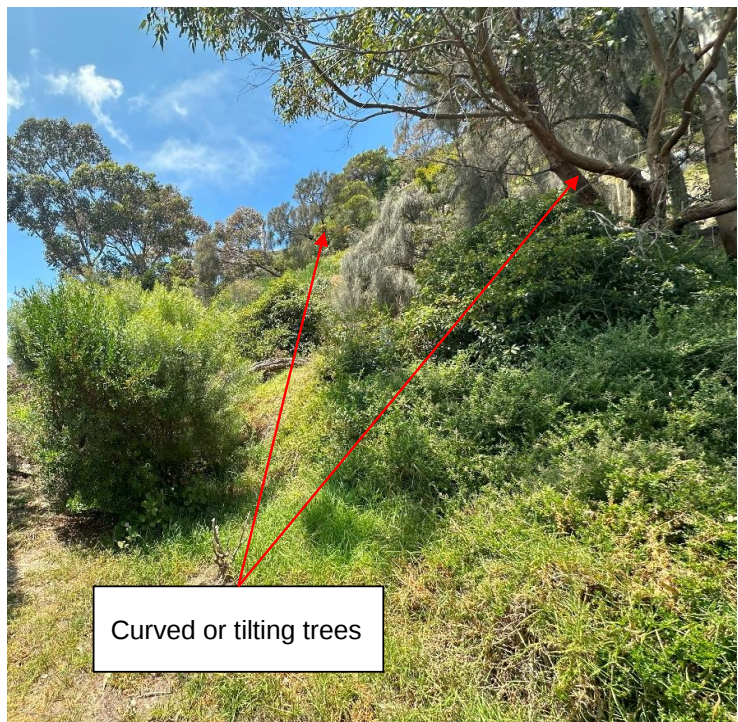
- Minor erosion was observed on unvegetated areas of the escarpment.
- Leaning and curved trees were observed on the escarpment, suggesting possible creep movement of the slope, Photo 12 Appendix B.

Photo 12 - Curved or tilting trees

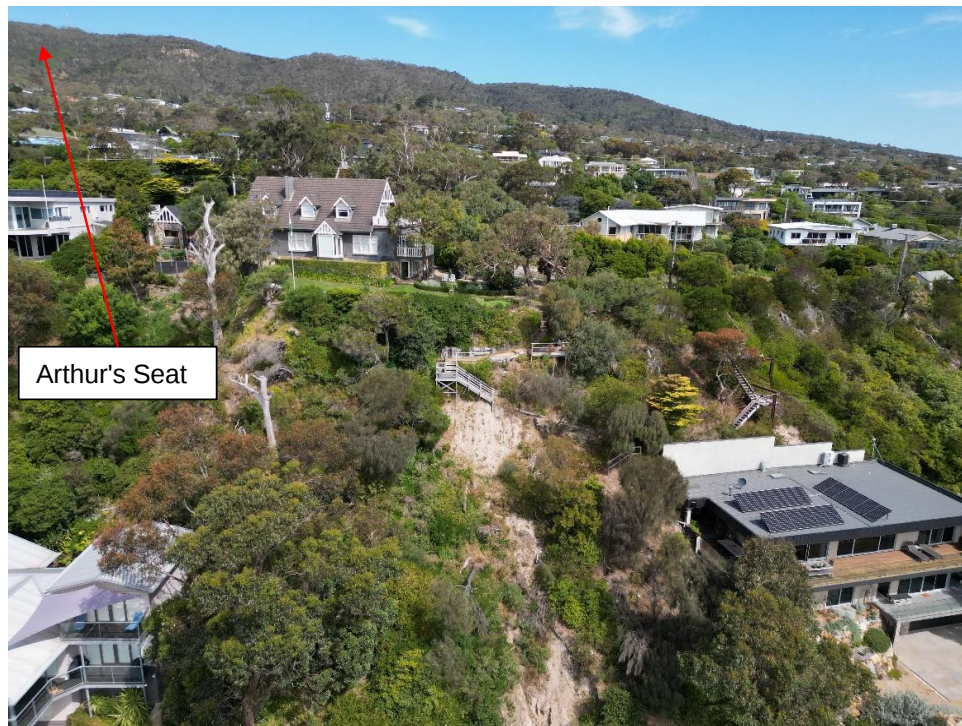
- Granite rock is exposed in shore platform below the road.
  - Steep to sub-vertical upper slopes is inferred to fail by undercutting and erosion of the lower slope leading to toppling/wedge style failures, Photo 15 Appendix B.

Photo 15 - Arthur's Seat in background
