Our Ref: PSM5226-002L Rev1

**RE: RISK ASSESSMENT. 10-12 VIEW POINT ROAD, MCRAE**

PSM were commissioned by Harwood Andrews (**HA**) on behalf of Mornington Peninsula Shire (**MPS**) to carry out a Landslide Risk Assessment (**LRA**) at 10-12 View Point Road, McRae (the "**Site**") in accordance with the Australian Geomechanics Society (**AGS**) Guidelines on Landslide Risk Assessment (AGS, 2007). The scope of the LRA is restricted to the following:

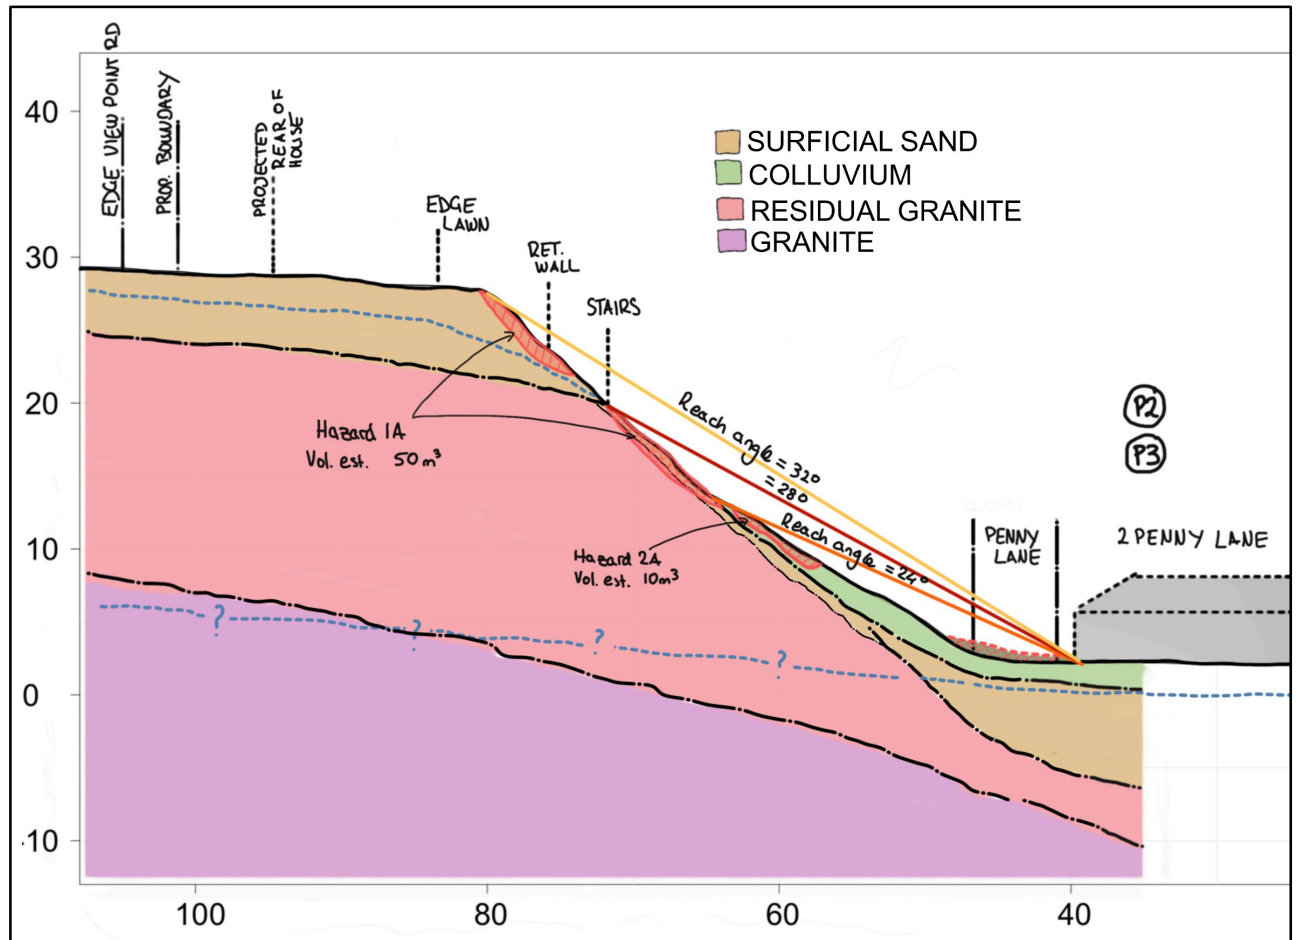
**Inset 10: Landslide hazards**

| Hazard ID | Mode of Failure | Discussion | Estimated $P_{(H)}$ |
|---|---|---|---|
| 1A | Translational slide – New landslide outside of area affected by 2022 landslide | <p>Volume estimate = 20 to 50 m<sup>3</sup></p> <p>Table 7 of RMS (2014):</p> <ul style="list-style-type: none"> <li>• Detachment mechanism is apparent, but failure does not appear imminent.</li> <li>• Triggering could be expected to required severe event.</li> </ul> <p>AGS (2007c):</p> <p><i>The event will probably occur under adverse conditions over the design life</i></p> <p>Assumed to initiate from upper slope areas not affected by November 2022 landslide.</p> | 1x10 <sup>-2</sup> to 5x10 <sup>-3</sup> |
| 1B | Debris flow following 1A | <p>Volume estimate = 20 m<sup>3</sup></p> <p>Similar rainfall event to November 2022 rain event and occurring between 8 to 24 hours considered a likely trigger or possible infrastructure damage following 1A.</p> <p>Adopt 50% conditional probability of infrastructure damage or ponding water in debris from other source</p> | 1x10 <sup>-2</sup> to 5x10 <sup>-3</sup> |

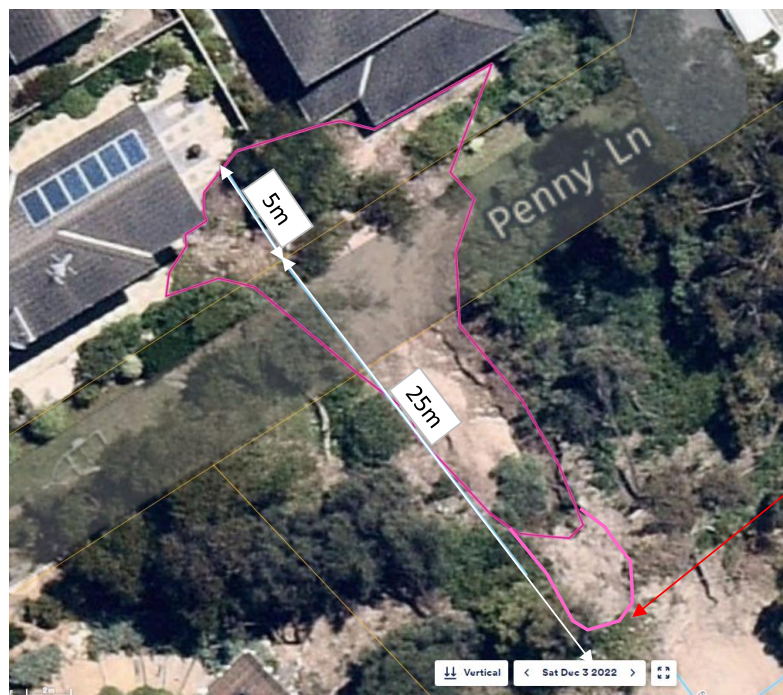
- A series of trees were removed on property P1 between April 2021 and September 2021, Appendix A1 & A2. This is supported by street view images between February 2018 and October 2022, Appendix A3 & A4.
- The translational slide scarp has approximate dimensions of 8 m x 5 m (in plan), Appendix A5.
- The debris flow:
  - Initiated from an area approximately 20m southeast of the property P1 northwestern boundary and was approximately 5 m wide.
  - Run out was approximately 5 m into properties P2 and P3, Appendix A6.

Figure A6: Nearmap 3/12/2022 approximate run out distances

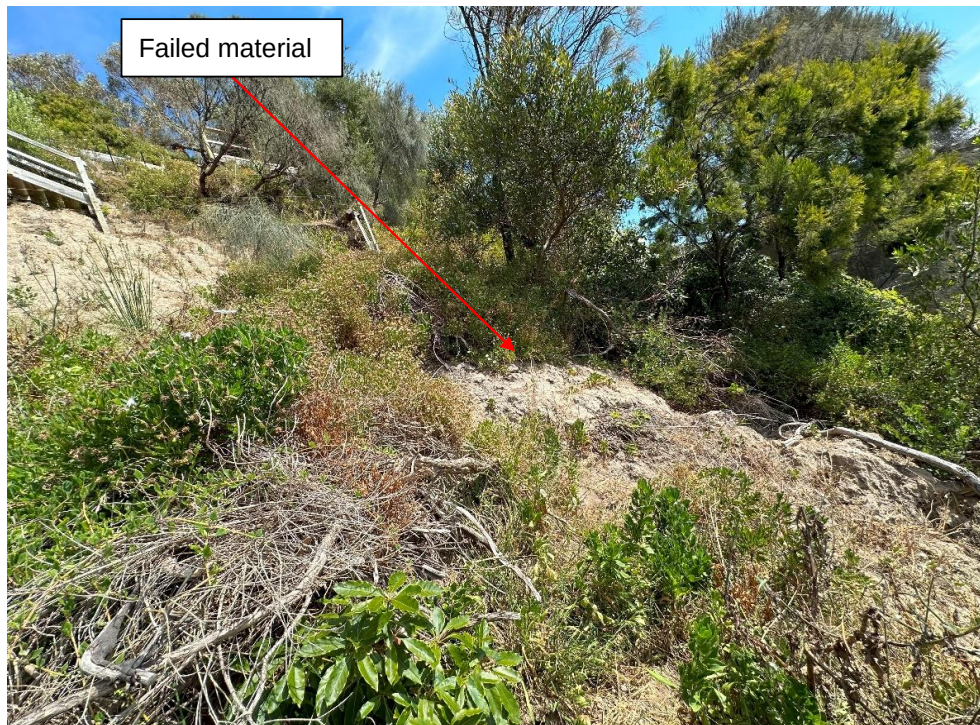
- Disturbed ground that had undergone translational sliding but did not mobilise into a debris flow was observed on the right (western) flank of the Landslide, Photo 4 Appendix B

Photo 4 - Failed material still on slope

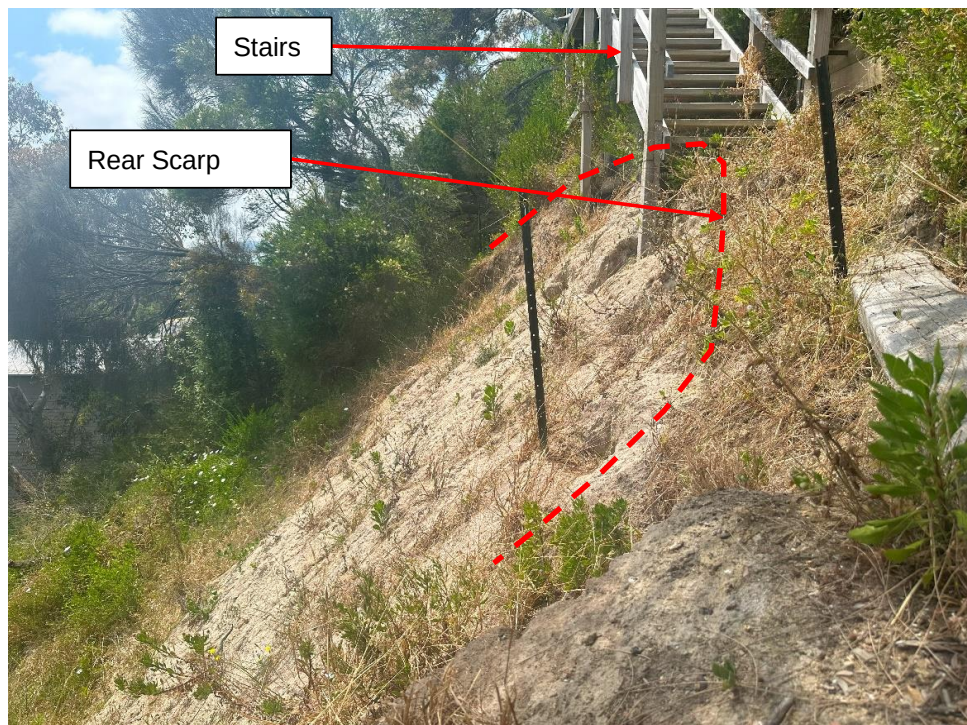
- A lack of prominent backscarp, Photo 5 Appendix B, with minor steepening observed in the backscarp area and with a slope angle of approximately 45 degrees.

Photo 5 - Rear scarp of landslide, note lack of oversteepened backscarp

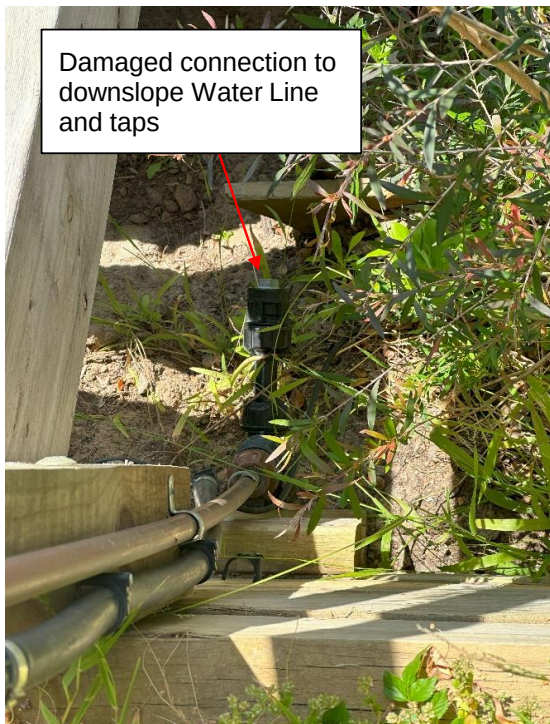
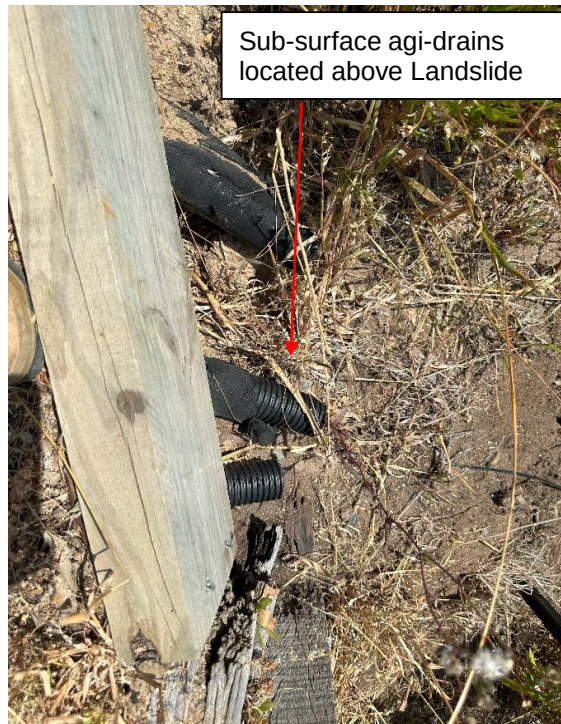
- Subsurface ‘agi-drains’
  - Water pipes including taps. A 20 to 25 mm diameter blue line polyethylene pipe with a damaged connection was observed near the top of the stairs, immediately above the rear scarp of the landslide.

Damaged connection to downslope Water Line and taps

Sub-surface agi-drains located above Landslide

Photo 7 - Water infrastructure including water pipes (on left), and subsurface 'agi drains' (on right)

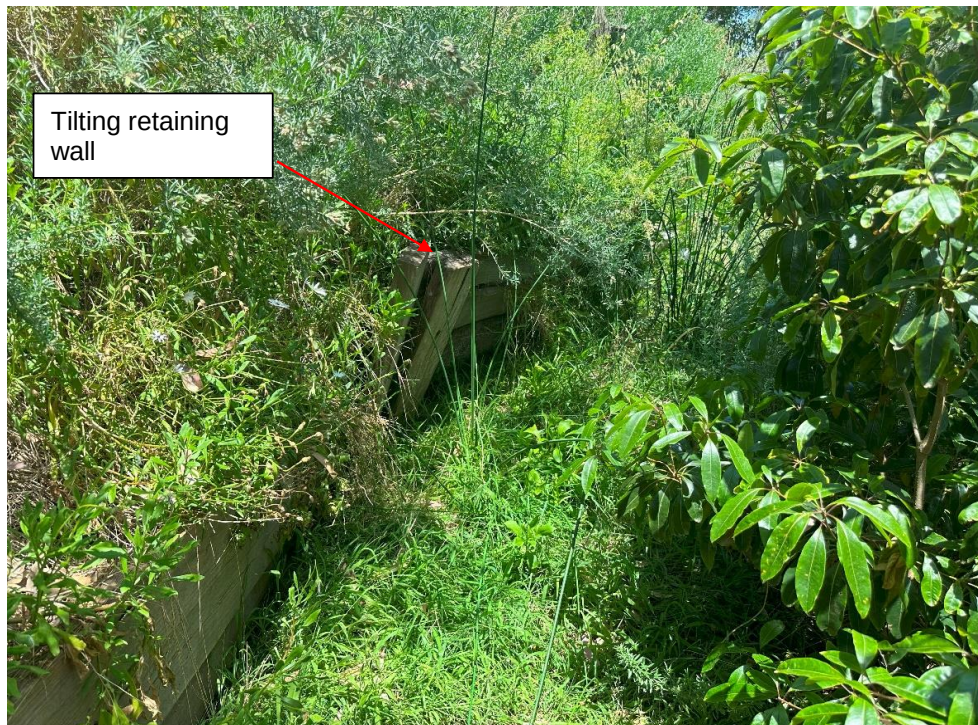
- The condition of RWs across the Site was generally poor, with overturning and bulging RWs observed. A section of RW to the east of the Landslide had significant tilts. This indicates possible instability in the ground above the RW and possible structural or geotechnical failure of the RW, Photo 10 Appendix B. RWs appear to be leaning more than as documented by Stantec (refer Section 2.2).

Photo 10 - Tilting retaining walls on left side of Landslide

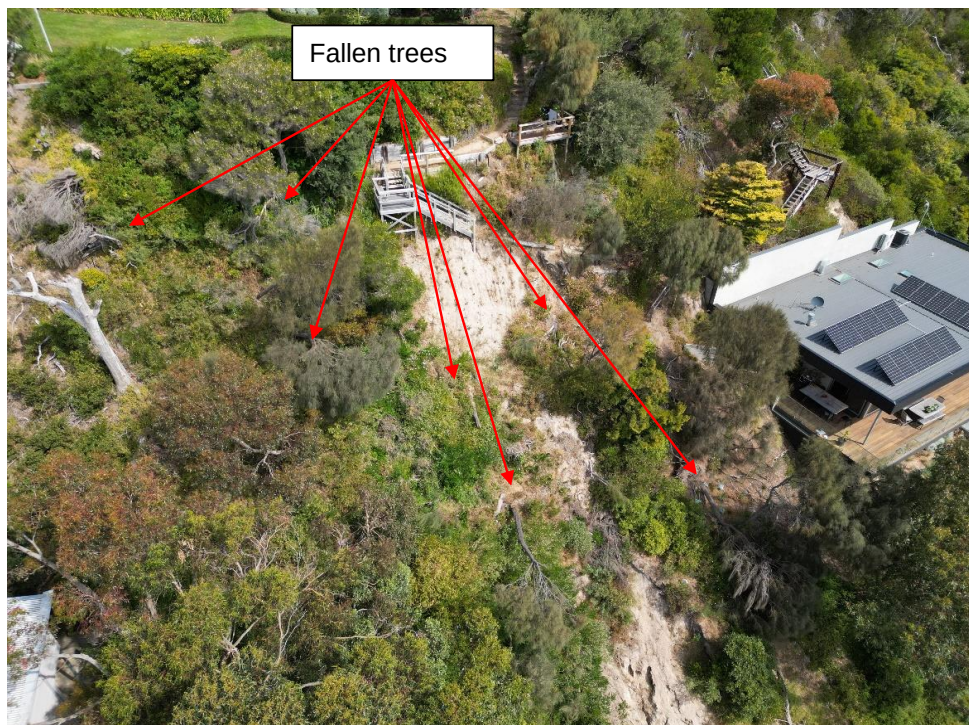
- Numerous fallen trees were observed across the escarpment slope, Photo 11 Appendix B. Most of the failed trees appear to have failed from causes unrelated to the Landslide, i.e., wind or poor root embedment. At least one tree appears to have fallen because of the Landslide.

Photo 11 - Fallen trees

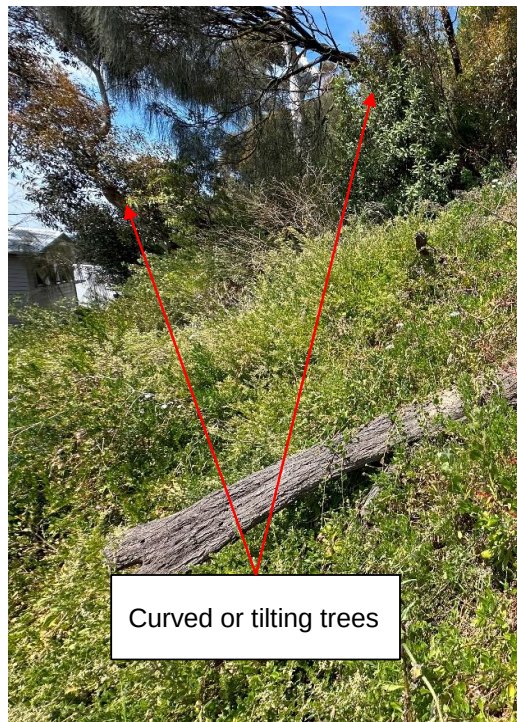
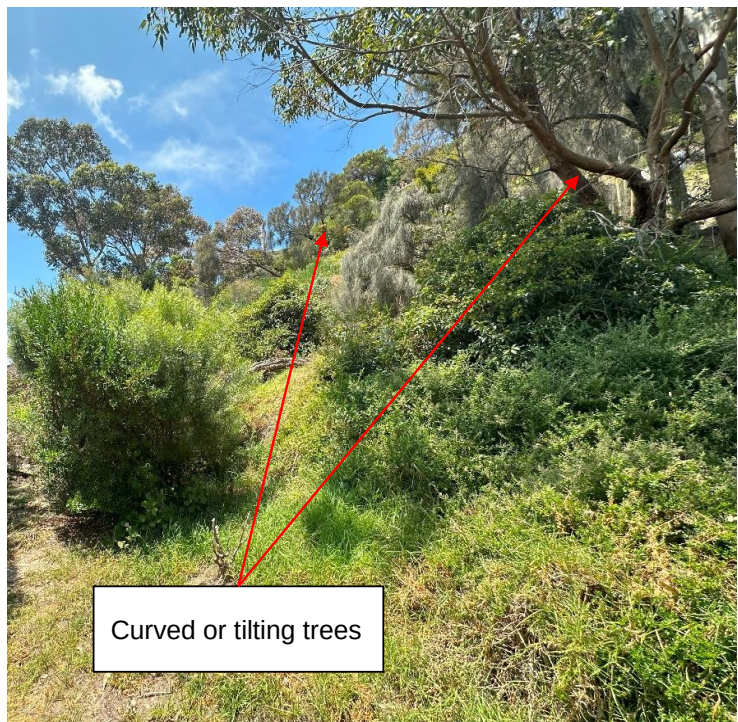
- Minor erosion was observed on unvegetated areas of the escarpment.
- Leaning and curved trees were observed on the escarpment, suggesting possible creep movement of the slope, Photo 12 Appendix B.

Photo 12 - Curved or tilting trees

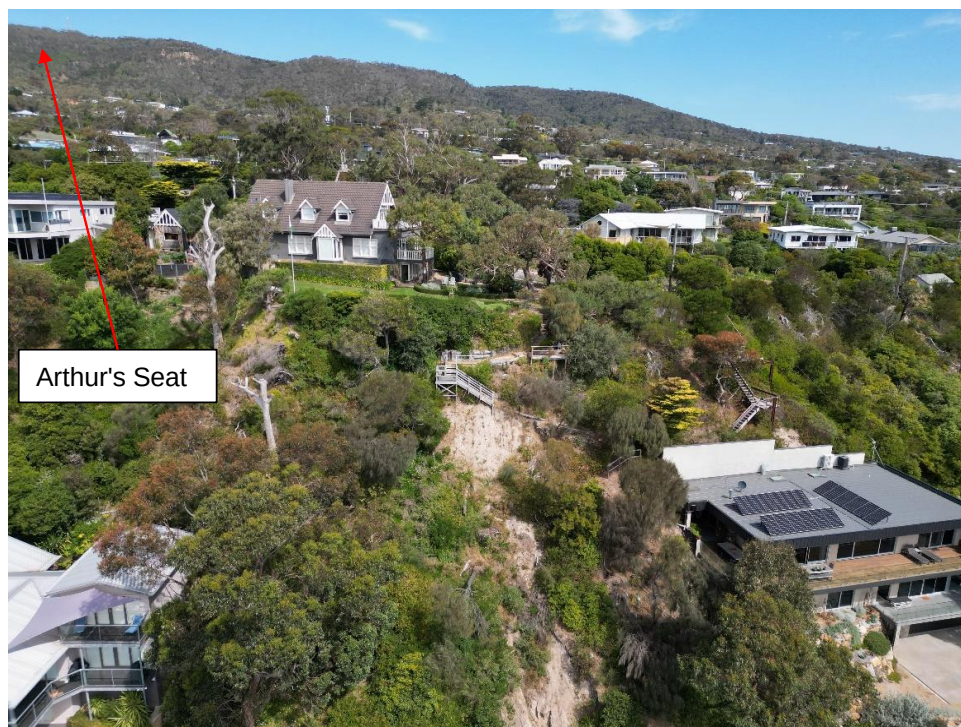
- Granite rock is exposed in shore platform below the road.
  - Steep to sub-vertical upper slopes is inferred to fail by undercutting and erosion of the lower slope leading to toppling/wedge style failures, Photo 15 Appendix B.

Photo 15 - Arthur's Seat in background
