# INITIAL INSPECTION REPORT

Application No: EO-144/22

Property Address: 10-12 View Point Road MCCRAE VIC 3938

Date: 21/11/2022

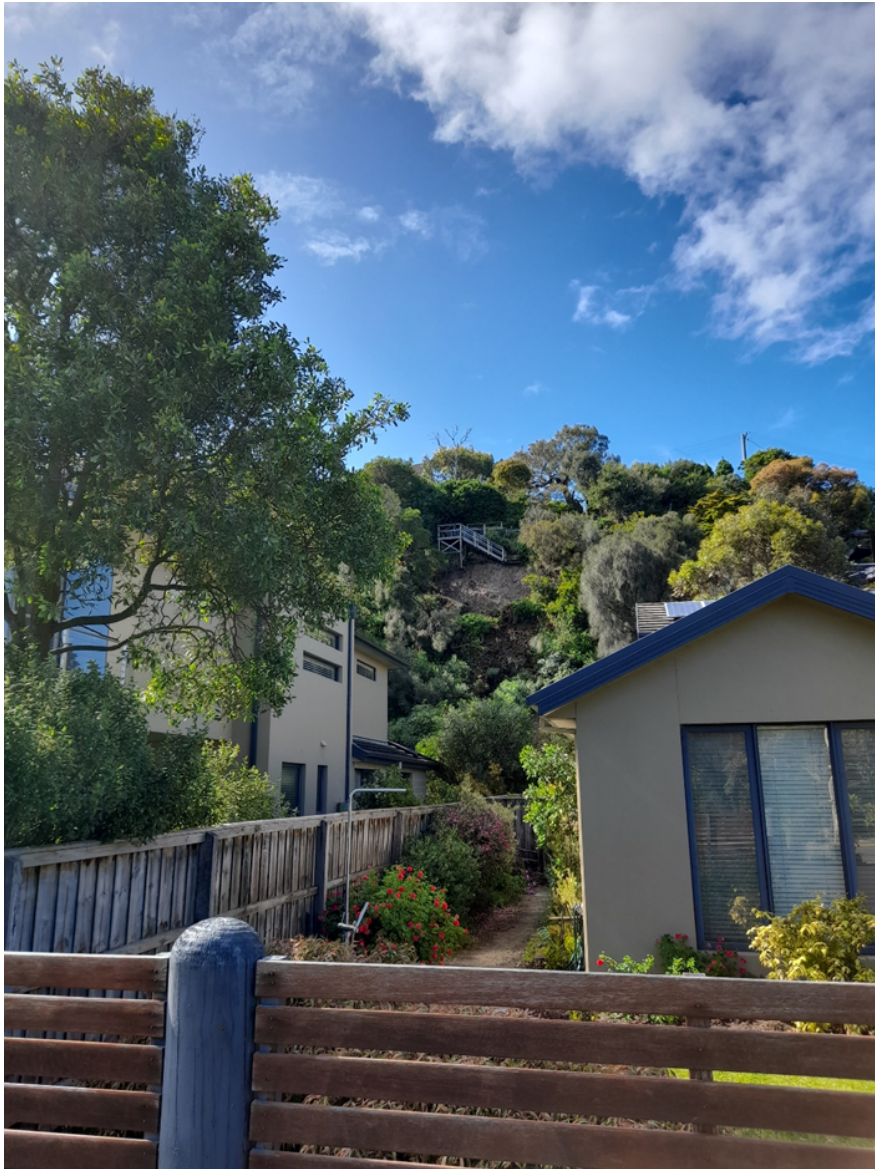
I observed from Point Nepean road perspective the land slip up at the top of the crest to a number of properties that face another road at the top of the embankment. Soil has collapsed from the top crest embankment and has slid approx. halfway down the embankment bring vegetation down with the displaced soil/rock. Some of the soil that has been further displaced and descended to the natural ground level at the bottom of the hill has become liquified due to a burst water hose saturating the soil whereby the soil has fallen into the backyards of 2 Penny Lane and 3/613 Point Nepean rd McCrae.

Photograph 1: The photo below is taken from the street Point Nepean Road, McCrae of the land slip up on the crest of the subject land, the stair has become unstable.
