CHARLESWORTH ST & WALLER PL

Pits #2 & 3

Water Issues Observed

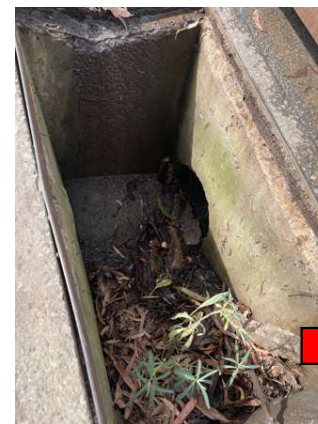
**Pit #1 - BEFORE**

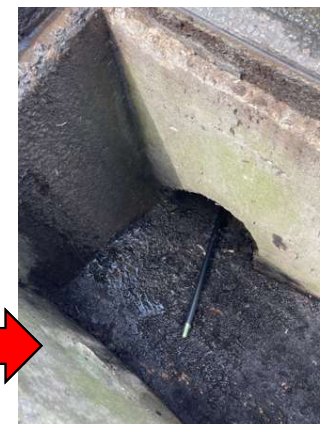
**AFTER PIT #1 CLEARED**

Pit #1 was cleared by hand (even though not at intervention levels and the pipe outlet wasn't obstructed).

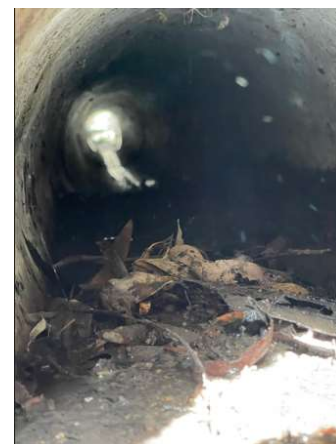
The line from Pit #1 to #3 was proved to be unobstructed and functional.

Line from pit #1 to #3 is clear and un-obstructed

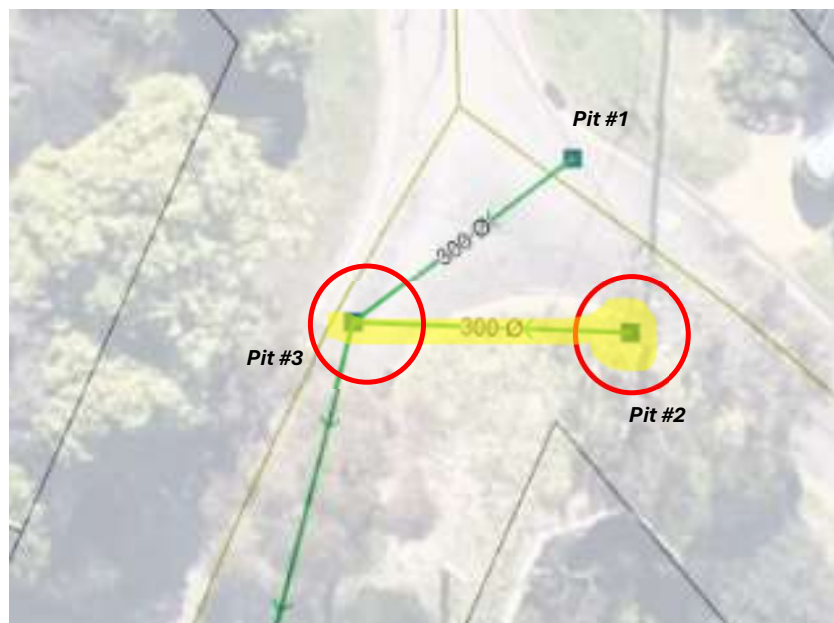
Pit #3 – Has approx 100mm slurry on bottom – but not within maintenance intervention & not obstructing inlet / outlets

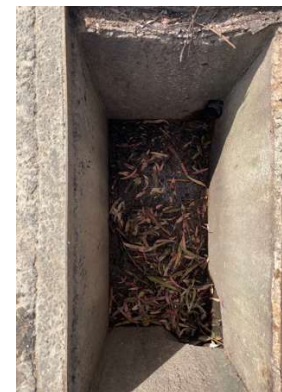
Pit #2 – Only light debris

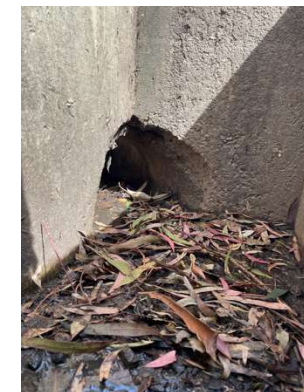
**Pit #2 – Outlet is clear.
Not within maintenance
intervention**

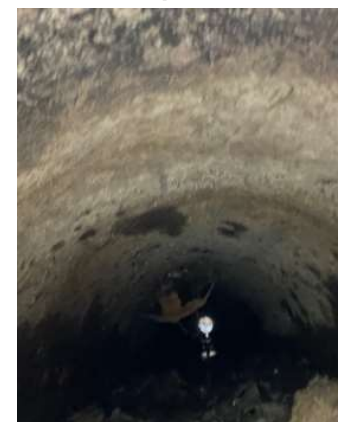
Line from pit #2 to #3

Line from pit #2 to 3 is proven to be unobstructed using flexi rods

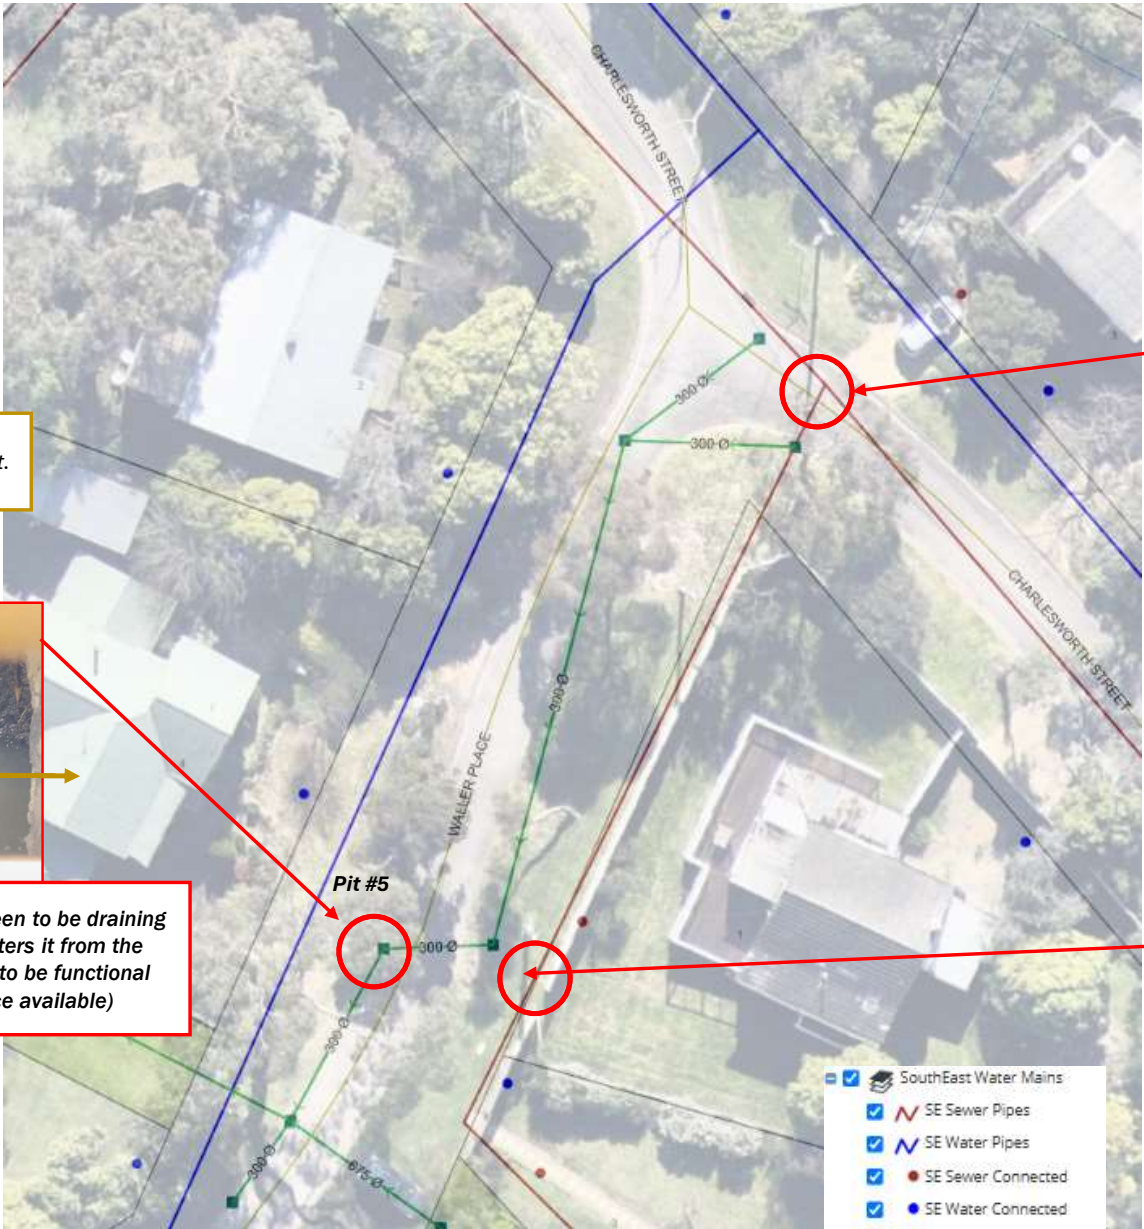
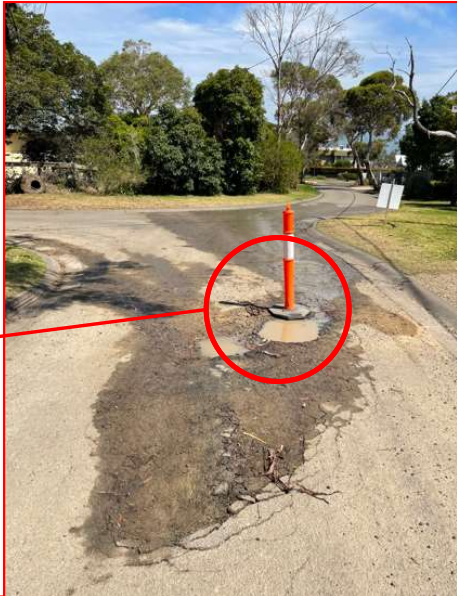
Pit #5 – Is visibly seen to be draining the water that enters it from the street. Confirmed to be functional (Video evidence available)

Water is visibly seen to be bubbling out from the pothole and running down the street into the kerb & storm water pits

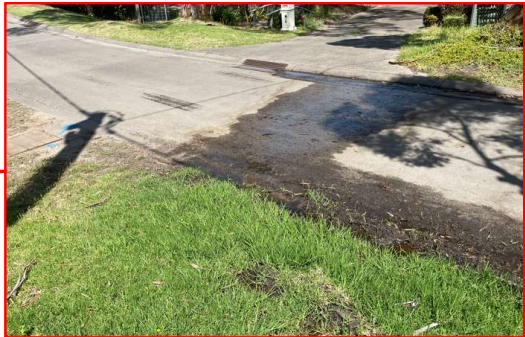
Saturated nature strip flowing onto the road.
Water is actively bubbling up on a day of no rain.

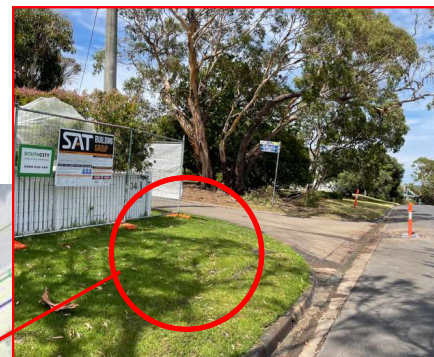
Nature strip is completely saturated

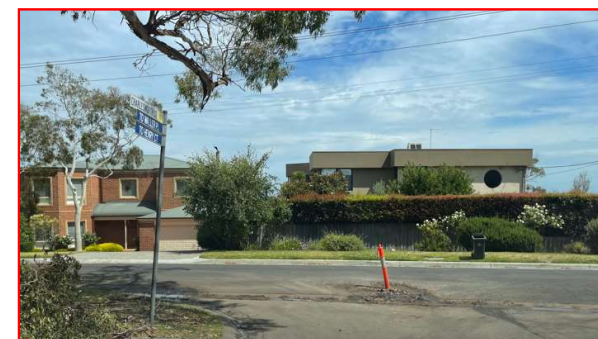
Water is seen to be actively coming up from the road / pothole on a day of no rain – 9/01/2025.

No stormwater assets under the road at this location
