Prepared for Mornington Peninsula Shire
 Asset ID NP12212055
 Location View Point Road, 1 McCrae
 Date 30/08/2023
 Operator Craig Hunt

Upstream Node 962658
 Downstream Node 964409
 Survey Direction Downstream
 Inspected Length 23.07 meters
 Camera Type Tractor
 Standard WSA 05-2008 2.2

Conduit Shape Circular
 Material PP
 Size 300

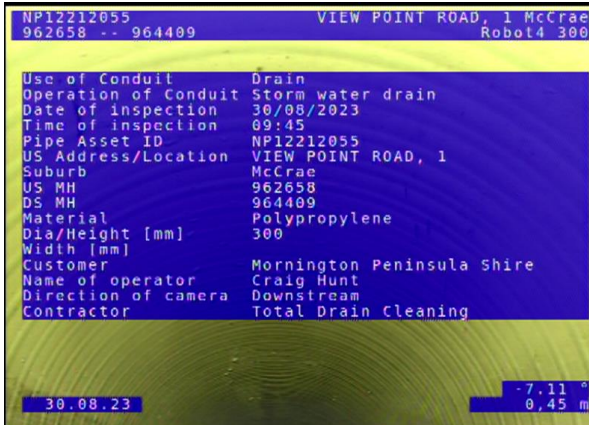
Location of Observation: 0.45m Video Position: 00:00:00

Observation Code: STMH

Start node, maintenance hole, Nodename:, 962658

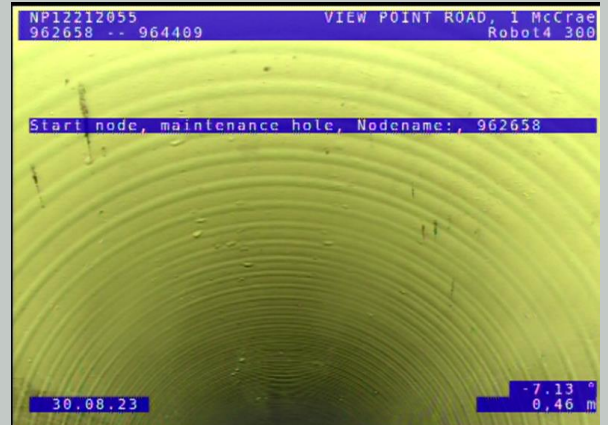
Location of Observation: 0.45m Video Position: 00:00:00

Observation Code: STMH [PHOTO 2]

Start node, maintenance hole, Nodename:, 962658

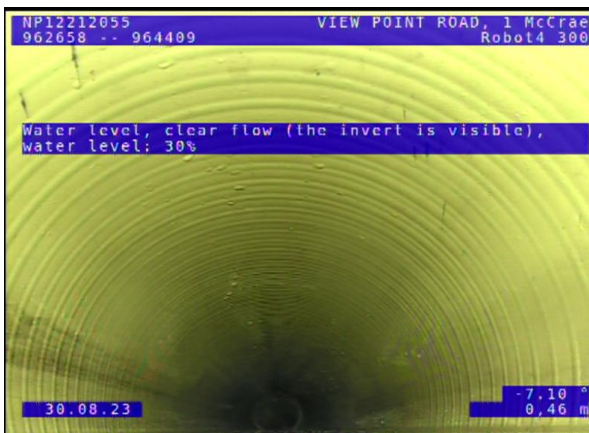
Location of Observation: 0.46m Video Position: 00:00:15

Observation Code: WLC

Water level, clear flow (the invert is visible), water level: 30%

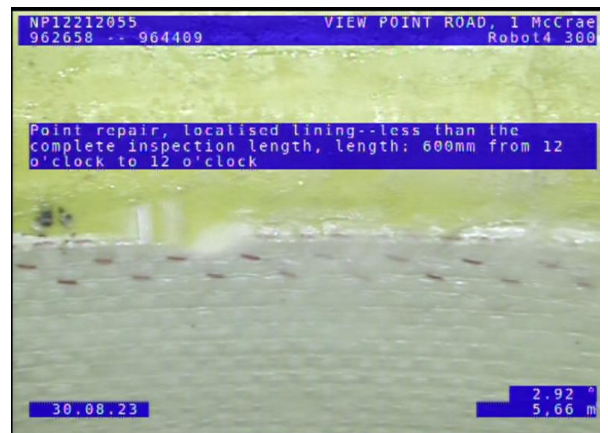
Location of Observation: 5.66m Video Position: 00:01:05

Observation Code: RPL

Point repair, localised lining--less than the complete inspection length, length: 600mm from 12 o'clock to 12 o'clock

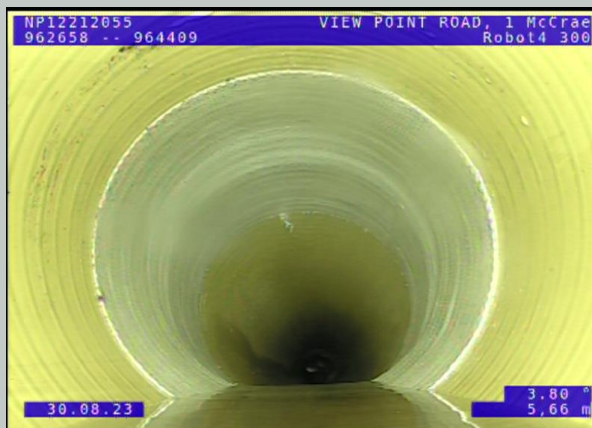
Location of Observation: 5.66m Video Position: 00:01:05
 Observation Code: RPL[PHOTO 2]
 Point repair, localised lining--less than the complete inspection length, length: 600mm from 12 o'clock to 12 o'clock

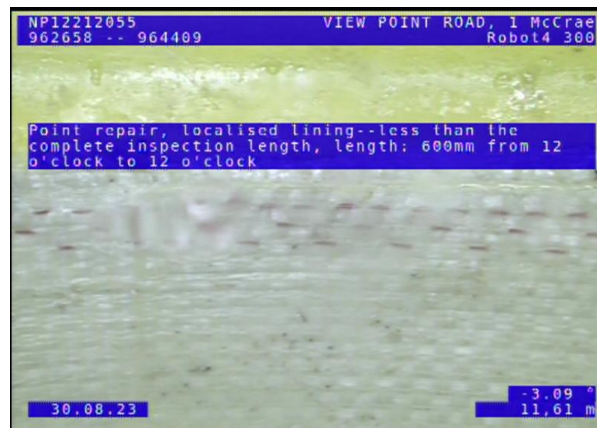
Location of Observation: 11.61m Video Position: 00:01:52
 Observation Code: RPL
 Point repair, localised lining--less than the complete inspection length, length: 600mm from 12 o'clock to 12 o'clock

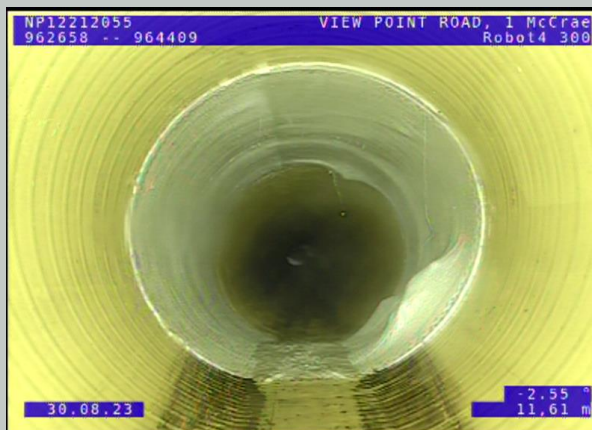
Location of Observation: 11.61m Video Position: 00:01:52
 Observation Code: RPL[PHOTO 2]
 Point repair, localised lining--less than the complete inspection length, length: 600mm from 12 o'clock to 12 o'clock

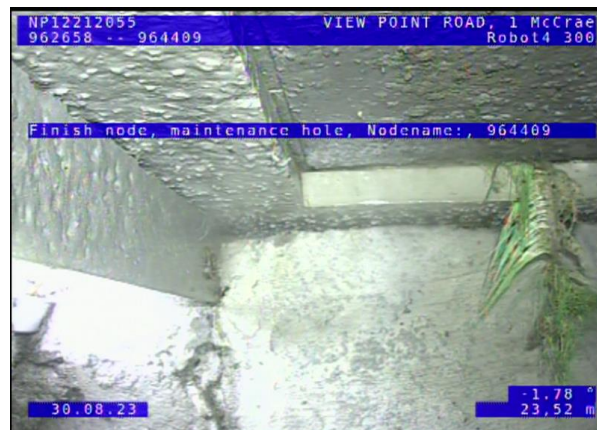
Location of Observation: 23.53m Video Position: 00:02:58
 Observation Code: FHMH
 Finish node, maintenance hole, Nodename:, 964409
