Prepared for Mornington Peninsula Shire  
 Asset ID NP12212117  
 Location Prospect Hill Road, 7 McCrae  
 Date 30/08/2023  
 Operator Craig Hunt

Upstream Node 929094  
 Downstream Node 962658  
 Survey Direction Upstream  
 Inspected Length 34.88 meters  
 Camera Type Tractor  
 Standard WSA 05-2008 2.2

Conduit Shape Circular  
 Material RC  
 Size 300

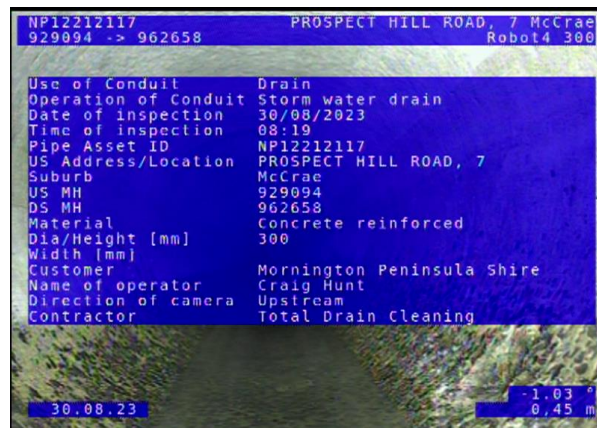
Location of Observation: 0.45m

Observation Code: STMH

Start node, maintenance hole, Nodename:, 962658

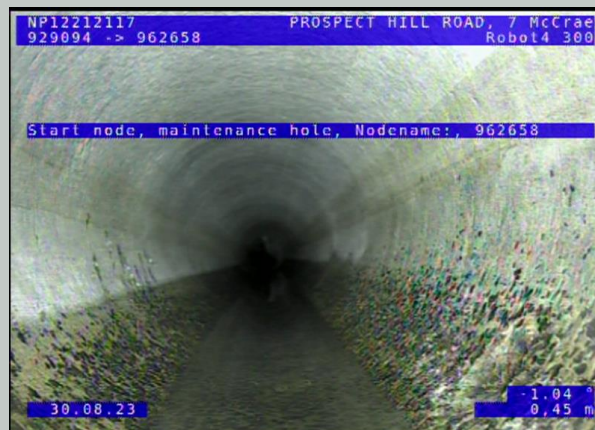
Location of Observation: 0.45m Video Position: 00:00:00

Observation Code: STMH[PHOTO 2]

Start node, maintenance hole, Nodename:, 962658

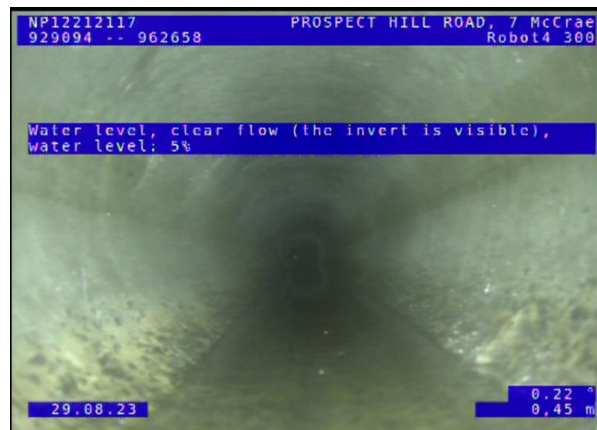
Location of Observation: 0.45m

Observation Code: WLC

Water level, clear flow (the invert is visible), water level: 5%

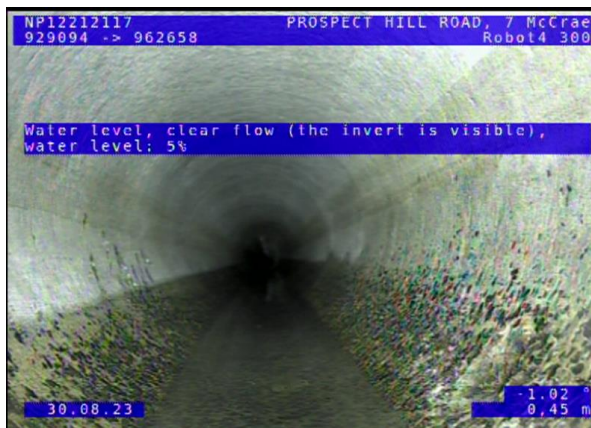
Location of Observation: 0.45m      Video Position: 00:00:17  
 Observation Code: WLC  
 Water level, clear flow (the invert is visible), water level: 5%

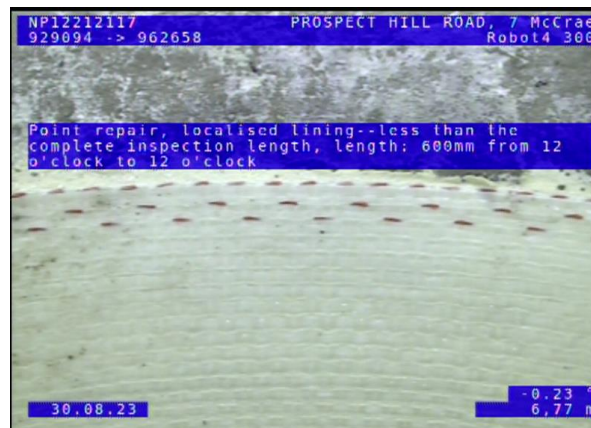
Location of Observation: 6.77m      Video Position: 00:00:45  
 Observation Code: RPL  
 Point repair, localised lining--less than the complete inspection length, length: 600mm from 12 o'clock to 12 o'clock

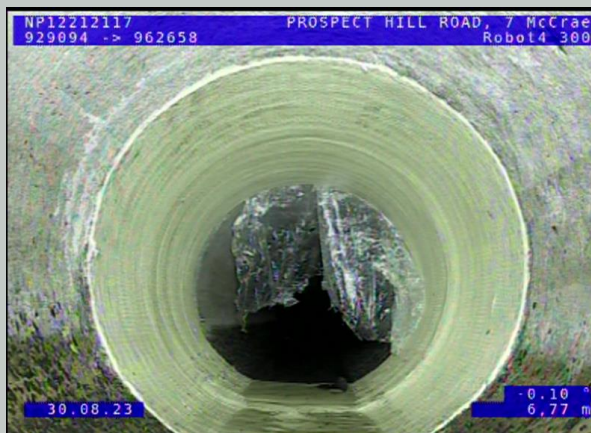
Location of Observation: 6.77m      Video Position: 00:00:45  
 Observation Code: RPL[PHOTO 2]  
 Point repair, localised lining--less than the complete inspection length, length: 600mm from 12 o'clock to 12 o'clock

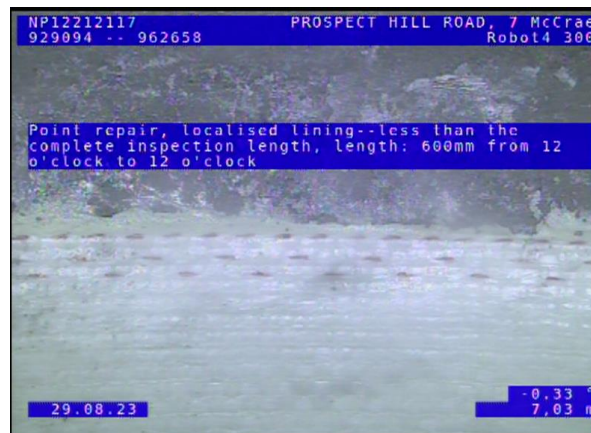
Location of Observation: 7.03m      Video Position: 00:00:49  
 Observation Code: RPL  
 Point repair, localised lining--less than the complete inspection length, length: 600mm from 12 o'clock to 12 o'clock

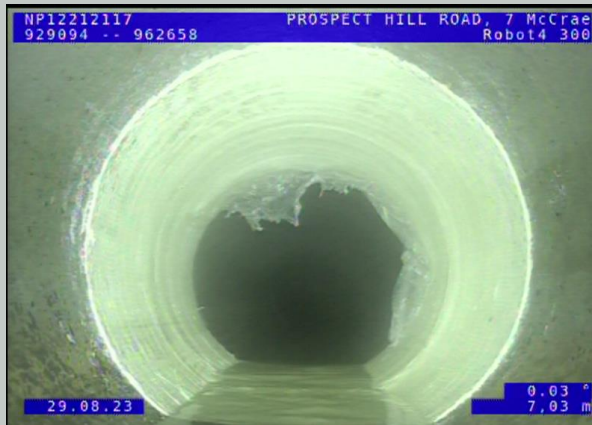
Location of Observation: 7.03m      Video Position: 00:00:49  
 Observation Code: RPL[PHOTO 2]  
 Point repair, localised lining--less than the complete inspection length, length: 600mm from 12 o'clock to 12 o'clock

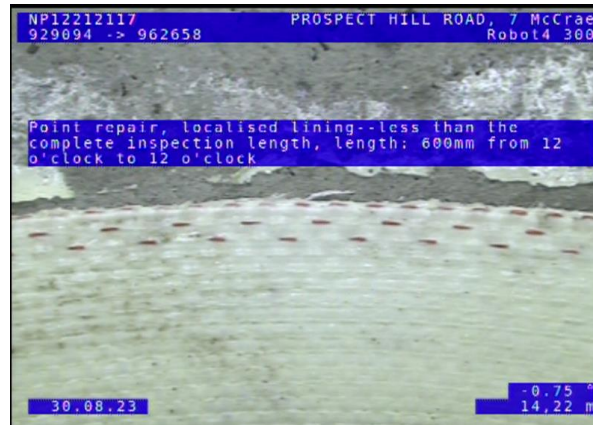
Location of Observation: 14.22m      Video Position: 00:01:47  
 Observation Code: RPL  
 Point repair, localised lining--less than the complete inspection length, length: 600mm from 12 o'clock to 12 o'clock

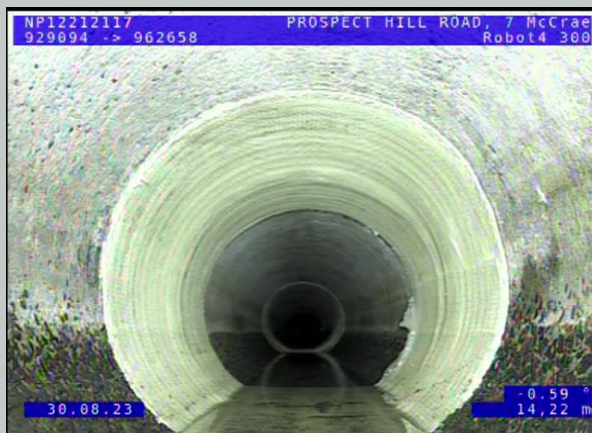
Location of Observation: 14.22m      Video Position: 00:01:47  
 Observation Code: RPL[PHOTO 2]  
 Point repair, localised lining--less than the complete inspection length, length: 600mm from 12 o'clock to 12 o'clock

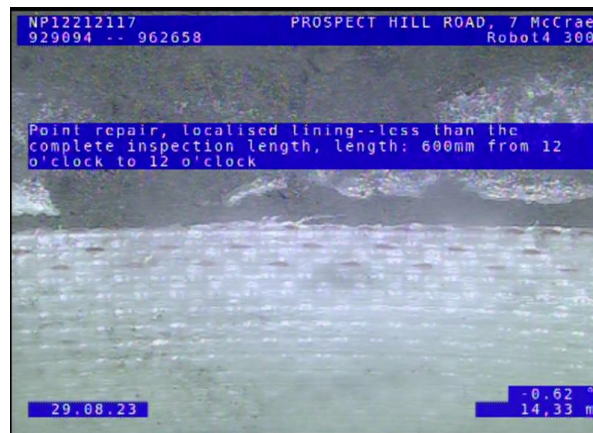
Location of Observation: 14.33m      Video Position: 00:01:34  
 Observation Code: RPL  
 Point repair, localised lining--less than the complete inspection length, length: 600mm from 12 o'clock to 12 o'clock

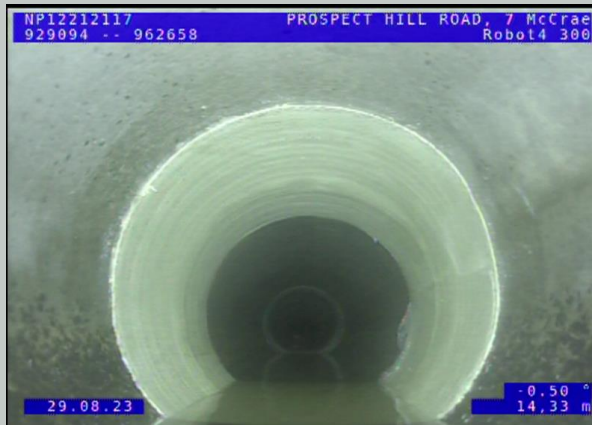
Location of Observation: 14.33m      Video Position: 00:01:34  
 Observation Code: RPL[PHOTO 2]  
 Point repair, localised lining--less than the complete inspection length, length: 600mm from 12 o'clock to 12 o'clock

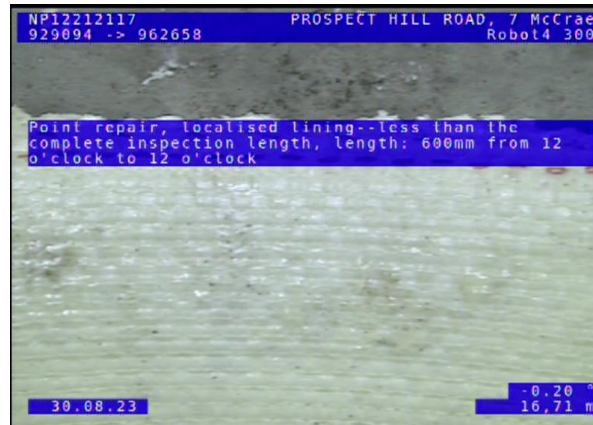
Location of Observation: 16.71m      Video Position: 00:02:33  
 Observation Code: RPL  
 Point repair, localised lining--less than the complete inspection length, length: 600mm from 12 o'clock to 12 o'clock

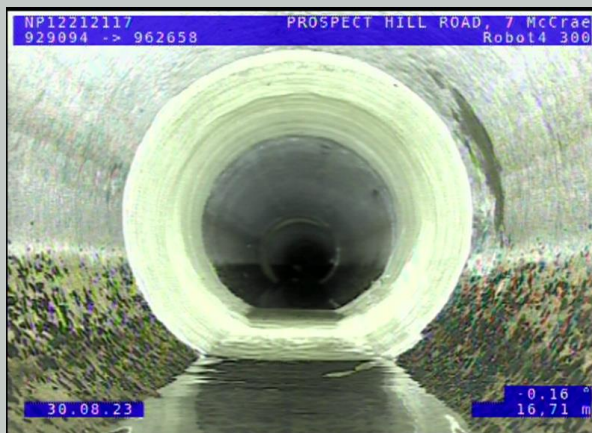
Location of Observation: 16.71m      Video Position: 00:02:33  
 Observation Code: RPL[PHOTO 2]  
 Point repair, localised lining--less than the complete inspection length, length: 600mm from 12 o'clock to 12 o'clock

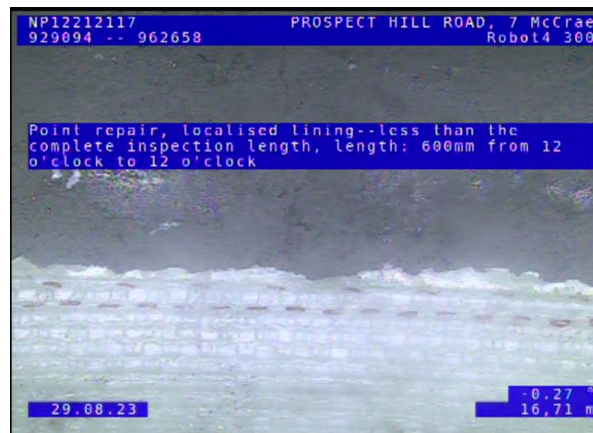
Location of Observation: 16.71m      Video Position: 00:02:05  
 Observation Code: RPL  
 Point repair, localised lining--less than the complete inspection length, length: 600mm from 12 o'clock to 12 o'clock

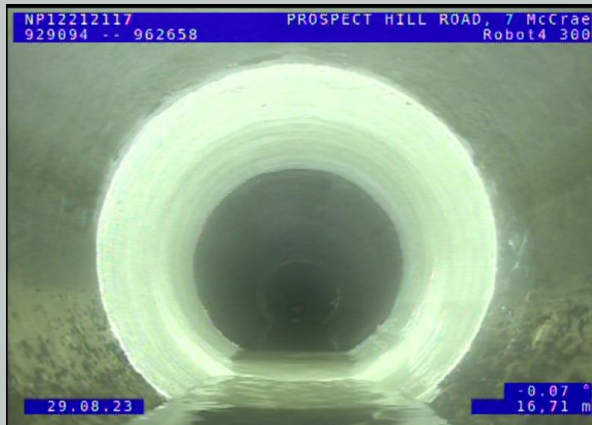
Location of Observation: 16.71m Video Position: 00:02:05

Observation Code: RPL[PHOTO 2]

Point repair, localised lining--less than the complete inspection length, length: 600mm from 12 o'clock to 12 o'clock

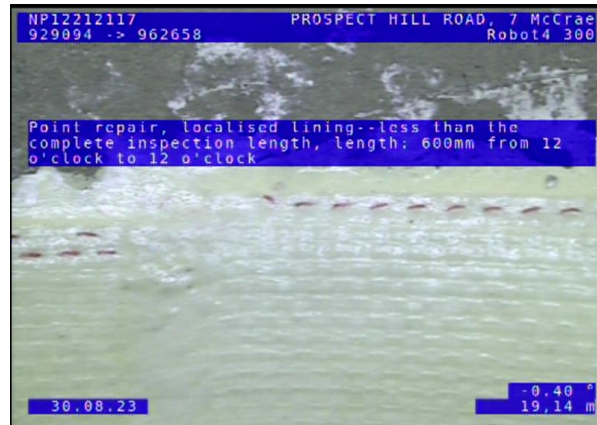
Location of Observation: 19.14m Video Position: 00:03:09

Observation Code: RPL

Point repair, localised lining--less than the complete inspection length, length: 600mm from 12 o'clock to 12 o'clock

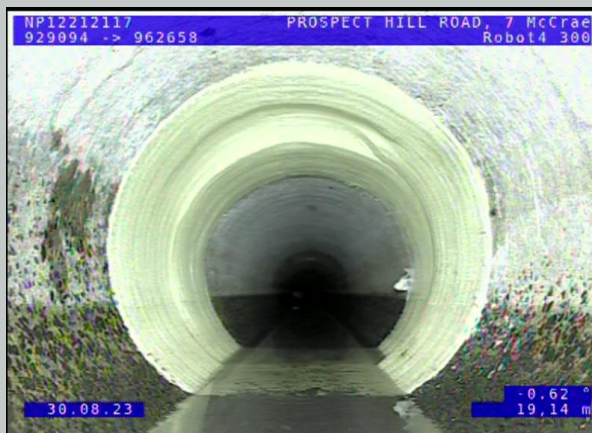
Location of Observation: 19.14m Video Position: 00:03:09

Observation Code: RPL[PHOTO 2]

Point repair, localised lining--less than the complete inspection length, length: 600mm from 12 o'clock to 12 o'clock

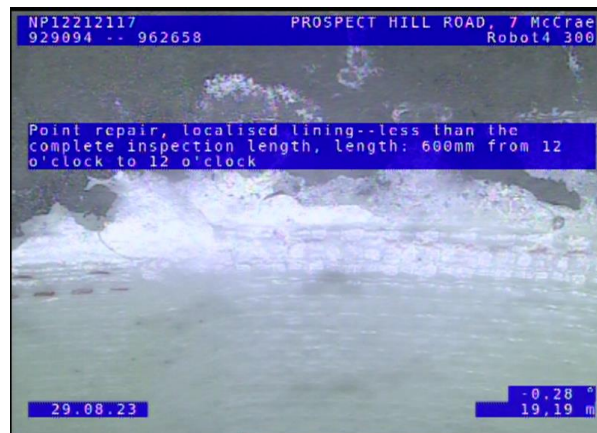
Location of Observation: 19.19m Video Position: 00:02:36

Observation Code: RPL

Point repair, localised lining--less than the complete inspection length, length: 600mm from 12 o'clock to 12 o'clock

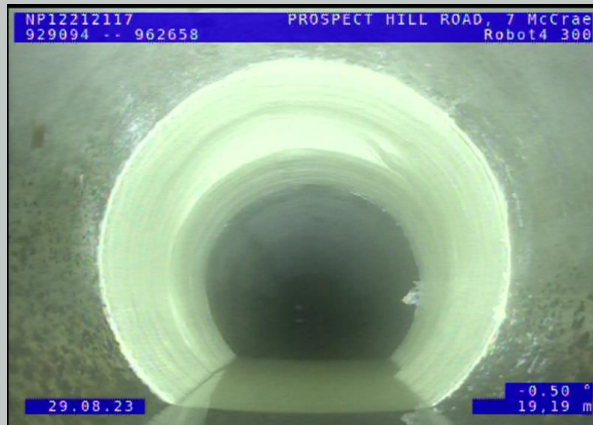
Location of Observation: 19.19m Video Position: 00:02:36

Observation Code: RPL[PHOTO 2]

Point repair, localised lining--less than the complete inspection length, length: 600mm from 12 o'clock to 12 o'clock

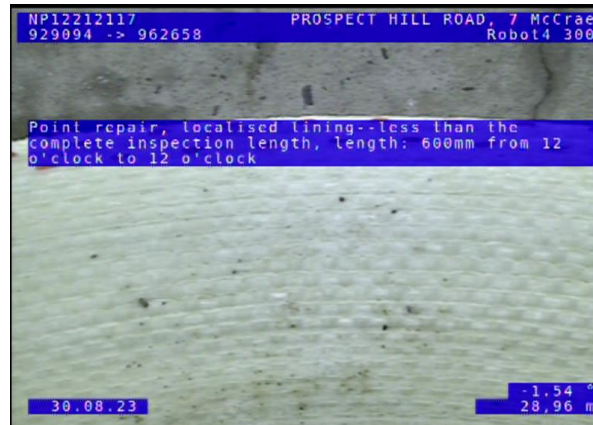
Location of Observation: 28.96m Video Position: 00:04:07

Observation Code: RPL

Point repair, localised lining--less than the complete inspection length, length: 600mm from 12 o'clock to 12 o'clock

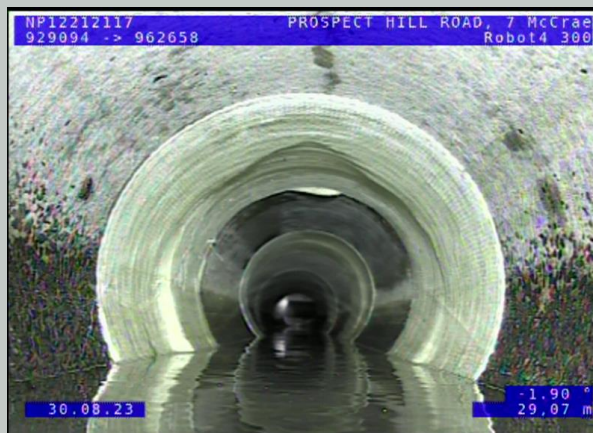
Location of Observation: 28.96m Video Position: 00:04:07

Observation Code: RPL[PHOTO 2]

Point repair, localised lining--less than the complete inspection length, length: 600mm from 12 o'clock to 12 o'clock

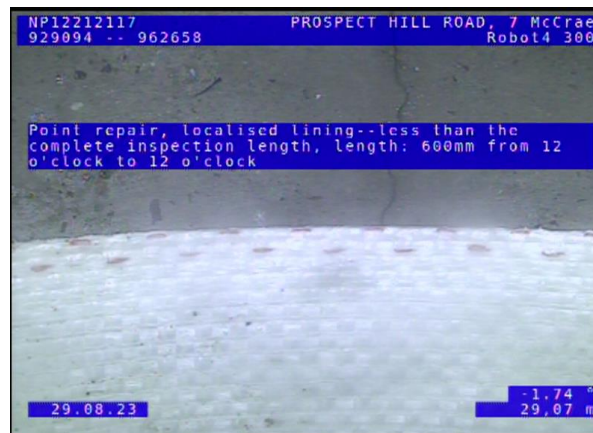
Location of Observation: 29.07m Video Position: 00:03:35

Observation Code: RPL

Point repair, localised lining--less than the complete inspection length, length: 600mm from 12 o'clock to 12 o'clock

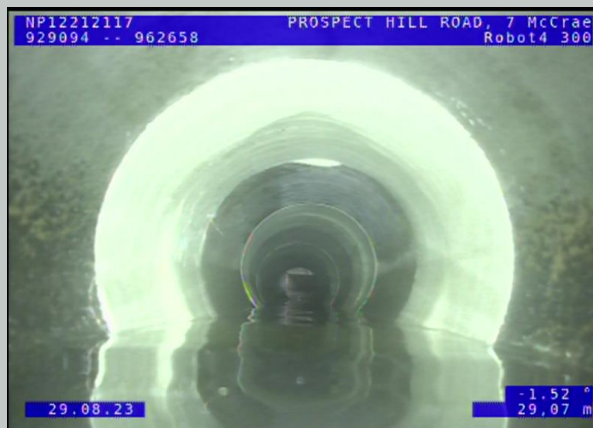
Location of Observation: 29.07m      Video Position: 00:03:35  
 Observation Code: RPL[PHOTO 2]  
 Point repair, localised lining--less than the complete inspection length, length: 600mm from 12 o'clock to 12 o'clock

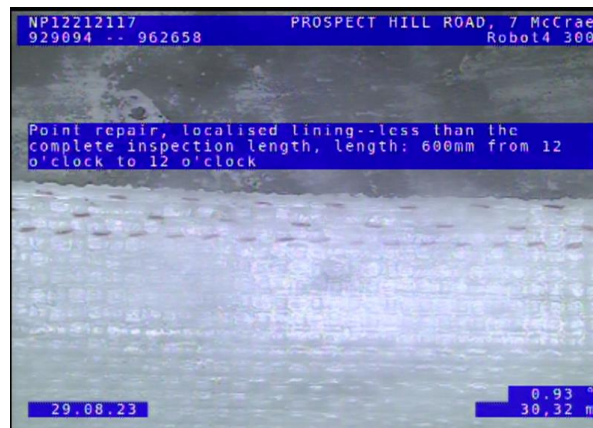
Location of Observation: 30.32m      Video Position: 00:04:00  
 Observation Code: RPL  
 Point repair, localised lining--less than the complete inspection length, length: 600mm from 12 o'clock to 12 o'clock

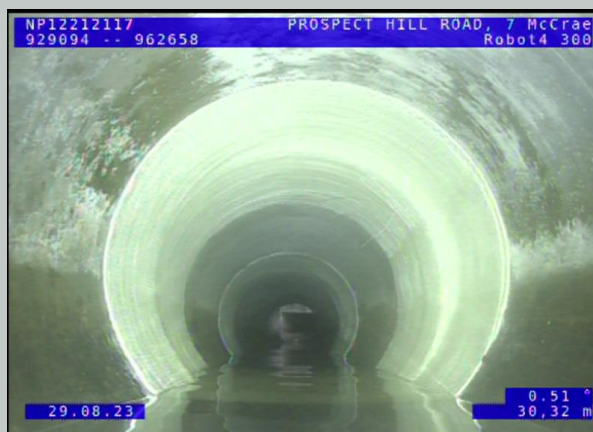
Location of Observation: 30.32m      Video Position: 00:04:00  
 Observation Code: RPL[PHOTO 2]  
 Point repair, localised lining--less than the complete inspection length, length: 600mm from 12 o'clock to 12 o'clock

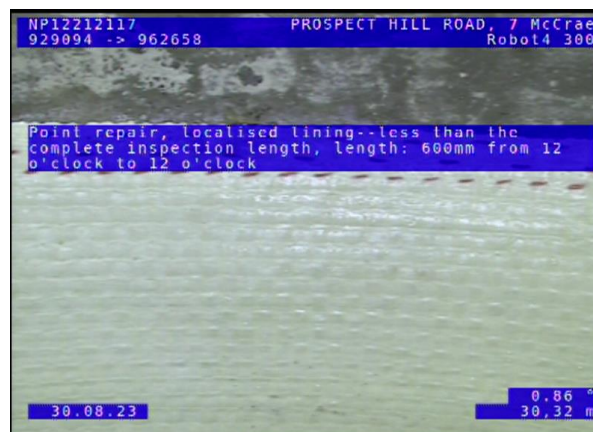
Location of Observation: 30.32m      Video Position: 00:04:43  
 Observation Code: RPL  
 Point repair, localised lining--less than the complete inspection length, length: 600mm from 12 o'clock to 12 o'clock

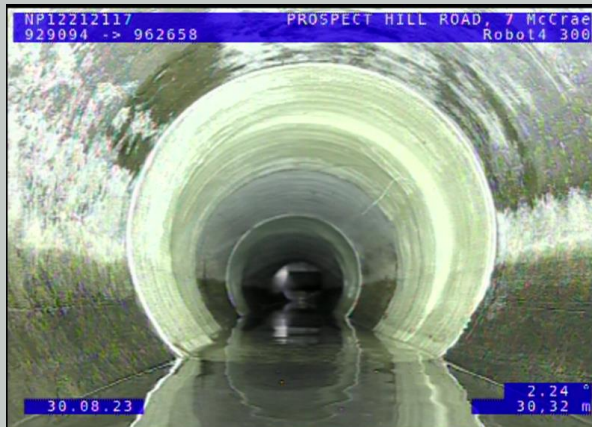
Location of Observation: 30.32m Video Position: 00:04:43

Observation Code: RPL[PHOTO 2]

Point repair, localised lining--less than the complete inspection length, length: 600mm from 12 o'clock to 12 o'clock

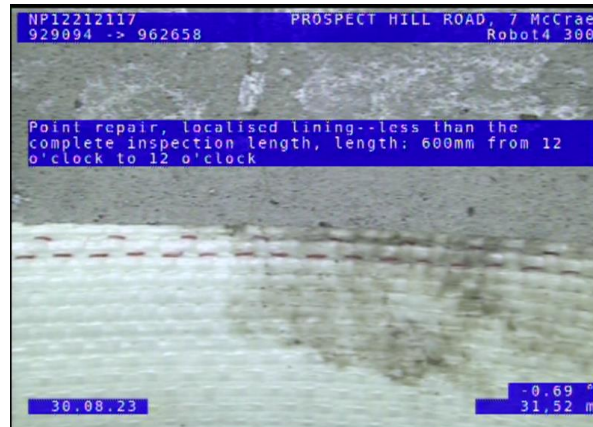
Location of Observation: 31.52m Video Position: 00:05:16

Observation Code: RPL

Point repair, localised lining--less than the complete inspection length, length: 600mm from 12 o'clock to 12 o'clock

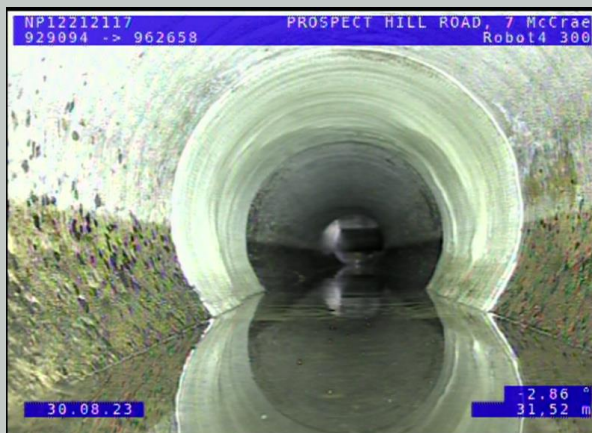
Location of Observation: 31.52m Video Position: 00:05:16

Observation Code: RPL[PHOTO 2]

Point repair, localised lining--less than the complete inspection length, length: 600mm from 12 o'clock to 12 o'clock

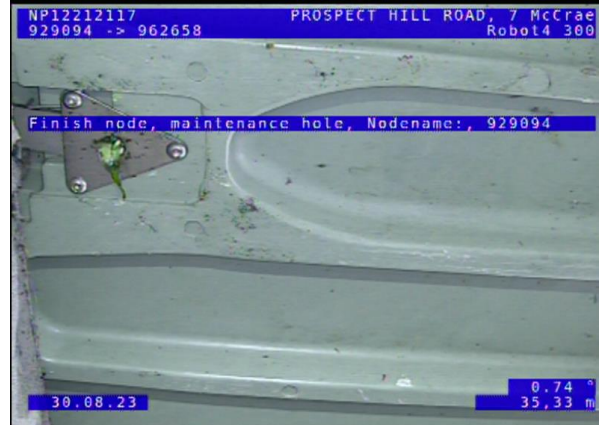
Location of Observation: 35.33m      Video Position: 00:05:59

Observation Code: FHMH

Finish node, maintenance hole, Nodename:, 929094
