Section Inspection - 15/01/2025 - A TOO B

Date of inspection 15/01/2025	Time of inspection 9:00 AM	Land ownership Public land	Pipe Asset ID A TOO B	Nr. 1
Project name <small>FULTONHOGAN - AE407 10-12 VIEW POINT ROAD MCCRAE</small>	Contractor's Job Number	Coding Standard WSA 2020	Name of operator Alex Elliott	Job ID 10-12 VIEW POINT ROAD MCCRAE

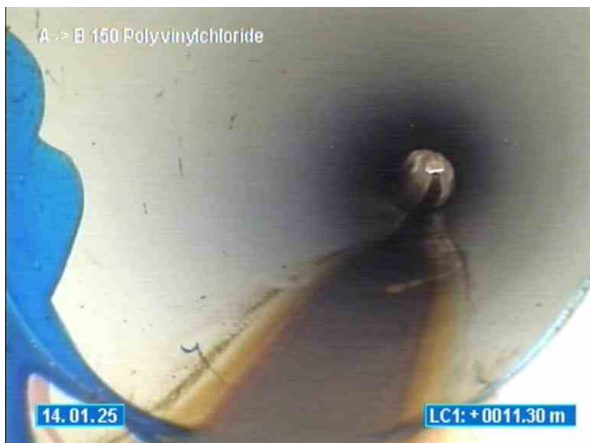
10-12 VIEW POINT ROAD MCCRAE_15.01.2025_090054_A
 TOO B _007.jpg, 00:03:24, 11.30
 Inspection (survey) abandoned, Line deviates

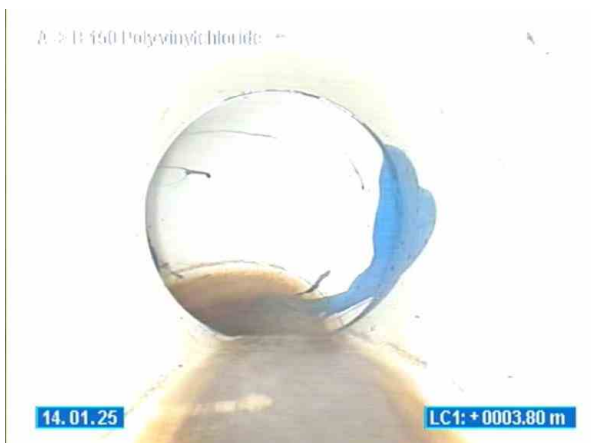
10-12 VIEW POINT ROAD MCCRAE_15.01.2025_083859_A
 TOO B _003.jpg, 00:04:25, 3.80
 The conduit curves to the left

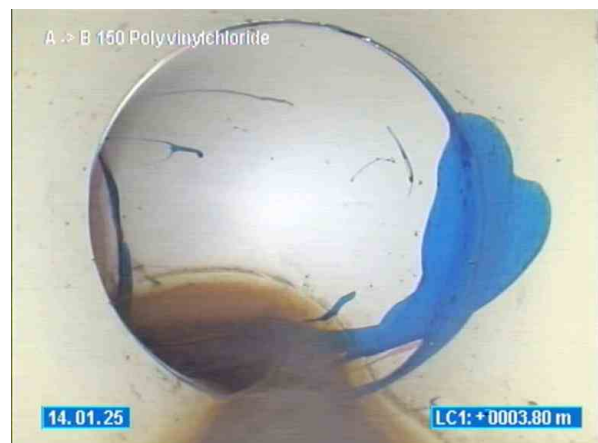
10-12 VIEW POINT ROAD MCCRAE_15.01.2025_083859_A
 TOO B _004.jpg, 00:05:13, 3.80
 Inspection (survey) abandoned, Line deviates

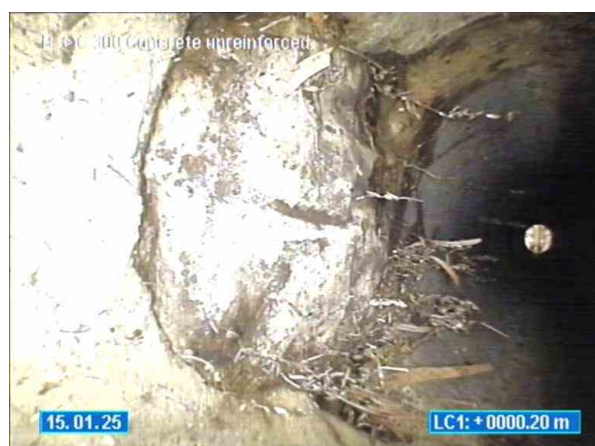
10-12 VIEW POINT ROAD MCCRAE_15.01.2025_102122_B
 TOO C _010.jpg, 00:02:28, 0.20
 Breaking, all pieces are present but some of them are visibly
 displaced from position, length of break: 300mm from 11
 o'clock to 1 o'clock

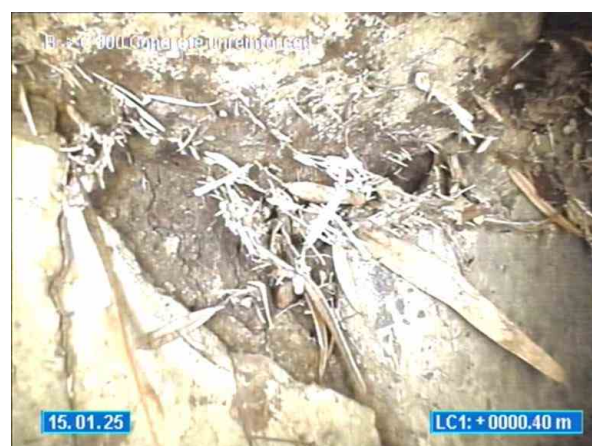
10-12 VIEW POINT ROAD MCCRAE_15.01.2025_102122_B
 TOO C _011.jpg, 00:02:54, 0.40
 Soil visible through defect

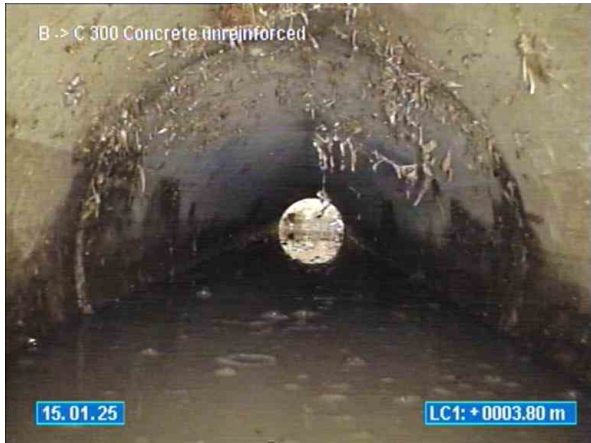
10-12 VIEW POINT ROAD MCCRAE_15.01.2025_102122_B
 TOO C _012.jpg, 00:03:34, 3.80
 Water flow at constant depth, turbid or discoloured water,
 20-25%

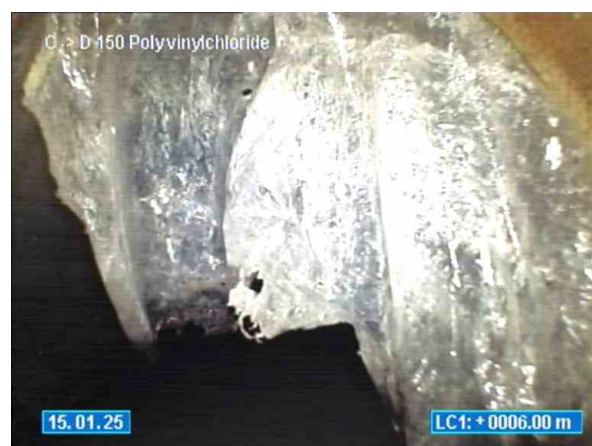
6.00	OBI	Obstruction, an object is intruding through the wall, Obstruction: 80% from 11 o'clock to 4 o'clock	00:04:25	10-12 VIEW POINT	5
	6.40	MC	Change of conduit material. New material, Concrete segments, at joint	00:04:25	10-12 VIEW POINT

10-12 VIEW POINT ROAD MCCRAE_15.01.2025_114611_C
 TOO D_024.jpg, 00:04:25, 6.00
 Obstruction, an object is intruding through the wall,
 Obstruction: 80% from 11 o'clock to 4 o'clock

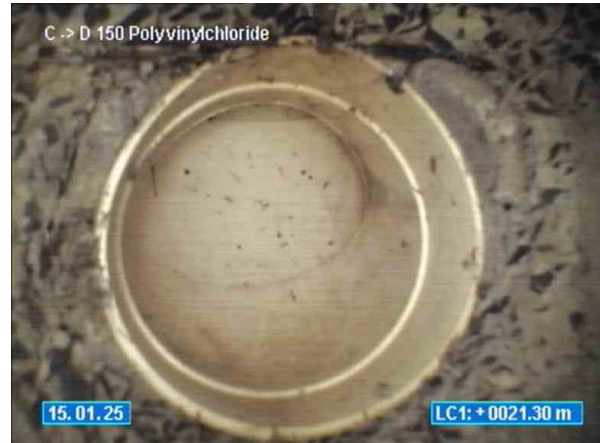
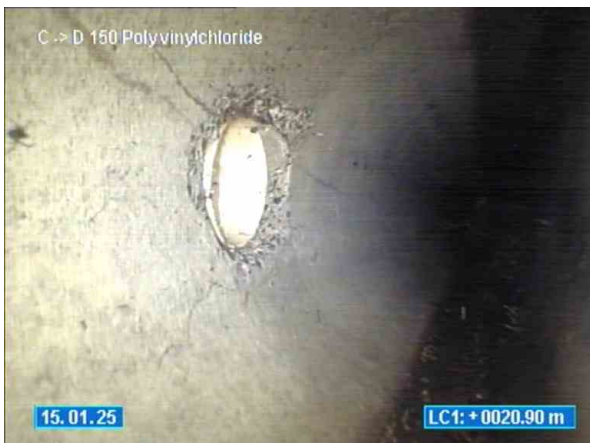
10-12 VIEW POINT ROAD MCCRAE_15.01.2025_114611_C
 TOO D_030.jpg, 00:04:25, 21.30
 Connection, unlined, connection appears to be open,
 Height/Diameter (mm): 100 at 12 o'clock

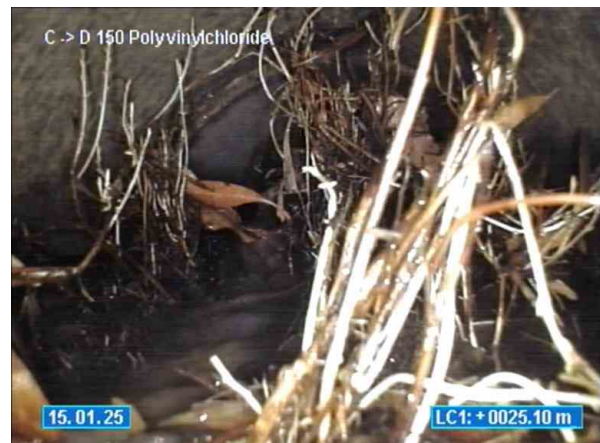
10-12 VIEW POINT ROAD MCCRAE_15.01.2025_114611_C
 TOO D_032.jpg, 00:00:00, 25.10
 Inspection (survey) abandoned, roots

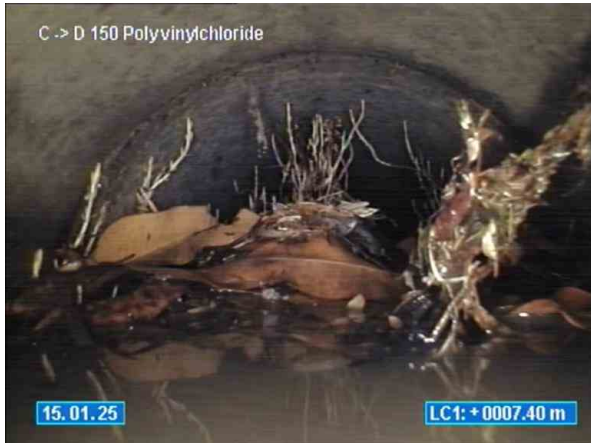
10-12 VIEW POINT ROAD MCCRAE_15.01.2025_104134_C
 TOO D_020.jpg, 00:05:13, 7.10
 Tap roots, reduction in cross sectional area, Obstruction: 50%
 from 9 o'clock to 3 o'clock

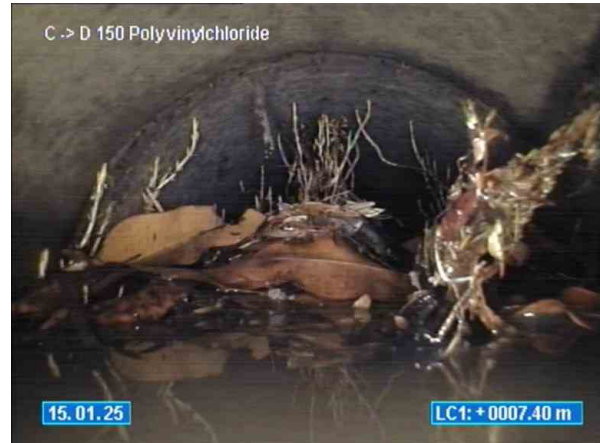
10-12 VIEW POINT ROAD MCCRAE_15.01.2025_104134_C
 TOO D_019.jpg, 00:07:08, 7.40
 Inspection (survey) abandoned, roots

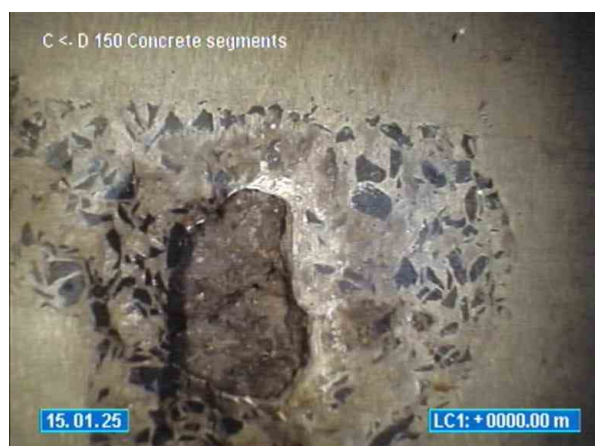
0.00	BM	Breaking, one or more pieces of conduit are missing, length of break: 100mm from 11 o'clock to 1 o'clock	00:33:07	10-12 VIEW POINT	3
	0.00	SV	Soil visible through defect	00:33:07	10-12 VIEW POINT	4

10-12 VIEW POINT ROAD MCCRAE_15.01.2025_132020_D
 TOO C _035.jpg, 00:33:07, 0.00
 Breaking, one or more pieces of conduit are missing, length of
 break: 100mm from 11 o'clock to 1 o'clock

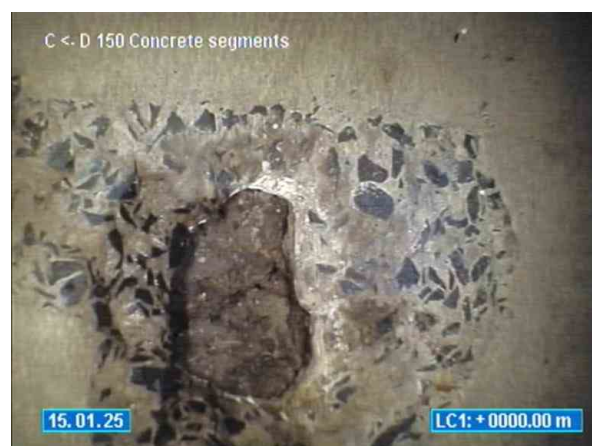
10-12 VIEW POINT ROAD MCCRAE_15.01.2025_132020_D
 TOO C _036.jpg, 00:33:07, 0.00
 Soil visible through defect

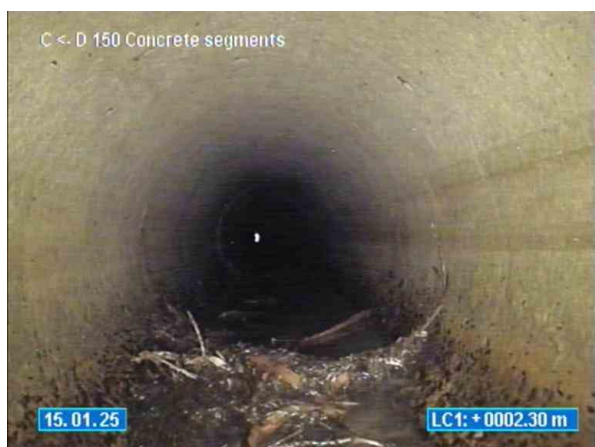
2.30	RRF	Recently cut fine roots-a relatively small number of cut minor roots remain, Obstruction: 20% from 4 o'clock to 8 o'clock	00:33:07	10-12 VIEW POINT	1

10-12 VIEW POINT ROAD MCCRAE_15.01.2025_132020_D TOO C _037.jpg, 00:33:07, 2.30
 Recently cut fine roots-a relatively small number of cut minor roots remain, Obstruction: 20% from 4 o'clock to 8 o'clock

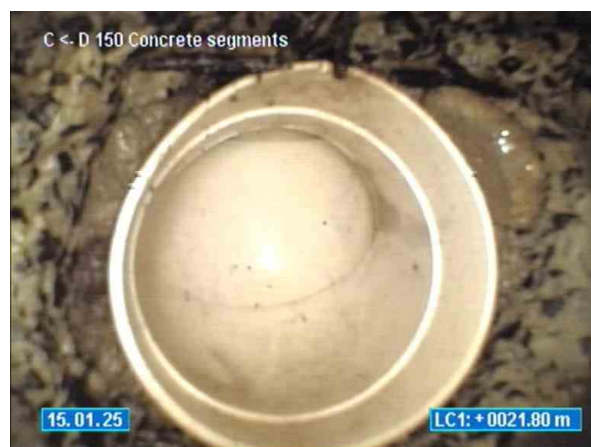
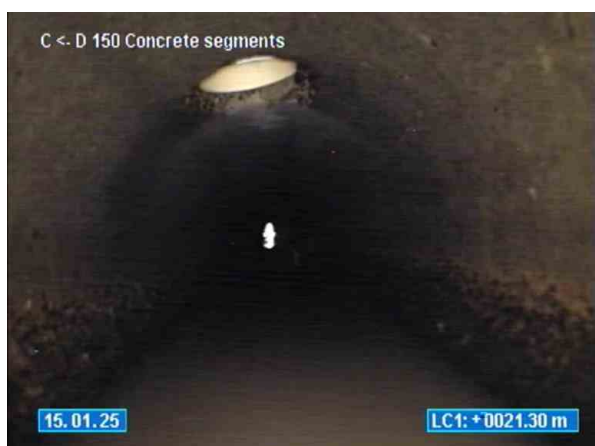
10-12 VIEW POINT ROAD MCCRAE_15.01.2025_132020_D
 TOO C _042.jpg, 00:33:07, 21.80
 Connection, unlined, connection appears to be open,
 Height/Diameter (mm): 150 at 12 o'clock

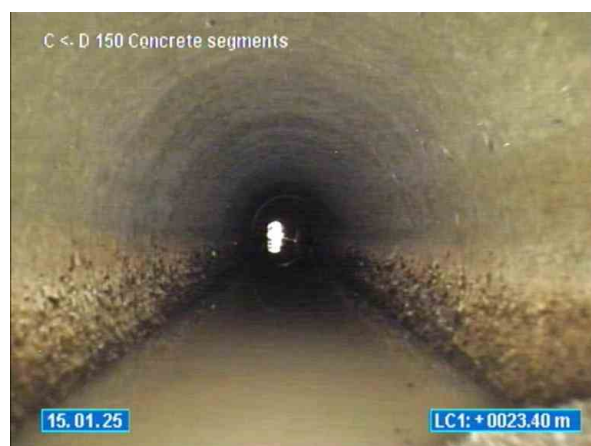
10-12 VIEW POINT ROAD MCCRAE_15.01.2025_132020_D
 TOO C _044.jpg, 00:33:07, 23.20
 Recently cut fine roots-a relatively small number of cut minor
 roots remain, Obstruction: 40%, at joint from 4 o'clock to 6
 o'clock

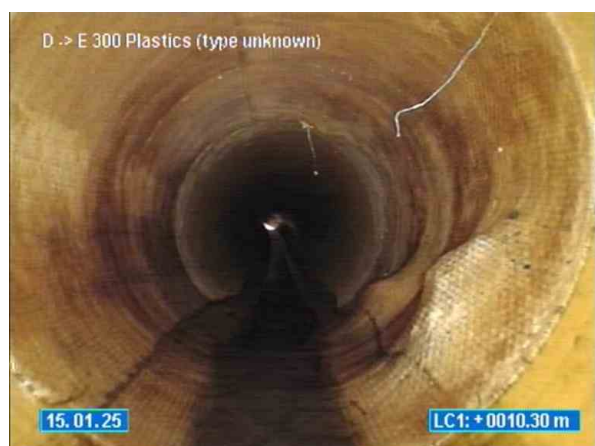
10-12 VIEW POINT ROAD MCCRAE_15.01.2025_135956_D
 TOO E _049.jpg, 00:01:48, 10.30
 The non-structural liner has bulged (no longer attached but
 liner is still intact) at 4 o'clock

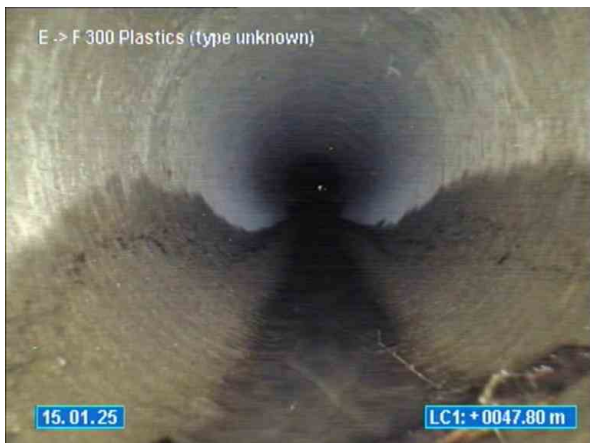
10-12 VIEW POINT ROAD MCCRAE_15.01.2025_141137_E
 TOO F _053.jpg, 00:05:39, 47.80
 Tap roots, reduction in cross sectional area, Obstruction: 10%
 from 6 o'clock to 7 o'clock

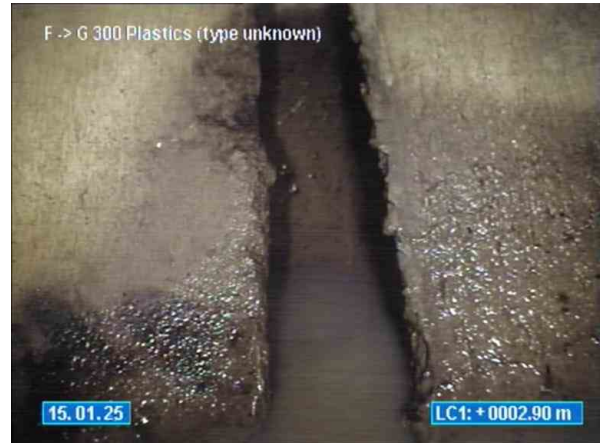
10-12 VIEW POINT ROAD MCCRAE_15.01.2025_142844_F
 TOO G _055.jpg, 00:01:41, 2.90
 Soil visible through defect, at joint
