Our Ref: PSM5665-090L

11 August 2025

RE: MCCRAE LANDSLIDE - MITIGATION

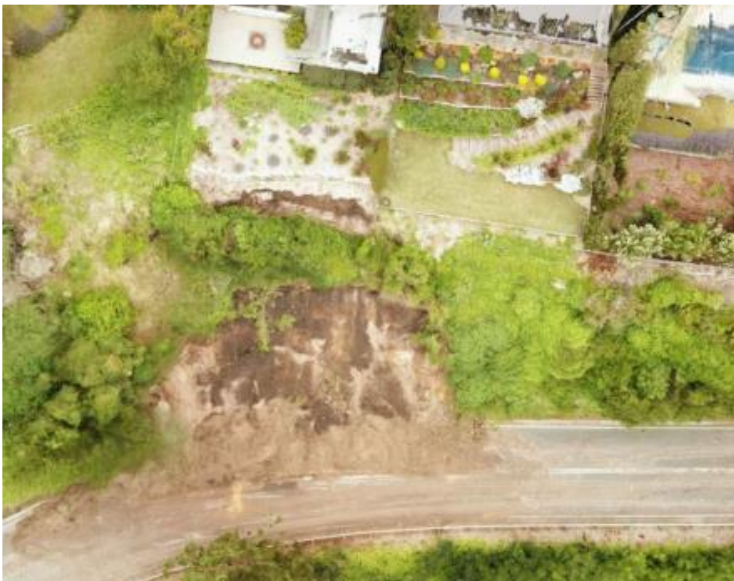
Figure 4 Collapsed Slope Prior to Stabilisation

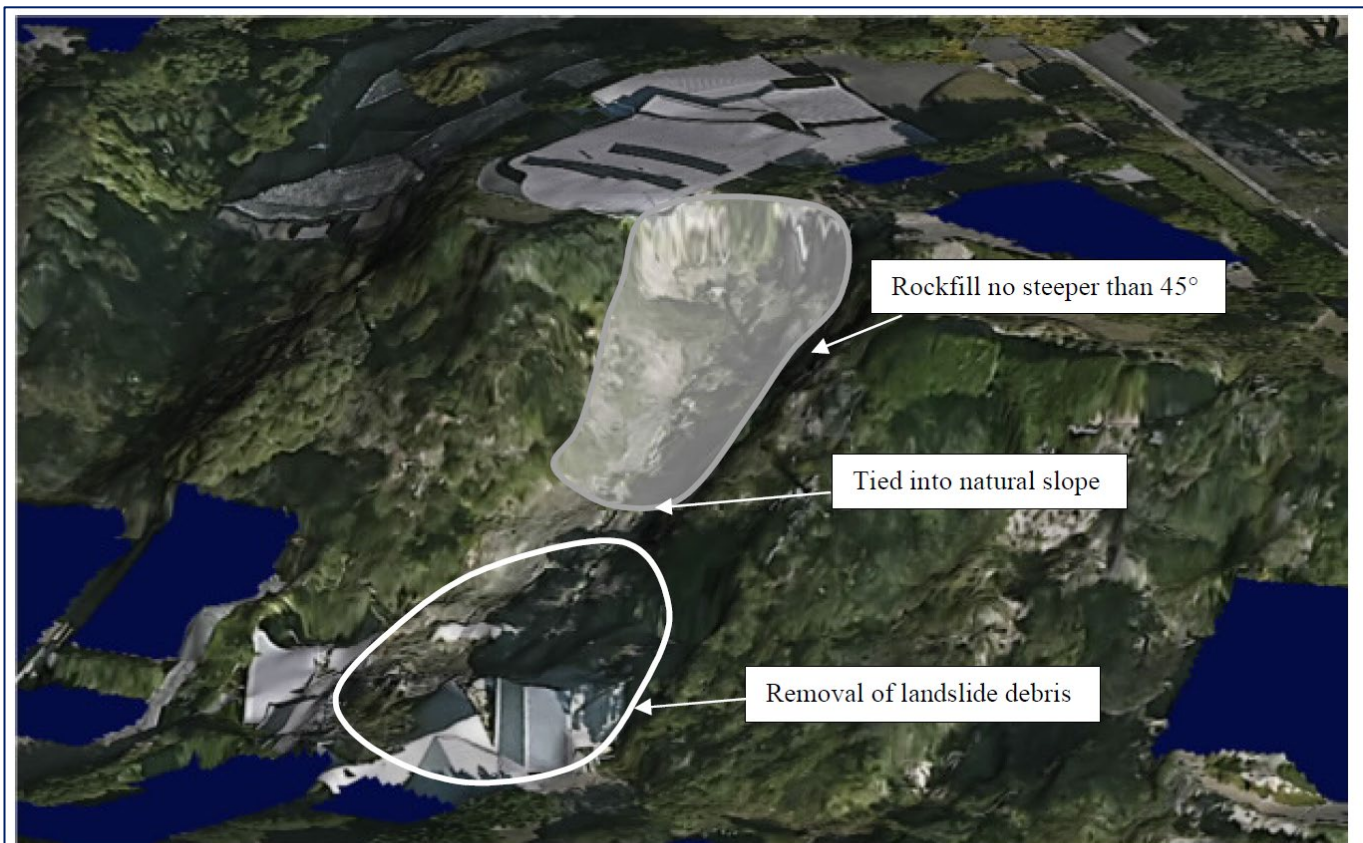
Inset 1: Figure 9.2 of the WSP Causation Report

Figure 9.2 3D image showing possible extent of rockfill required to reinstate zone of depletion arising from the 2025 landslide.

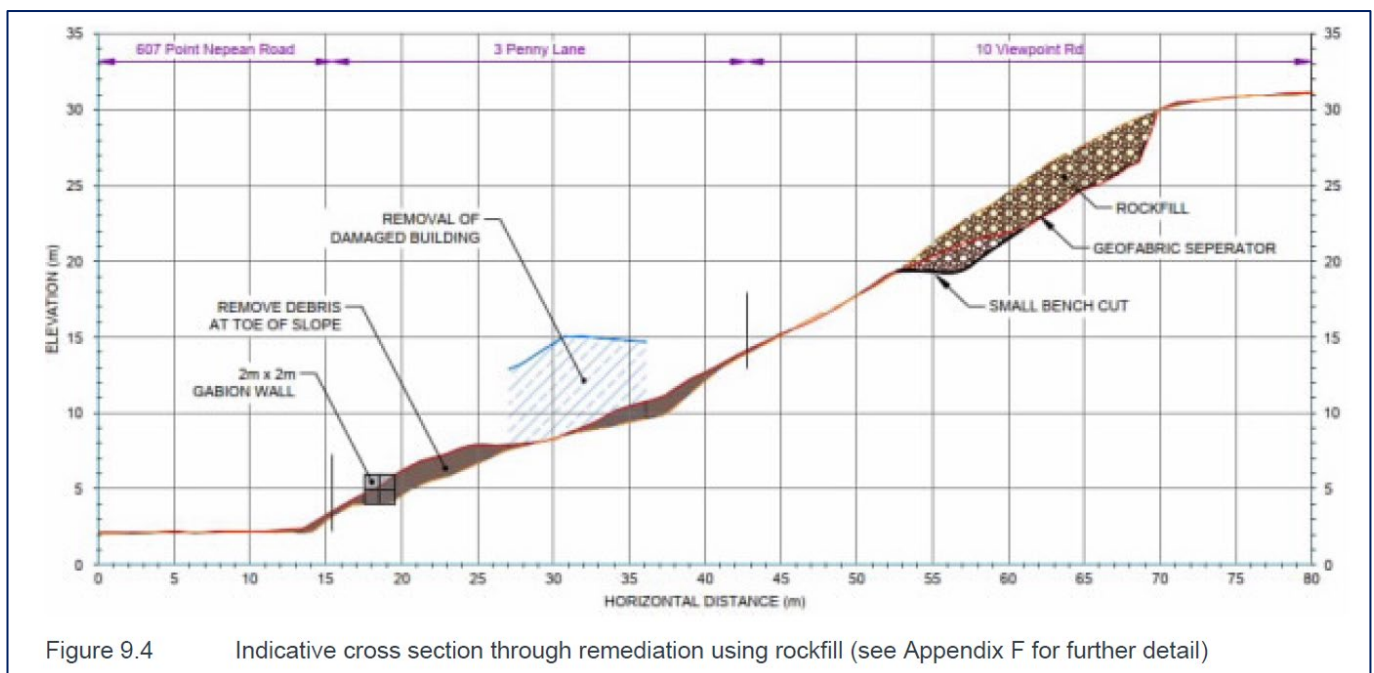
Inset 2: Figure 9.4 of the WSP Causation Report

Figure 9.4 Indicative cross section through remediation using rockfill (see Appendix F for further detail)

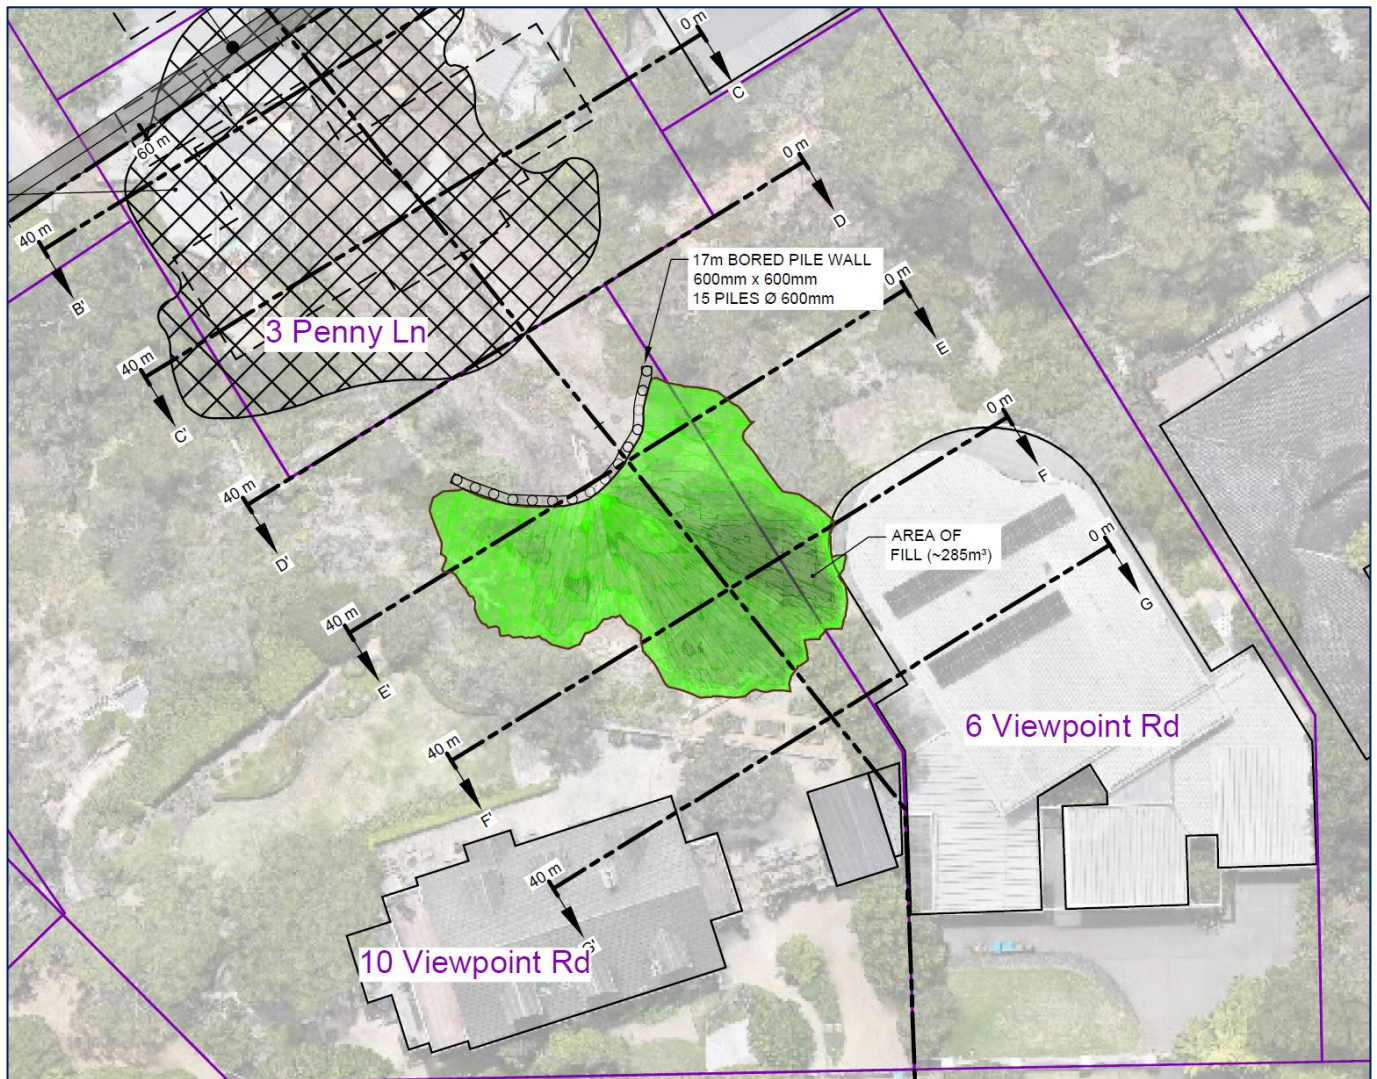
Inset 3: Extract from WSP Causation Report Appendix F Figure 3a

- A 17 m long bored pile wall at the toe of the rockfill (mid slope), Inset 3
- Piles 600 mm diameter and approximately 3 m depth, Inset 4
- A capping beam, inferred from Inset 4 and not explicitly stated.

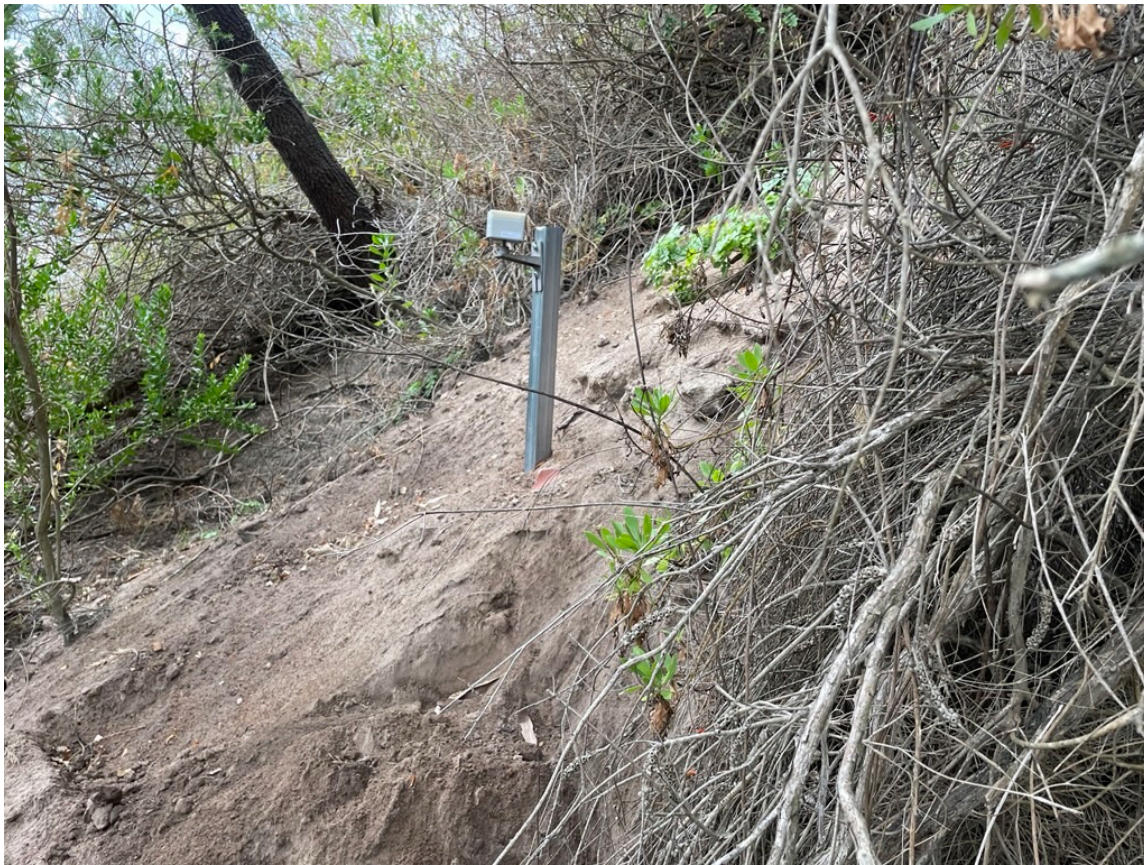
Inset 5: Recently dumped sand fill

- Removal of recently dumped sand fill from the area, Inset 5. Based on PSM inspections this material is assumed to have been dumped sometime between November 2023 and January 2025.
- The extent of treatment should include ravelling and undercut flanks and the headscarp immediately to the east as identified as part of the PSM LRA (Section 6.3.3.2 of the PSM LRA).
- The design should include placement of a nominal 100 mm thick layer of topsoil prior to installation of the soil nails and mesh to promote revegetation.
- The design should consider if temporary erosion protection e.g. coir matting is required for erosion protections while vegetation establishes.

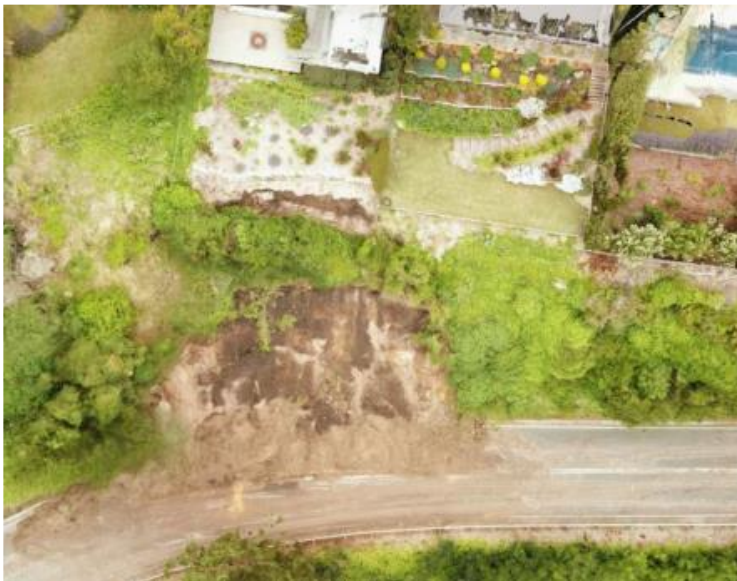
Figure 4 Collapsed Slope Prior to Stabilisation
