BOARD OF INQUIRY INTO THE MCCRAE LANDSLIDE

Statement of John Nicholas Bolch

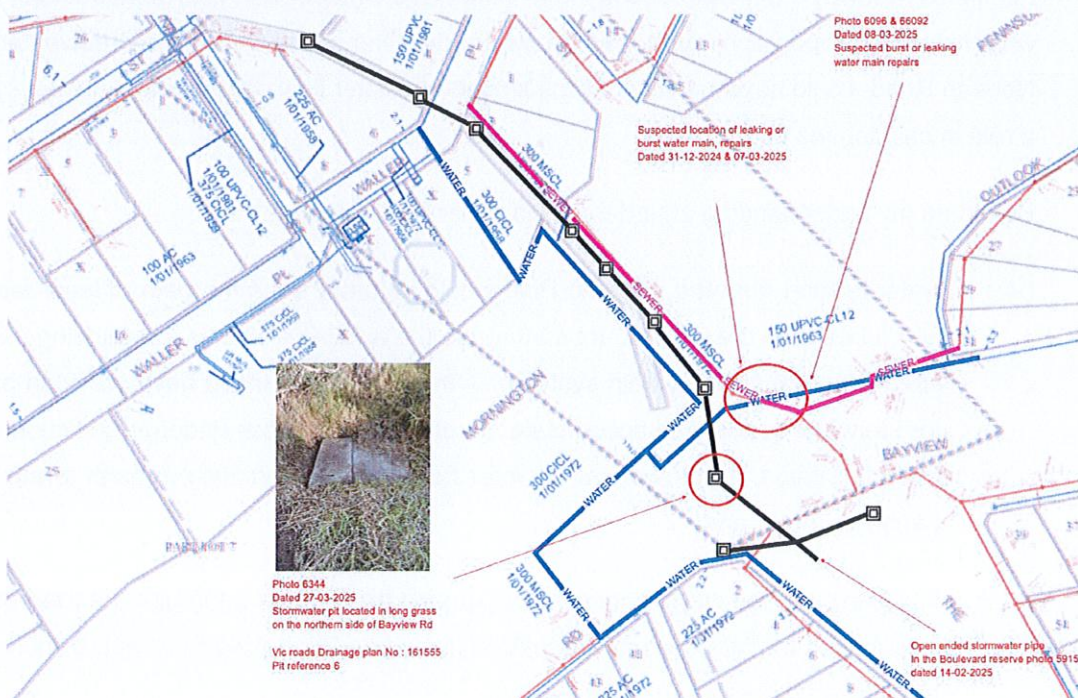
61. Having collected all this information, I have caused to be prepared an annotated map (extracted below), which is an overlay of two SEW maps I obtained from BYDA:

- 62.1 the bolded lines, which I have caused to be added, shows the network of water mains, sewer and stormwater assets under the Mornington Peninsula Freeway and the surrounding area. The water mains pipework is shown by the blue lines. The sewer pipework is shown by the pink lines. The stormwater pipework is shown by the black lines, which is based on my understanding of stormwater drainage plans I obtained from VicRoads and accessed via the MPSC GIS;
- 62.2 according to SEW's map, the water mains pipe that runs through the larger red circle is a 150mm UPVC pipe (the **Affected Pipe**). The nominated date for the Affected Pipe is 1 January 1963, which I understand approximates when the Affected Pipe was installed; and
- 62.3 the larger red circle indicates my best estimate of the approximate location of the leak or burst on the Affected Pipe.

63. The location of the water infrastructure assets under the Mornington Peninsula Freeway is noteworthy. I understand, from conversations with Brett, that the area under the freeway and through which the pipework runs was originally an open creek bed. That creek bed was filled in and dual 750mm stormwater pipes were installed during the construction of the Mornington Peninsula Freeway. This has caused me to think that the modifications to infrastructure, coupled with the natural topography of the land between the Mornington Peninsula Freeway and Point Nepean Road, could have significantly influenced the water flow patterns, and ultimately played a role in causing the Landslides.

- 64.1 water leaking from the Affected Pipe would naturally seek the path of least resistance, which likely led the water to travel through the existing trenches surrounding the sewer, stormwater, and water main systems — those trenches could have provided pathways for the water to flow and accumulate. In other words, these underground channels may have facilitated the movement of water from the Affected Pipe through to the McCrae Landslide Area; and
- 64.2 it is likely that the water saturated the ground and surfaced through the road at various locations in the McCrae Landslide Area, including Charlesworth Street, Coburn Avenue and Waller Place (as described above).

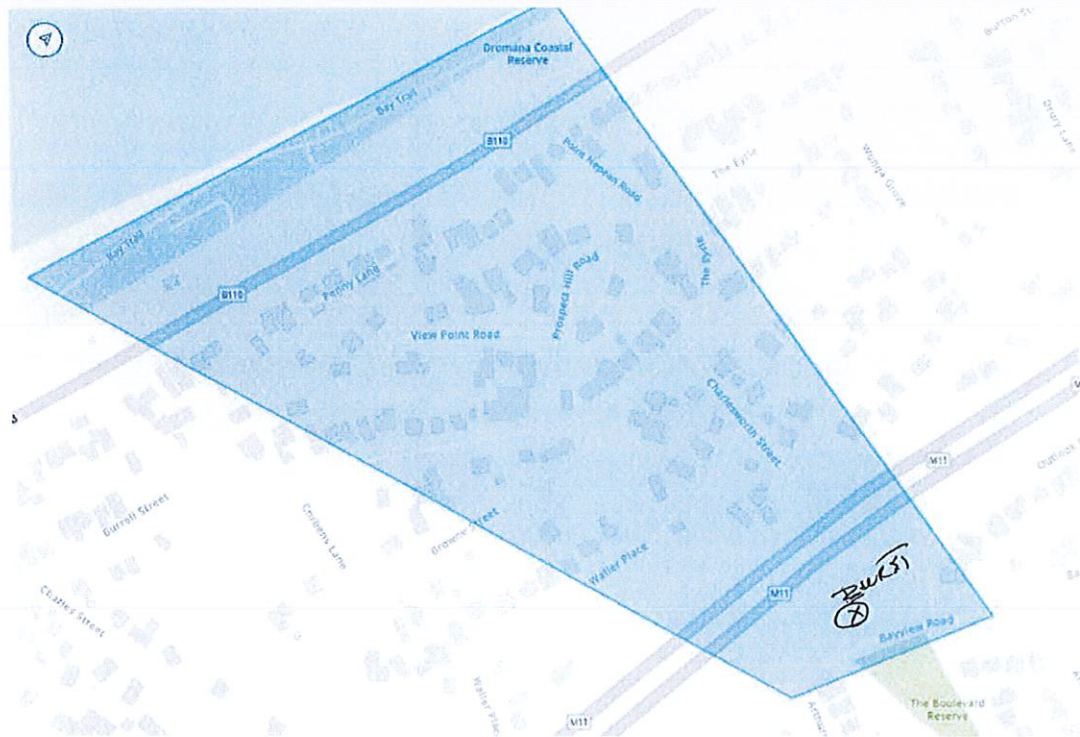
86. Based on the investigations conducted between mid-January and early March 2025, in my opinion, water saturation of the McCrae Landslide Area has been a significant contributing factor to the Landslides. The excessive water accumulation, potentially exacerbated by ongoing water leakage and inadequate stormwater drainage management, likely played a central role in destabilising the surrounding land and precipitating the Landslides.
87. Set out below is a map I prepared which shows the potential area of water saturation caused by the burst of the Affected Pipe shaded in blue (based on the topography of the McCrae Landslide Area):
