Landslip McCrae Jan 25

3 Penny Lane and 10-12 View Point

Owners – Actions Items

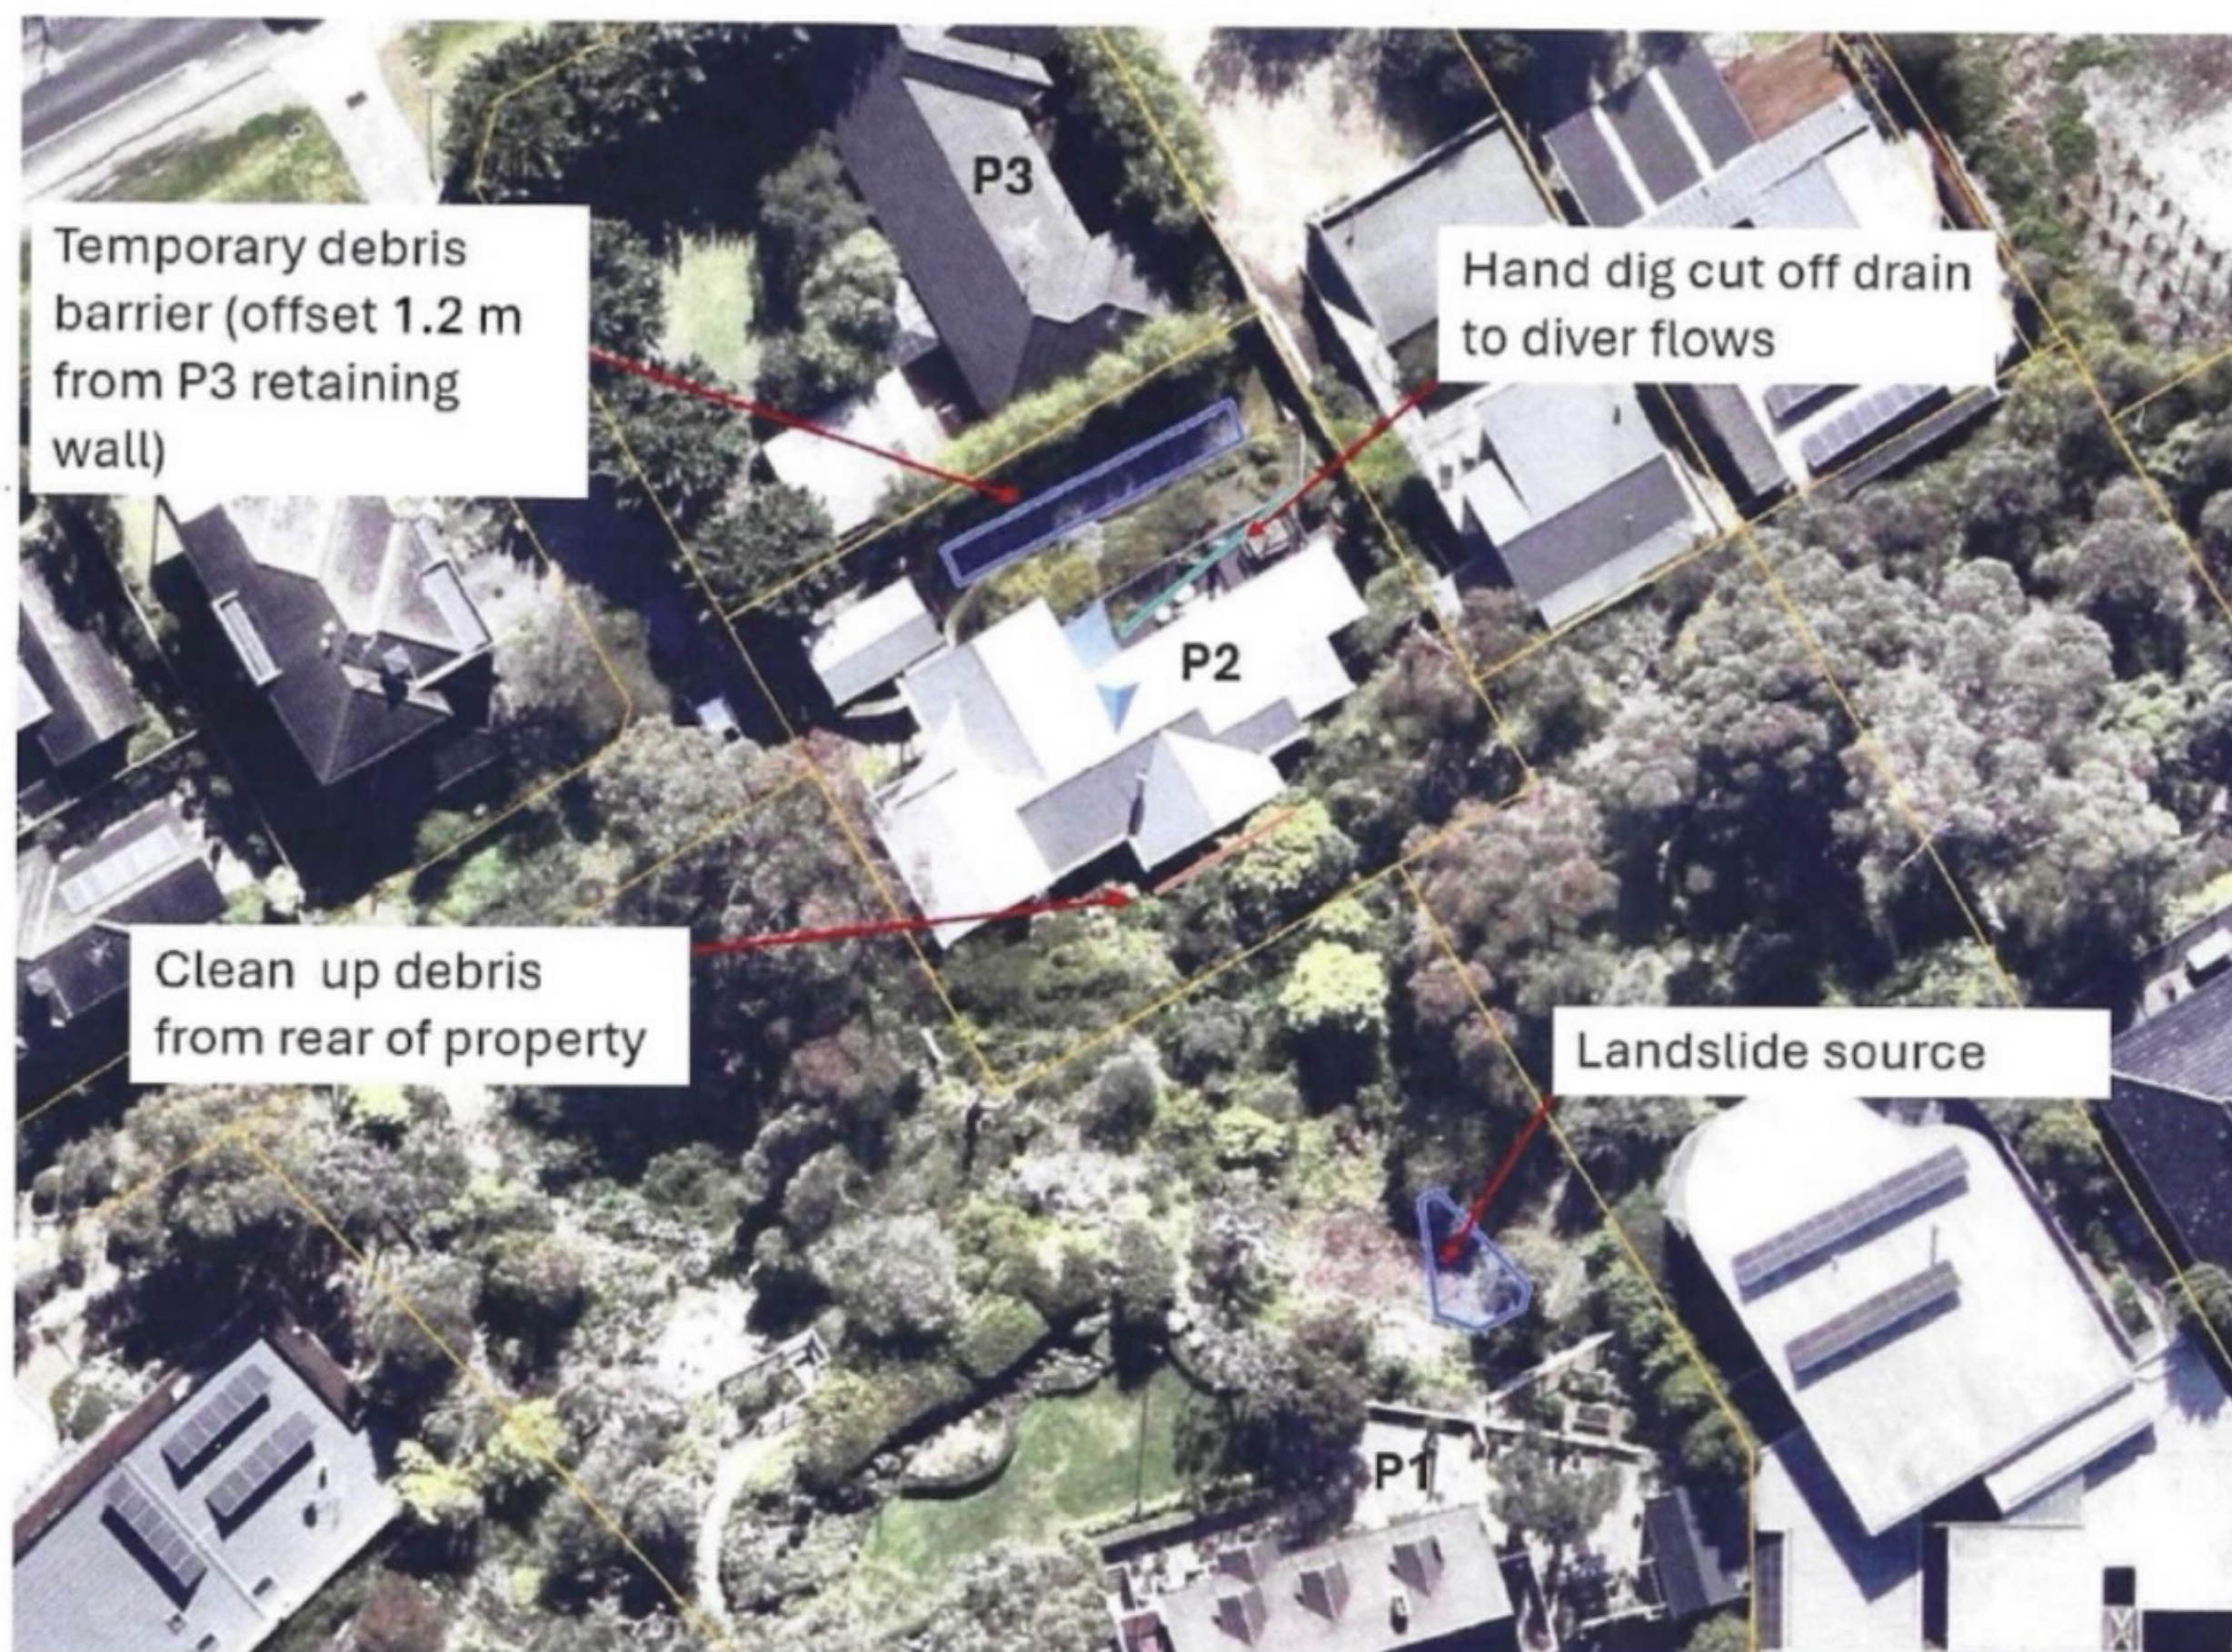
- Initiated from in front of a recently constructed retaining wall on P1 and has impacted the rear of P2, Photo 1.
- The Landslide was initiated on the night of Sunday, 5th January 2025, following two days of dry, hot weather. Rainfall followed the event.
- Translational slide which has evacuated materials down to the natural granitic soils at the base of the Landslide.
- A sub-vertical head scarp up to 1.5 m high, Photo 2.
- A significant portion of the headscarp was saturated and with measurable flow of water (0.15-0.2 L/s) flowing along the base and down the hill. The seepage was observed at the contact with surficial soils (fills/ancient landslide debris) and the underlying natural soils.
- Volume in the range of 15 to 20 m³.
