BOARD OF INQUIRY INTO THE MCCRAE LANDSLIDE

Statement of Kevin Barry Hutchings

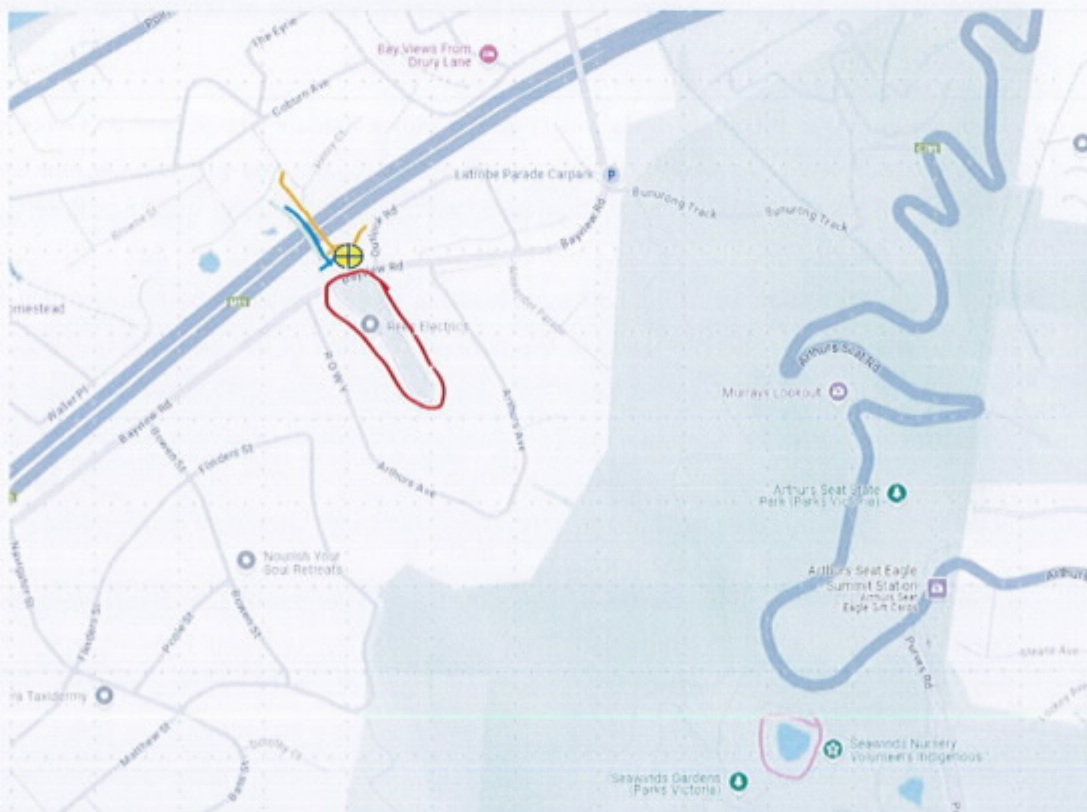
41. Set out below is a map I have prepared which shows: (i) the dam I inspected circled in pink; (ii) the Boulevard Stormwater Storage Basin circled in red; (iii) the Burst Site indicated by the yellow circle; and (iv) a rough indication of the stormwater, water and sewer lines flowing from the Burst Site as indicated by the green, blue and orange lines.

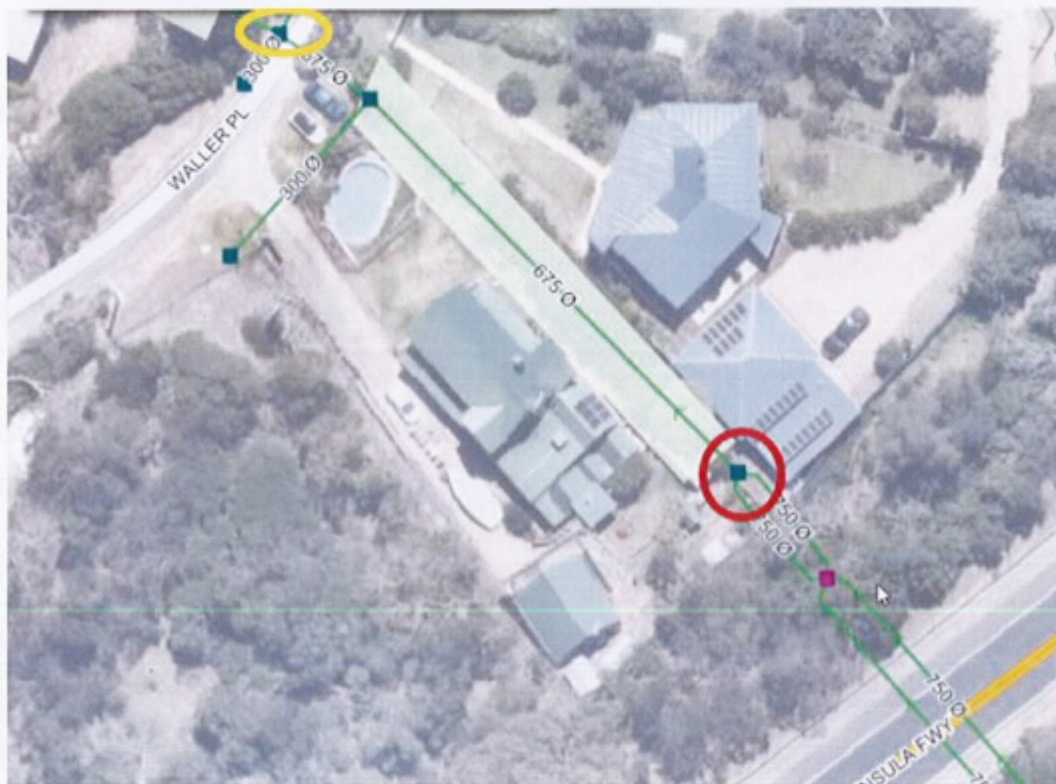
57. Set out below is a screenshot of an online map accessed on MPSC's Mapping GIS website. The map has been annotated to show: (i) the Waller Place Stormwater Drain circled in yellow; and (ii) what I understand to be the Rear Waller Place Stormwater Pit circled in red.
