Subject: FW: Detail on how burst in Bayview rd, McCrae was identified

Subject: Detail on how burst in Bayview rd, McCrae was identified

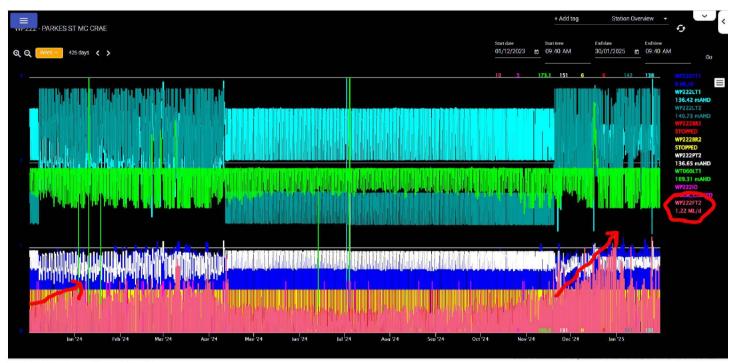
DEC 23 - JAN 25

As Parkes Street tanks supply the area, I looked at the tank outflow (Tag WP222FT2) difference from DEC 2023 to that of DEC 2024.

Its difficult to get a baseline flow for the tanks as they fill during the night, but I could see an increase in flow rate (see red trendline arrow in snip below).

DEC 23 (ave peak time flow leading to New Years 1-1.5meg) to DEC 24 (ave peak time flow leading to New Years 2.5 -3meg)

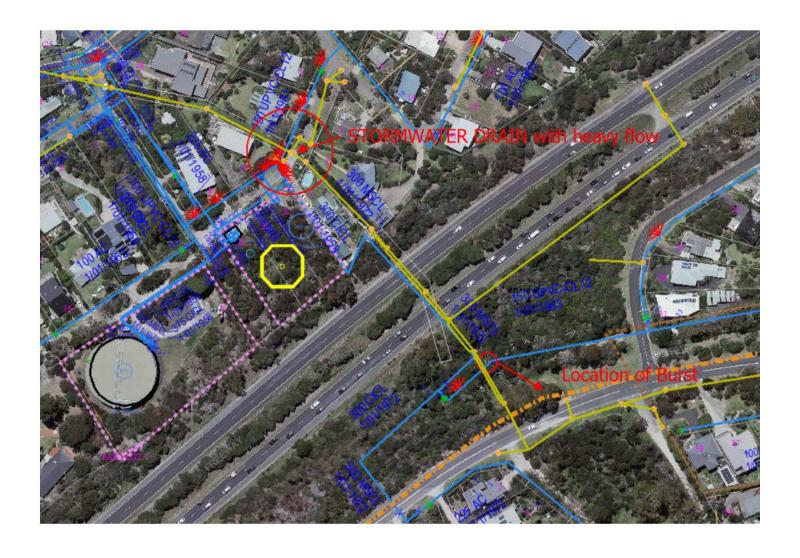
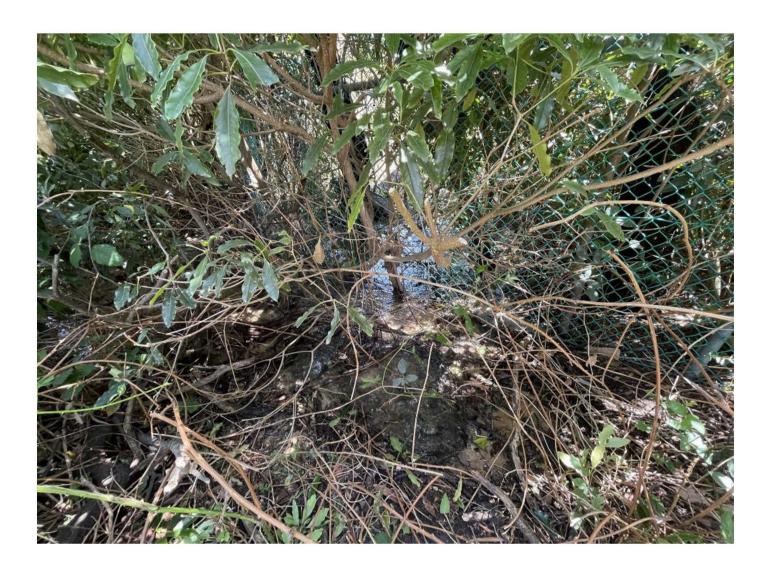
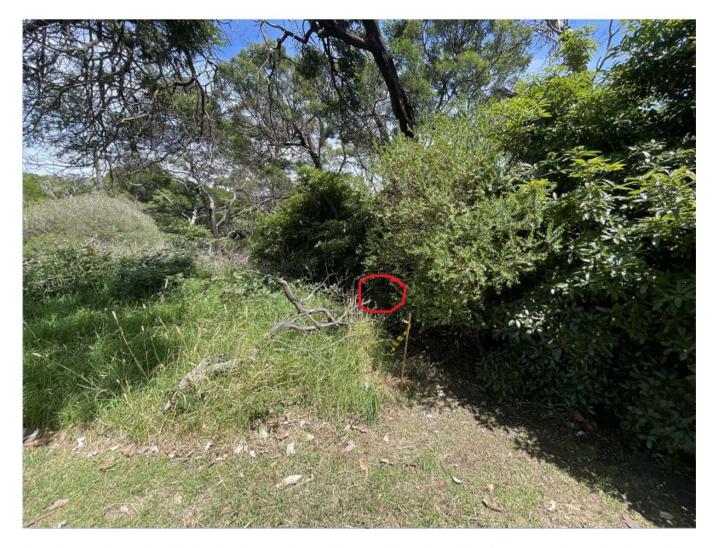
The grate is roughly 5m in length, 1m in width and 3-4m depth (see photos)

The open grate, I assume, is there the catch rainfall from this adjacent creek (currently dry) as it's the lowest point before it crosses the Peninsula Link.

It was whilst locating and sounding the valves in heavy bushland on the other side of the Mornington Freeway opp Bayview Road that I firstly heard water flow and later discovered water flowing into the large storm water pit through a grate that crosses the Peninsula link over to Waller Place. Following that surface water from the pit...i located the burst and tested the water's EC confirming it was potable water.

Note that the burst is not something someone would have called in as it was away from any walking paths and in heavy unmaintained bushland.

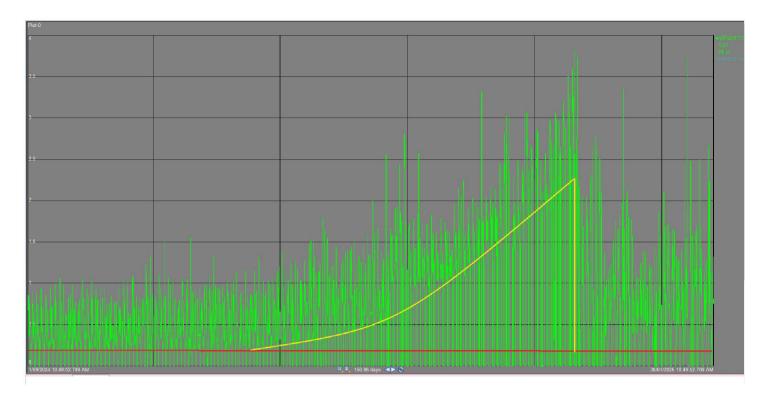
Once the repair was done by Service Stream, Dat and I were able to determine the approx. time and volume with a trend of the step change from the outlet of the tank at McCrae.

Below. Red line is baseline, yellow is increase. I believe it started early November until end of December, so \sim 60days. At the end it was a 2ML/d burst.

Volume wise it was about 60ML.
