# South East Water Submission to the Board of Inquiry into the McCrae Landslide

April 2025

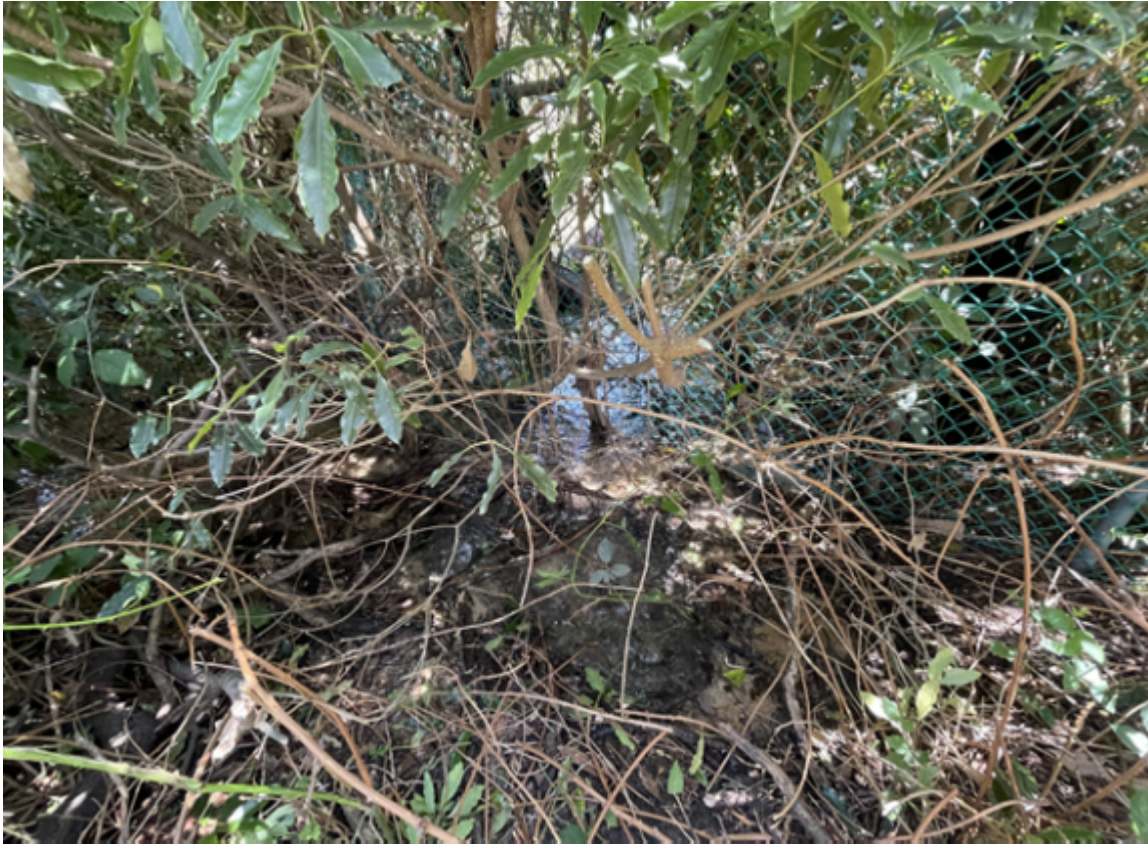
On 30 December 2024 at approximately 1pm SEW first became aware there was a burst on Water Main 104961. The burst was located on the edge of densely vegetated bushland between Bayview Road and the Mornington Peninsula Freeway, approximately 50 metres

*Figure 3 - Photo of the site of the Bayview Road burst, located in bushland*

- With approval from Council, removed fencing and trees to make site safe to work
- Identified small split approximately (100mm long) on the water pipe and repaired by replacing a 1 metre long section.

SEW considers that a significant portion of the drinking water released from the water main burst that was identified on 30 December 2024 travelled above ground to a stormwater pit approximately 30 metres away from the burst site.

SEW and its contractors repaired the burst water main on 31 December 2024 – 1 January 2025. The repair was complex, involving tasks including the following:
