**From:** Swain, Charles[Charles.Swain@sew.com.au]  
**Sent:** Mon 03/02/2025 4:08:19 PM (UTC+11:00)  
**To:** McCreesh, Declan[Declan.McCreesh@sew.com.au]  
**Subject:** FW: Detail on how burst in Bayview rd, McCrae was identified  
**Attachment:** IMG\_6690.jpg  
**Attachment:** IMG\_6691.jpg  
**Attachment:** IMG\_6693.jpg

**From:** Loudon, Gary <[Gary.Loudon@sew.com.au](mailto:Gary.Loudon@sew.com.au)>  
**Sent:** Thursday, 30 January 2025 2:43 PM  
**To:** Swain, Charles <[Charles.Swain@sew.com.au](mailto:Charles.Swain@sew.com.au)>  
**Cc:** Pham, Dat <[Dat.Pham@sew.com.au](mailto:Dat.Pham@sew.com.au)>; Meng, Jie <[Jie.Meng@sew.com.au](mailto:Jie.Meng@sew.com.au)>  
**Subject:** Detail on how burst in Bayview rd, McCrae was identified

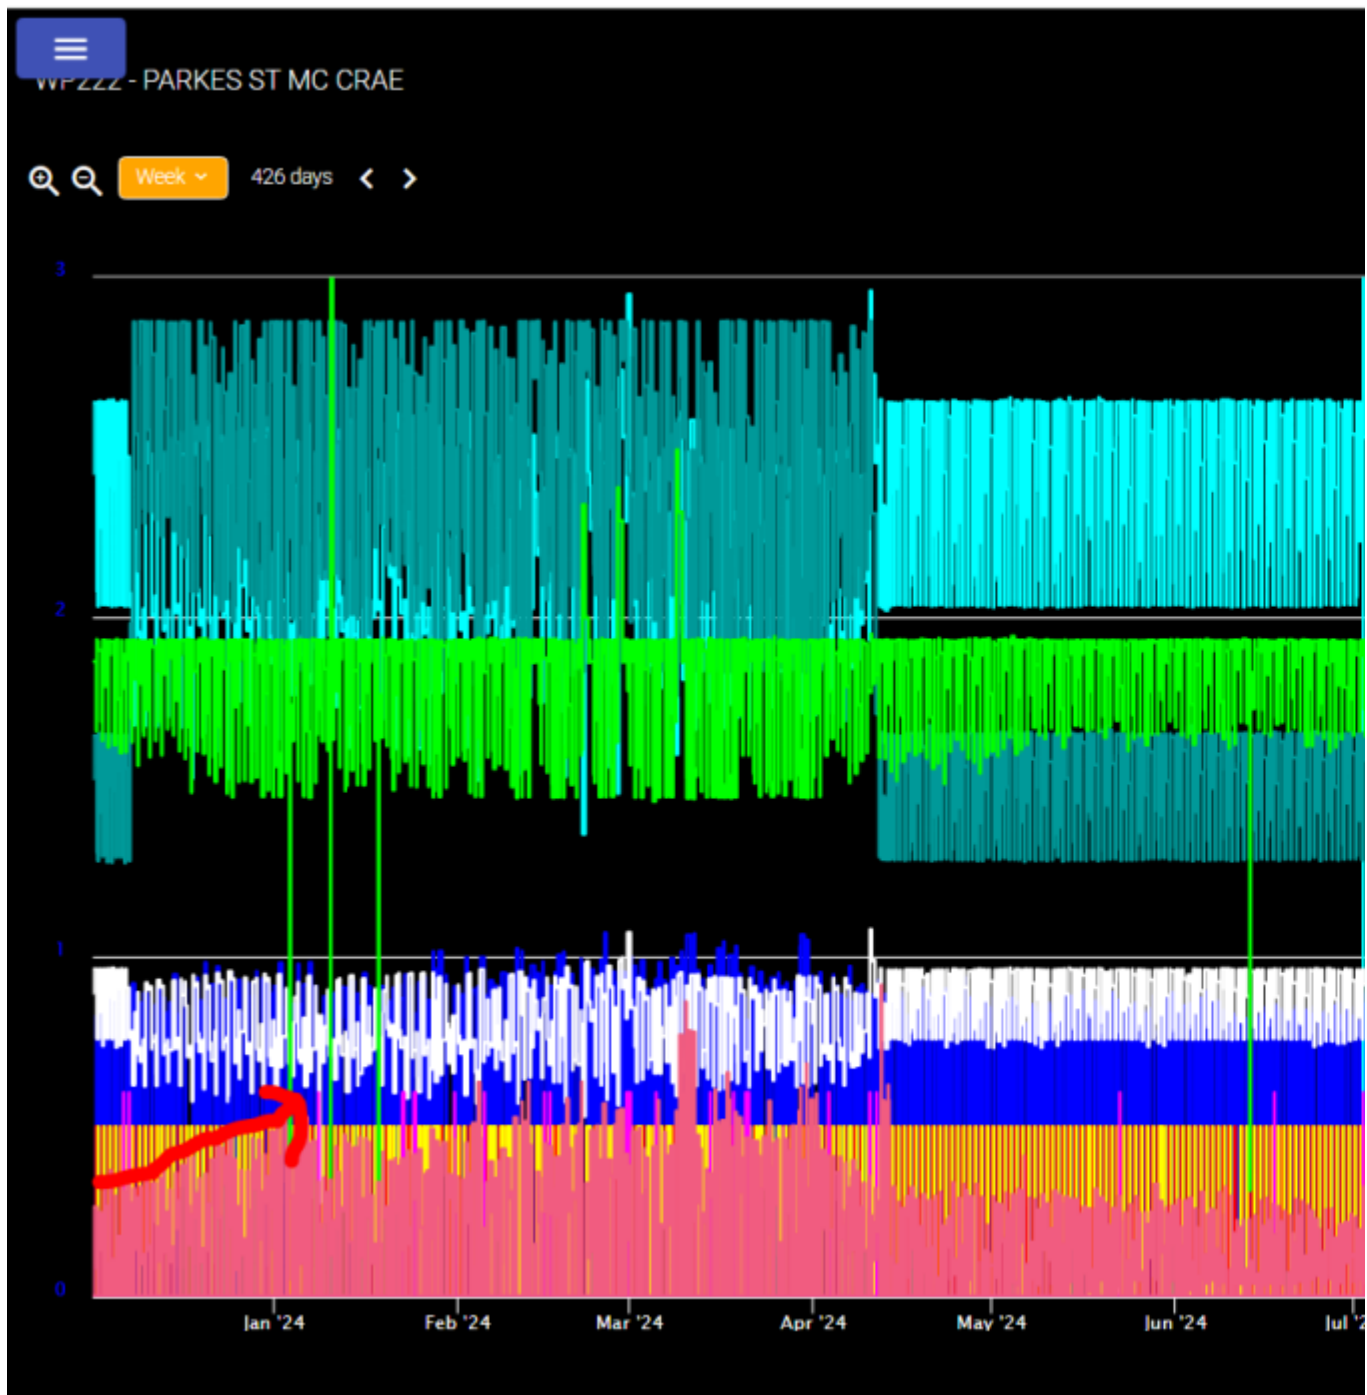
**DEC 23 – JAN 25**

As Parkes Street tanks supply the area, I looked at the tank outflow ( Tag **WP222FT2** ) difference from **DEC 2023** to that of **DEC 2024**.

Its difficult to get a baseline flow for the tanks as they fill during the night, but I could see an increase in flow rate (see red trendline arrow in snip below).

DEC 23 ( ave peak time flow leading to New Years 1-1.5meg ) to DEC 24 (ave peak time flow leading to New Years 2.5 – 3meg )

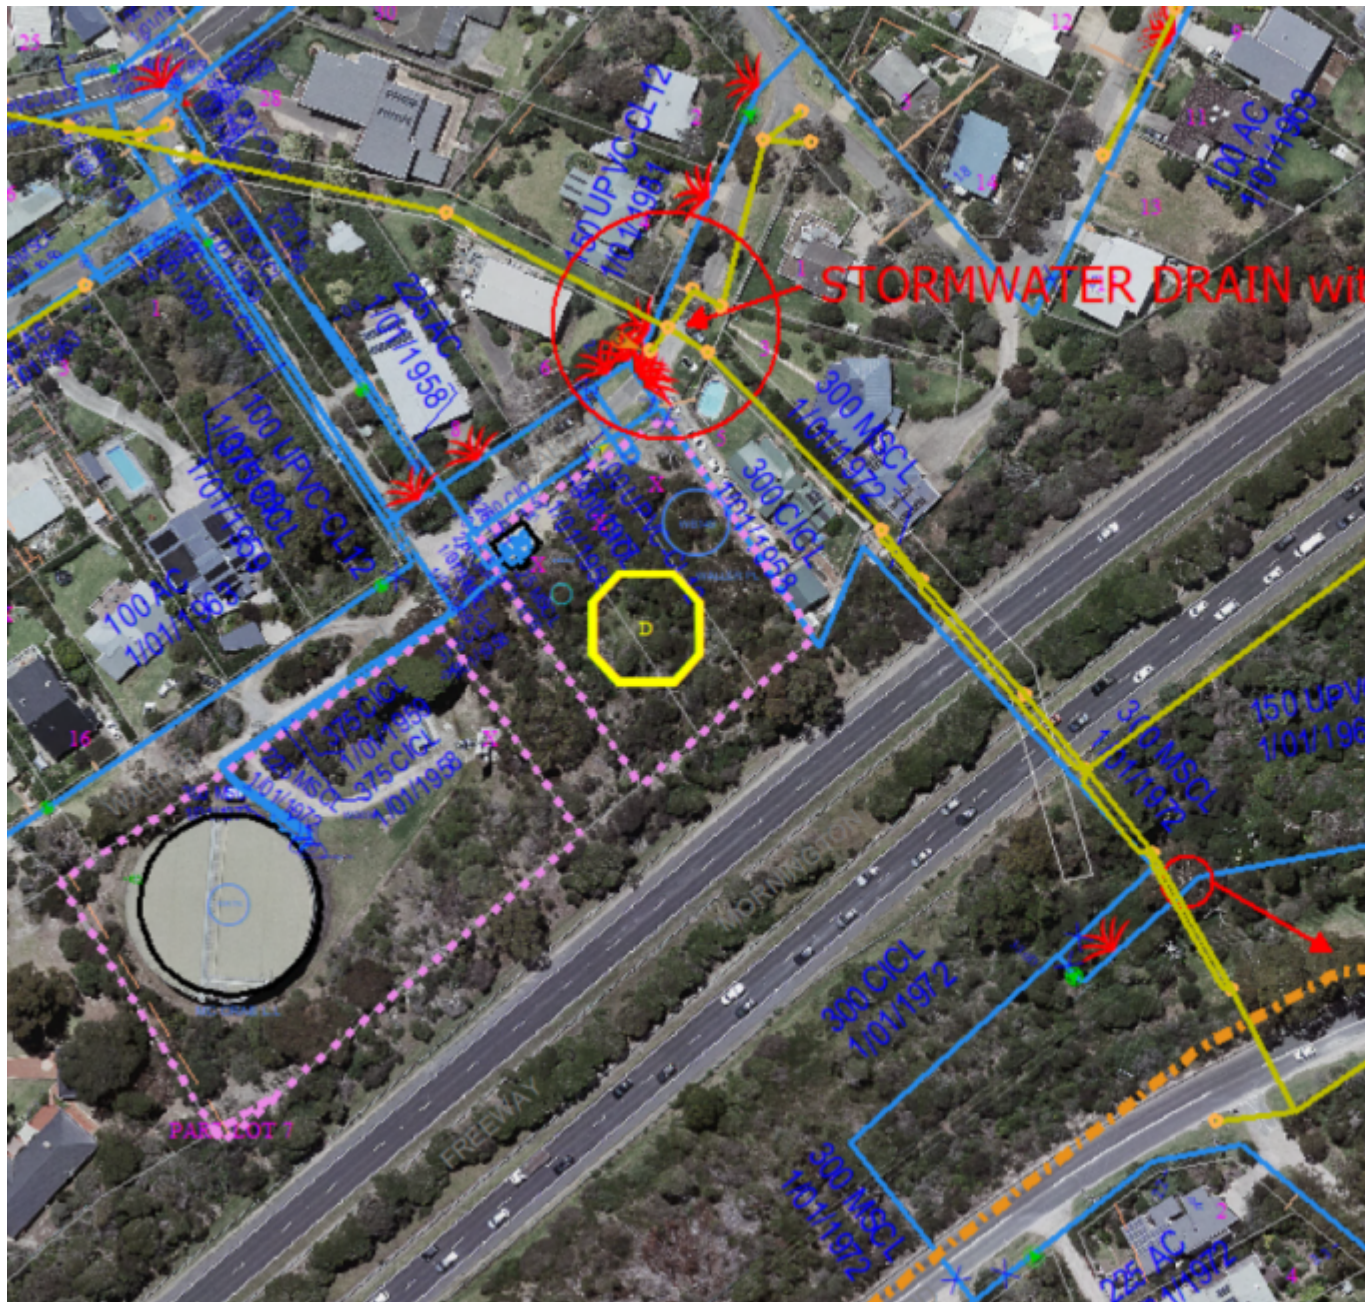
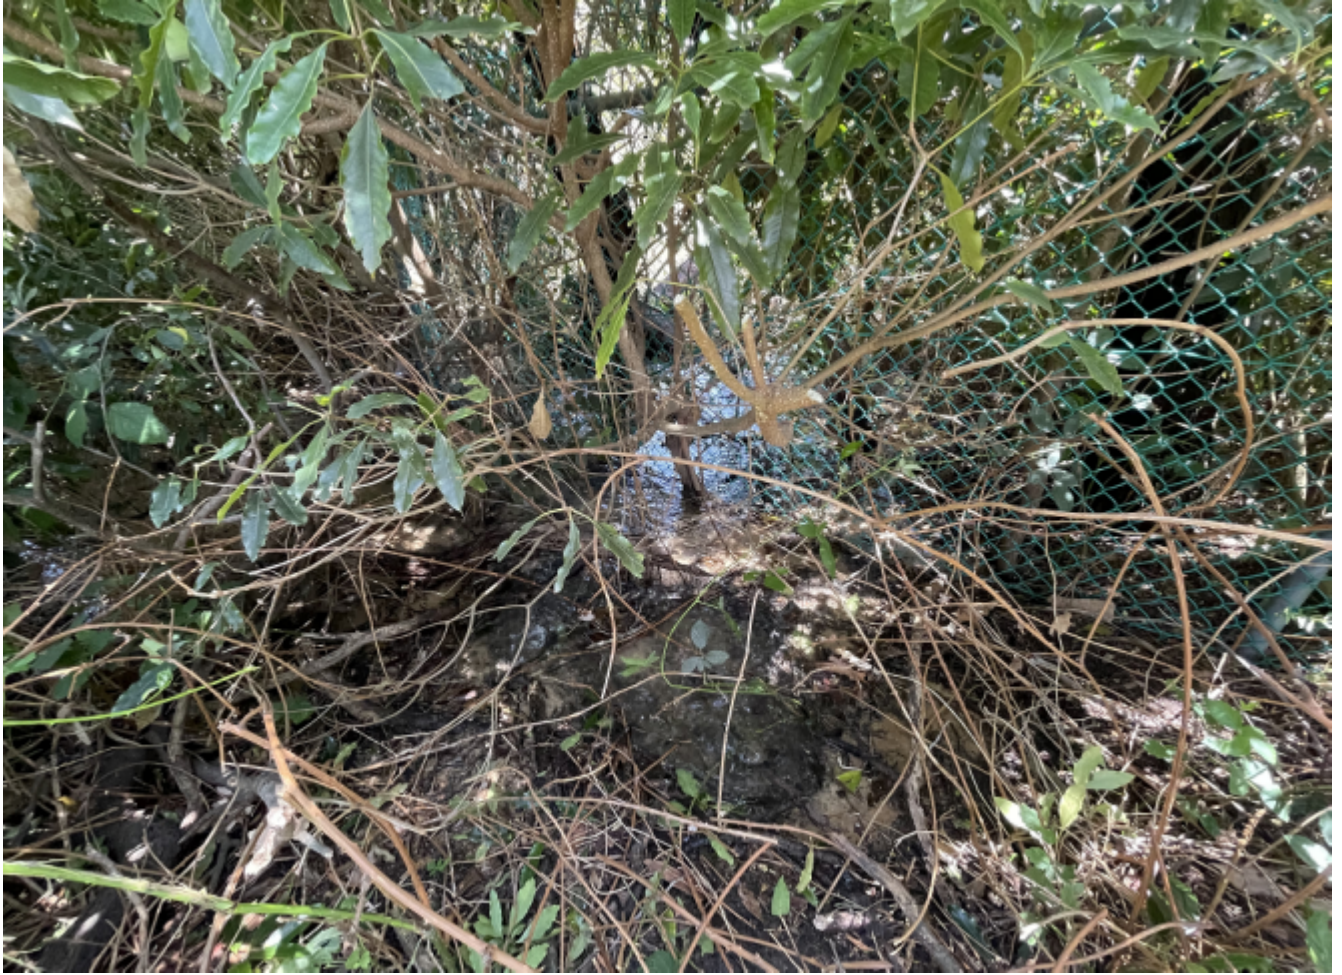
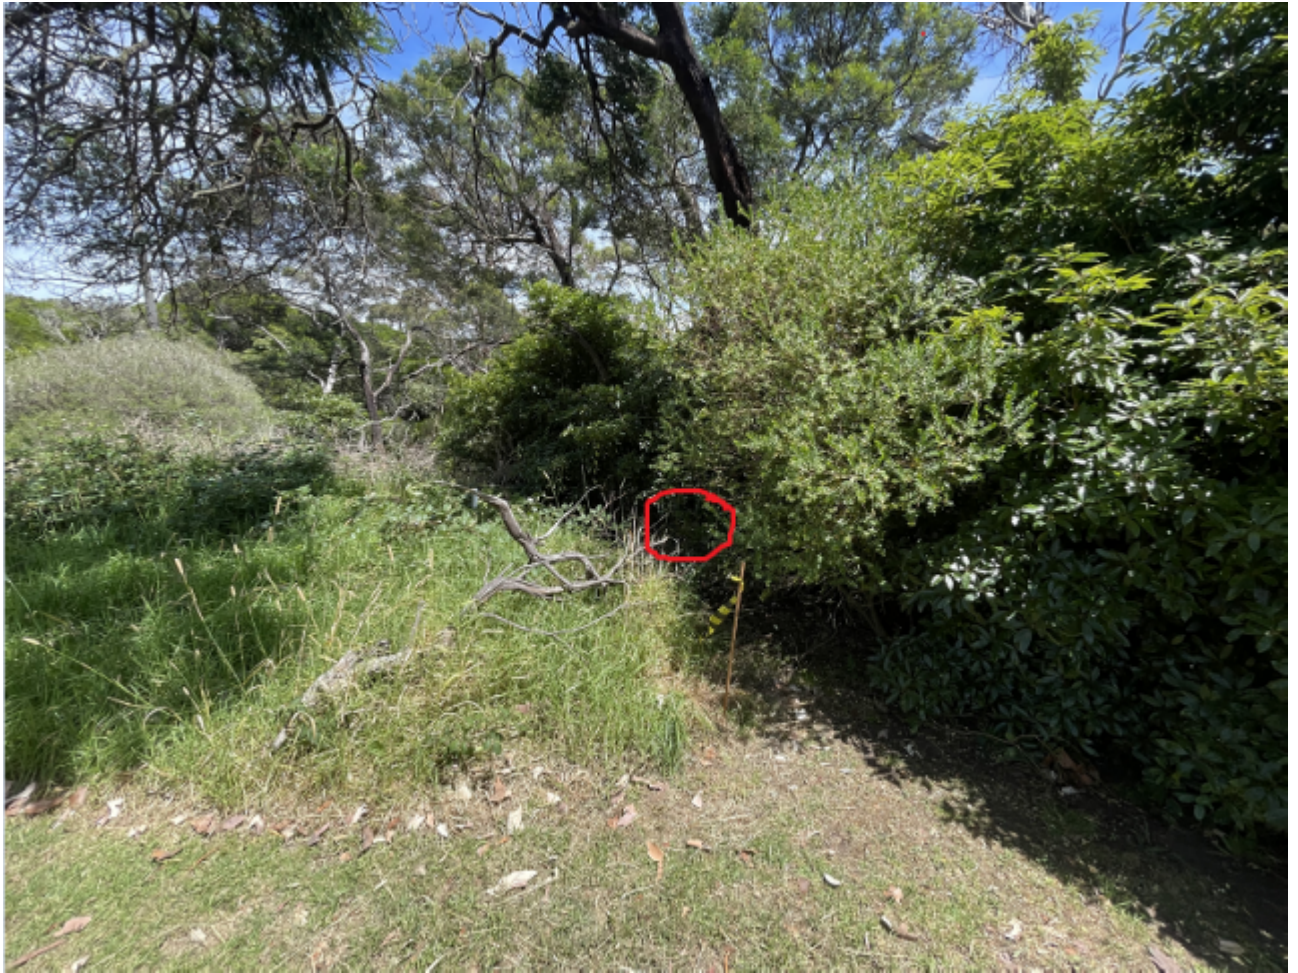
The grate is roughly 5m in length, 1m in width and 3-4m depth ( see photos )  
The open grate, I assume, is there the catch rainfall from this adjacent creek ( currently dry ) as it's the lowest point before it crosses the Peninsula Link.

Mornington Freeway opp Bayview Road that I firstly heard water flow and later discovered water flowing into the large storm water pit through a grate that crosses the Peninsula link over to Waller Place. Following that surface water from the pit....i located the burst and tested the water's EC confirming it was potable water.

Note that the burst is not something someone would have called in as it was away from any walking paths and in heavy unmaintained bushland.

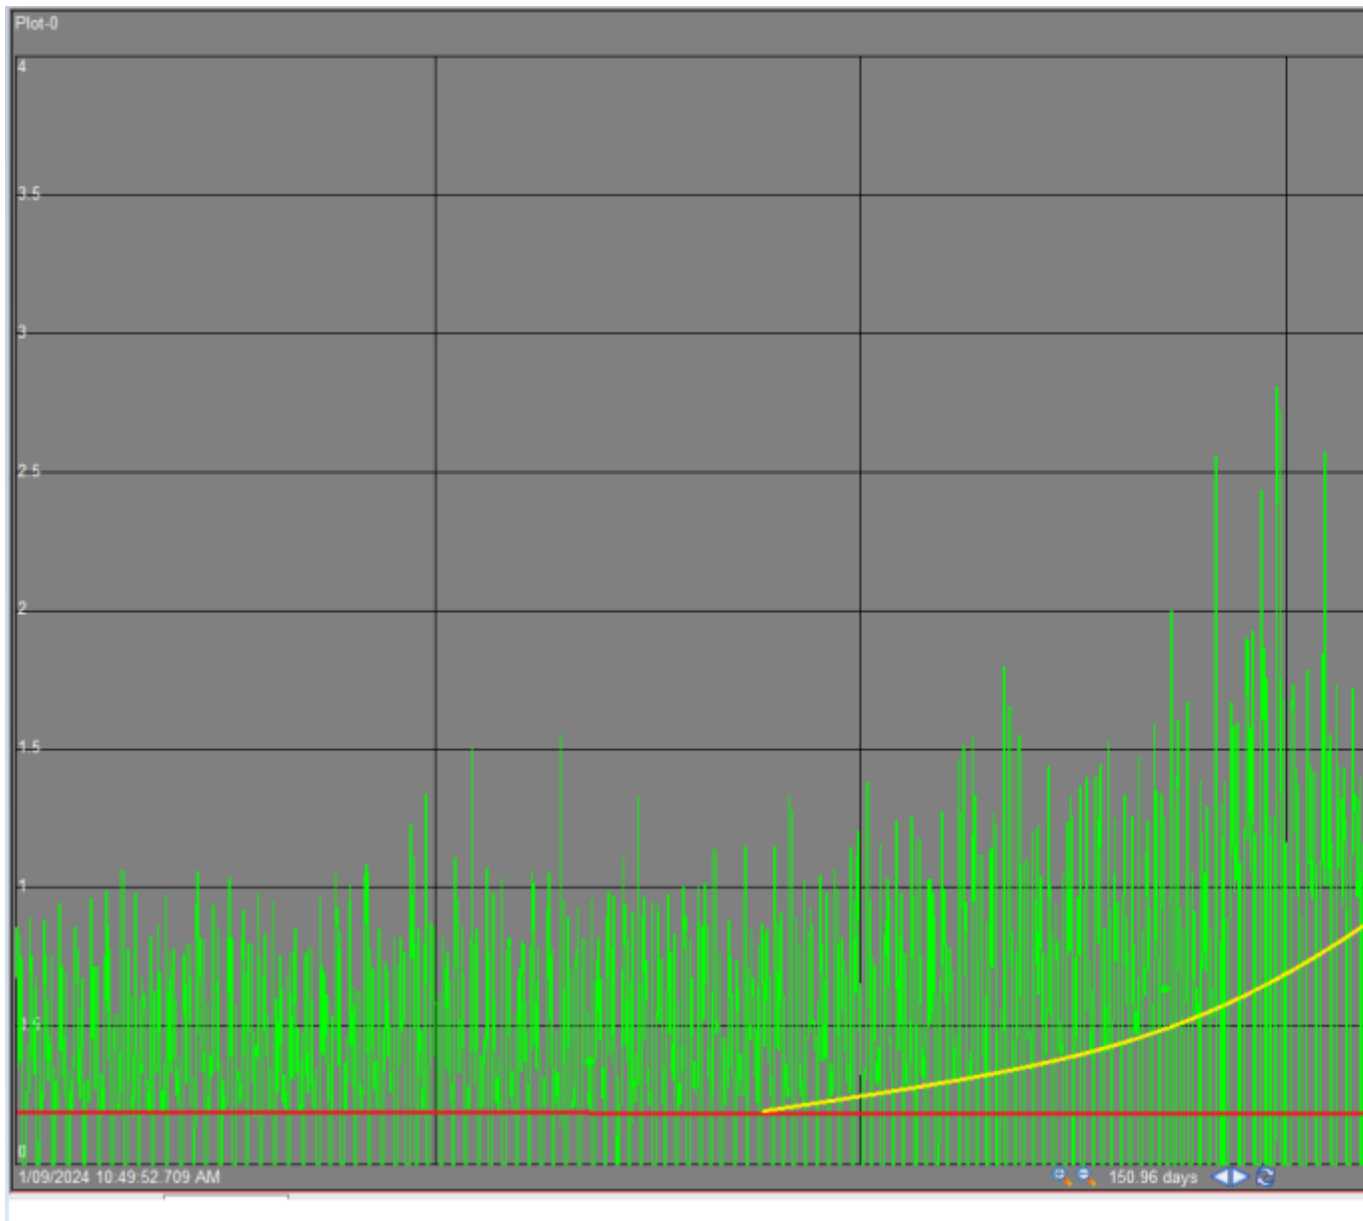
Once the repair was done by Service Stream, Dat and I were able to determine the approx. time and volume with a trend of the step change from the outlet of the tank at McCrae.

Below. Red line is baseline, yellow is increase. I believe it started early November until end of December, so ~60days. At the end it was a 2ML/d burst. Volume wise it was about 60ML.
