McCrae Landslide

Geochemistry Report

J1812.4R

8 August 2025

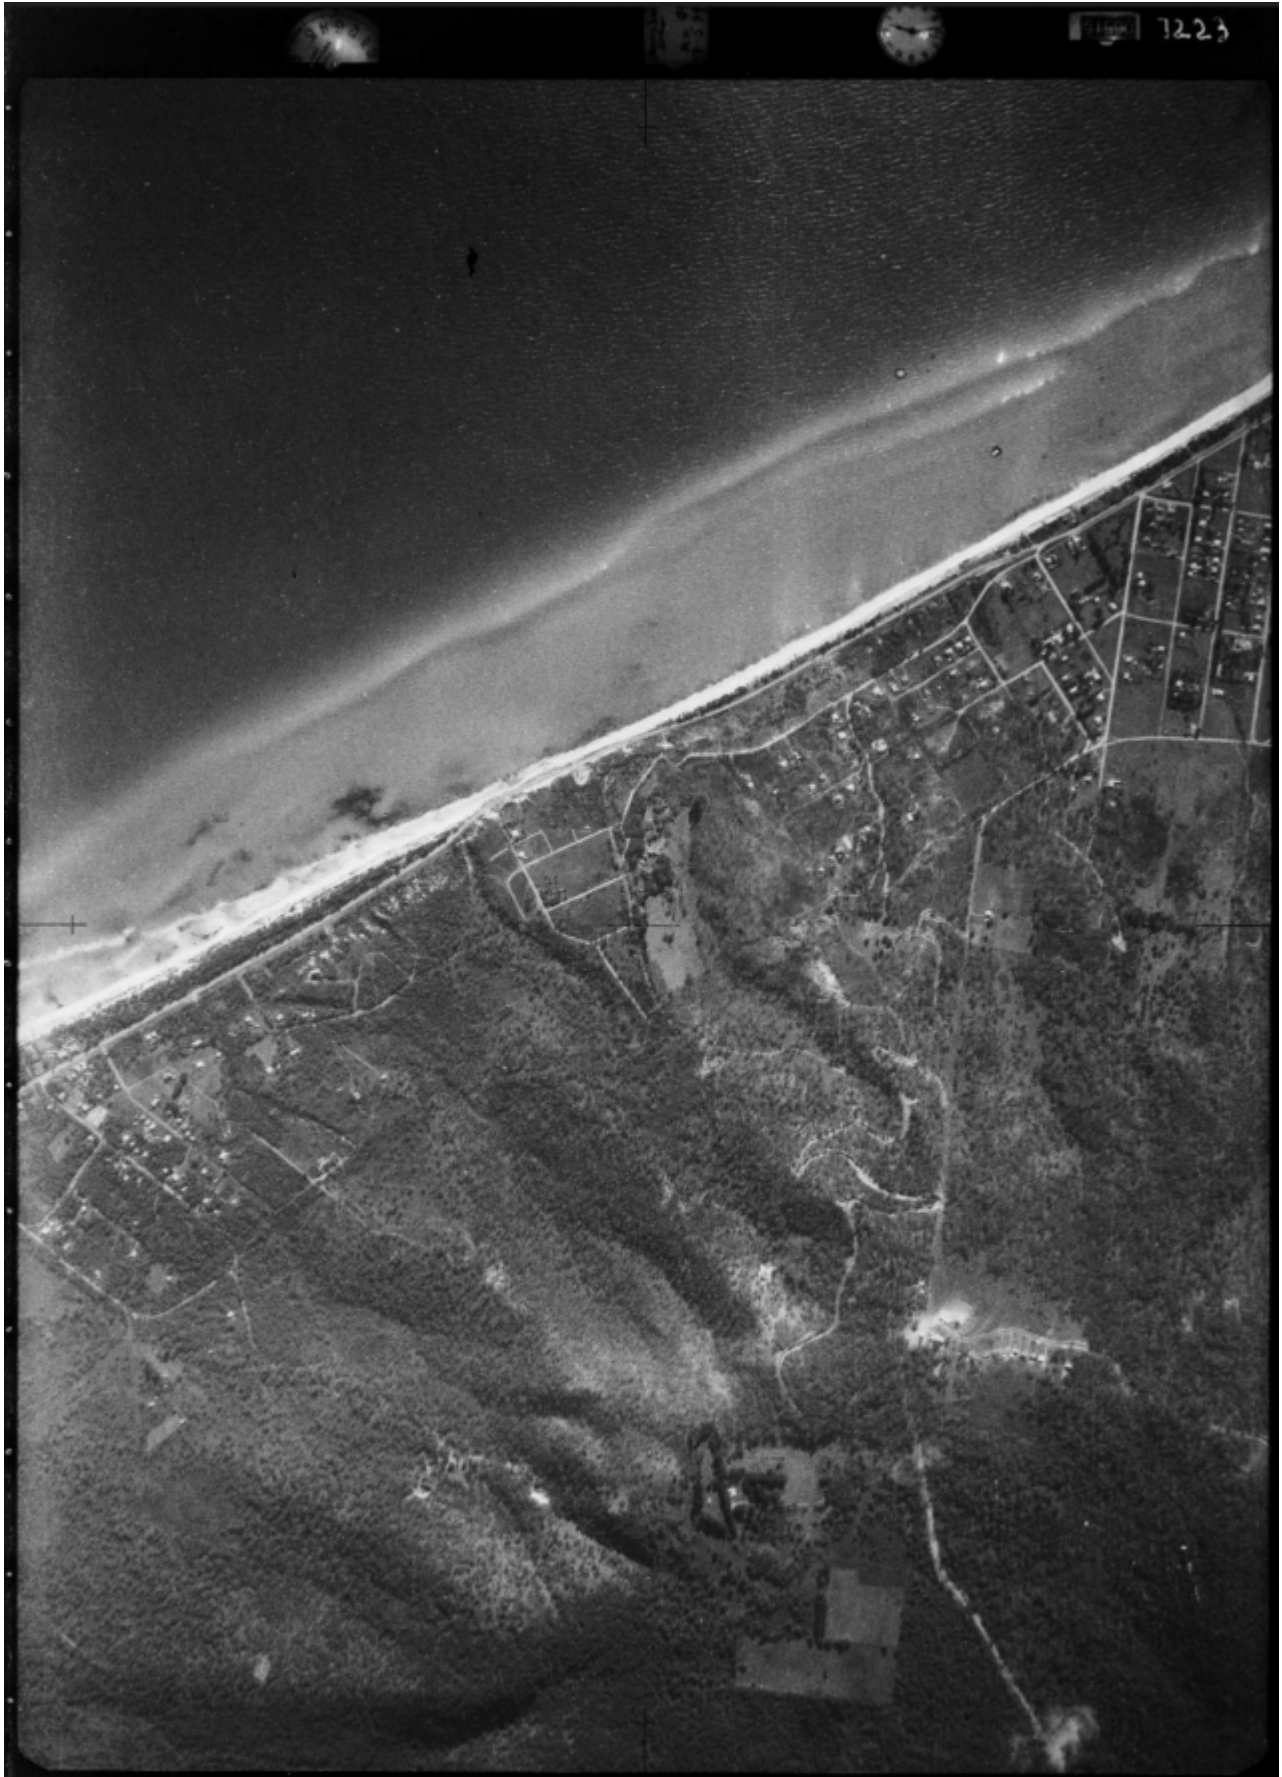
Figure 1: Aerial Photograph of the McCrae Area dated 1939. It can be seen that forest extends across most of the foot-slope

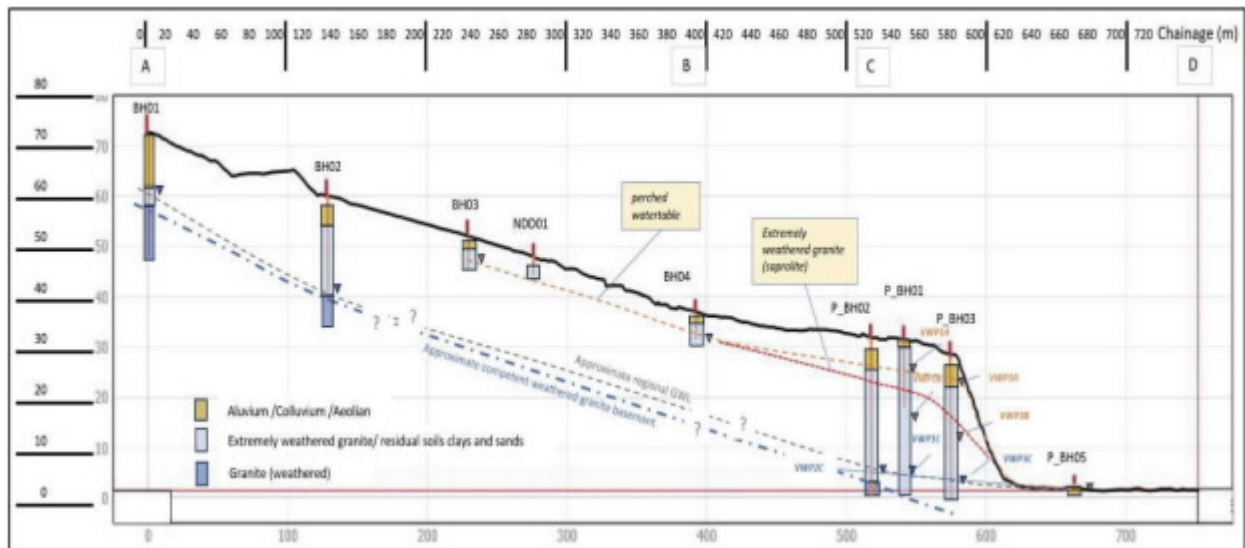
Figure 3: Section drawn approximately along the flowpath shown on Figure 5, showing depth of bores and screened sections in relation to interface flowpath.

As shown on **Figure 3**, SMEC BH3 and BH4 were screened across the interface between colluvium and residual soils. Thus the water samples obtained from these bores should be representative of interface groundwater. Chloride concentrations were 100 and 170 mg/L respectively.

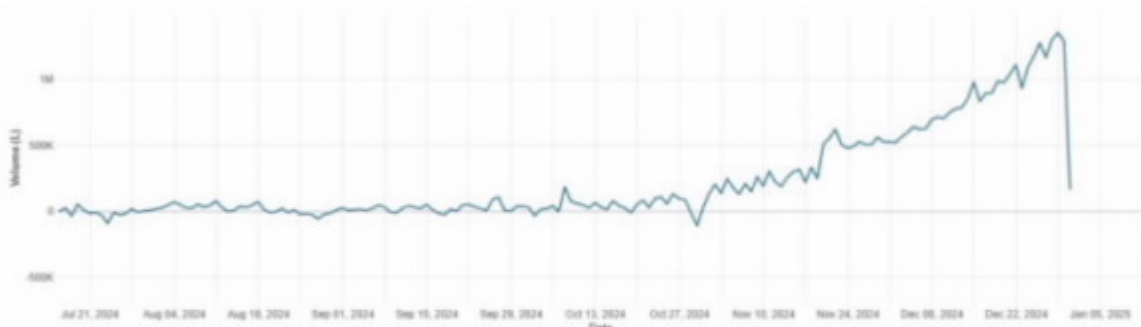
Figure 4: Rate of Outflow from SEW Bayview Road Water Main

The Bayview road mains leakage has been described in detail by others. In summary, it began two to three months prior to the landslide occurring, and was repaired on 1 January 2025, four days prior to the first landslide. **Figure 4** (WSP Figure 8.15) shows the estimated rate of discharge (in L/day) during the leak. It can be seen that leakage becomes apparent from about mid-October and increases exponentially until the repair was completed. Total loss was of the order of 37 ML and the ultimate leakage rate about 15 L/s. Evidence has been presented that effectively

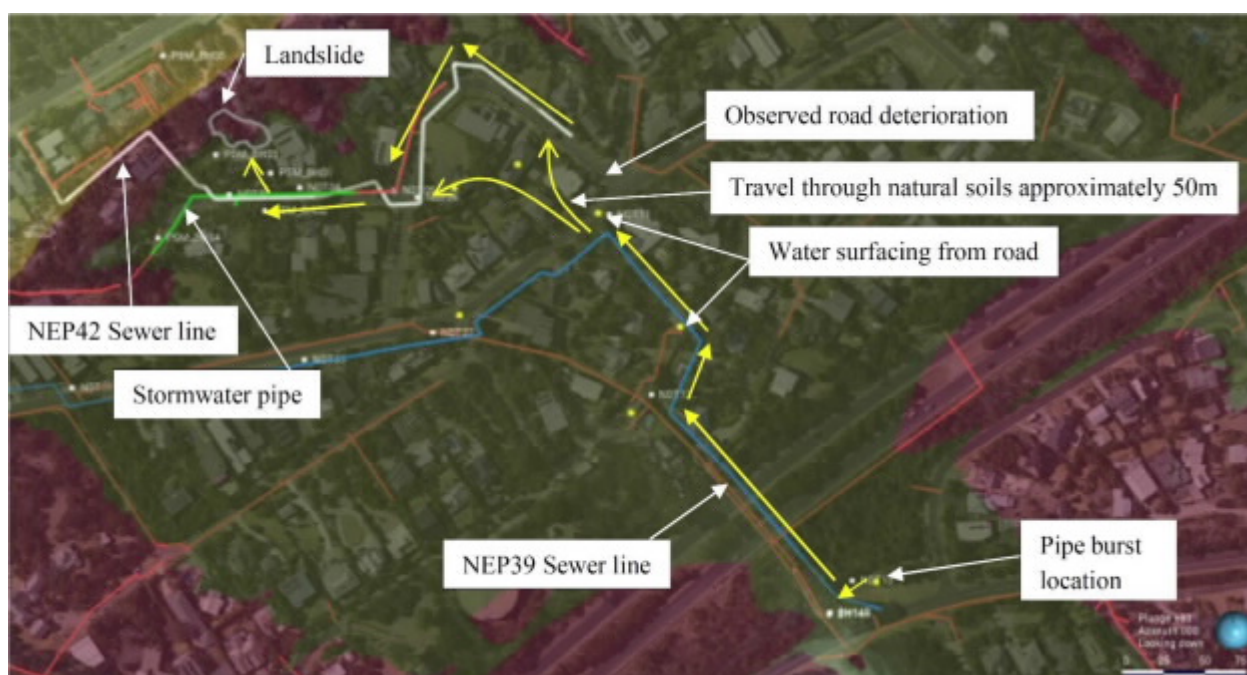
Figure 5: Flow Pathways through Sewer Embedment Material

Figure 5 (WSP Figure 8.27) shows a potential pathway through sewer trench embedment identified by WSP, and also discussed by SMEC. I understand that the marked water outbreak on Charlesworth Road near the junction with Coburn Avenue was substantial, with water flowing down the road, and the road surface needing immediate repair. This pathway continues through sewer embedment material around Prospect Hill Road to View Point Road, and along View Point Road. It is my understanding the predominant embedment material in the sewer trenches in this area is a gravel-sized aggregate derived from local weathered granite, which is likely to have similar geochemical characteristics to the granite parent material. As indicated above, samples of embedment material from the sewer excavation on Bay View Road were examined by XRD, with the results provided in **Table 3**. It can be seen that the principal minerals present at concentrations above 1% are Quartz, Sodium Plagioclase, Potassium feldspars, Biotite and Kaolinite, with Calcite present in sand bedding only. I have modelling the reaction of the silicate minerals with SEW mains water and concluded that the extent to which these minerals will dissolve in the likely time available is small.

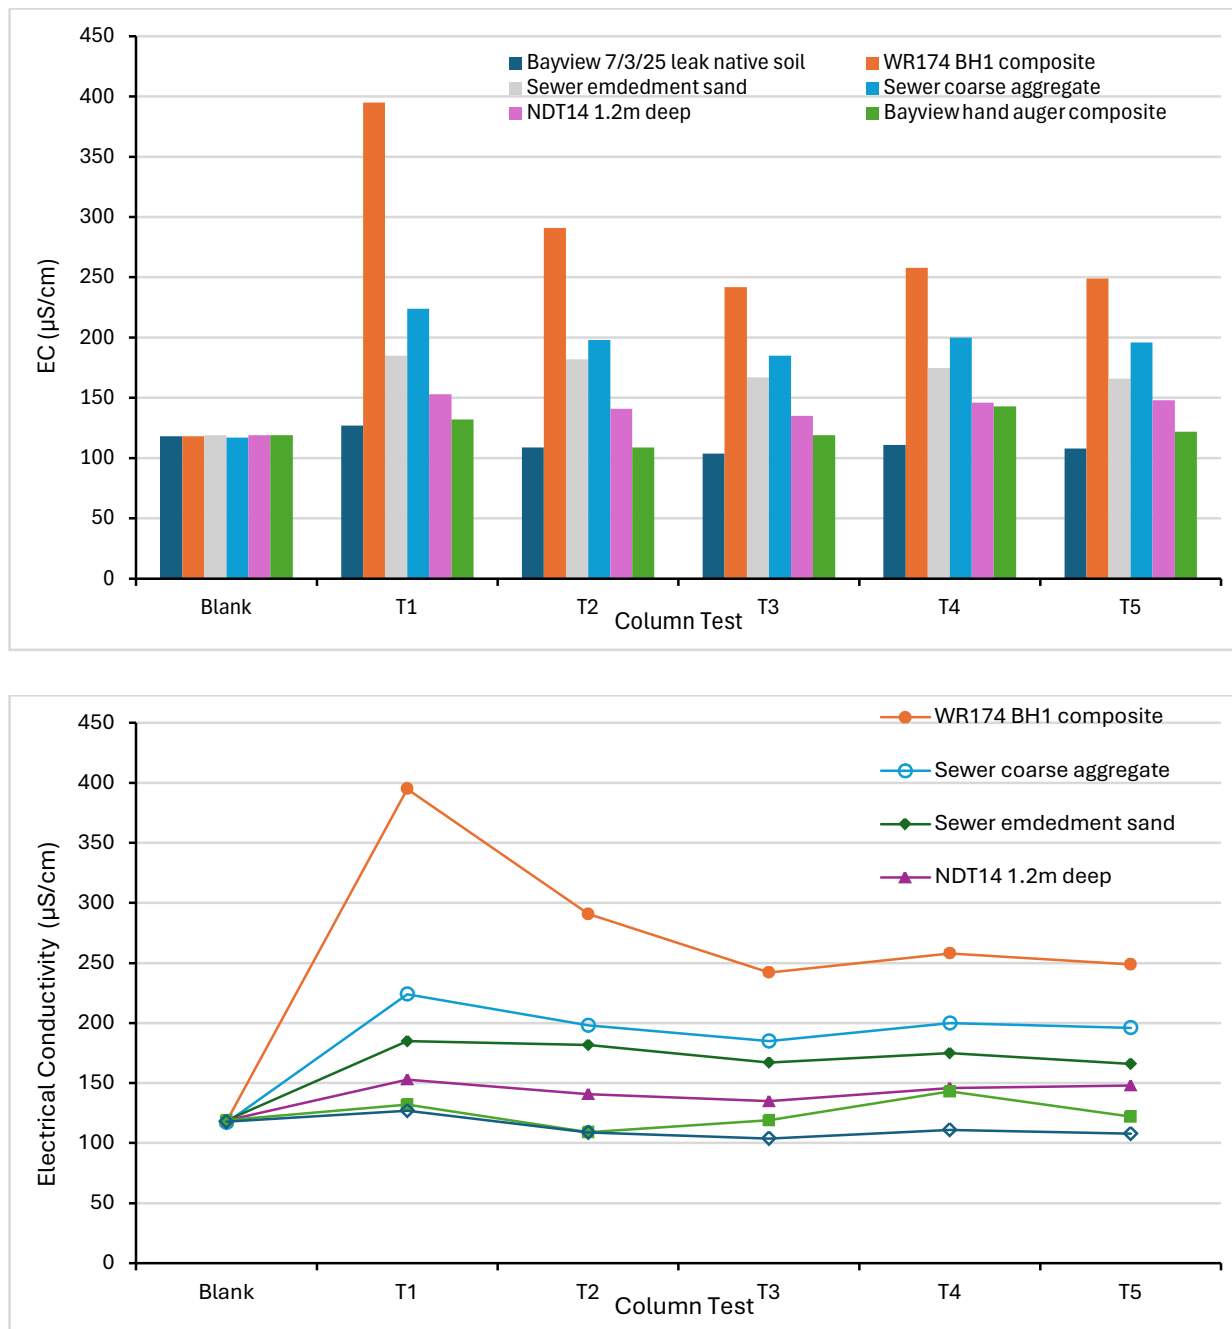
Figure 6: Leaf Tests

Column leaching (LEAF) tests carried out on these samples (**Figure 6**) using mains water showed an initial step increase followed by stability. It is considered that the initial small peaks may reflect the wash-out of fine colloidal material or weakly sorbed ions.

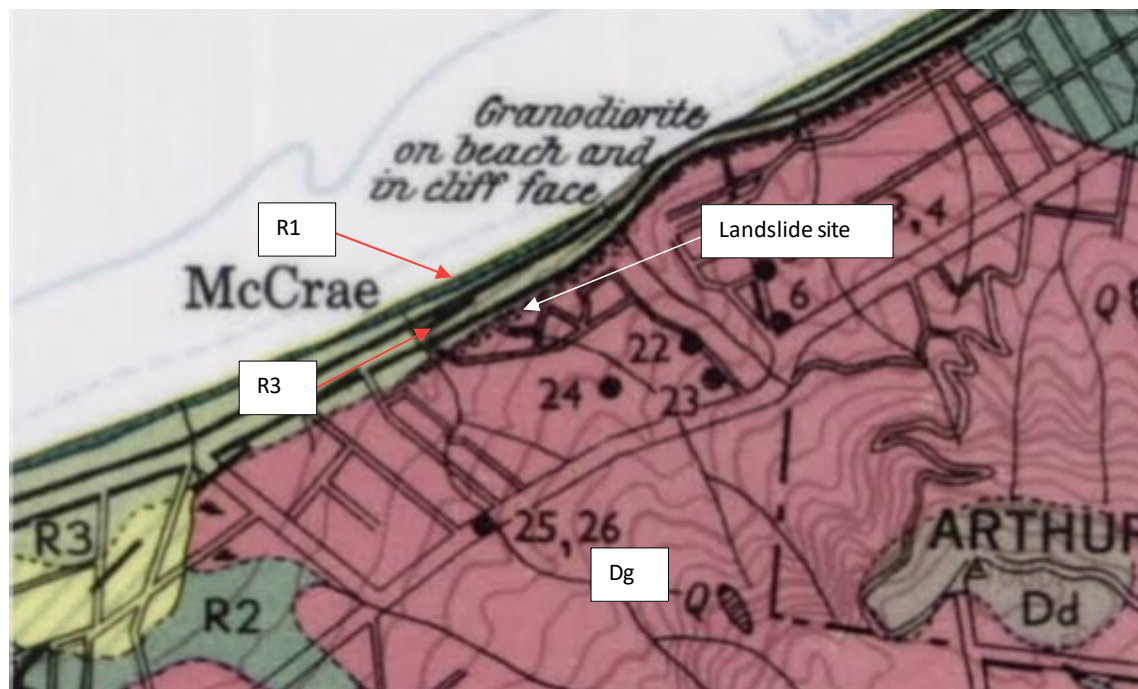
Figure 7: Geology

Both PSM and WSP indicate that groundwater, and water released from the Bayview mains leak, may have travelled through paleochannels that have been filled with transported soil or colluvium. **Figure 7** shows and explains the regional geology and WSP’s conceptual model of the general stratigraphy and groundwater flow are attached as **Figures 8 and 9**. I note that there appears to be some disagreement regarding the presence, or at least the thickness, of residual granite at the head-scarp (**Figures 10 and 11**), but regardless, the model proposed is of groundwater flow at the interface between colluvium and residual or extremely weathered granite. I emphasise that I agree with this model to the extent that it is restricted to interface flow, as shown on **Figure 8**, but not flow through a substantial thickness of colluvium. In my experience, and from what I can observe in the photographs, the colluvium en masse is not likely to be a very permeable material. I think that a hydraulic conductivity of 1×10^{-5} m/s would be the most that could reasonably be assumed, and it may well be lower. The cross sectional area of 375 m² and consequent flux (discharge) 50% higher than shown in WSP Table 8.2 are also, in my opinion, unrealistic. From a geochemical perspective, it is likely that the colluvium contains a much higher proportion of clay than the either the residual granite of the trench embedment material, and water is thus likely to emerge with a more pronounced Na-Cl signature.

The Devonian-age Dromana Granite extends from Arthurs Seat to the escarpment. Holocene coastal deposits to the north-west between the scarp foot and the coast. The Selwyn Fault trends parallel to and beneath or somewhat to the north-west of the scarp.

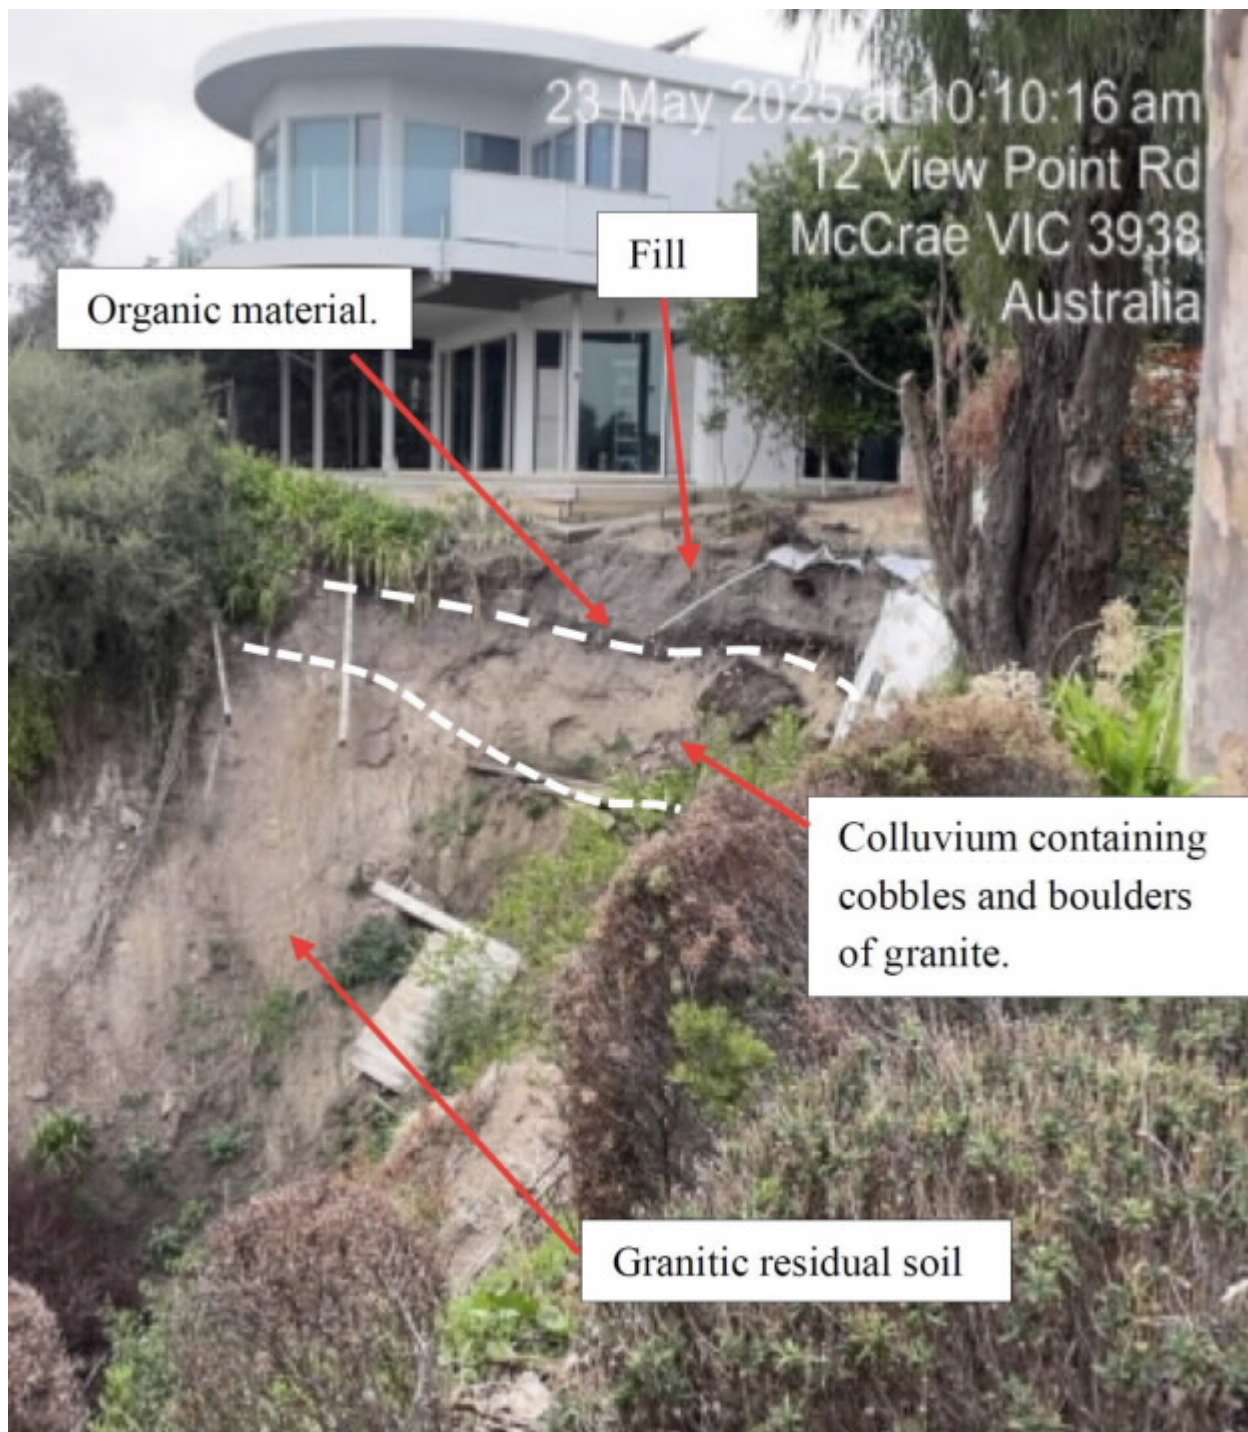
Figure 10: (Figure 6.1 from WSP Causation Report) Photograph showing layer structure in head-scarp

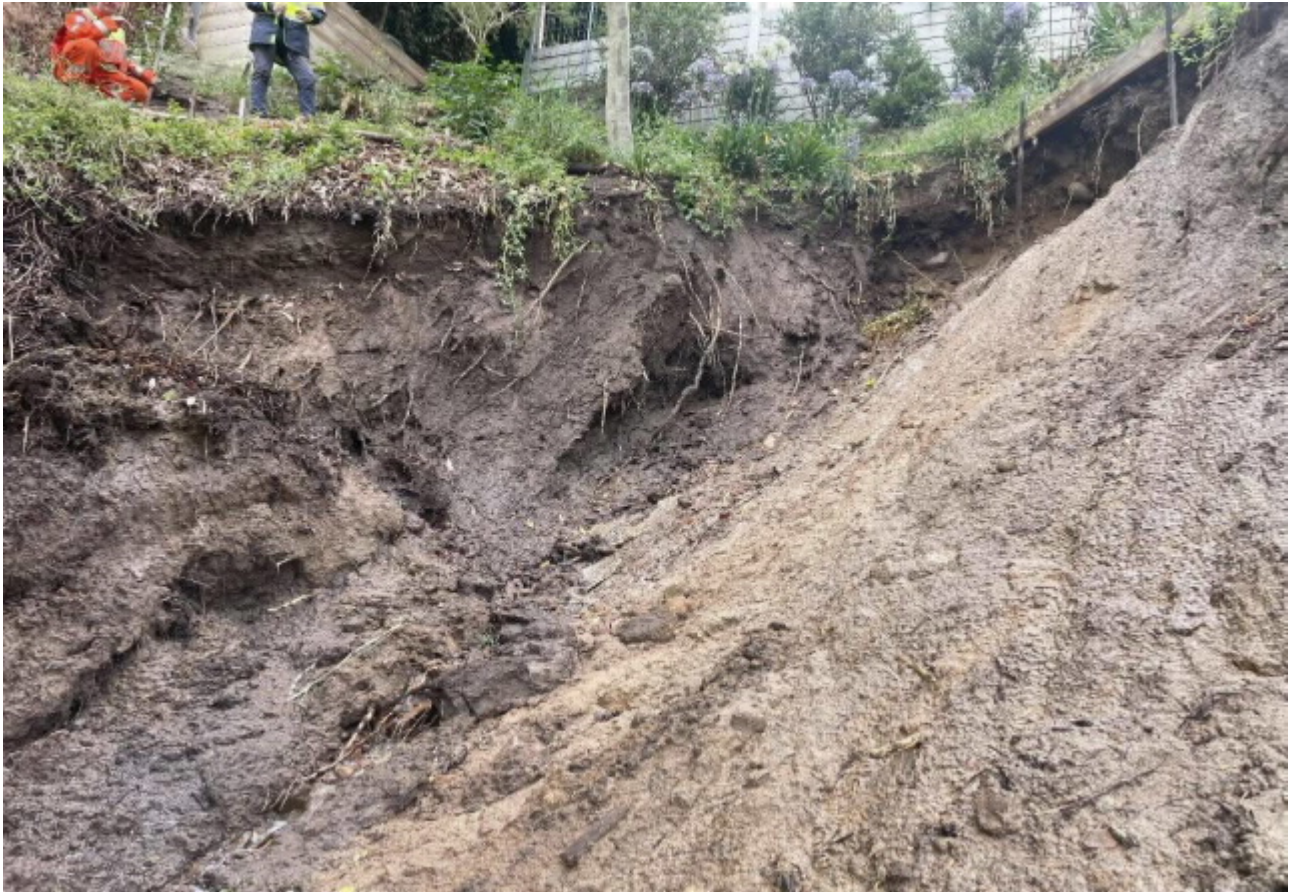
Figure 11: PSM Photograph of head-scarp, the EW granite seen in the right foreground, suggests that interface groundwater flow may be locally on an EW Granite interface, rather than on a residual interface.

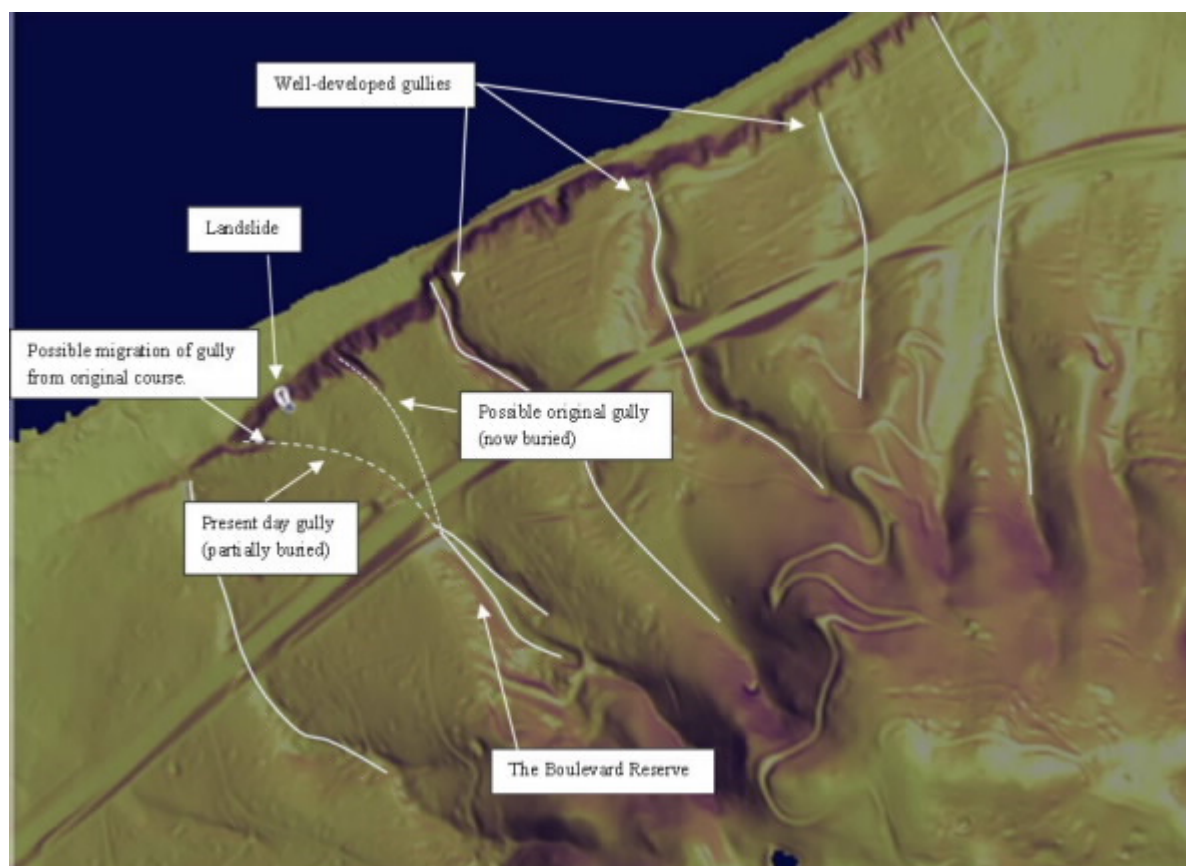
Figure 12: Gully Erosion

I agree with the process of landscape evolution outlined by WSP, It is possible that the original gully marked on the DEM (**Figure 12**) is present, and that the interface drainage observed at No. 7 Prospect Hill Road is associated with

There seems to be no evidence for the “possible original gully” on the 1939 AP and its presence would be inconsistent with the otherwise vet even spacing of the gullies, capturing equivalent drainage volumes.

It is likely that the gully beds have a similar overall slope to that of the land surface, with locally steeper sections.

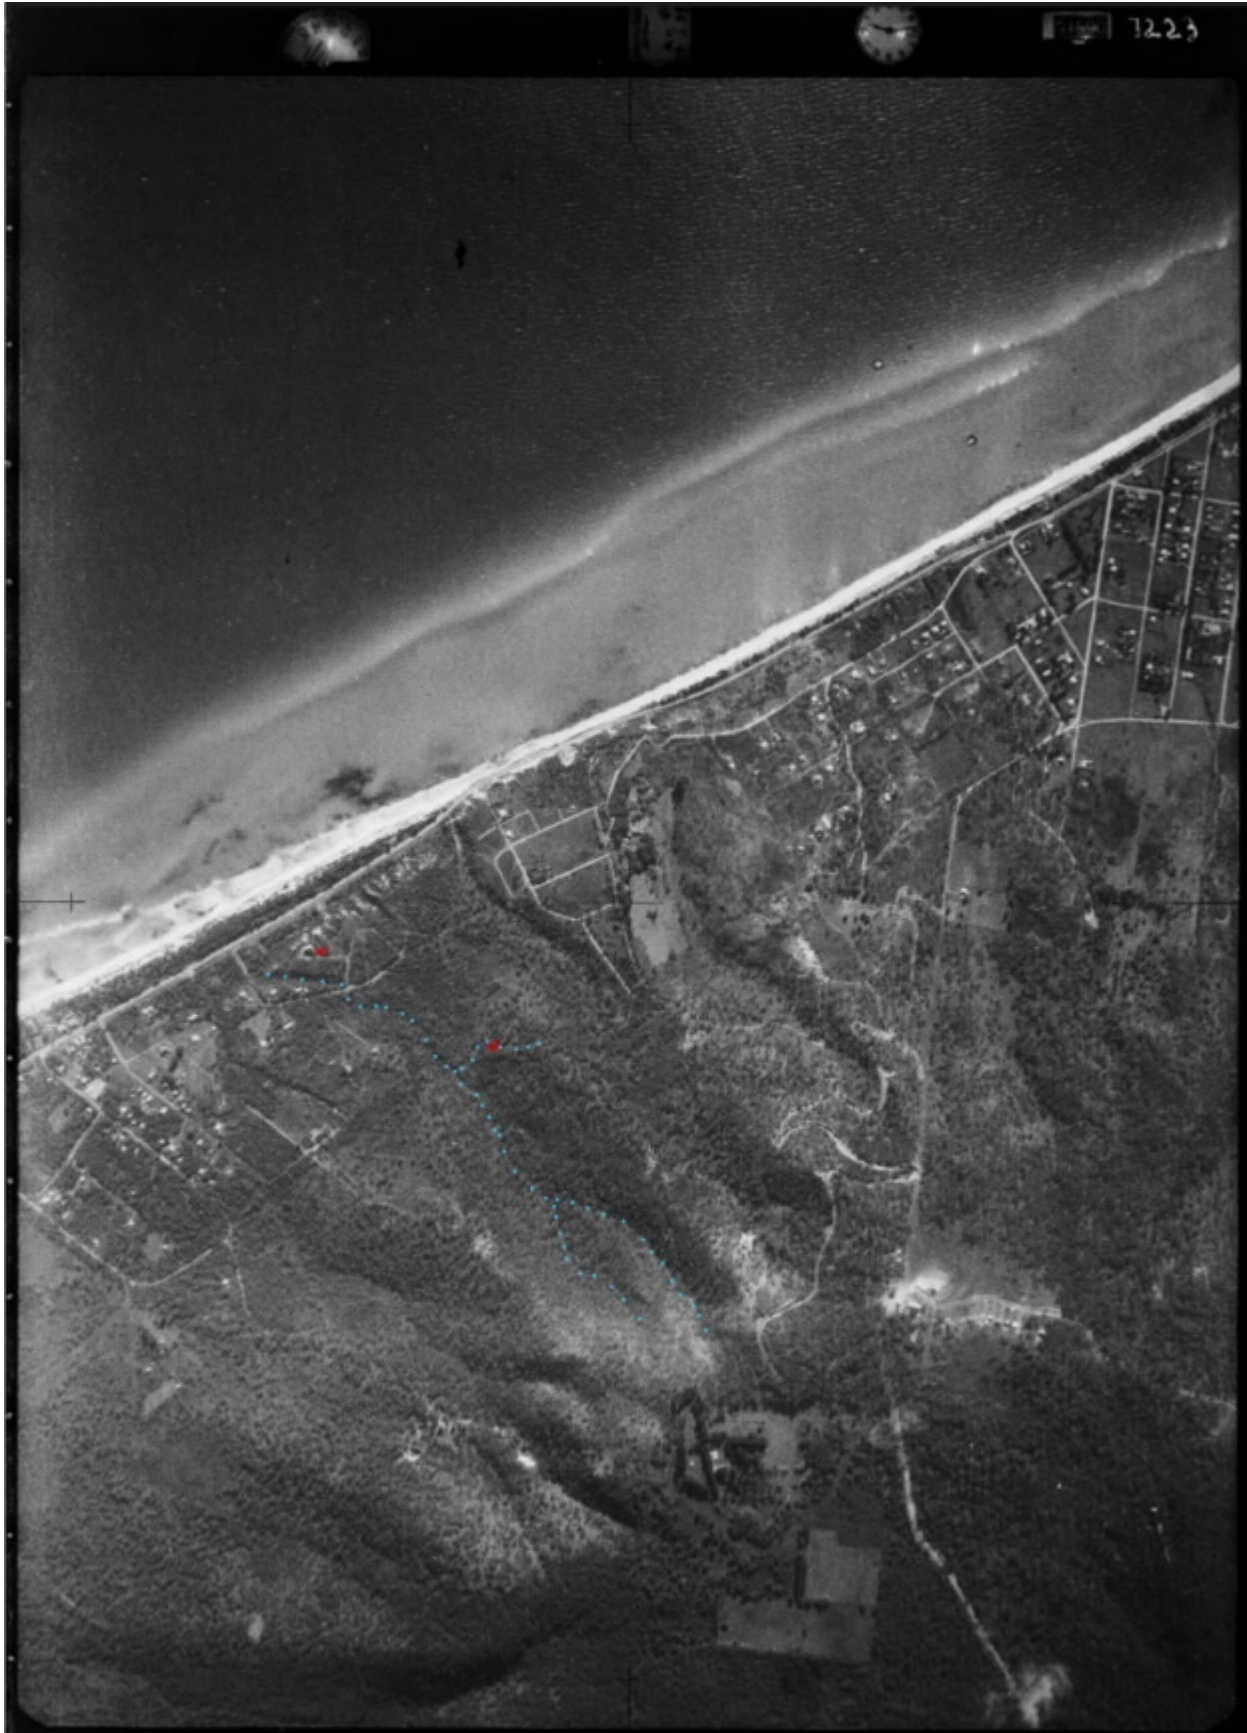
this. There is some sign of disturbance on the marked-up 1939 aerial photo (**Figure 13**) but it is not clear what this represents.

Figure 13 – 1939 Photograph marked up with location of Bayview Road leak, and landslide, also highlighting gully.
