McCrae Landslide

Causation Report

McCrae Landslide
Causation Report

Board of Inquiry into the McCrae Landslide

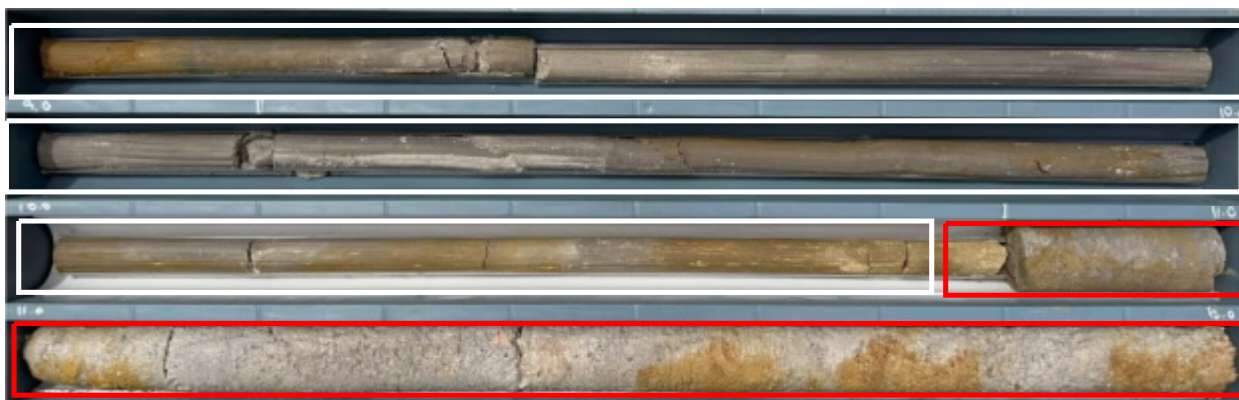
Figure 6.6 Core recovered from BH01 showing residual soils (white) and extremely weathered granite (red). Depth range 8 m to 12 m below ground surface.

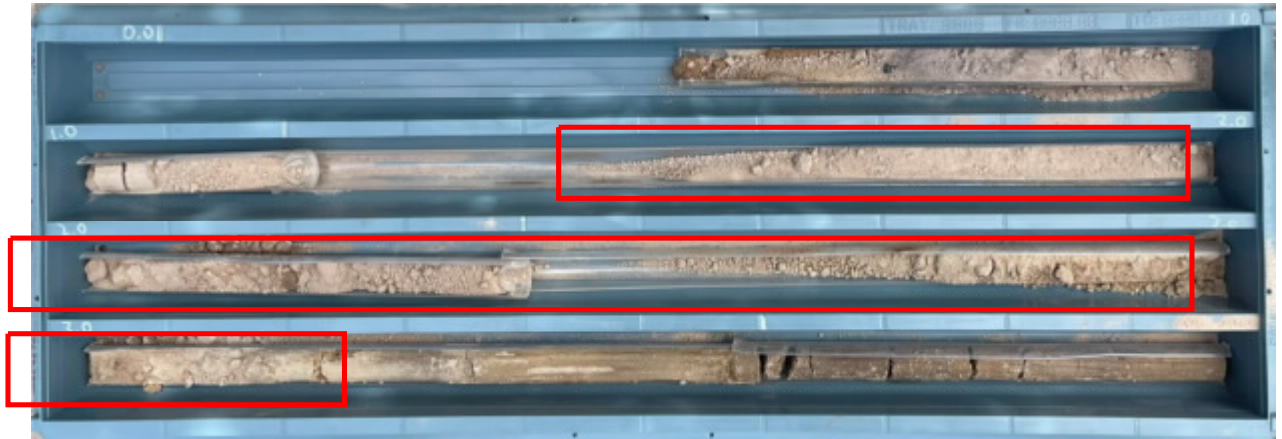
Figure 6.7 Colluvium (red) observed in BH04, overlying granitic residual soils.

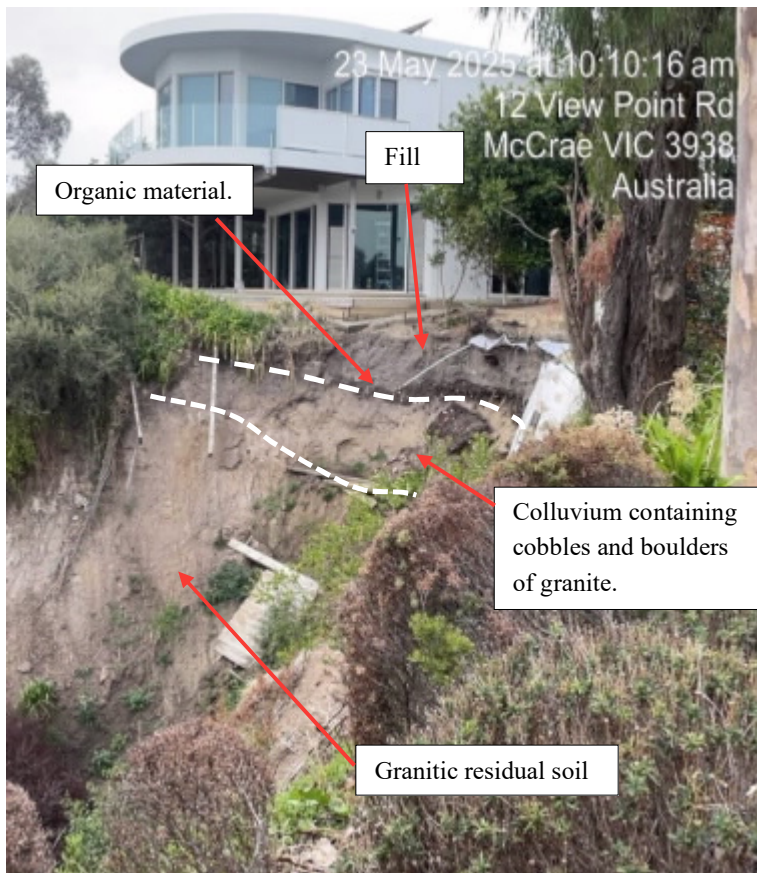
Figure 6.8 Sub-surface profile as identified within the landslide headscarp.

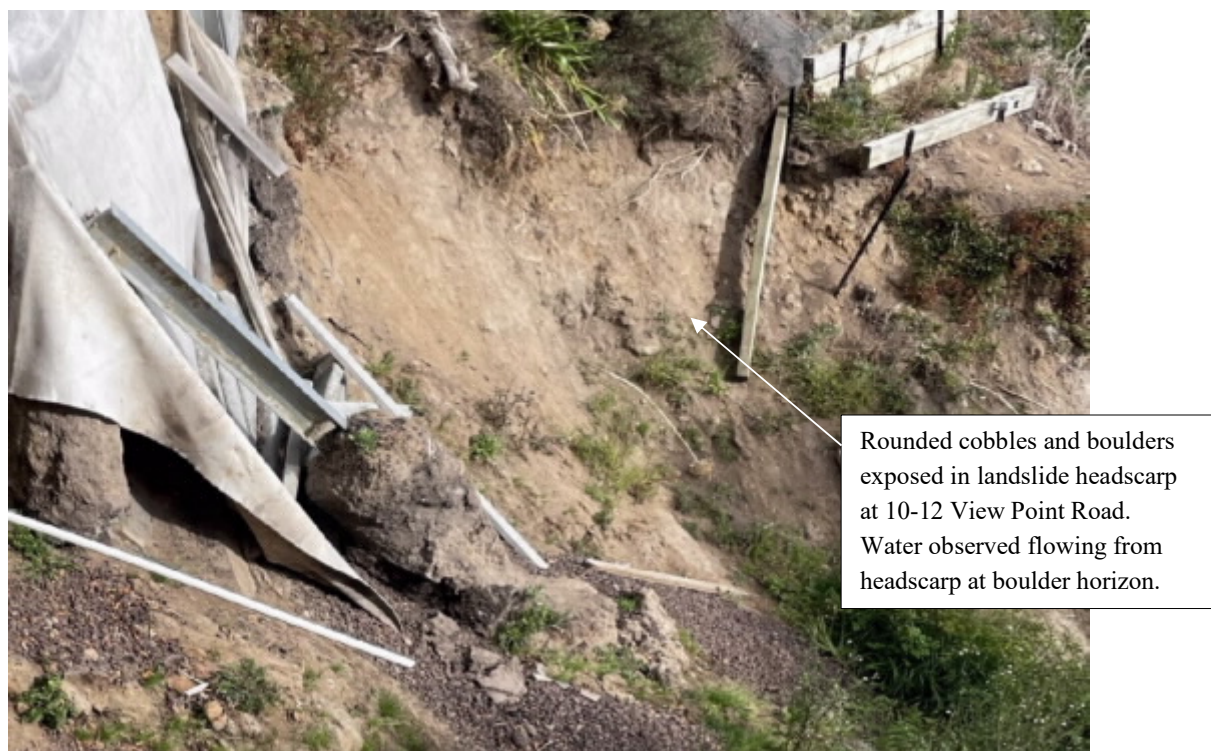
Figure 6.10 Examples of materials exposed in landslide headscarp

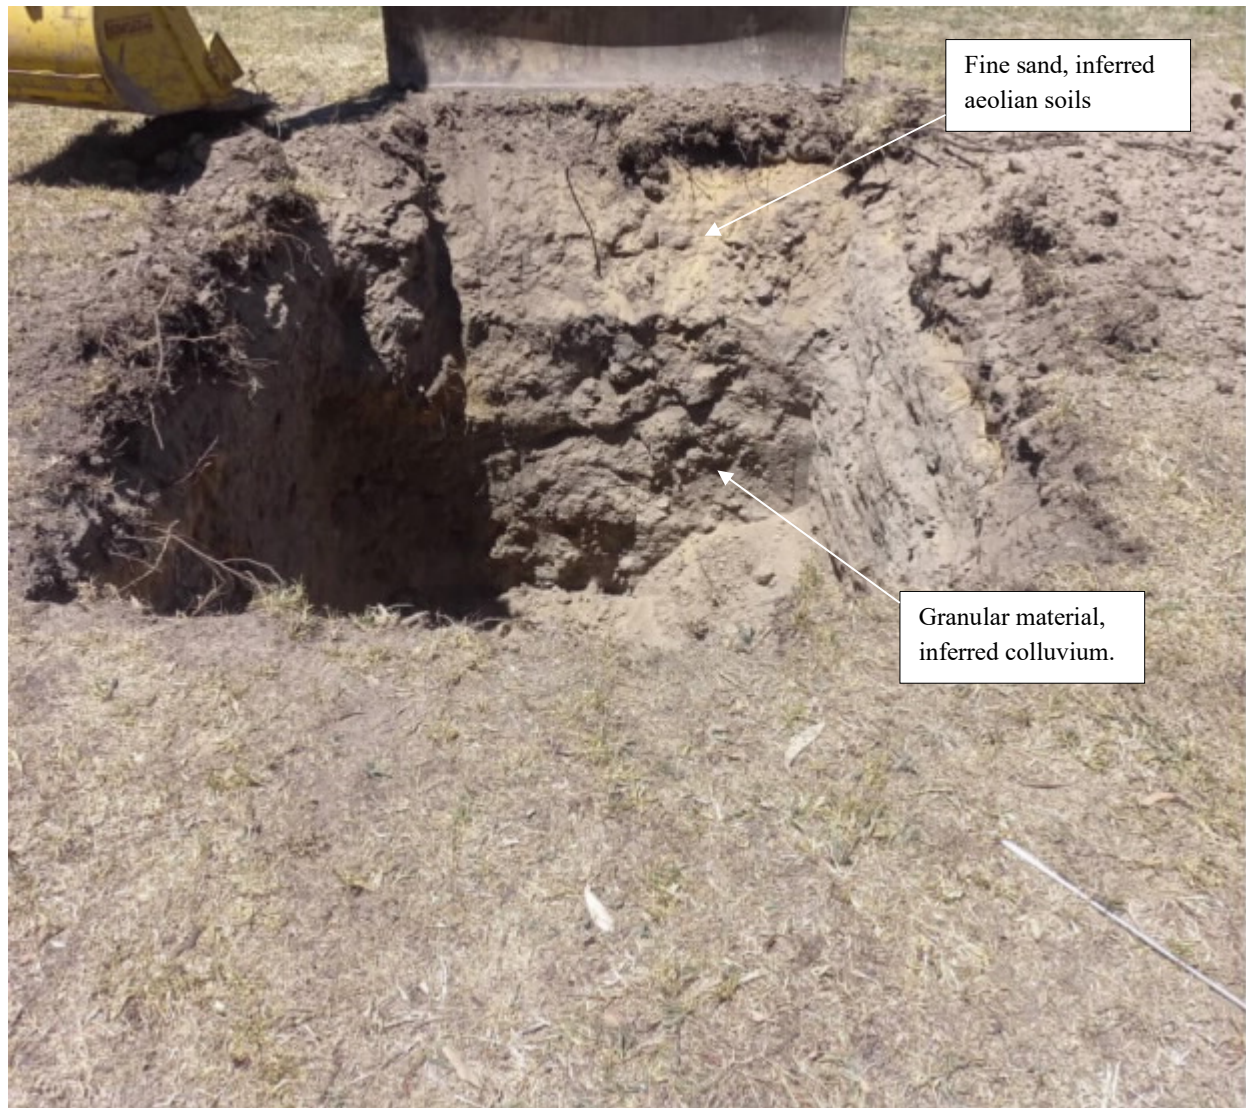
Figure 6.11 Transported soils exposed on Bayview Road opposite The Boulevard Reserve (SME.0001.0001.0120)

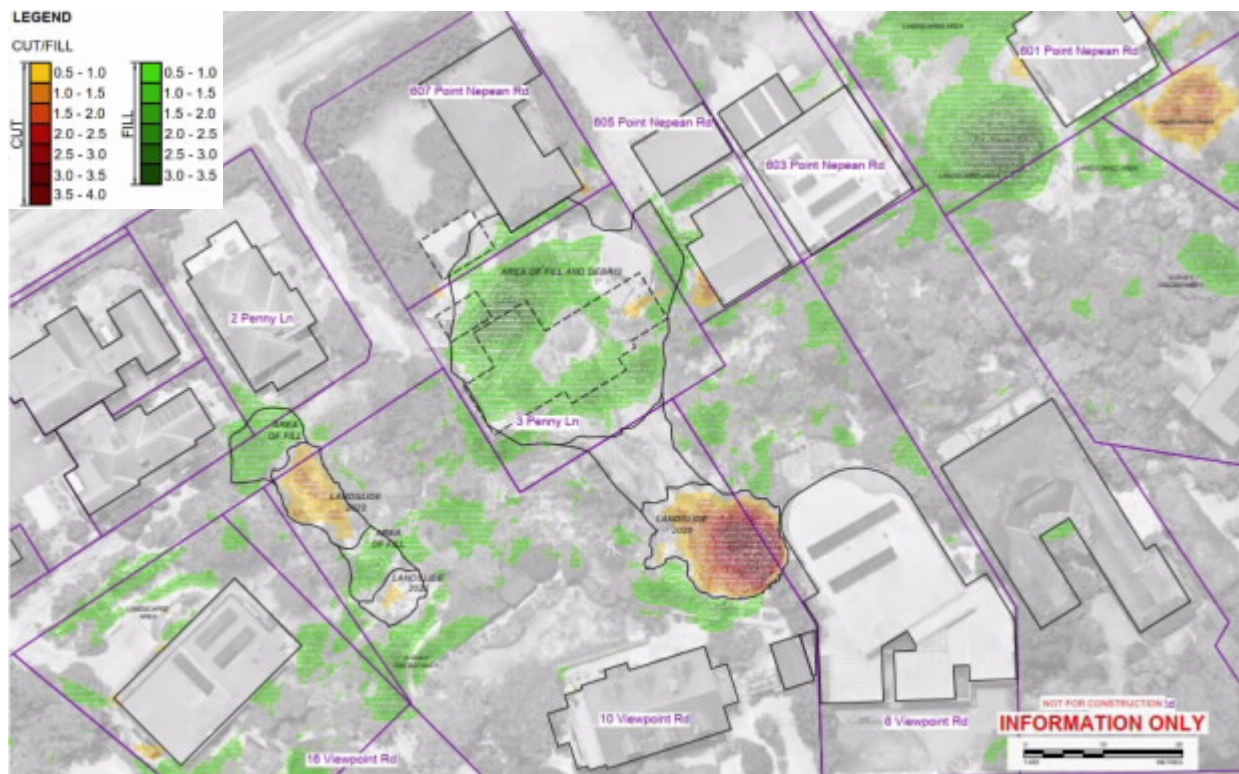
Figure 6.12 Landscape modifications made between 2017 and 2025 based on comparison of LiDAR.

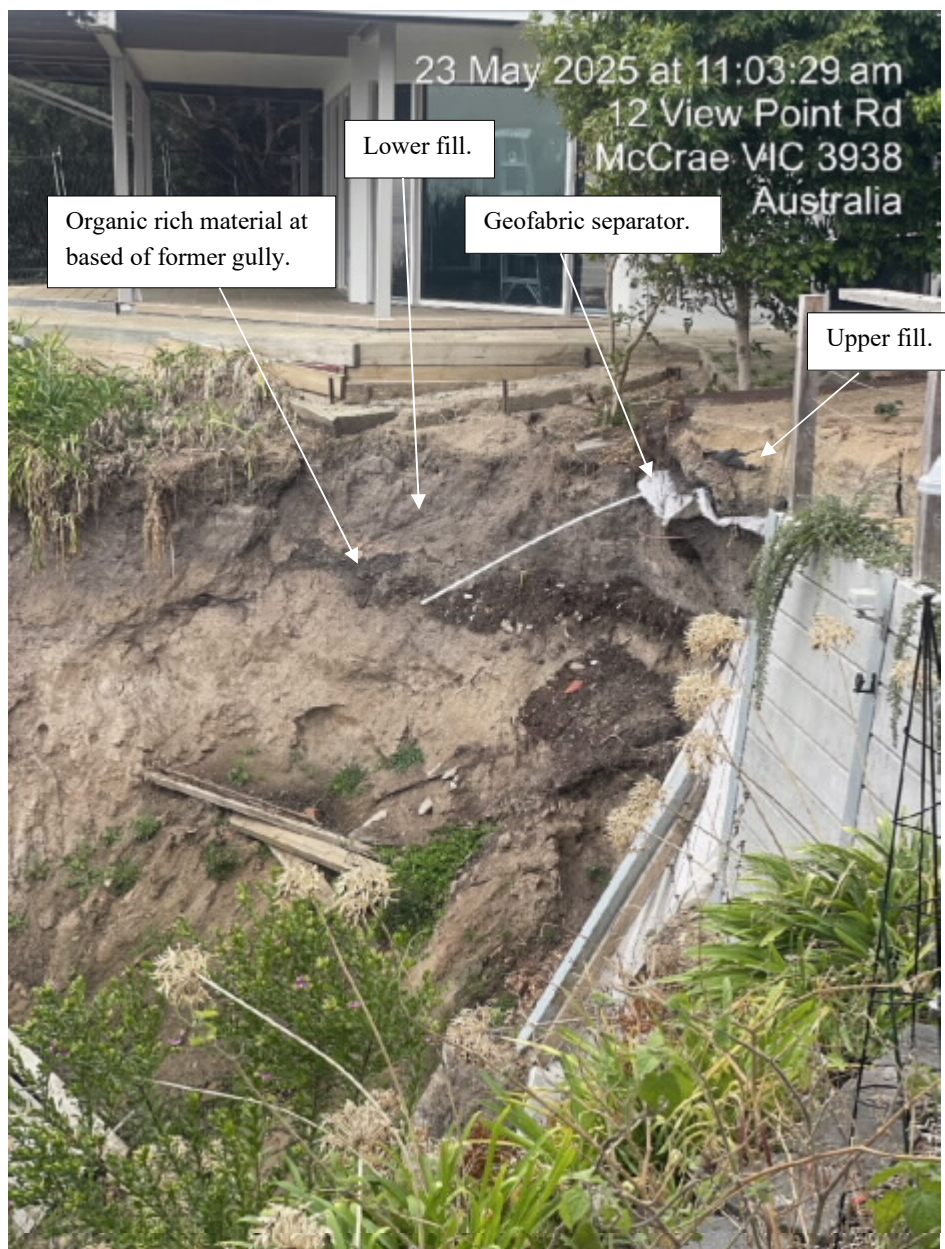
- a. There is an organic material 200 mm to 300 mm thick at the base of the gully which immediately overlies the transported soils. The organic material appears to contain waste plastic suggesting the fill overlying it is of relatively young age (e.g. fill is more likely to have been placed in the last 50 years rather than the last 100 years). The organic material may be natural, although this cannot be determined from visual observation alone and could represent organic material that has accumulated in a minor water course.
- b. A lower fill comprising what appears to be silty sand based on visual assessment that is likely to be locally derived, possibly from the transported soils or residual granite.
- c. An upper fill comprising orange clayey sand about 0.4 m thick. A layer of geofabric separates the upper and lower fill.

Figure 7.5 Fill materials exposed in the headscarp formed by the 14 January 2025 landslide.

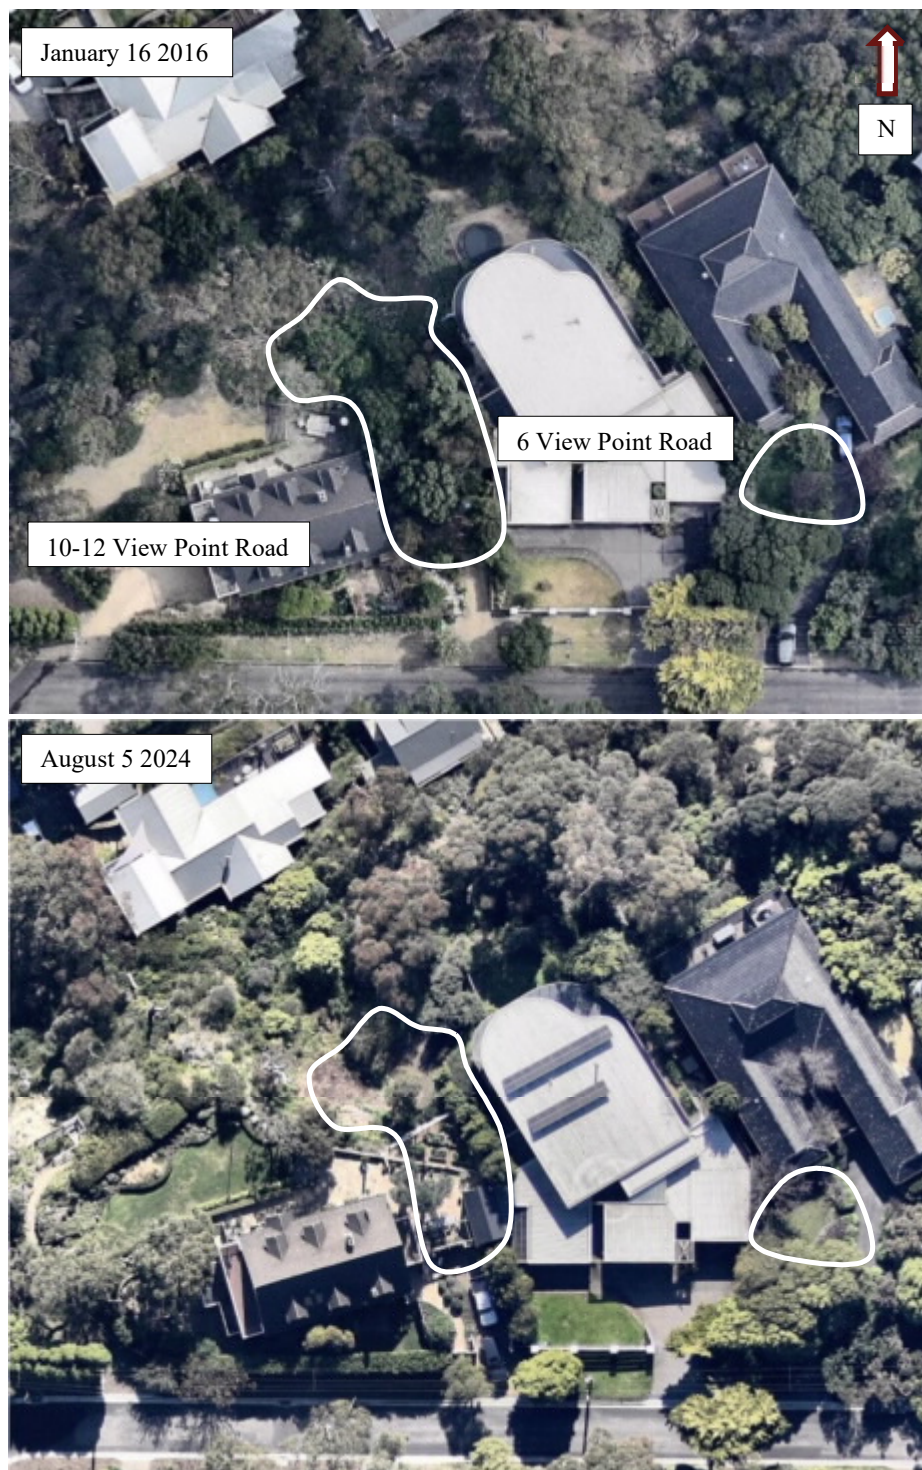
- 107) Vegetation has been progressively removed from the McCrae escarpment in the years preceding the 2022 and 2025 landslides as illustrated in Figure 7.9.

Figure 7.9 Comparative aerial photos showing vegetation removal on and around the McCrae escarpment in the vicinity of the January 2025 landslides between 2016 and 2024.

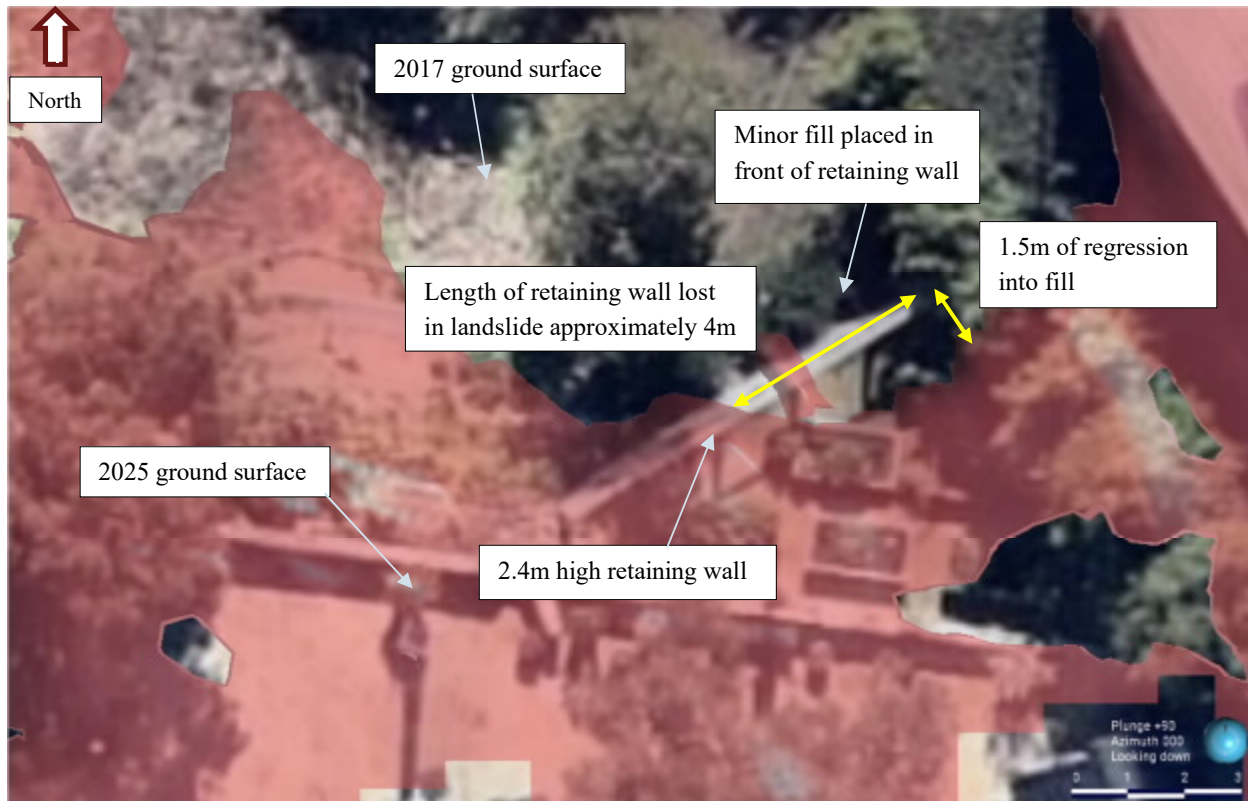
- 112) Comparison between the 2017 and 2025 ground surfaces allows an estimate of the proportion of landslide debris derived from natural materials and from the soils retained behind the retaining wall (Figure 7.11). This comparison indicates that less than 5% of the landslide debris is derived from fill. This estimate is calculated with a low to moderate confidence given the 2017 ground surface may not have been reflective of the actual ground surface immediately preceding the landslide.

Figure 7.11 Comparison of 2017 and 2025 ground surface showing proportion of retaining wall and fill evacuated during the landslide.

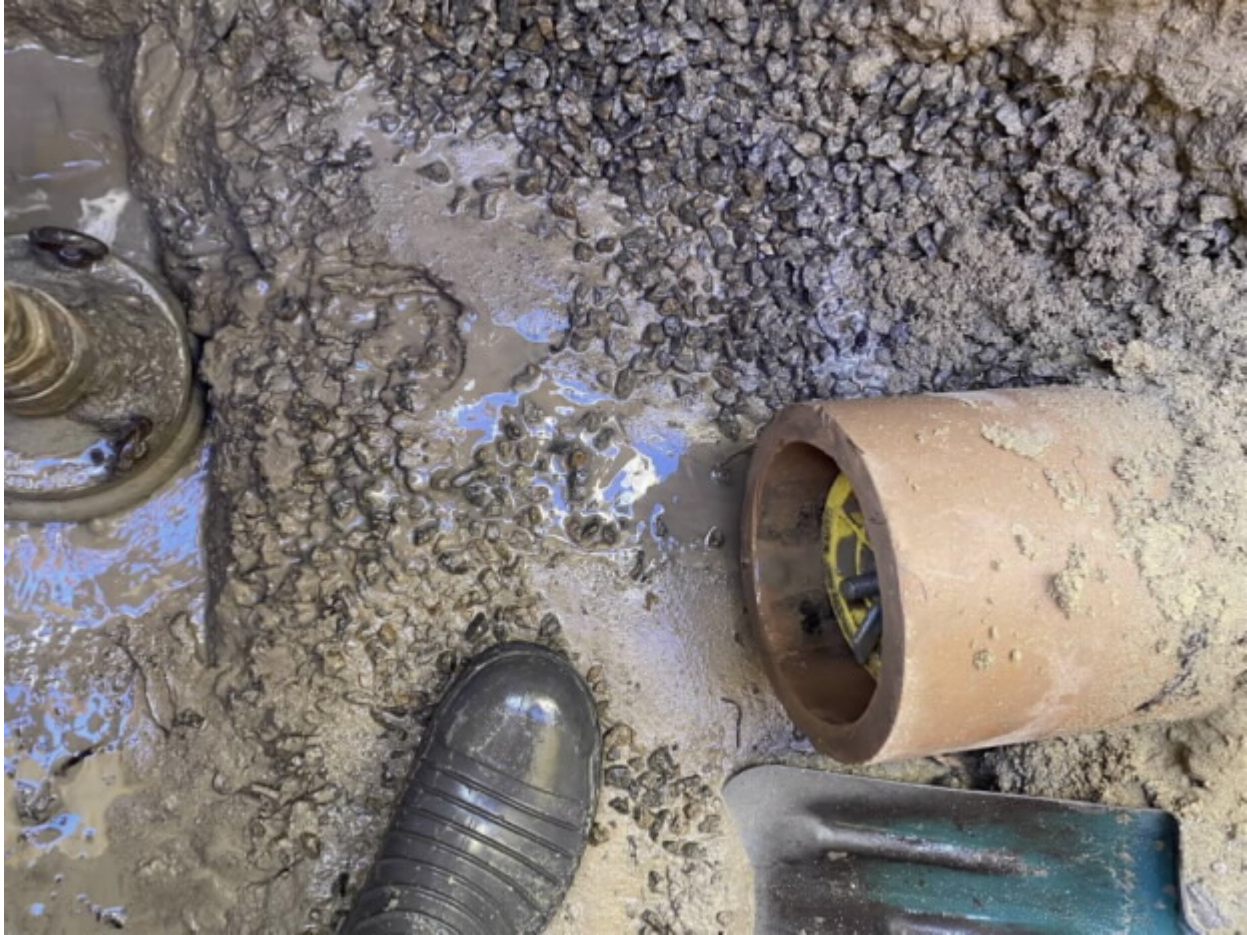
Figure 7.15 Vitreous clay sewer on gravel bed (reference SME.0001.0001.0018)

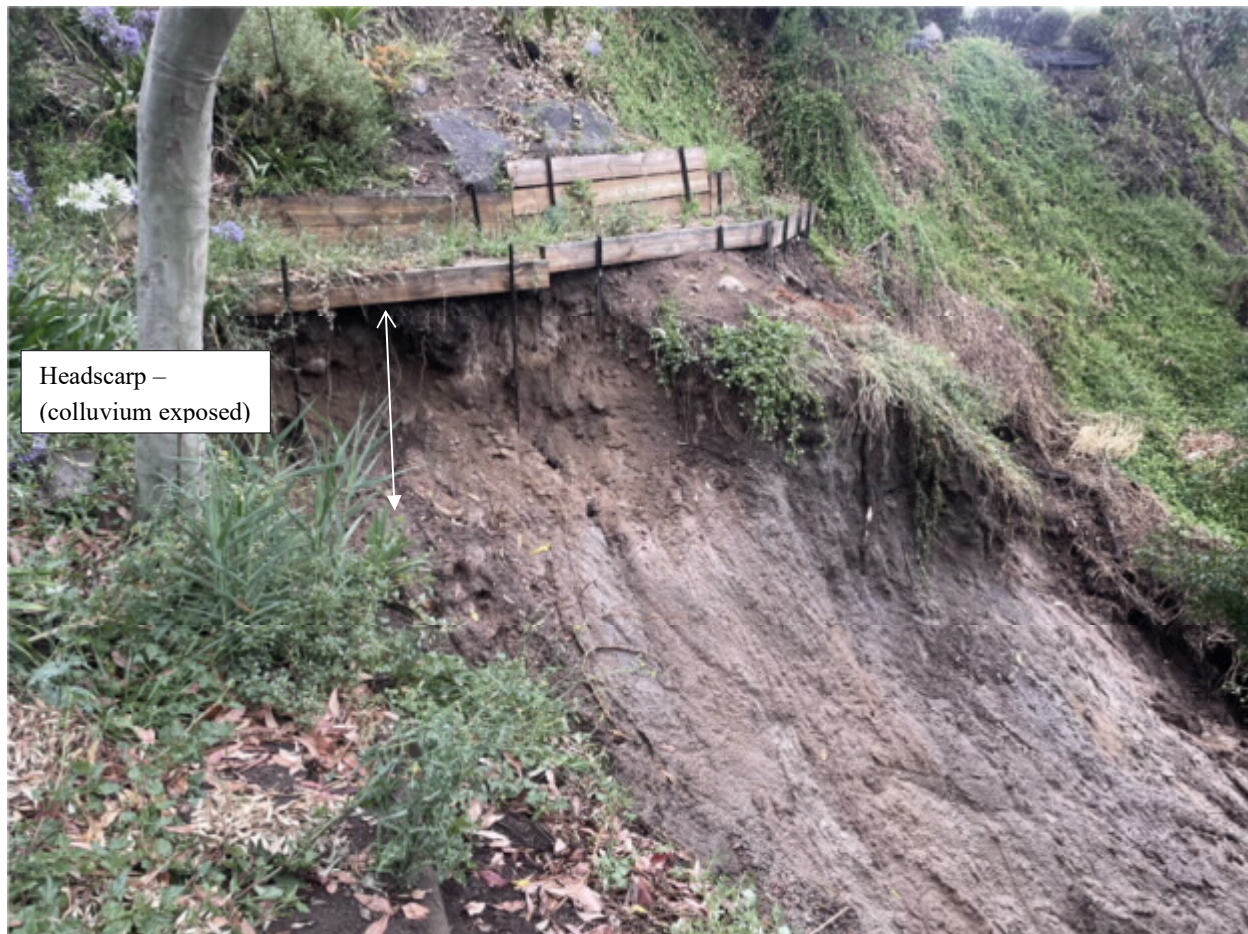
Figure 8.1 Headscarp following 5 January landslide.

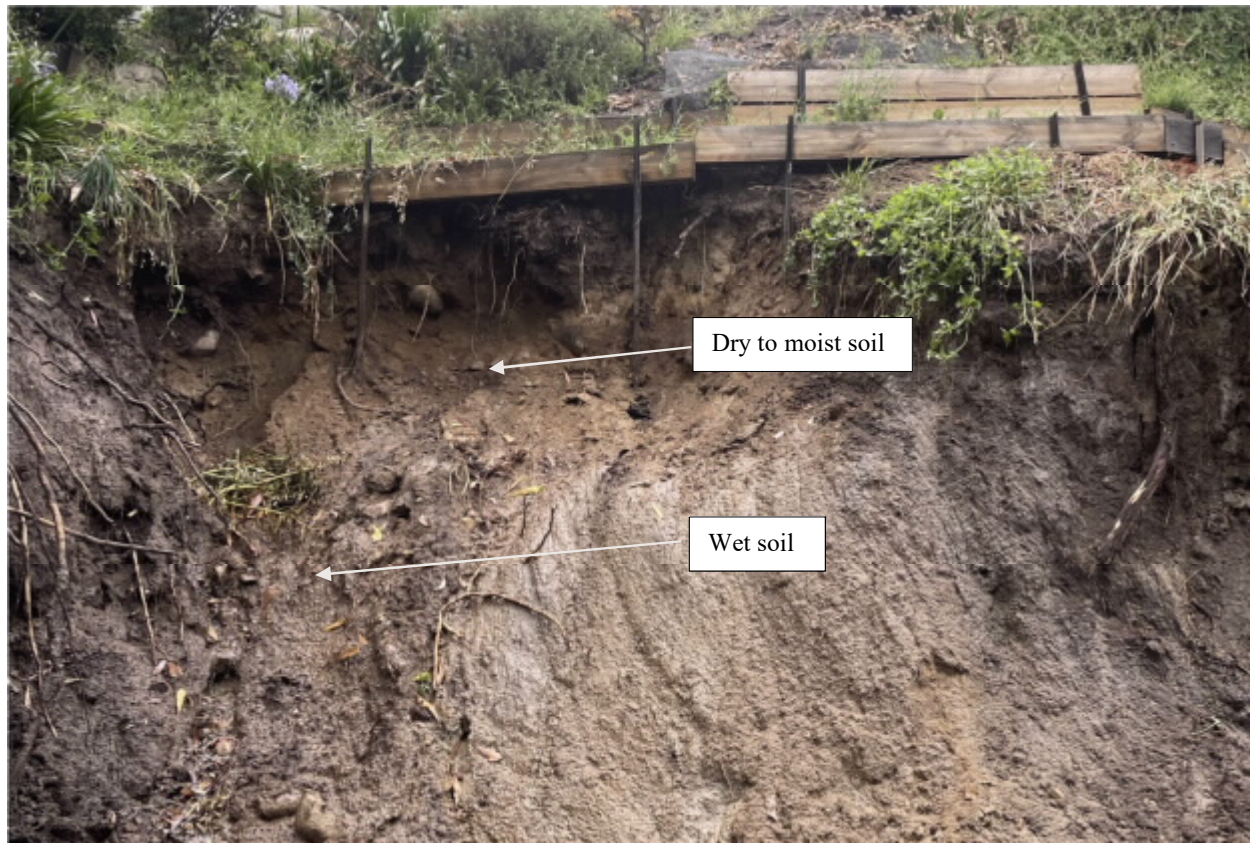
Figure 8.12 Photo of headscarp following 5 January 2025 landslide with areas of dry and wet ground annotated.
PSM.50000.0001.0114, photo dated 6 January 2025.

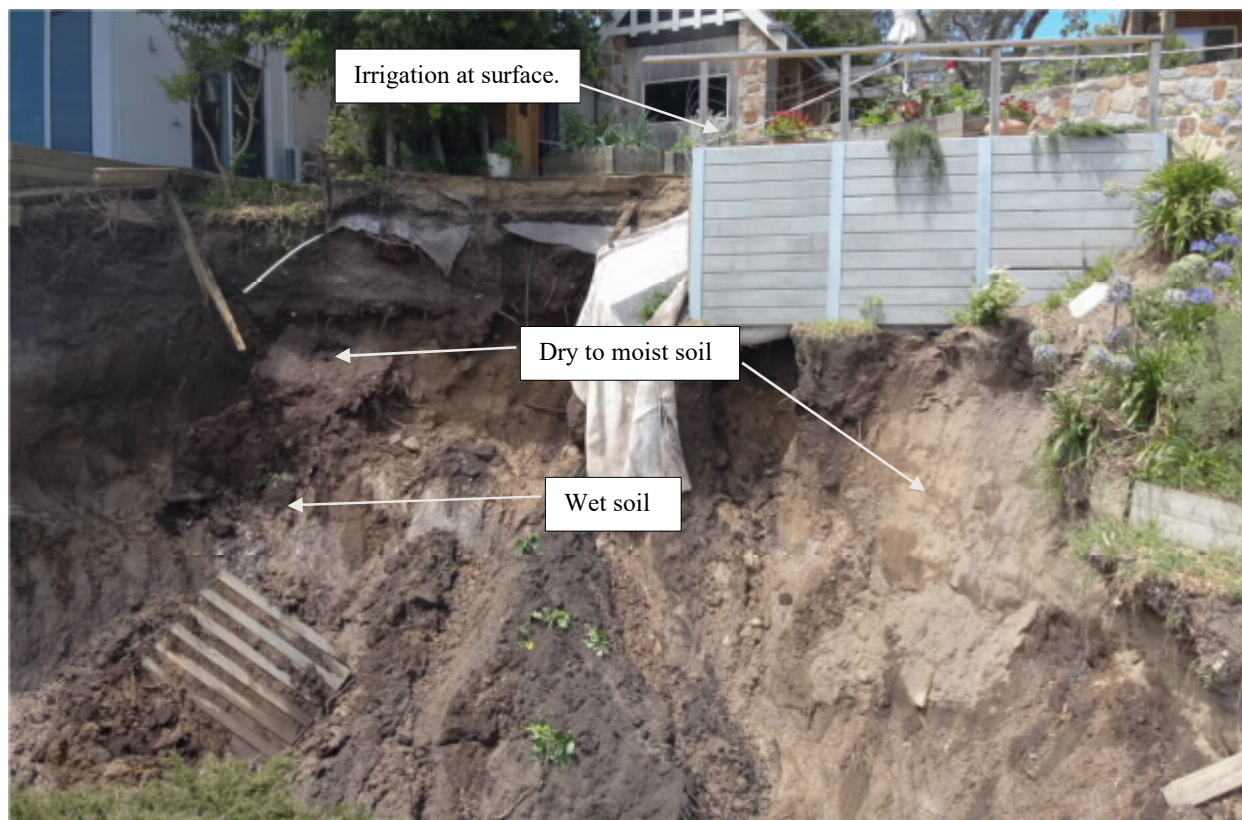
Figure 8.13 Photo of headscarp following January 14 landslide with areas of dry and wet ground annotated.
PSM.5000.0001.0290, photo dated 15th January 2026.

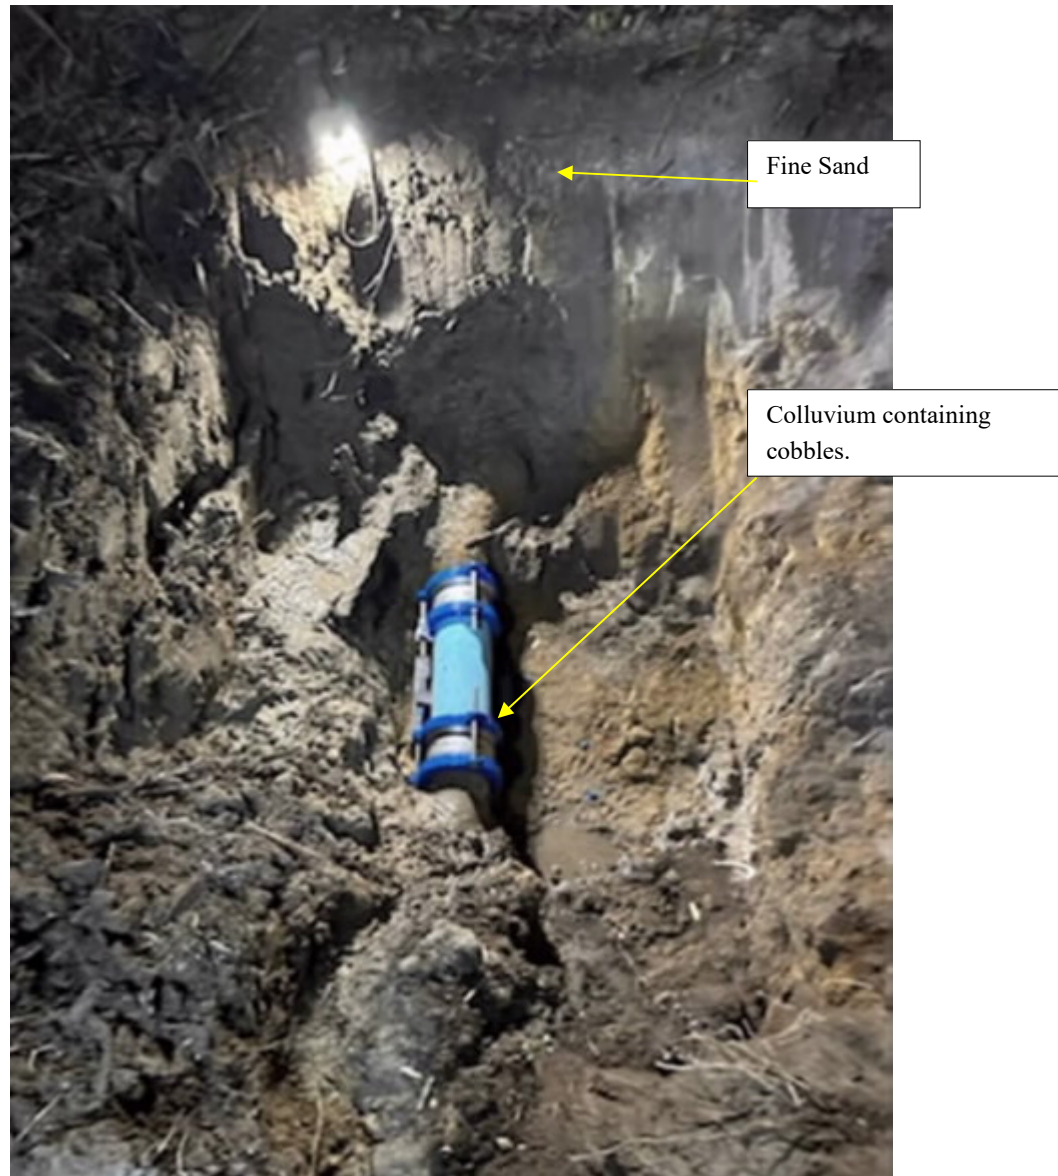
Figure 8.17 Photo of pipe repair (SME.0001.0001.0047).

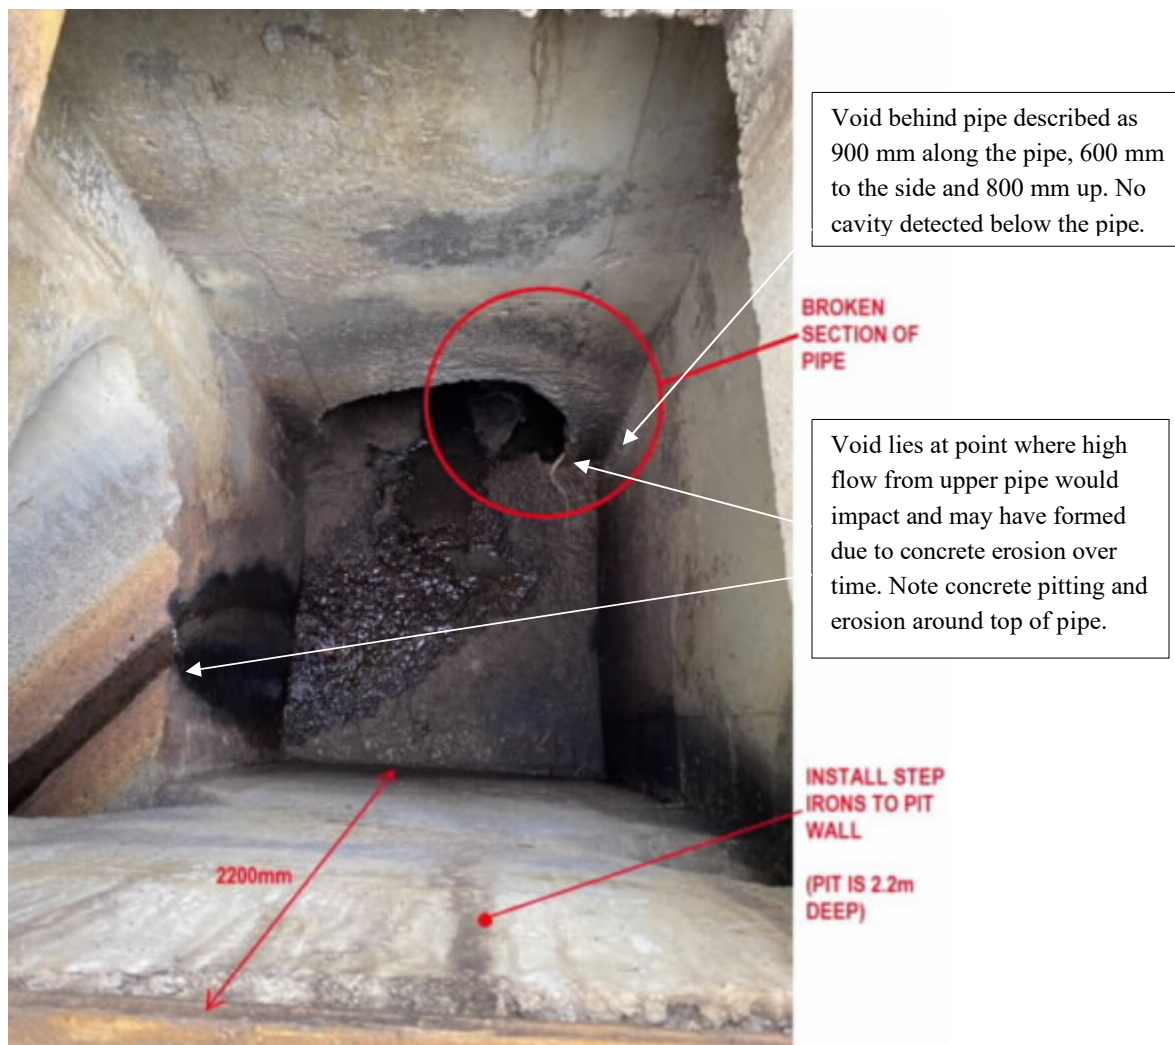
Figure 8.22 Breach in stormwater pipe and associated void formation adjacent to stormwater pipe at 25 Coburn Avenue observed in March 2025. Mornington Peninsula Shire annotations in red, my annotations in white (MSC.5031.0001.4490).

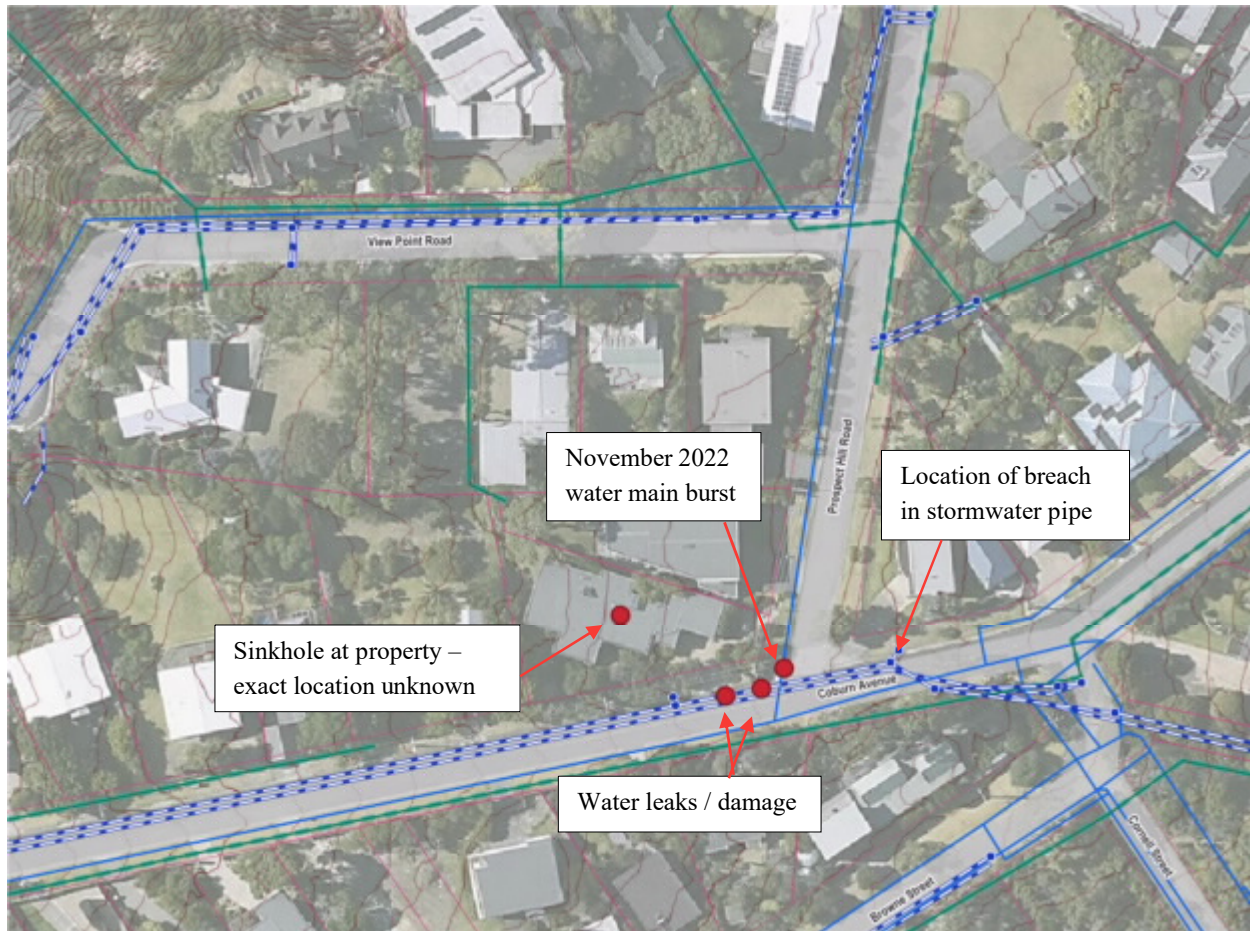
Figure 8.23 Location of stormwater pipe breach and adjacent impact of adjacent water main burst in 2022 (compiled from information provided in (SEW.0001.0001.0142).

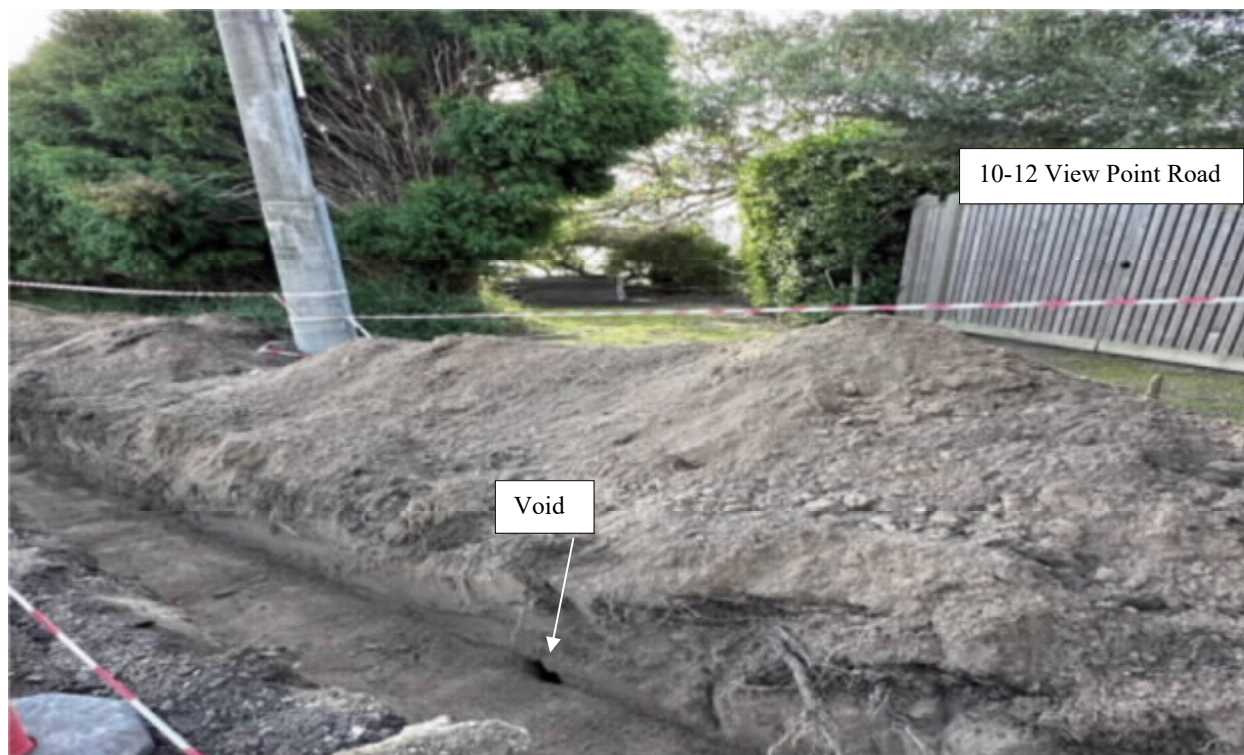
Figure 8.24 Image taken during excavation works for stormwater upgrade on View Point Road in 2023. Void observed within excavated trench (RES.0001.0003.0001).

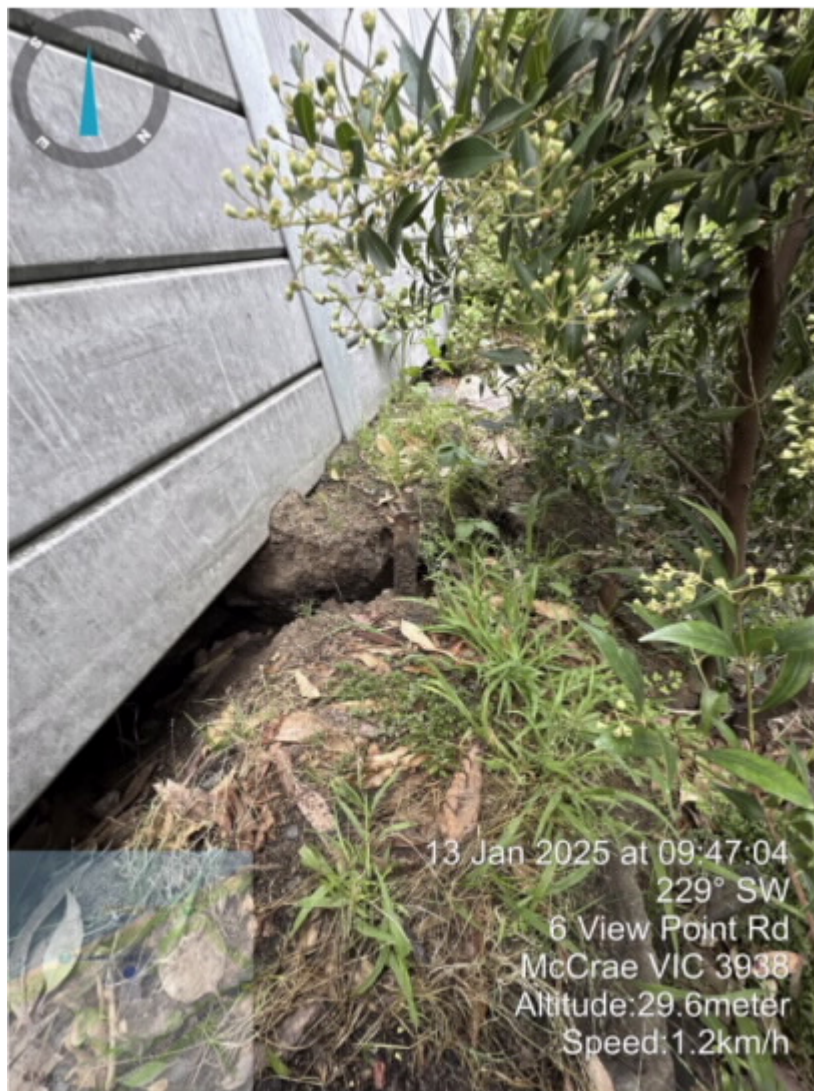
Figure 8.35 Tension Cracking at toe of retaining wall at 10-12 View Point Road (MSC.5035.0001.0033)

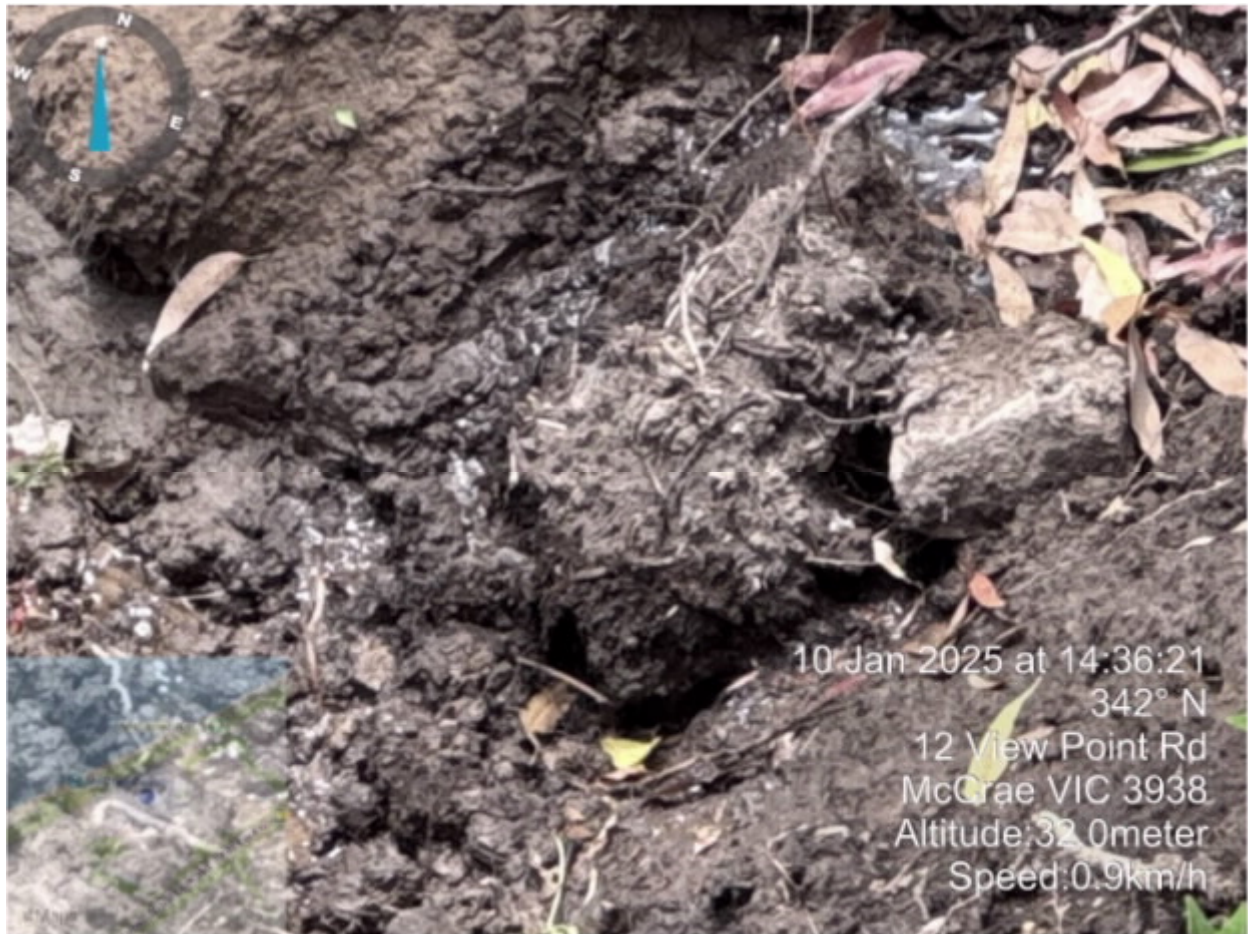
Figure 8.36 Water seeping from escarpment at 10-12 View Point Road (MSC.5035.0001.0022)

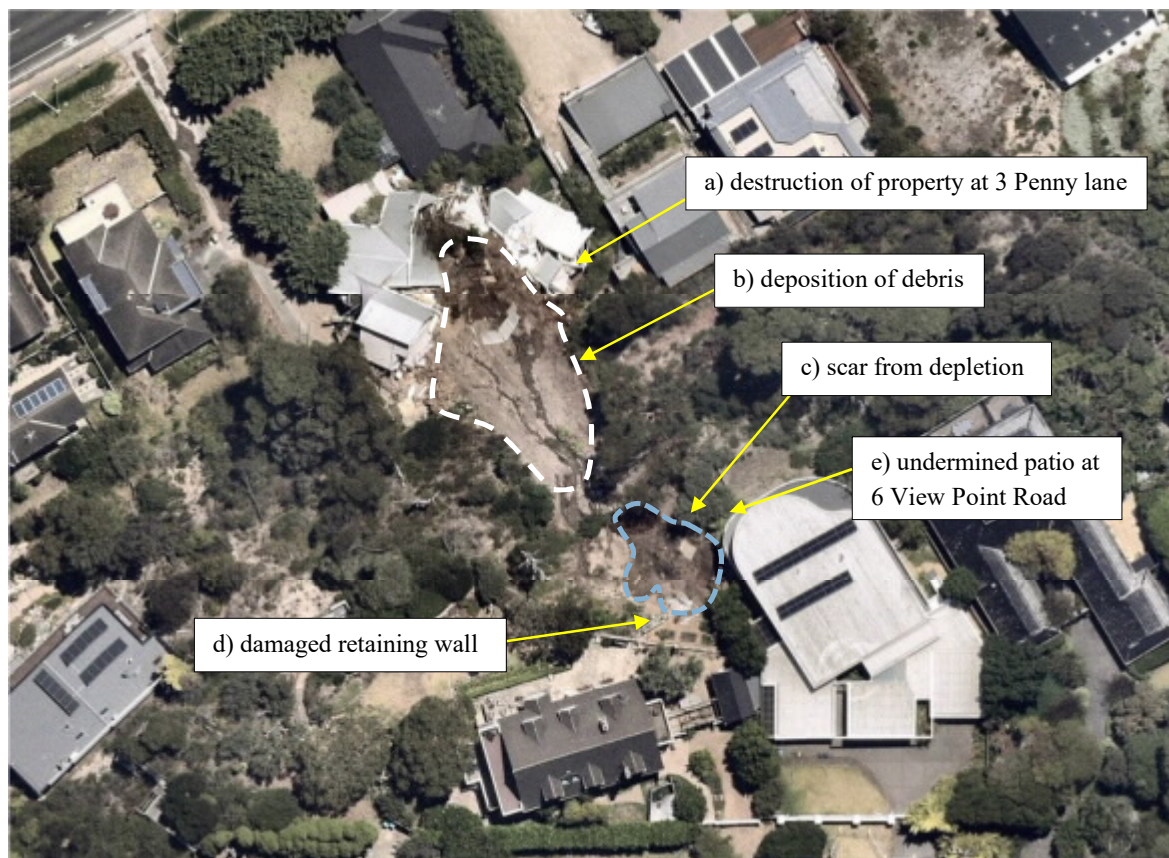
Figure 9.1 Annotated plan showing key damage caused by the 2025 landslide
