Leak Report

17 Charles Street McCrae Victoria 3938 Australia

Service Stream

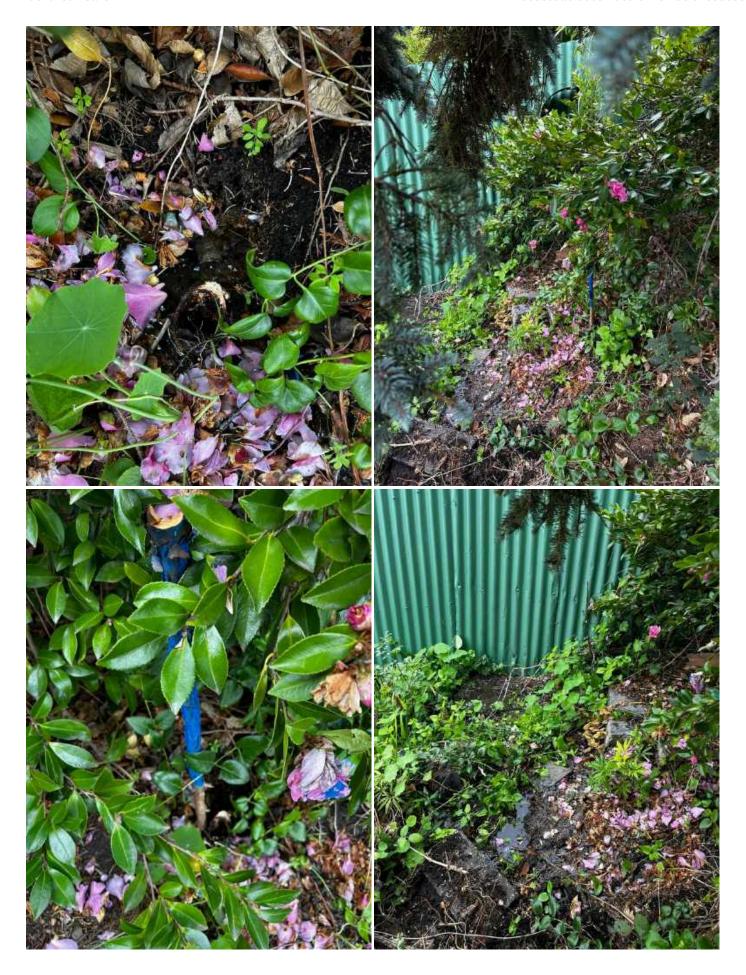
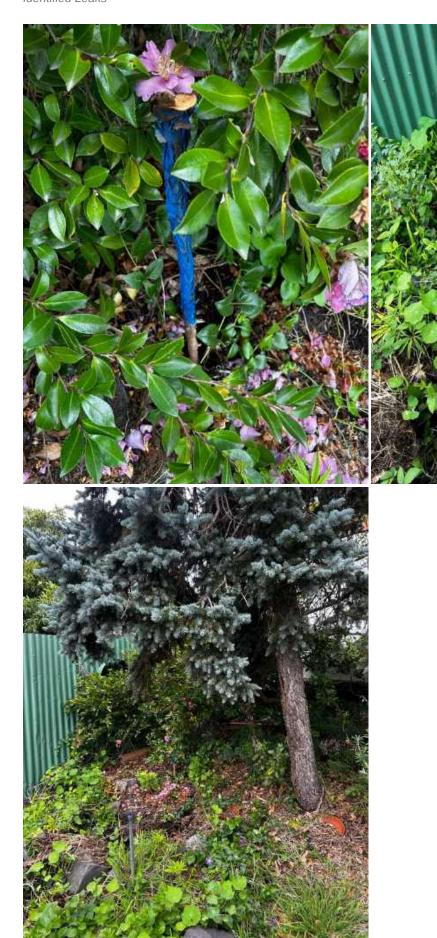
Went around the have of the property and there wad couple of outside taps to sound and I narrowed down the leak between the first two outside taps. I then had a look around the first tap, and I walked a bit further around and could hear a leak noise, and then I saw water running down bank.

Please see the photos down below of location and leak, I have marked up the leak with a stick and sprayed it blue. I have isolated the supply again.
