Leak Report

22 William Street McCrae Victoria 3938 Australia

Downer

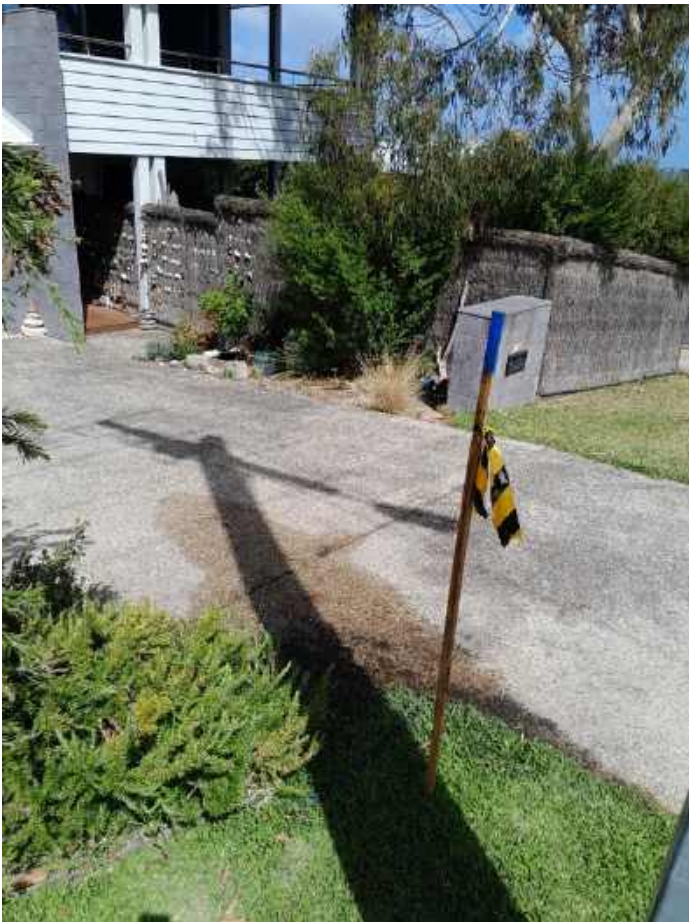
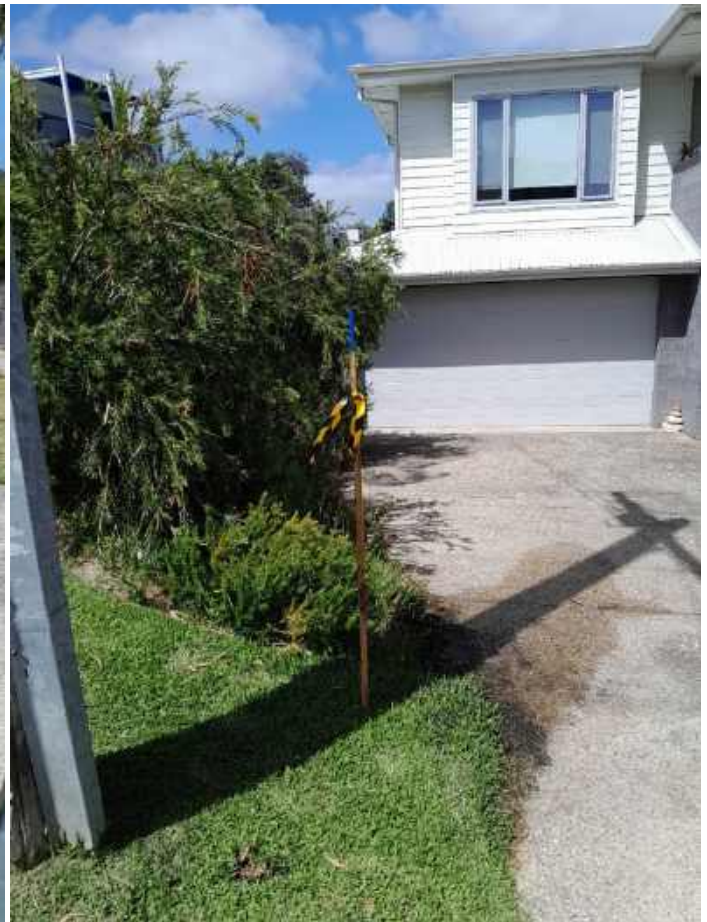
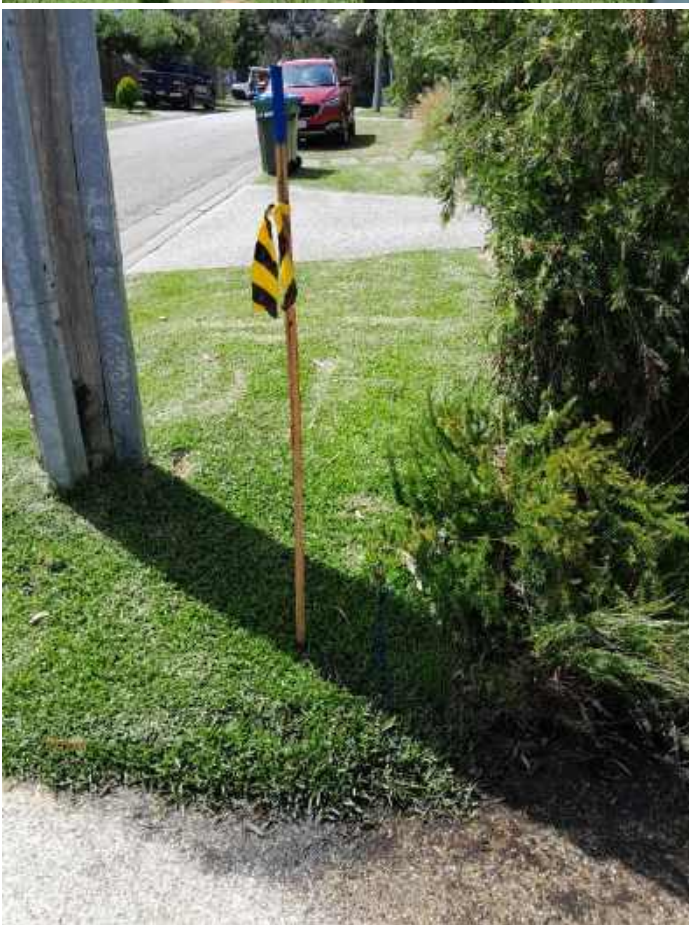
Photo

Suspect there's a small leak on the main here. I have ran a quick correlation here, but correlation didn't bring up anything, but there's not much noise here. There's only a very slight noise on the Fire plug further up.

I have probed down in naturestrip, but I'm unable to get onto the main to listen directly as it's 80mm AC here, so im probably just missing the main. I did listen anyway, and I think I might be picking up the faintest of noise, but it's hard to tell.

This is directly in line with the main and its seeping down driveway now, and the customer is concerned due to the incident down Penny Lane. I think it's just a very small leak on the main here, and I'm just unable to hear it. I'm unable to test the water myself.

Suggest excavating around wet patch to expose main.
