Leak Report

23 Flinders Street McCrae Victoria 3938 Australia

South East Water

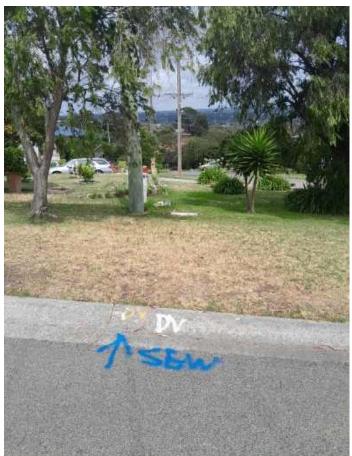
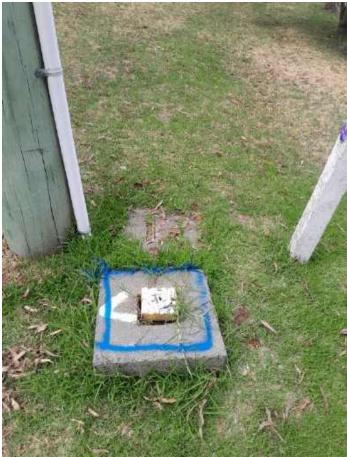
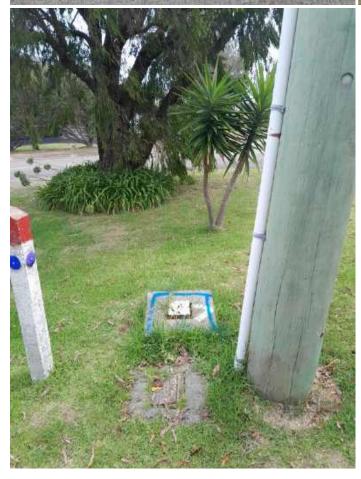
Photo

Lear Address	McCrae Victoria 3938 Australia
Zone	South East Water ► Reactive Leaks
Leak Asset Type	Valve
Flow Rate (L/min)	0.5
Has the leak been called in by DS Technician?	No
Job Ref	NA
Leak Visible	No
Comments	Suspected leak on valve. Picking up noise on valve and hydrant next to it hasn't got much noise on it. Managed to get the valve cover off, and there's no leak showing, but it's very saturated/wet in valve chamber when probing with FSB.
