# Leak Report

## 37 Somers Avenue McCrae Victoria 3938 Australia

#### **PROJECT**

☐ Service Stream

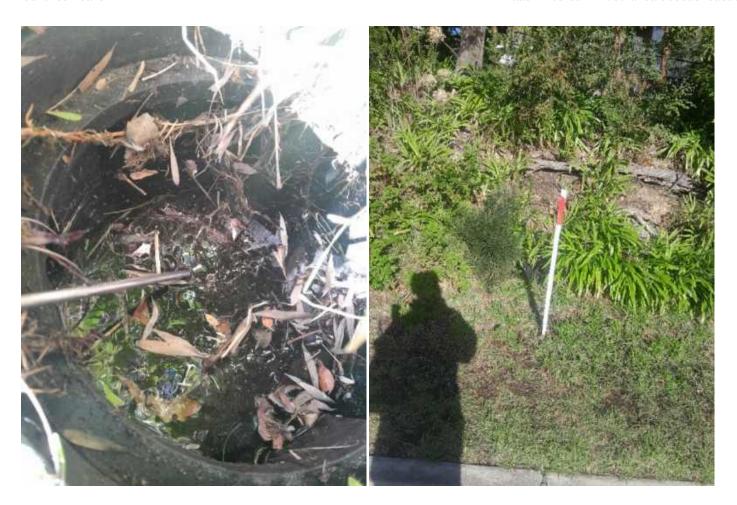
McCrae Victoria 3938 Australia
Zone	South East Water ▶ Parkes St Tank Zone
Leak Asset Type	Hydrant
Flow Rate (L/min)	0.3
Has the leak been called in by DS Technician?	No
Leak Visible	No
Comments	Ground hydrant leaking from ball
